APPENDIX H

Erosion Inventory and Assessment Information

Ayr, ON - Watercourse Erosion Inventory and Assessment

Watercourse Erosion Inventory and Assessment
Ayr, ON
County of North Dumfries

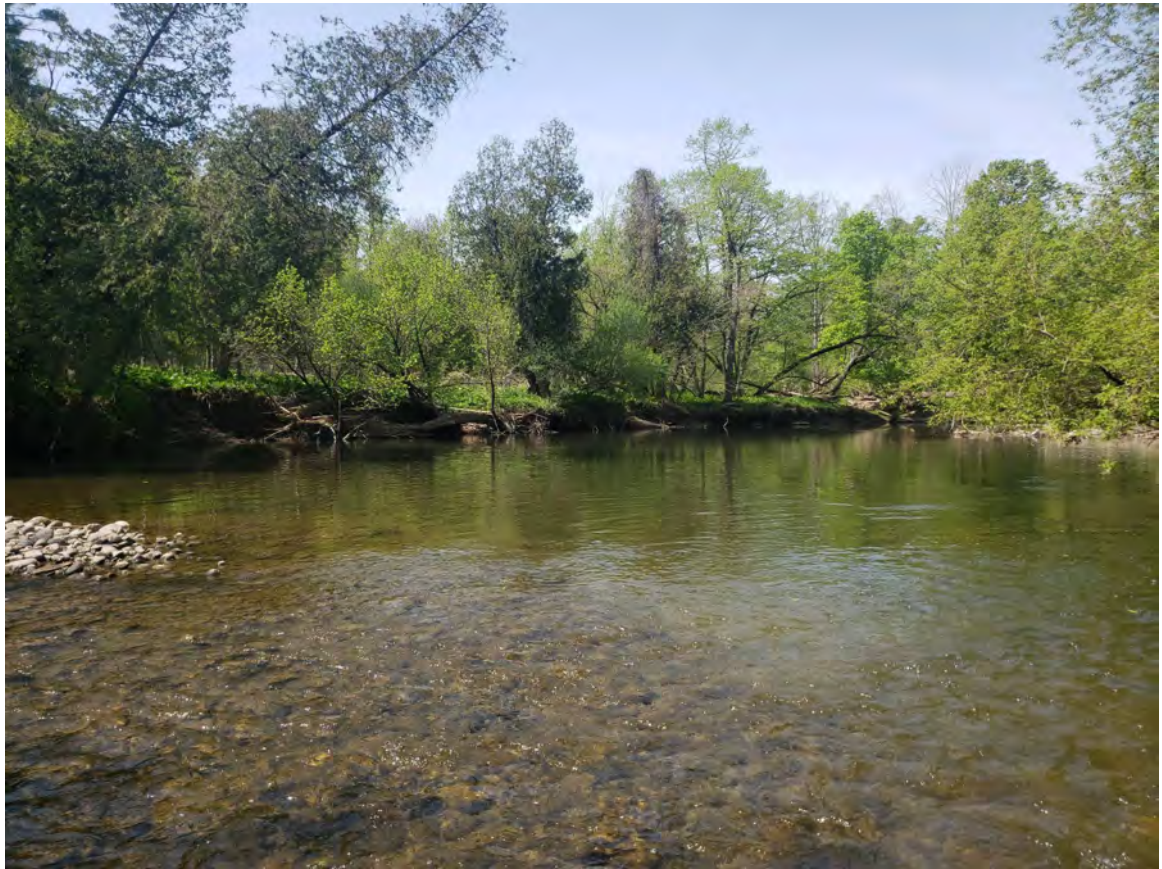
Nith River 4-2_Bank Undercutting_PS(2)_1.jpeg

undercutting occurs on the south side of the river. river very shallow at this area, ~1/2 foot at deepest.

EROSION TYPE(S)	SEVERITY	N	E	Z	PTID
Bank Undercutting	3 - Major	4791987.41	544502.61	278.359	41

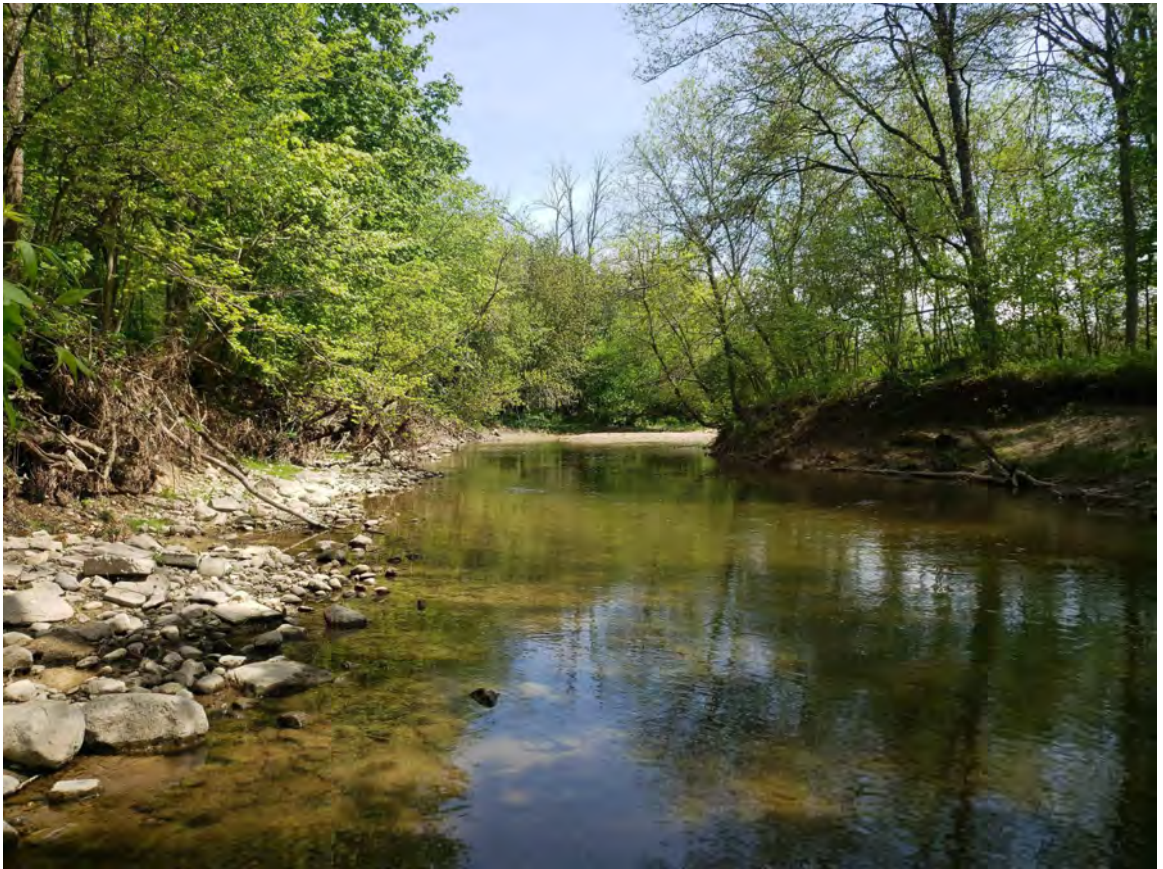
Nith River 4-2_Bank Undercutting_PS(3)_1.jpeg

bank undercutting occurs on both sides of the bank. Northside is connected to homeowner's backyard.

EROSION TYPE(S)	SEVERITY	N	E	Z	PTID
Bank Undercutting	3-Major	4792144.96	544430.19	277.642	42

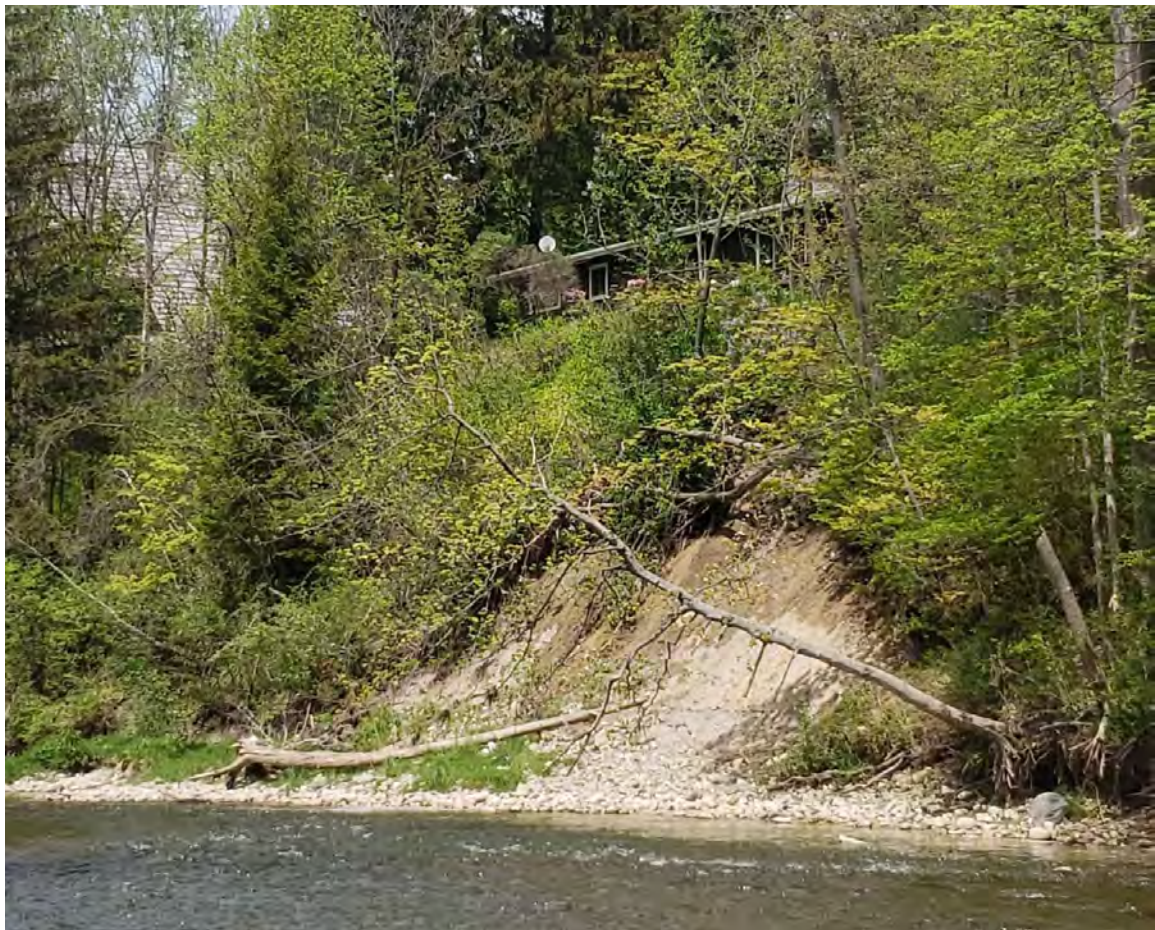
Nith River 4-4_slumping_PS(1)_1.jpeg

Active erosion, signs of slope instability near backyard of private residence-close to house.

EROSION TYPE(S)	SEVERITY	N	E	Z	PTID
Active Bank Erosion	4- Safety Hazard	4792369.47183	543892.977405		48

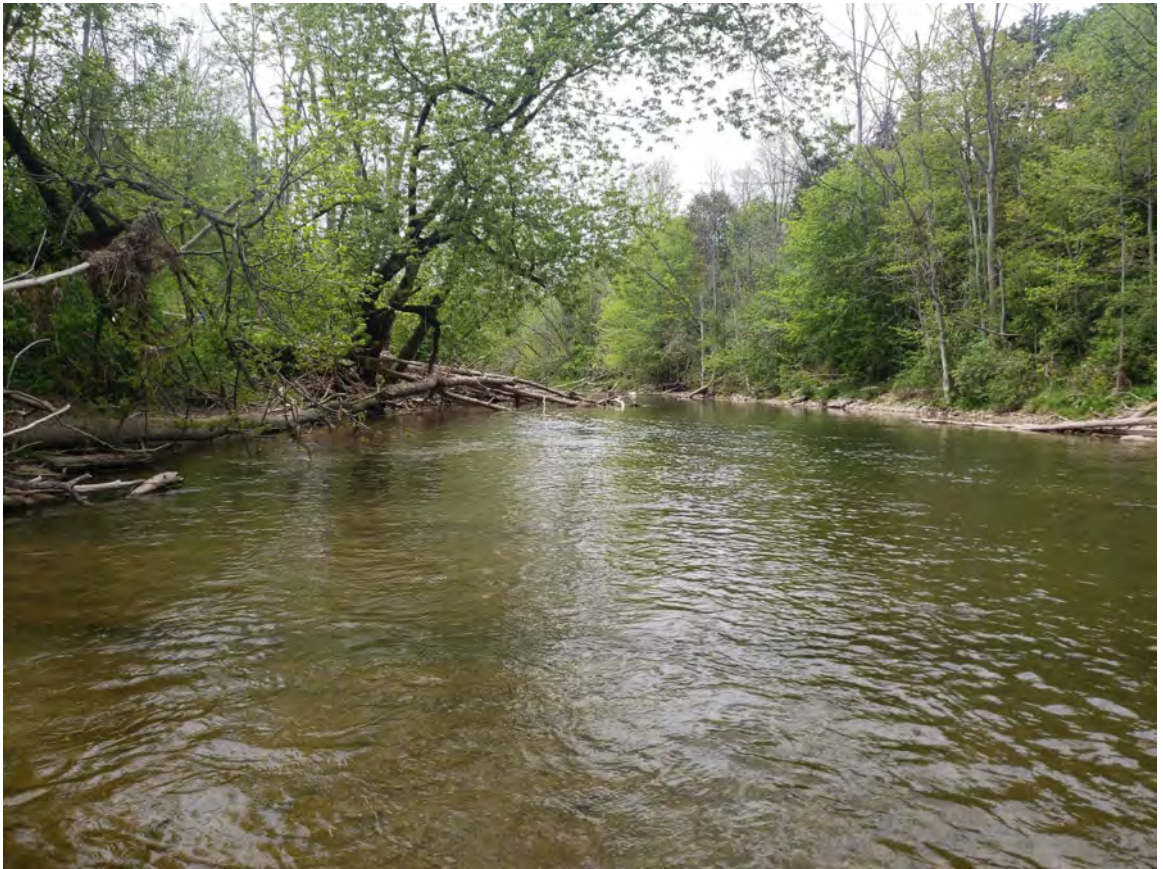
Nift River 4-4_ Log_Debris Jam _PS(2)_1.jpeg

log debris take up approximately 1/3 of the width of the river. Some bank undercutting /active bank erosion also beginning in this location with signs of bank instability.

EROSION TYPE(S)	SEVERITY	N	E	Z	PTID
Log/Debris Jam	3- Major	4792449.49557	543808.213585		49

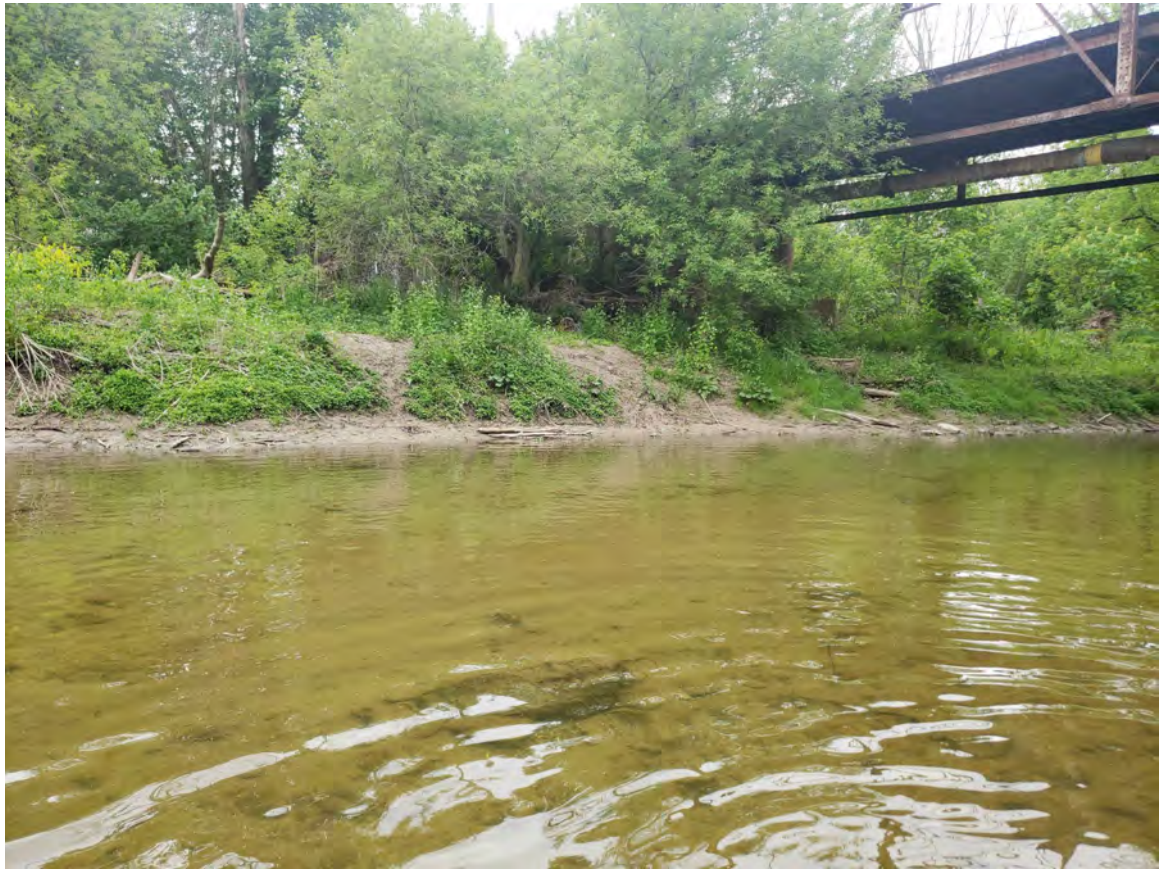
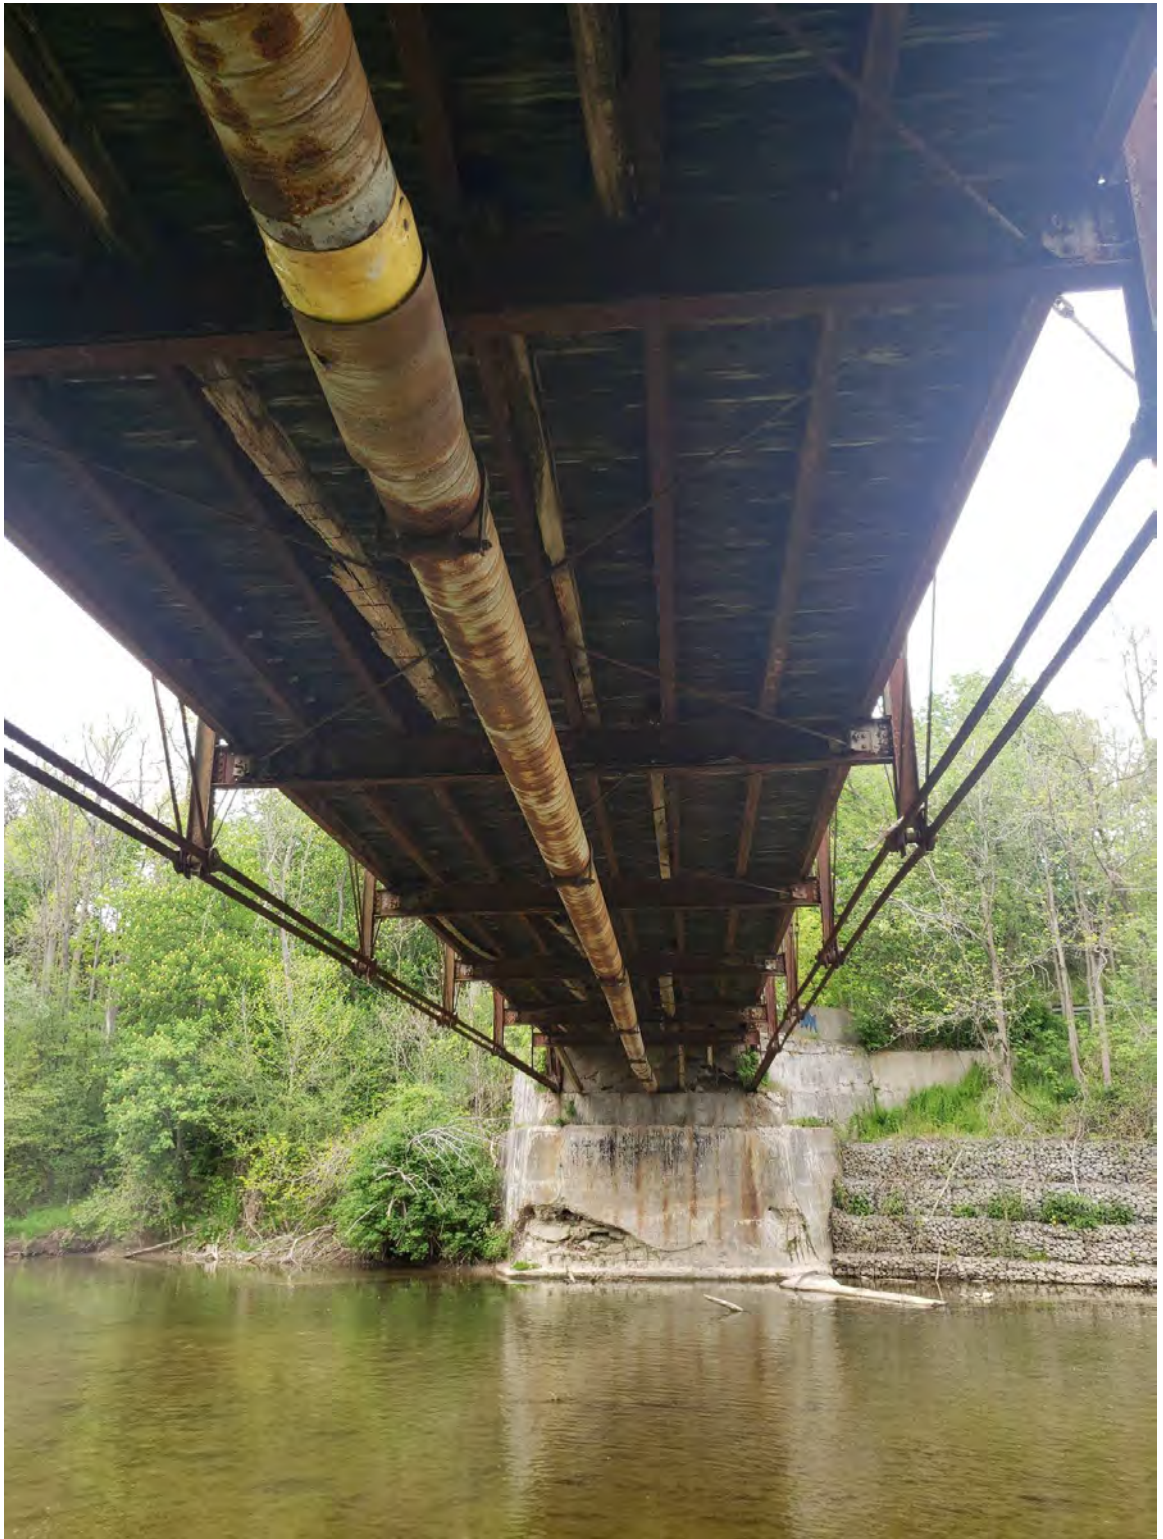
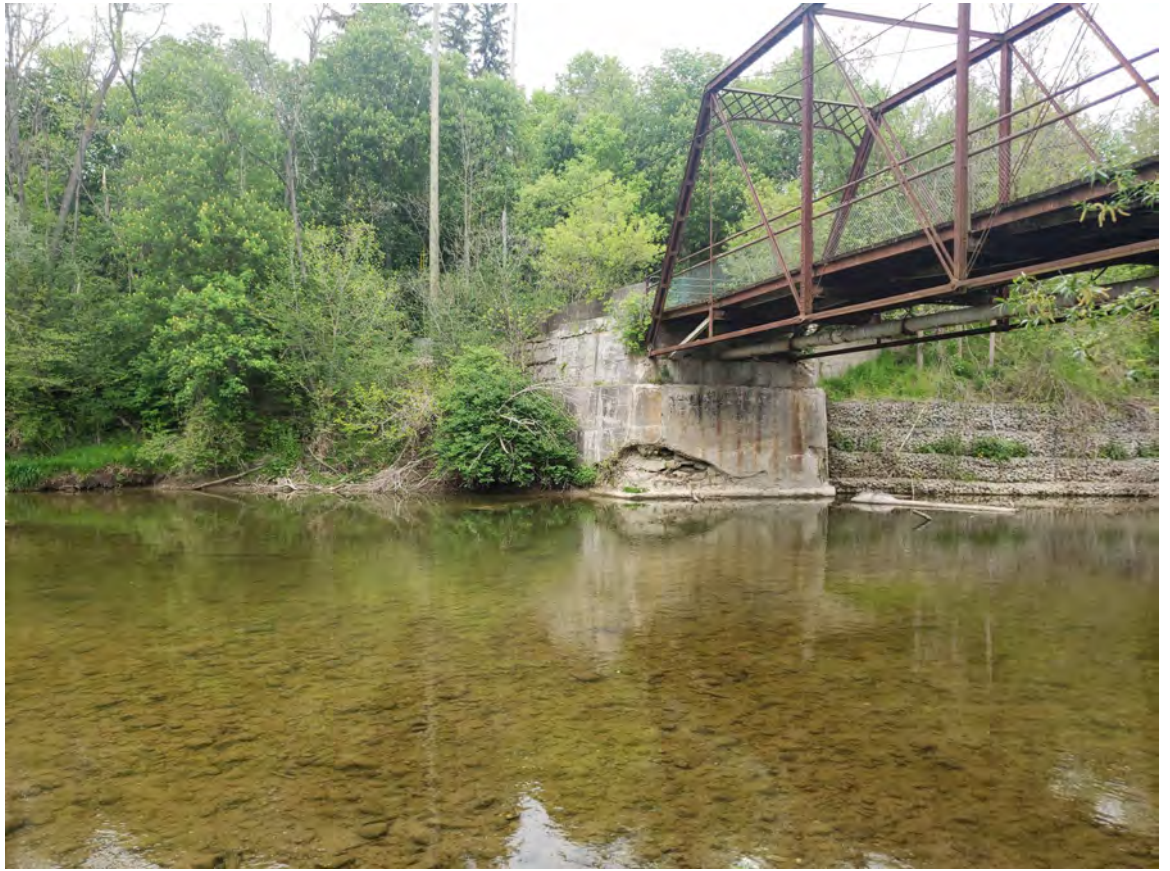
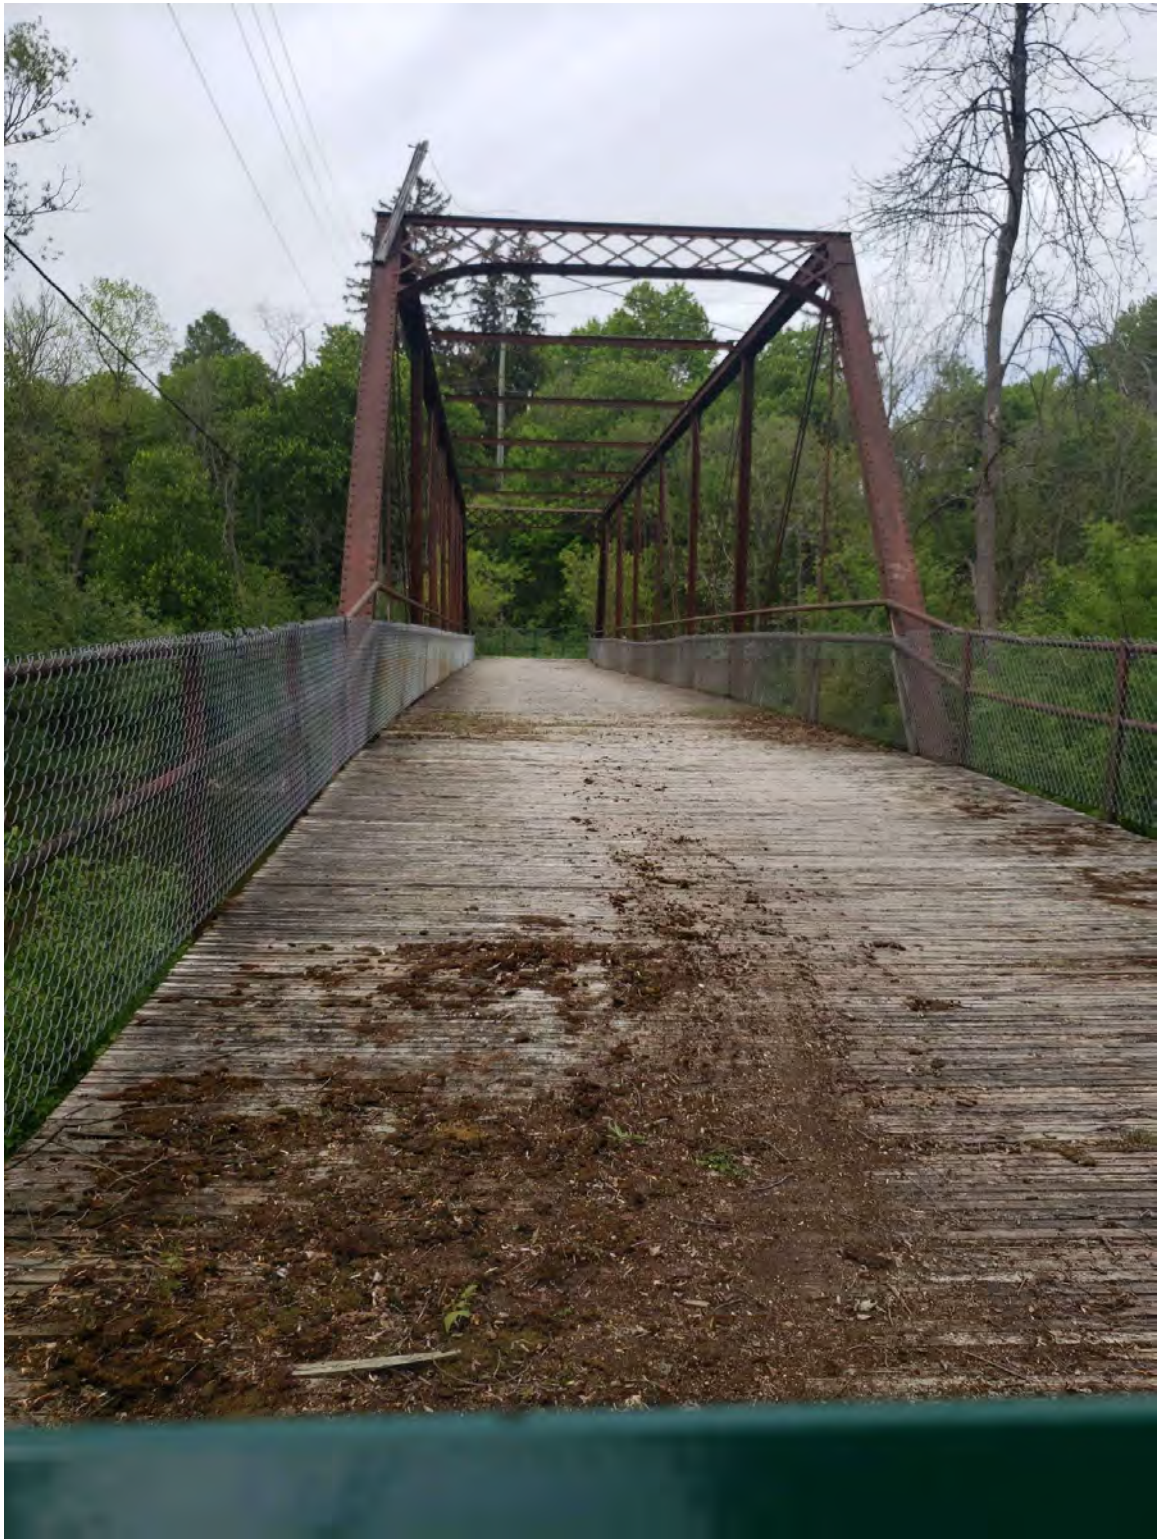
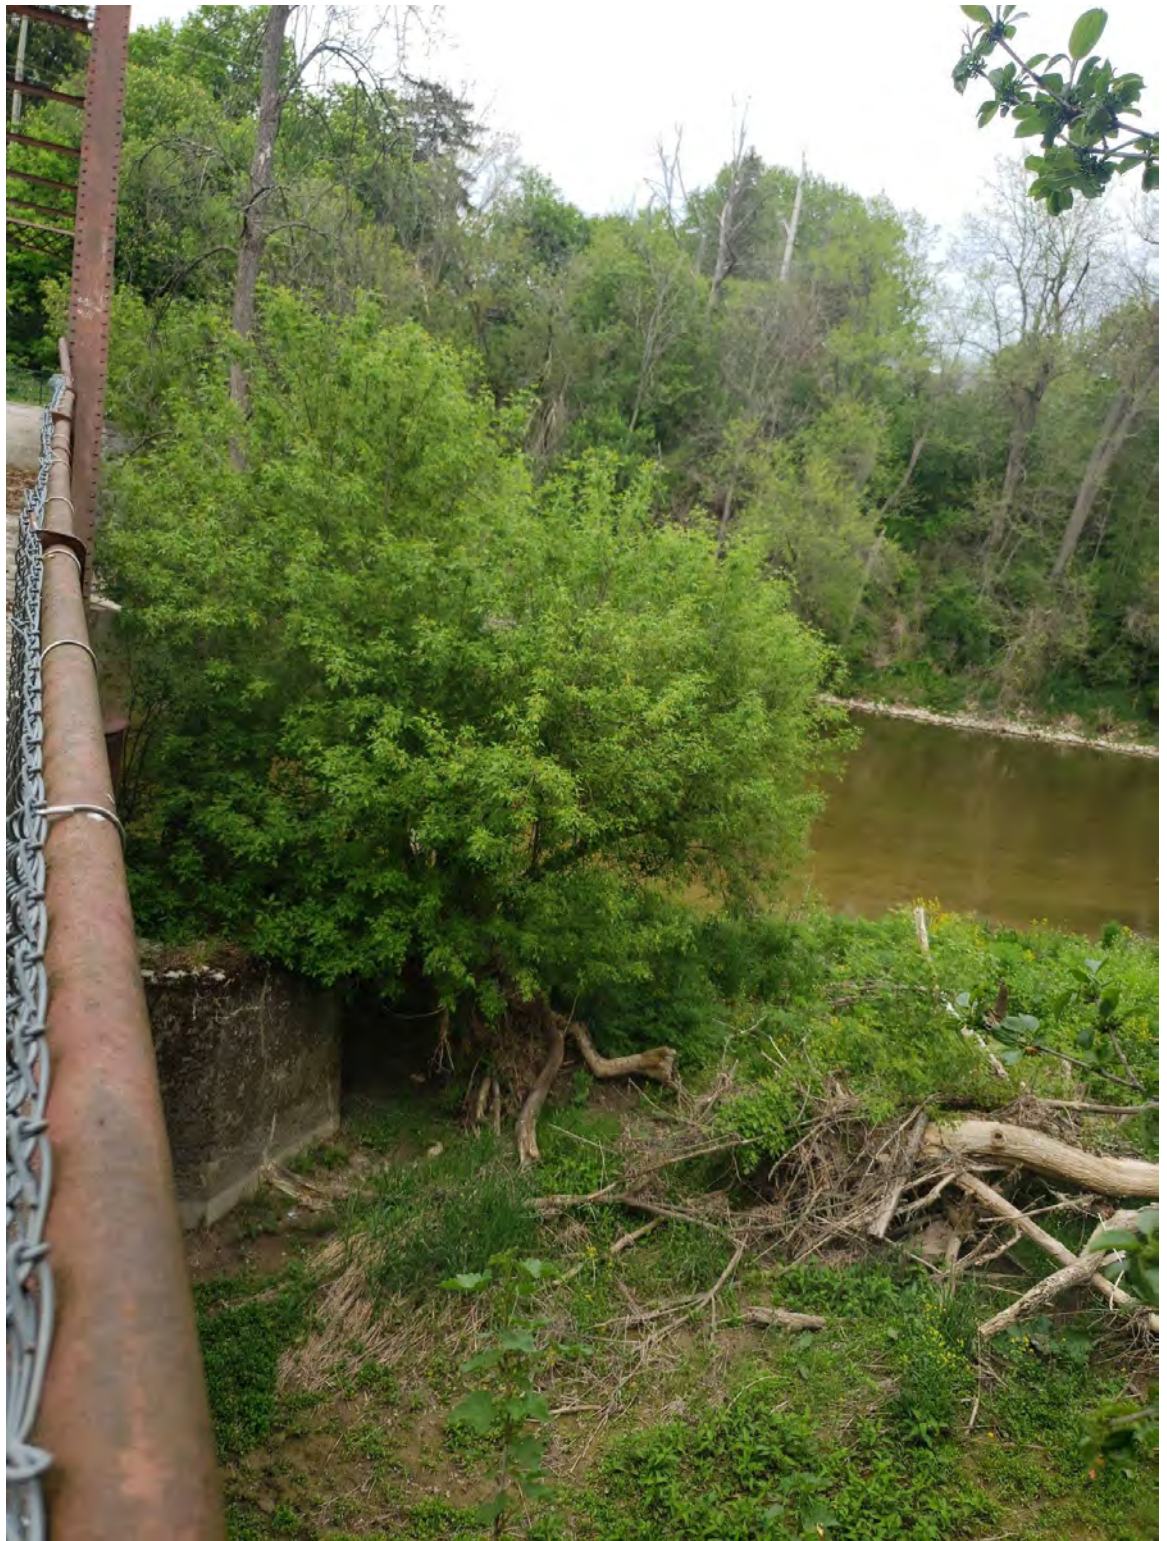
Bridge in state of disrepair – structural damage to concrete footings. Tree debris and vegetation taking root on gabion wall on south side of bridge.

EROSION TYPE(S)	SEVERITY	N	E	Z	PTID
Structural damage - bridge	4- Safety Hazard	4792503.58827	543594.352237		50

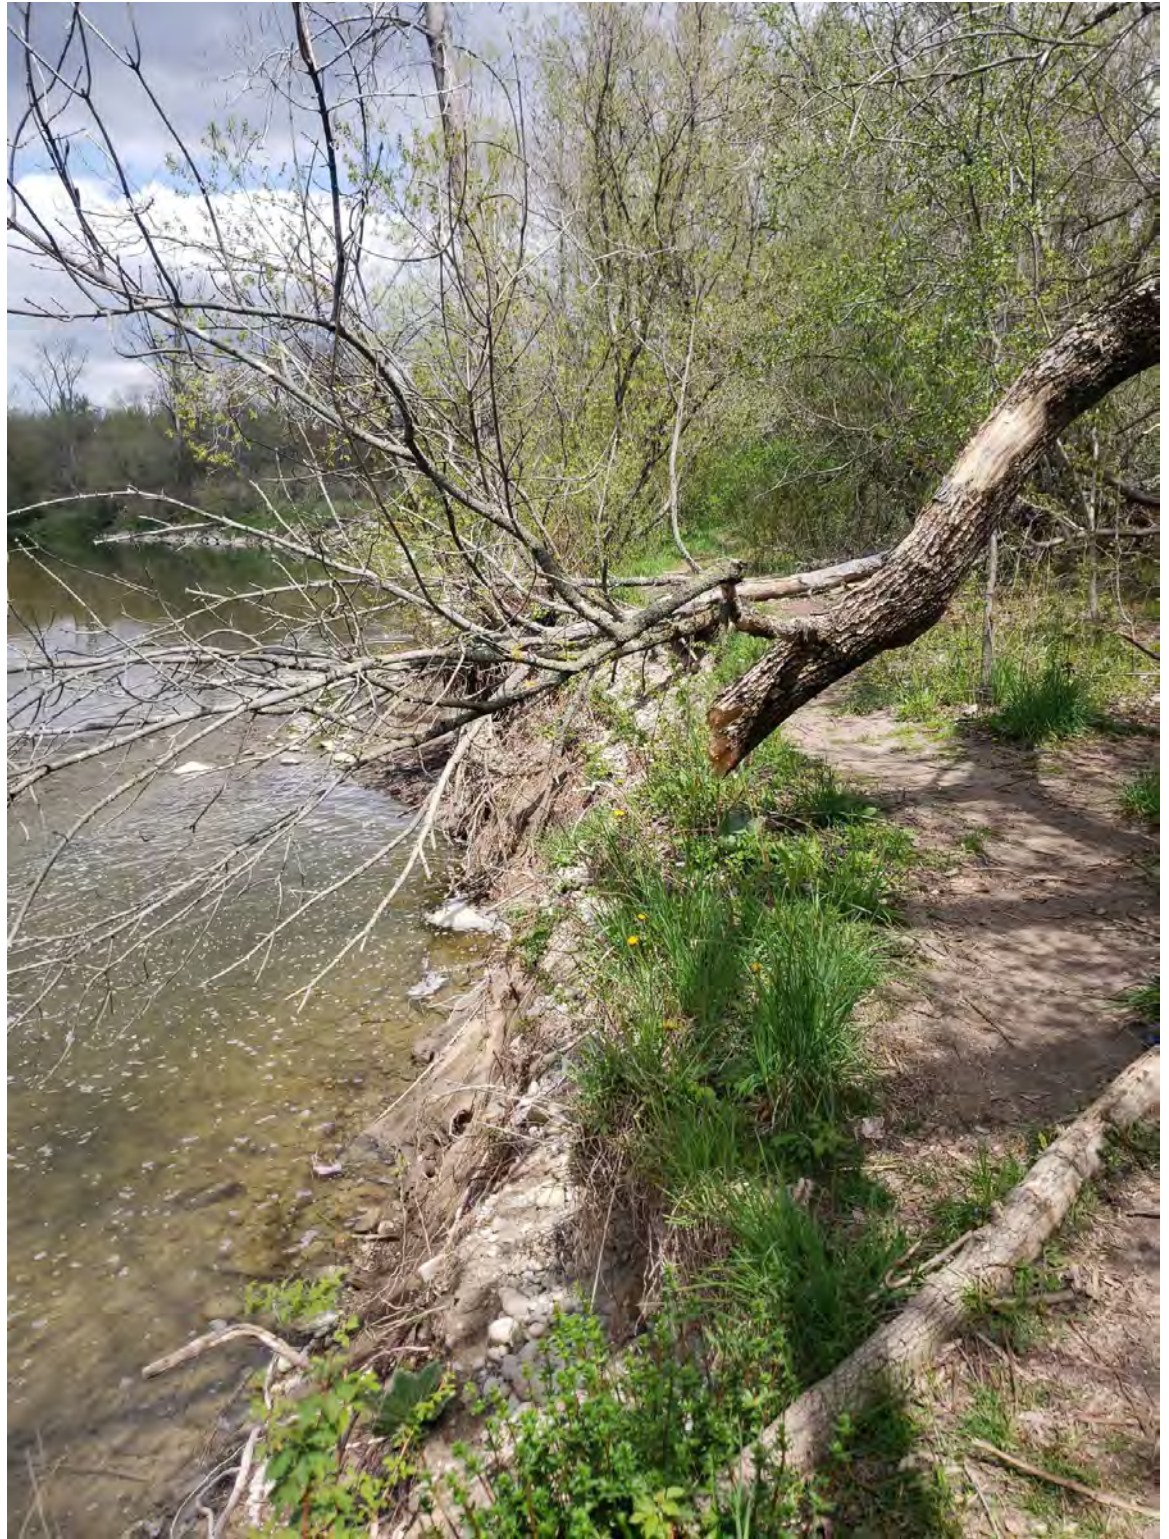
Ayr Section 1-2_Bank Undercutting_PS(1)_2.jpeg

Bank undercutting occurring very close to footpath

EROSION TYPE(S)	SEVERITY	N	E	Z	PTID
Bank Undercutting	4- Safety Hazard	4793696.07	543169.09	284.412	1

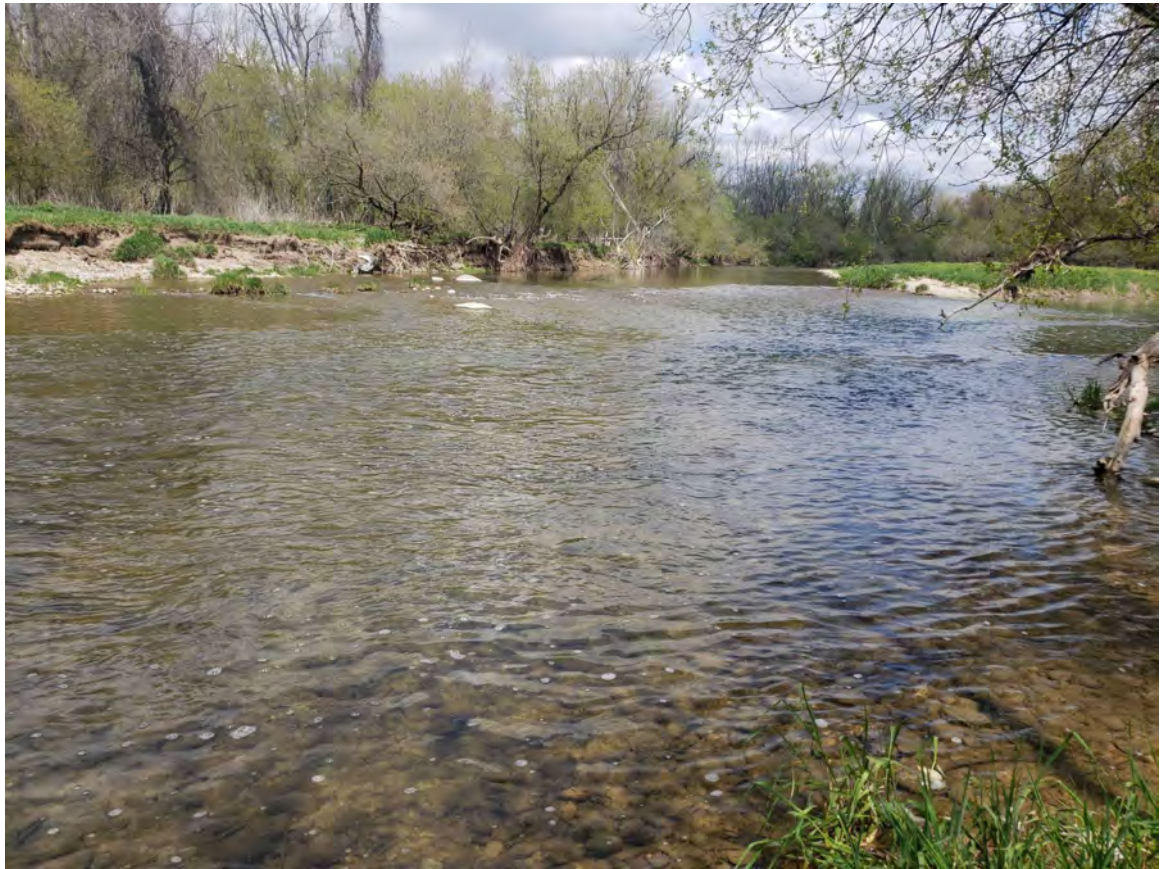
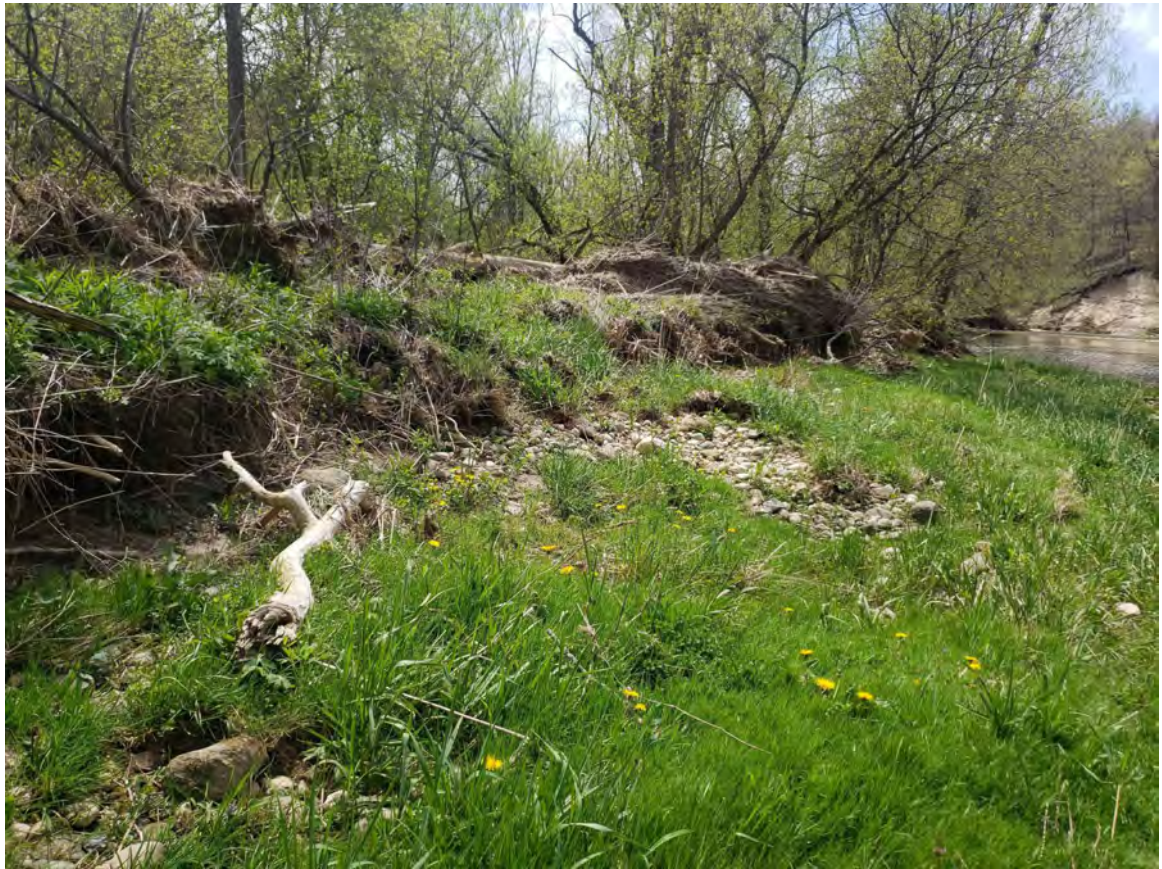
Undercutting of bank and dead vegetation / debris falling into main channel. Evidence of river overtopping bank and flowing overland during high water levels, forms seasonal pond at PTID3.

EROSION TYPE(S)	SEVERITY	N	E	Z	PTID
Bank Undercutting	2- Moderate	4793309.13	542993.56	281.755	2

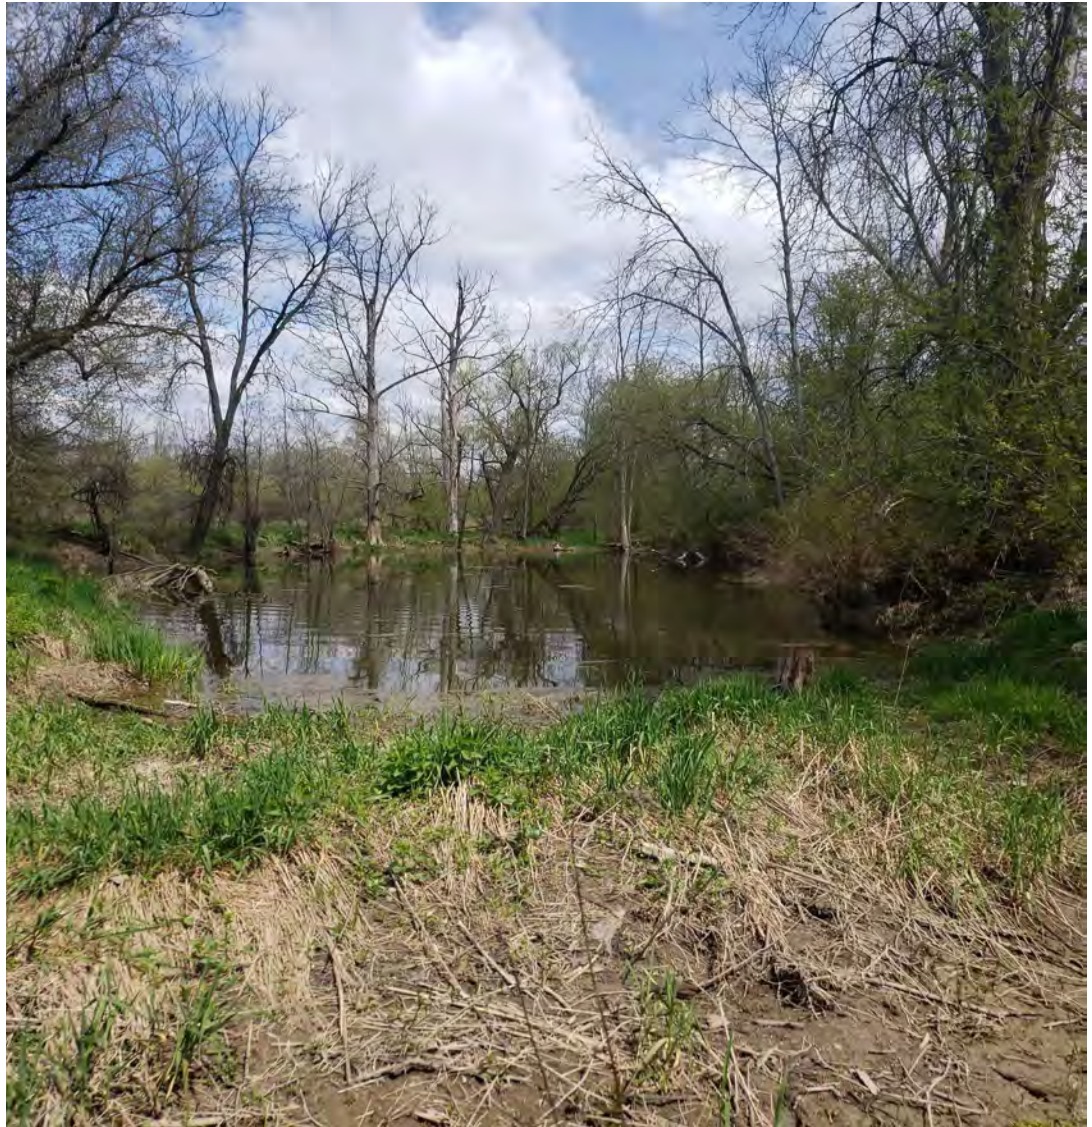
Ayr Section 1-2_Surface Scouring_PS(3)_1.jpeg

First photo facing north depicting inland surface scouring. Second photo facing south- dead vegetation likely resulting from seasonal flooding / high water levels.

EROSION TYPE(S)	SEVERITY	N	E	Z	PTID
Surface Scouring	1- Minor	4793154.79	542955.82	281.599	3

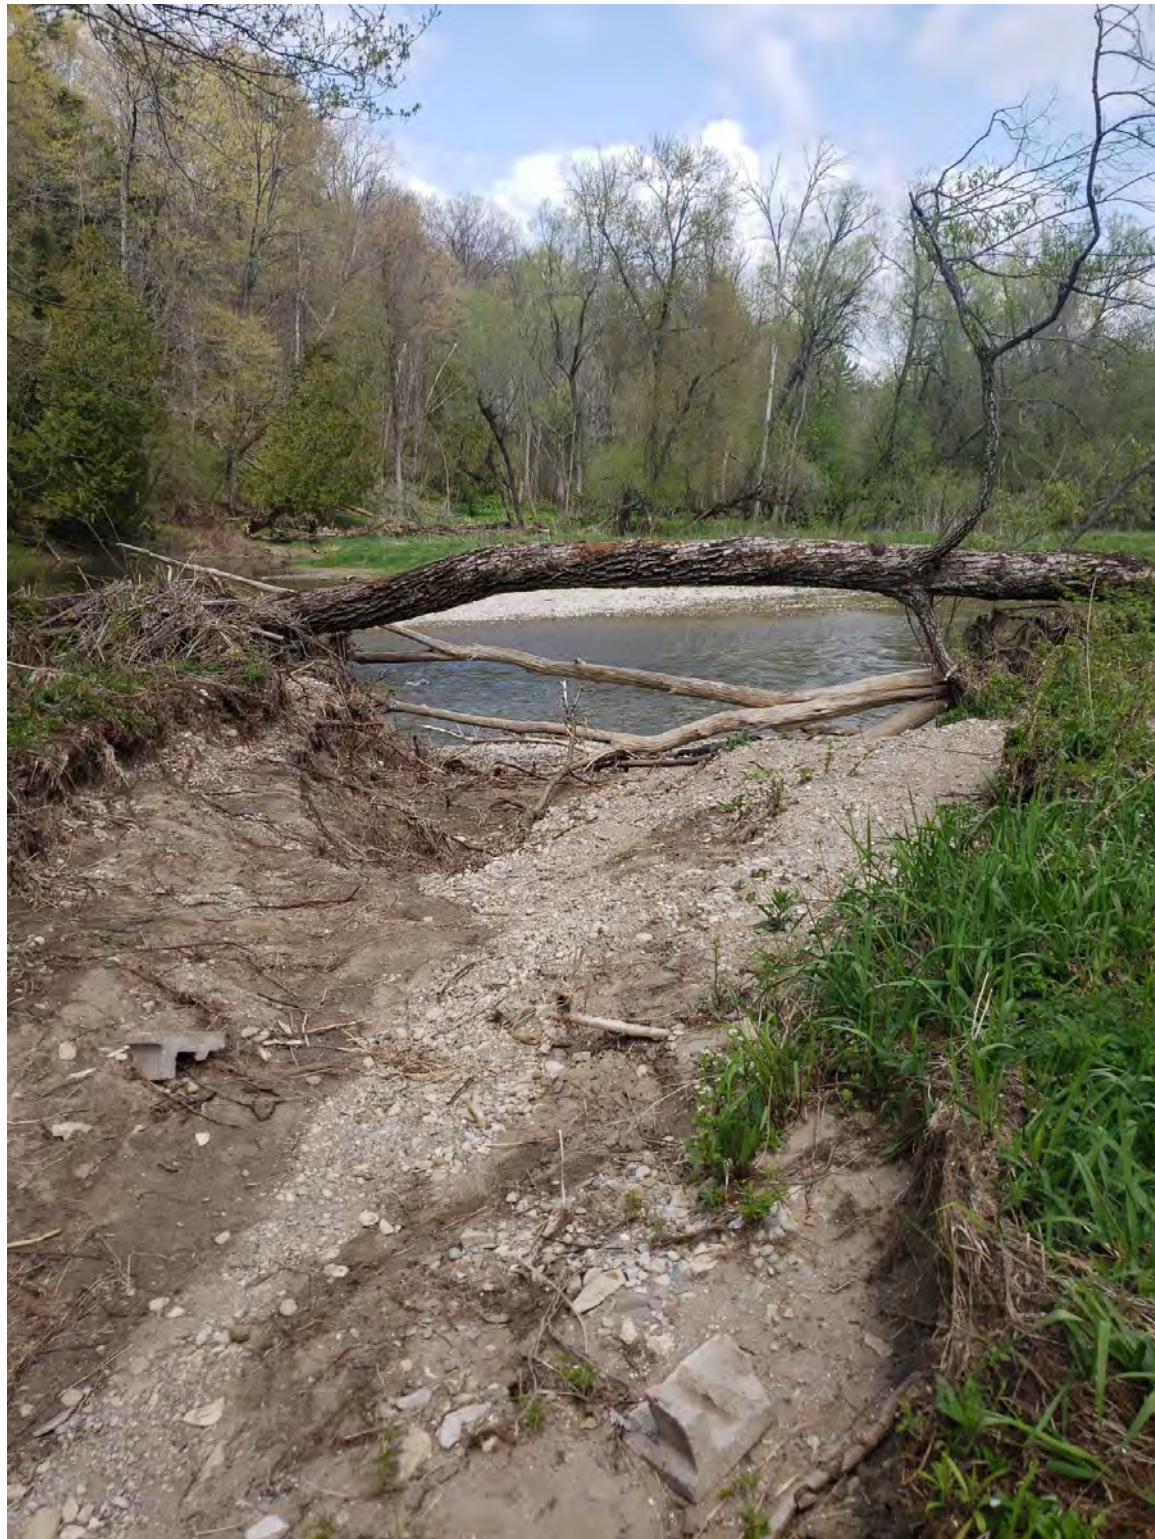
Ayr Section 1-1_Lateral Bank Erosion_PS(4)_1.jpeg

1st picture facing north depicts main lateral erosion site dead vegetation suggests during high water levels, water flowing overland (south) bypassing main channelized area. See the difference in log colours in photo 1. Dead vegetation unnaturally wraps around trees. Beginning of an outlet may be seen at PTID 6. 2nd and 3rd pictures are facing south.

EROSION TYPE(S)	SEVERITY	N	E	Z	PTID
Lateral Bank Erosion	2- Moderate	4793147.79	542908.79	282.54	4

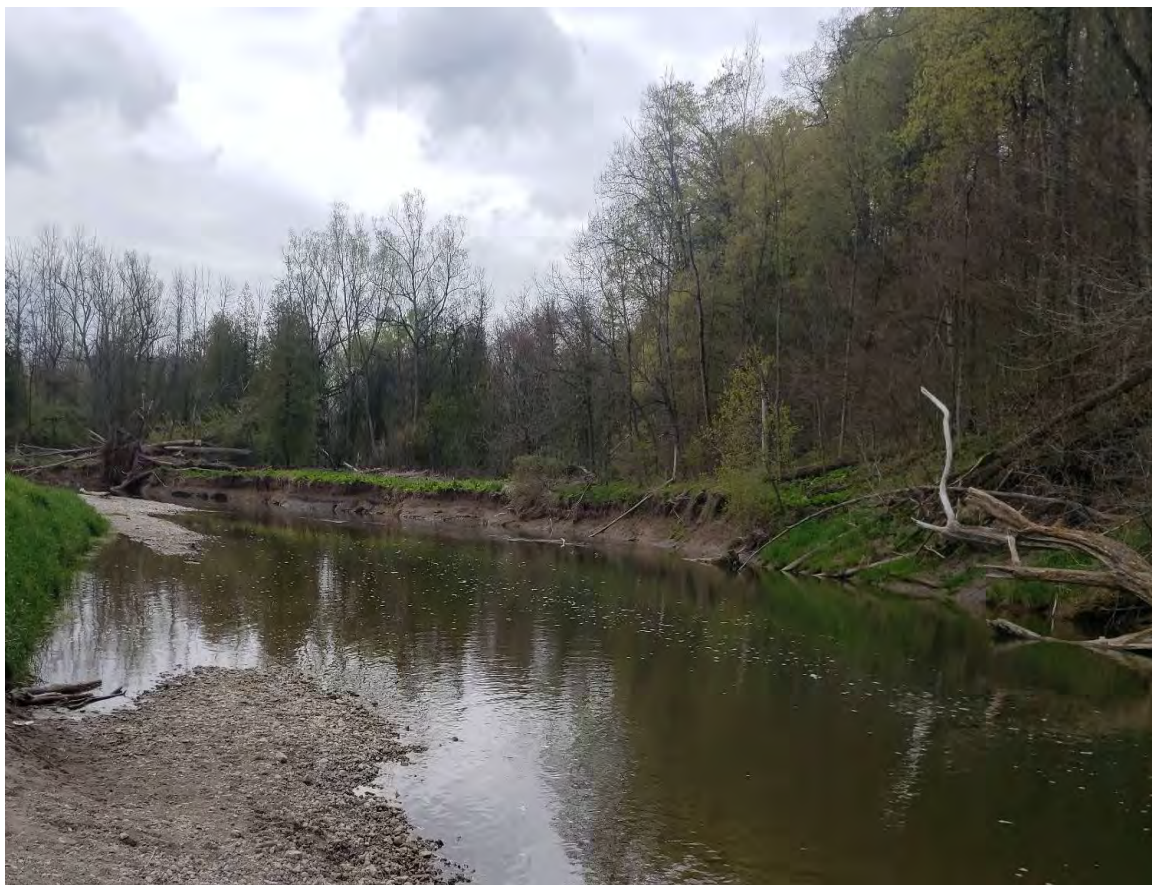
Ayr Section 1-1_bank undercut, bank slumping, log debris_PS(5)_1.jpeg

Additional information First picture facing south- bank undercut beginning to show. Second photo

facing NE, opposite bank slumping with fallen log debris collecting within channel. Large trees at top of high bluff getting close to undercutting.

EROSION TYPE(S)	SEVERITY	N	E	Z	PTID
bank undercut, bank slumping, bank scour, log debris	3 - Major	4793110.23	542872.52	281.677	5

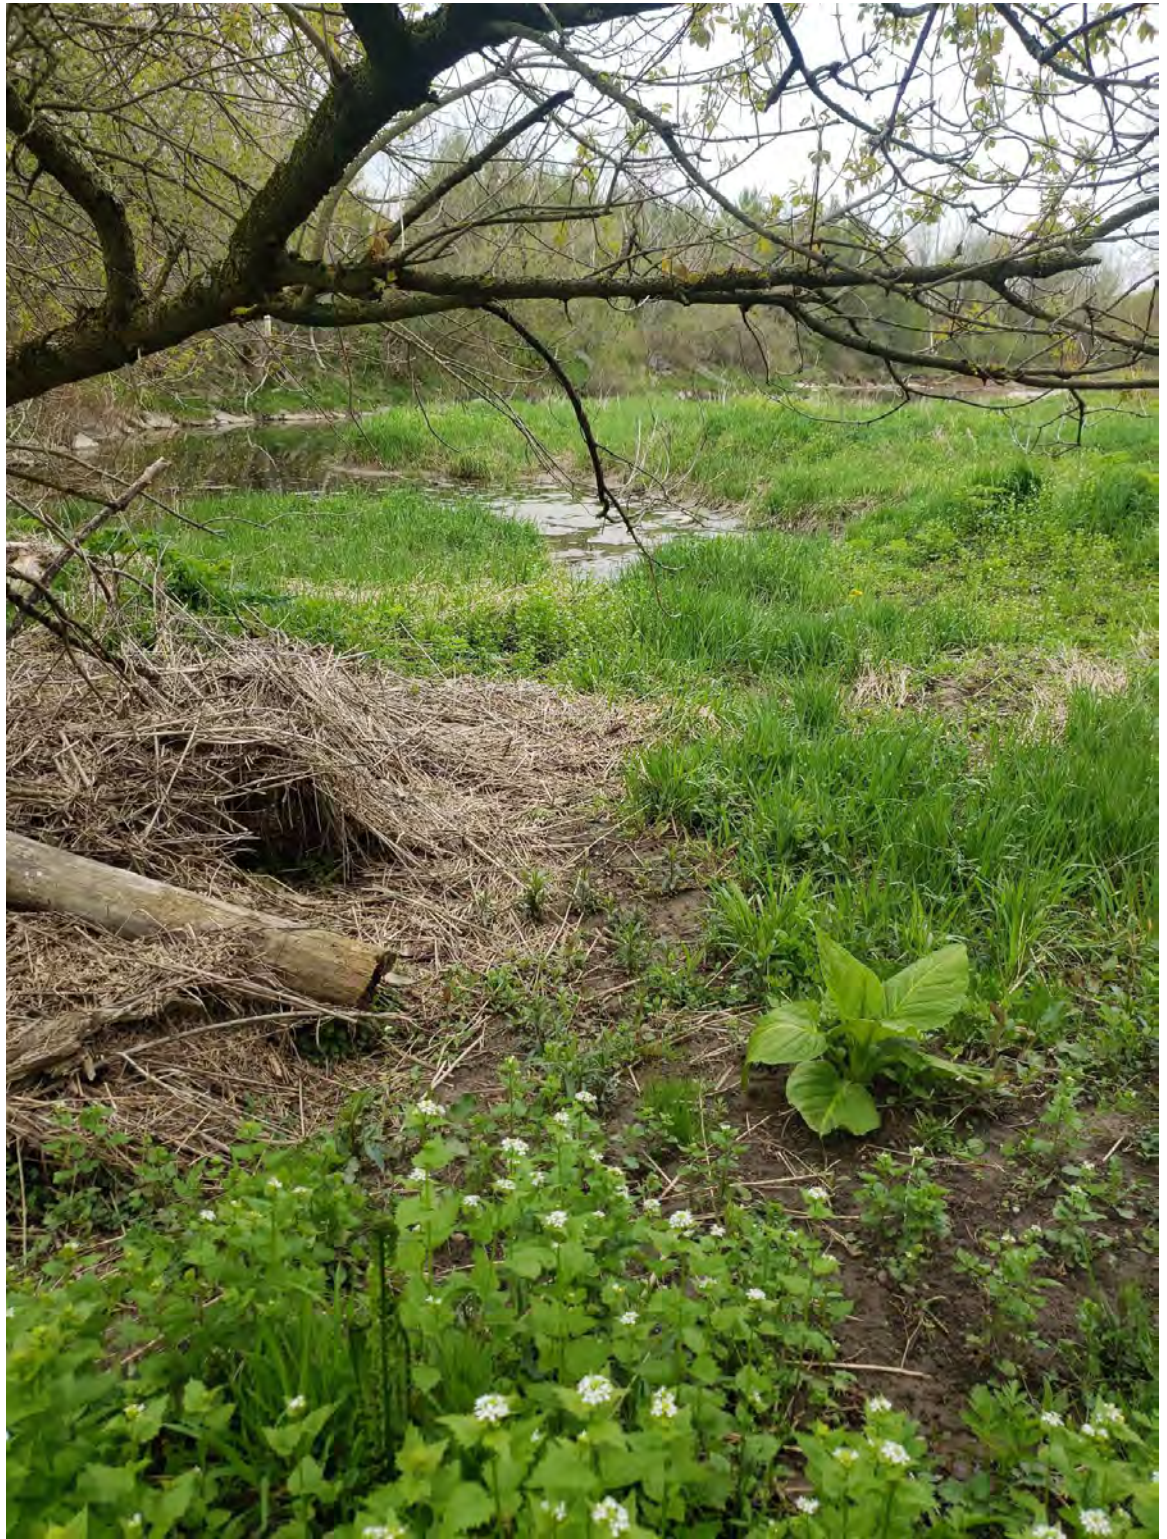
Ayr Section 1-1_Bank Scour_PS(1)_2.jpeg

Evidence of bank / surface scouring from footpath and sediment deposits in low flow pool (separate from main river). Photos facing south.

EROSION TYPE(S)	SEVERITY	N	E	Z	PTID
Bank Scour	1- Minor	4793093.28	542951.89	281.572	6

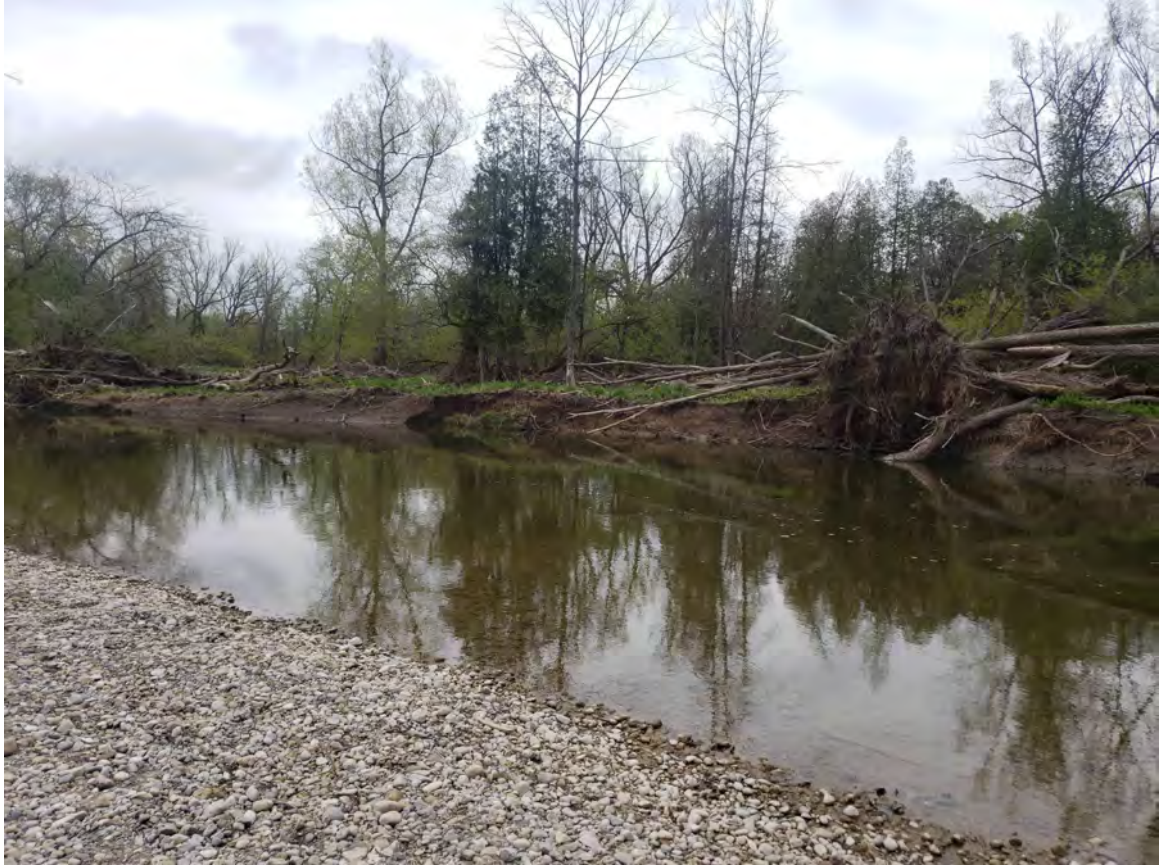
Ayr Section 1-1_bank undercut, and log_debris jam_PS(2)_1.jpeg

Additional information Erosion found on south bank of river. Minor log debris fallen into main channel from bank.

EROSION TYPE(S)	SEVERITY	N	E	Z	PTID
Bank Undercut	2- Moderate	4793022.84	542903.52	280.824	7
