APPENDIX H

Erosion Inventory and Assessment Information

Ayr, ON - Watercourse Erosion Inventory and Assessment

Watercourse Erosion Inventory and Assessment
Ayr, ON
County of North Dumfries

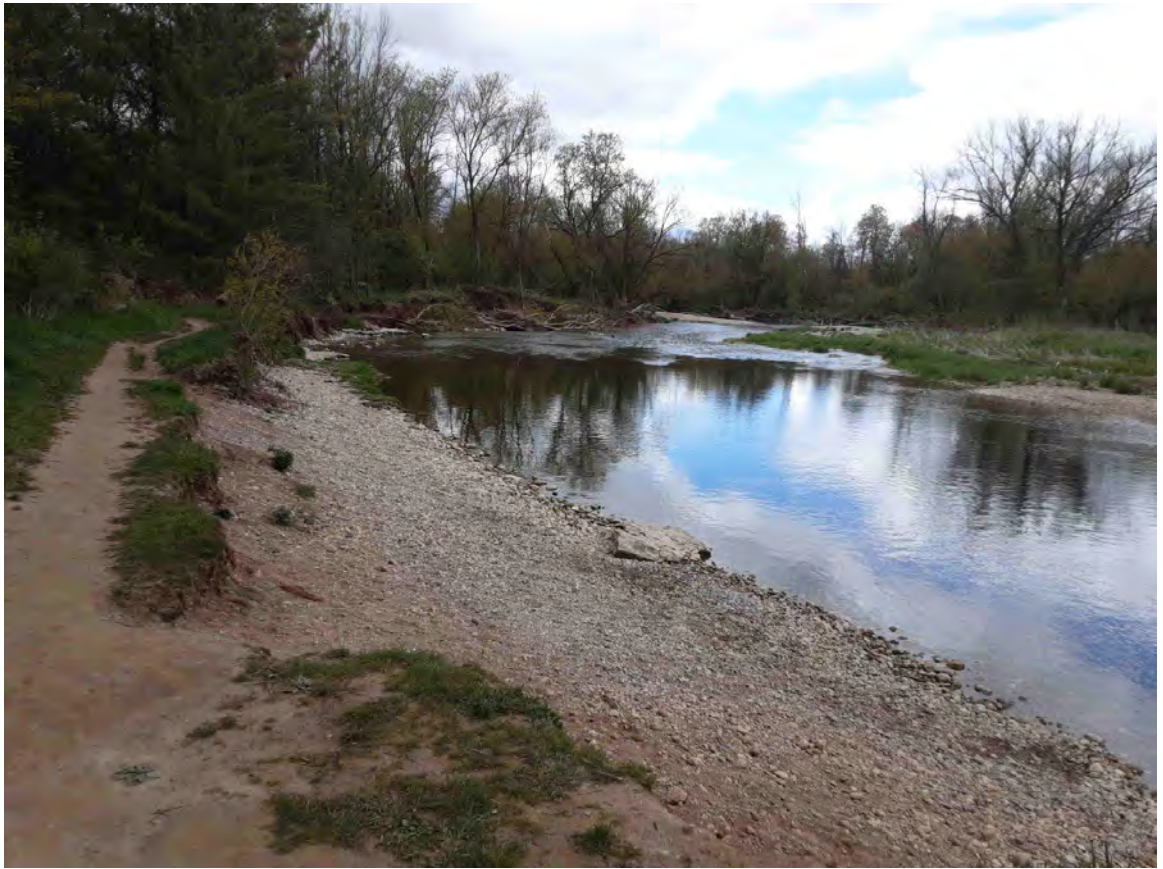
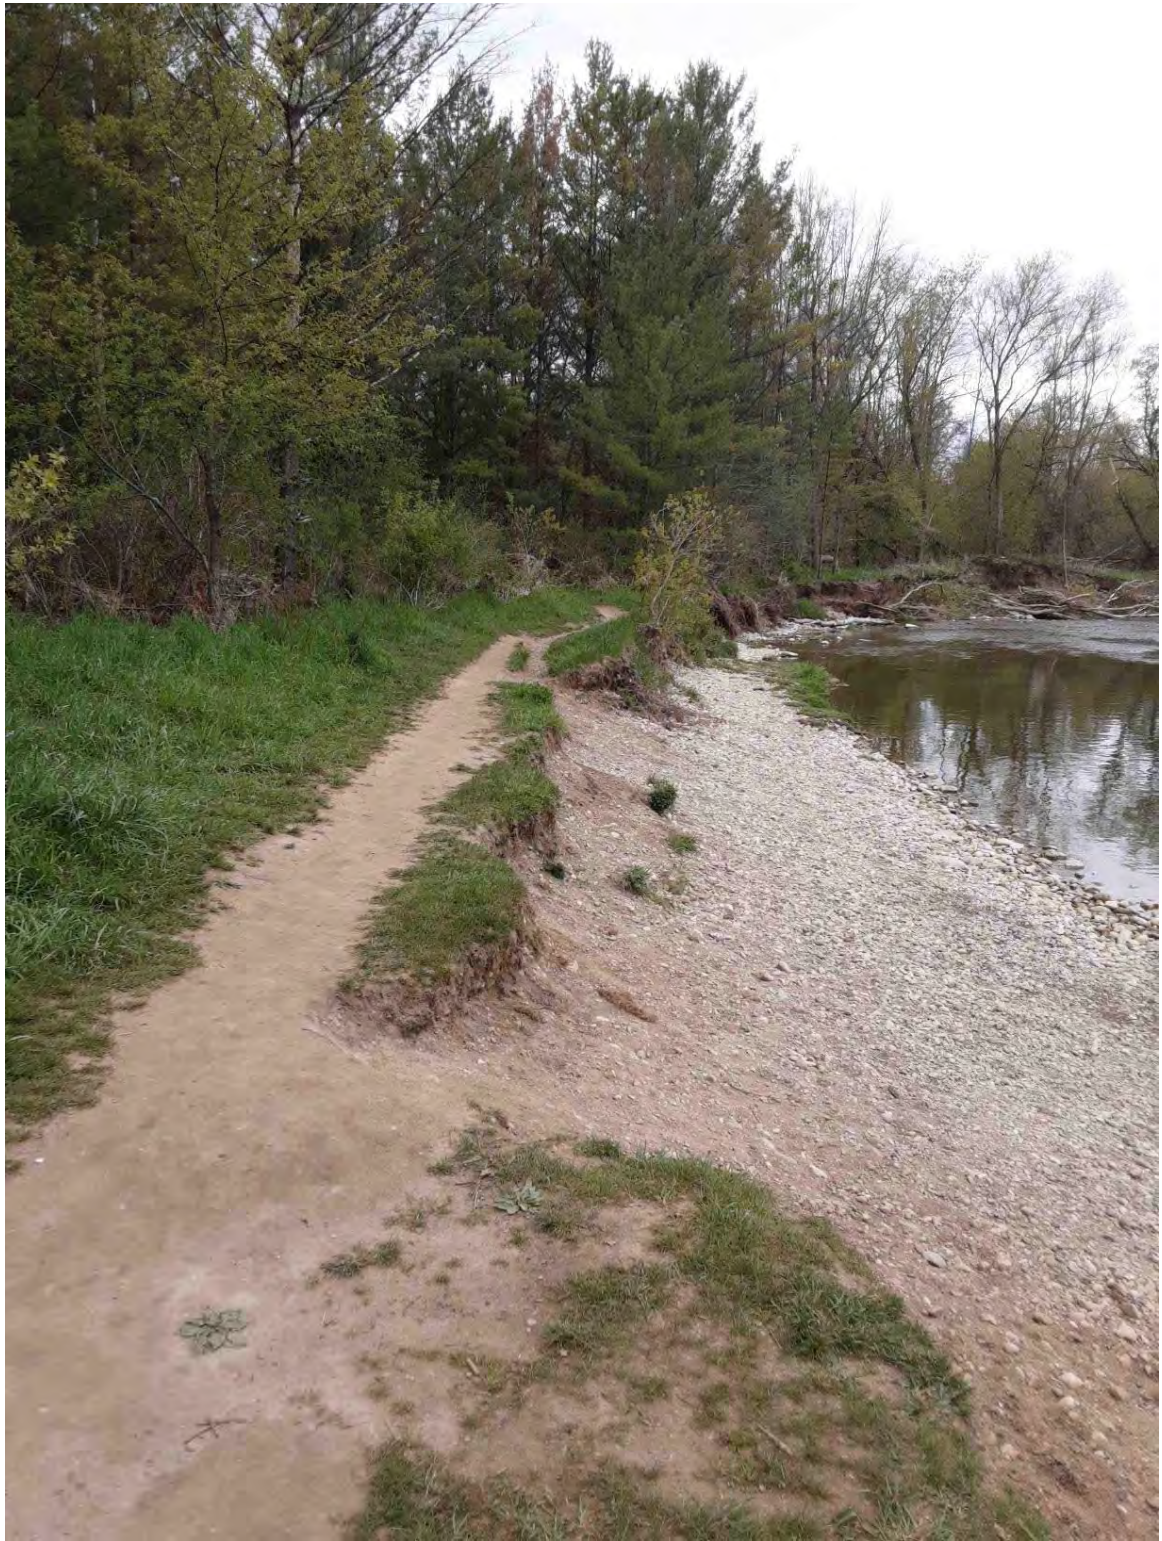
Some erosion near and affecting some parts of established pedestrian trail during period of high flow / water level. Unstable ground could be potential safety hazard for trail users.

EROSION TYPE(S)	SEVERITY	N	E	Z	PTID
Bank Undercutting	4- Safety Hazard	4793006.95	543027.41	282.01	8

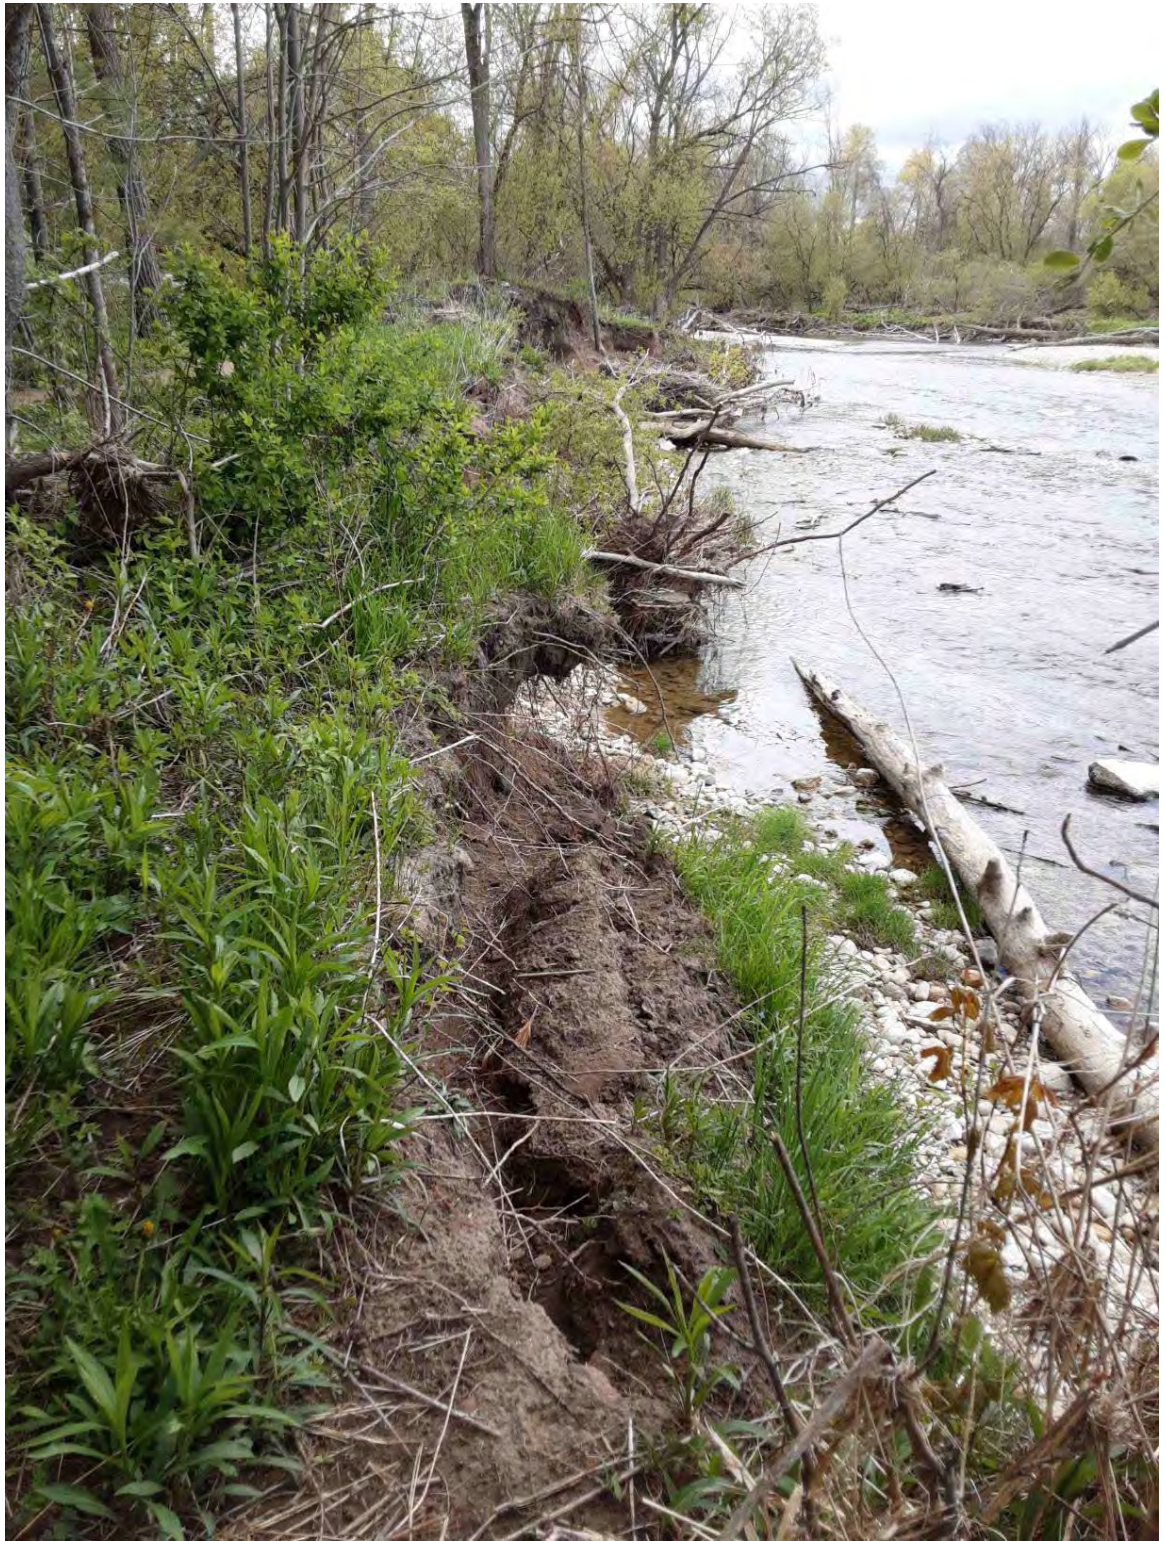
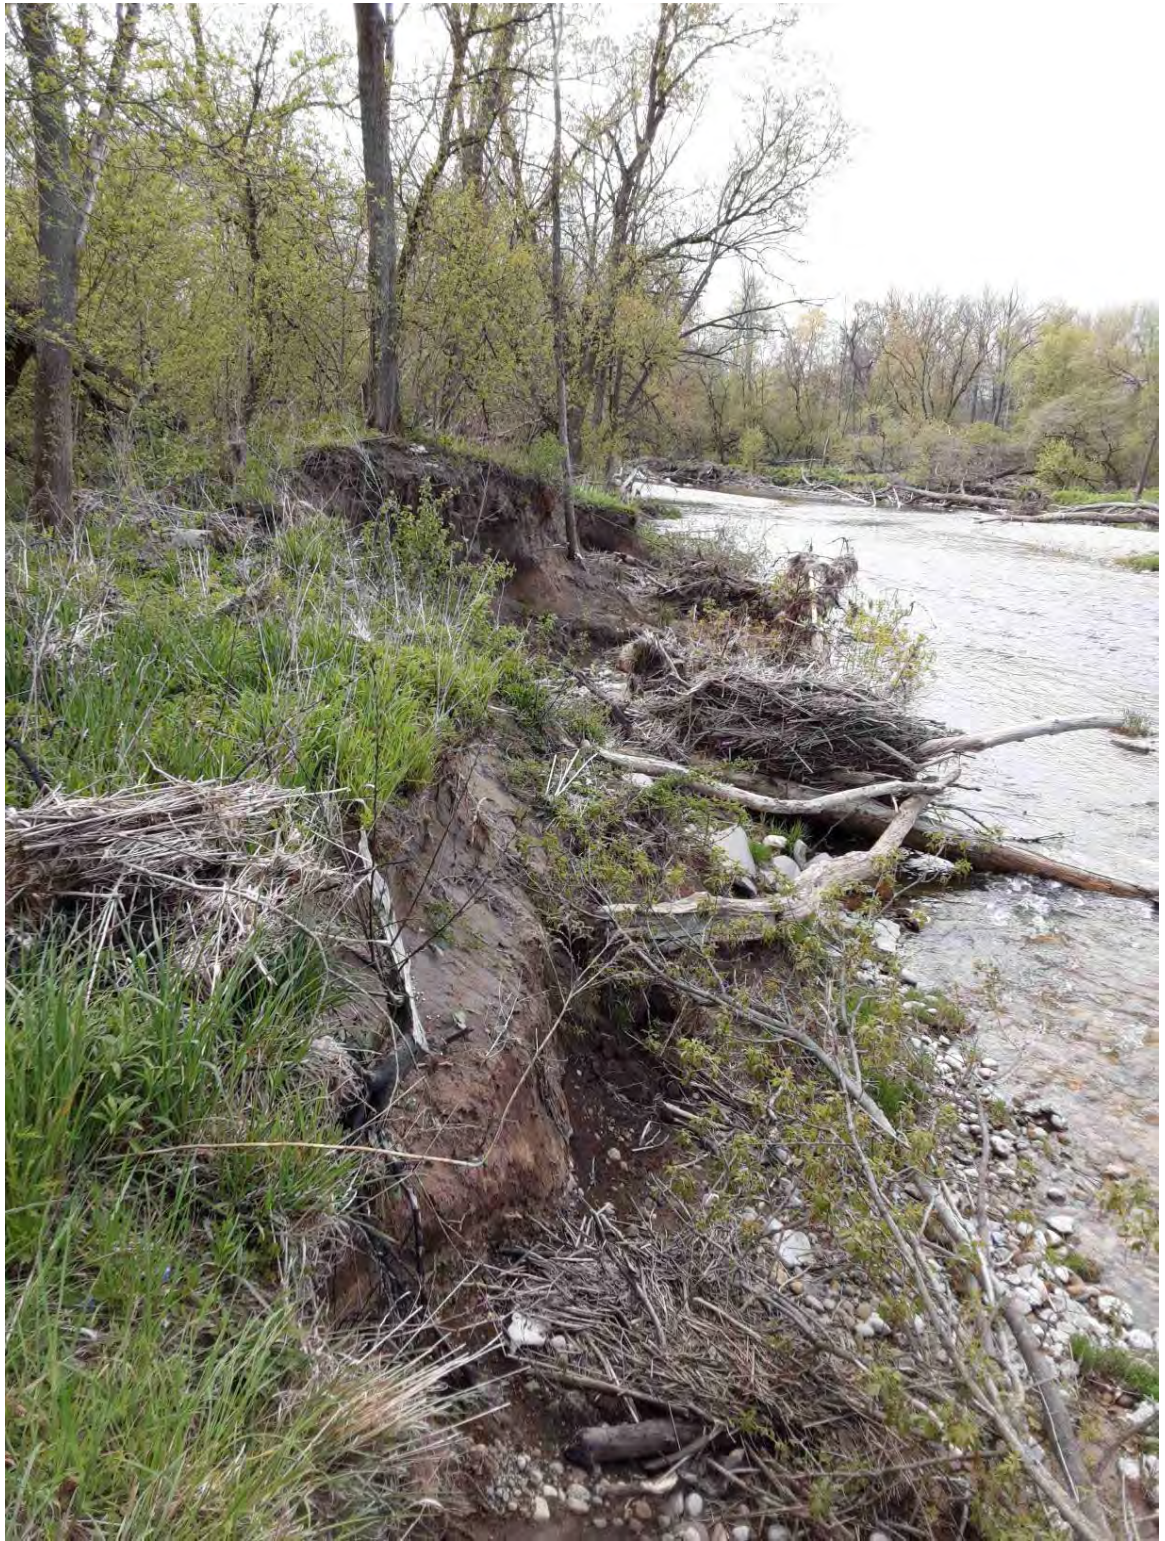
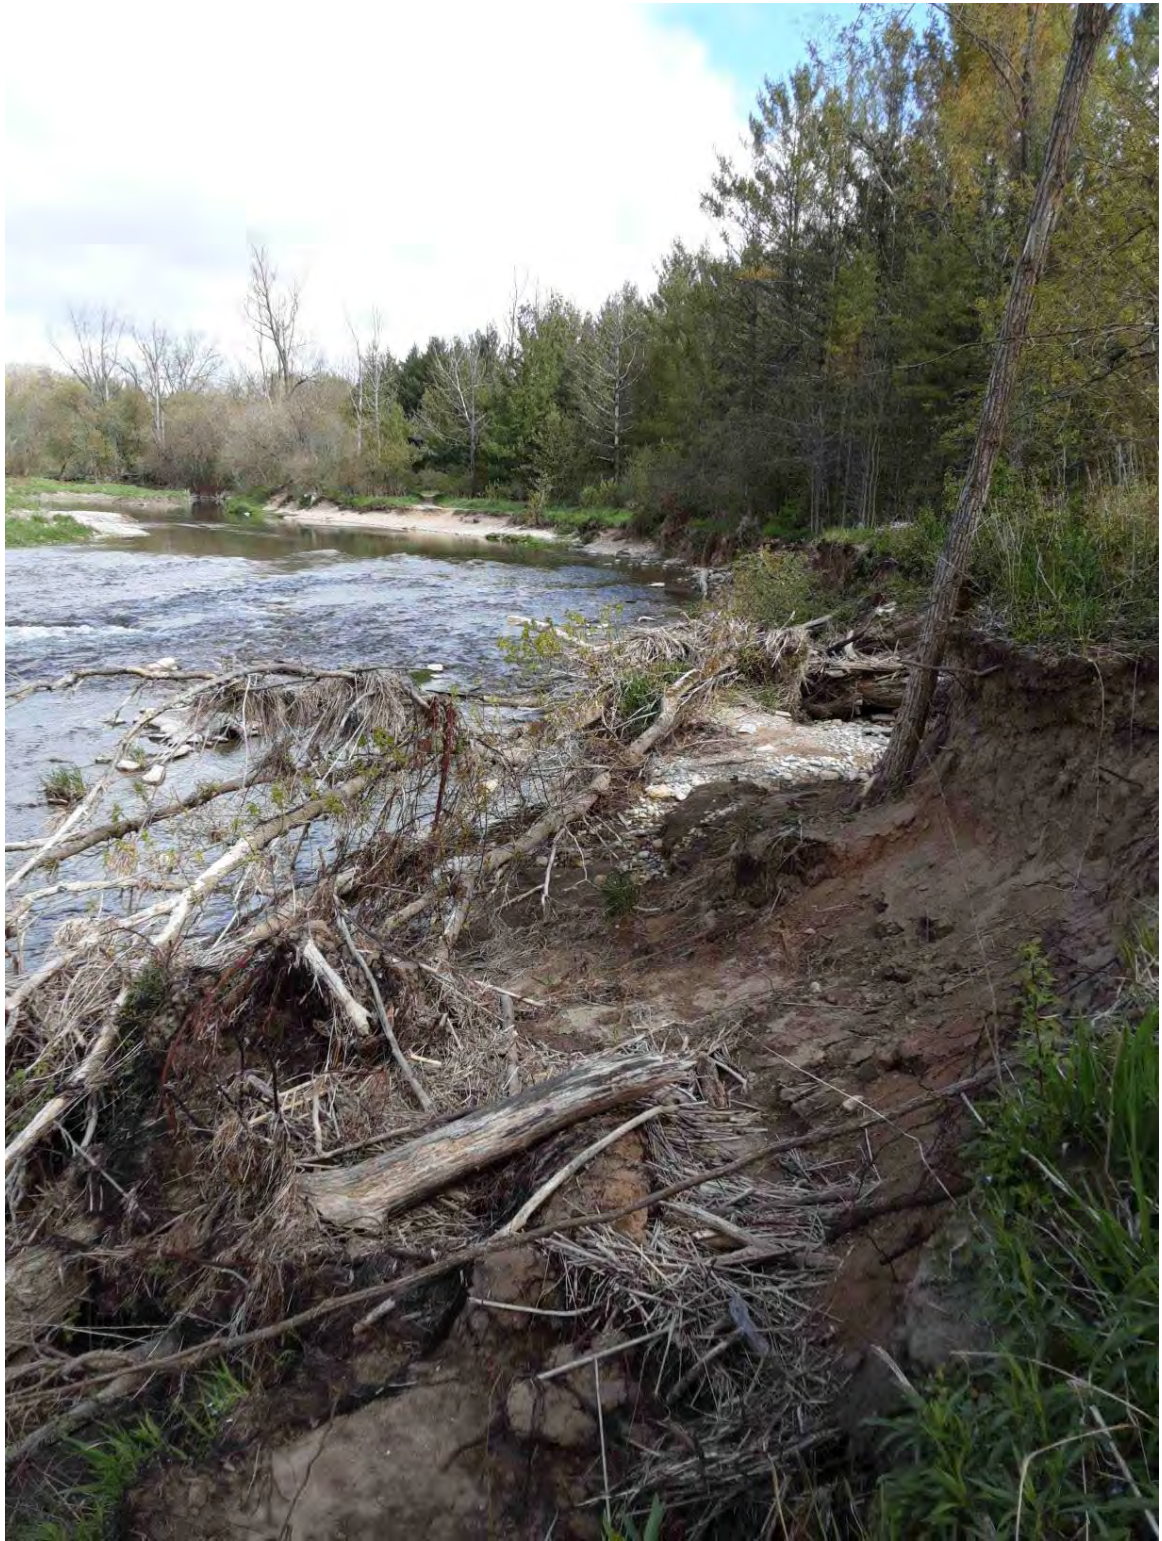
Banks and vegetation are collapsing into the channel. If erosion continues to cut back bank - may affect the established walking trail.

EROSION TYPE(S)	SEVERITY	N	E	Z	PTID
Bank Undercutting	3 - Major	4792961.69	543047.49	282.23	9

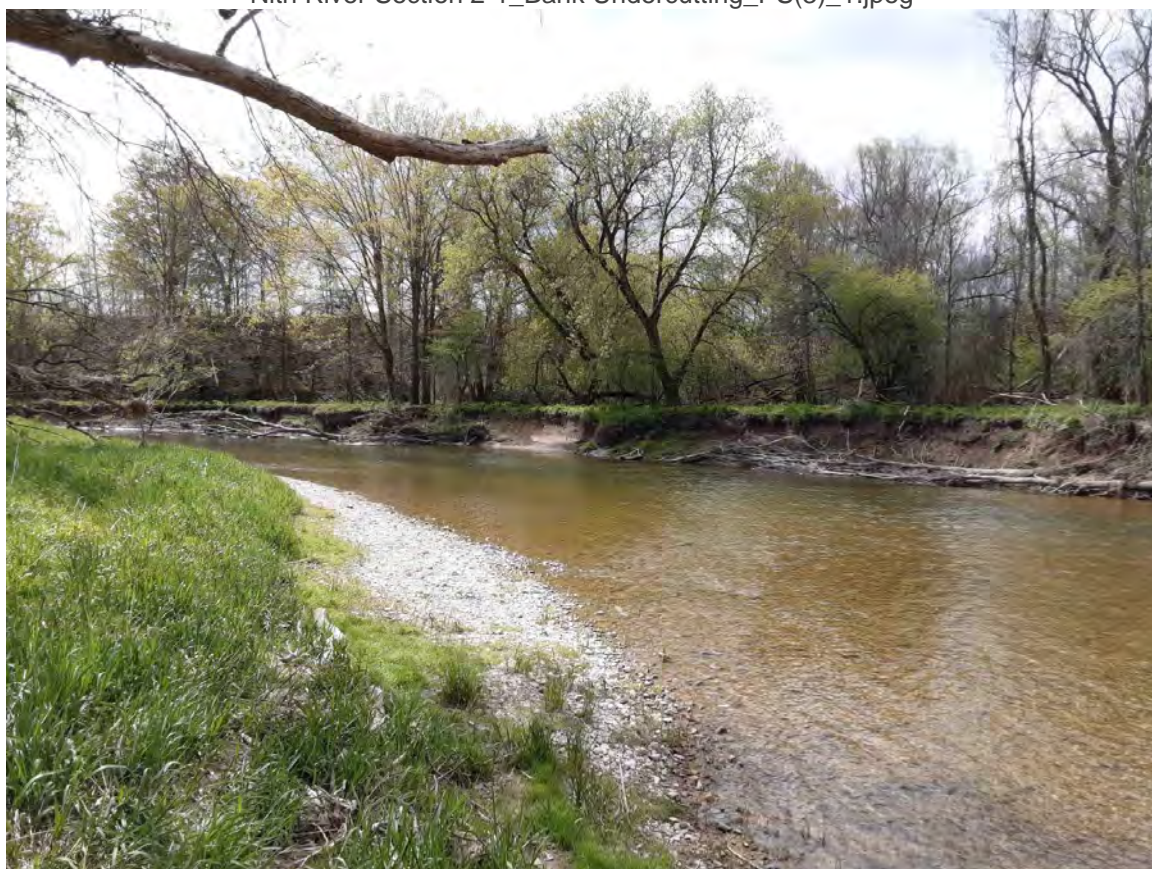
Nith River Section 2-1_Bank Undercutting_PS(3)_2.jpeg

Additional information Heavy erosion observed on south side of river eroding due to high flow volume

and flow velocities during wet weather undercutting banks.

EROSION TYPE(S)	SEVERITY	N	E	Z	PTID
Bank Undercutting	3 - Major	4792764.19	543075.14	280.62	10

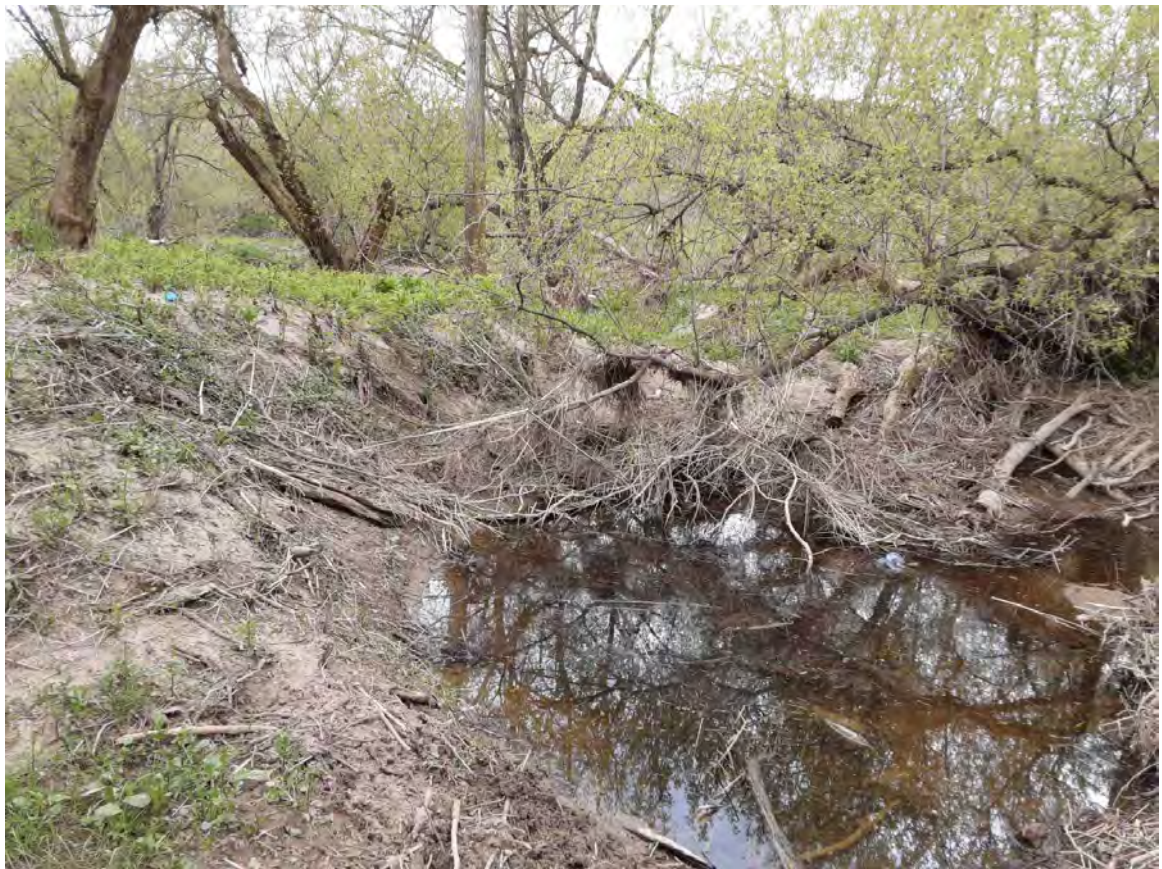
Nith River Section 2-2_Lateral Bank Erosion_PS(1)_1.jpeg

Inland lateral bank erosion and surface scouring -likely seasonal flood plain with ponding. Possible over land flow bypassing main channel during period of flooding / high flow due to meandering river.

EROSION TYPE(S)	SEVERITY	N	E	Z	PTID
Lateral Bank Erosion	2- Moderate	4792791.98	543074.92	281.5	11

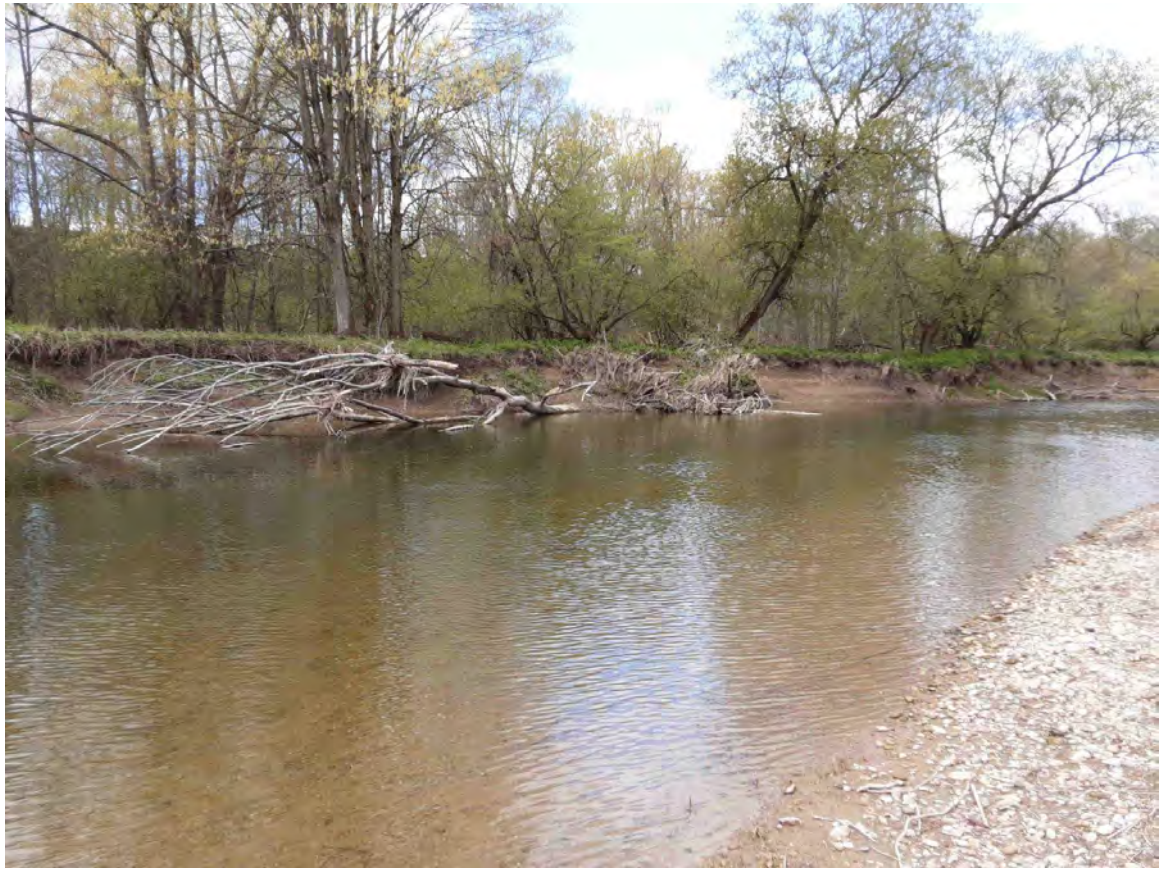
Nith River Section 2-2_Bank Undercutting_PS(2)_3.jpeg

Bank undercutting due to high flow volume and velocity at tight meander. Log debris in main channel.

EROSION TYPE(S)	SEVERITY	N	E	Z	PTID
Bank Undercutting	2- Moderate	4792723.28	543137.04	279.89	12

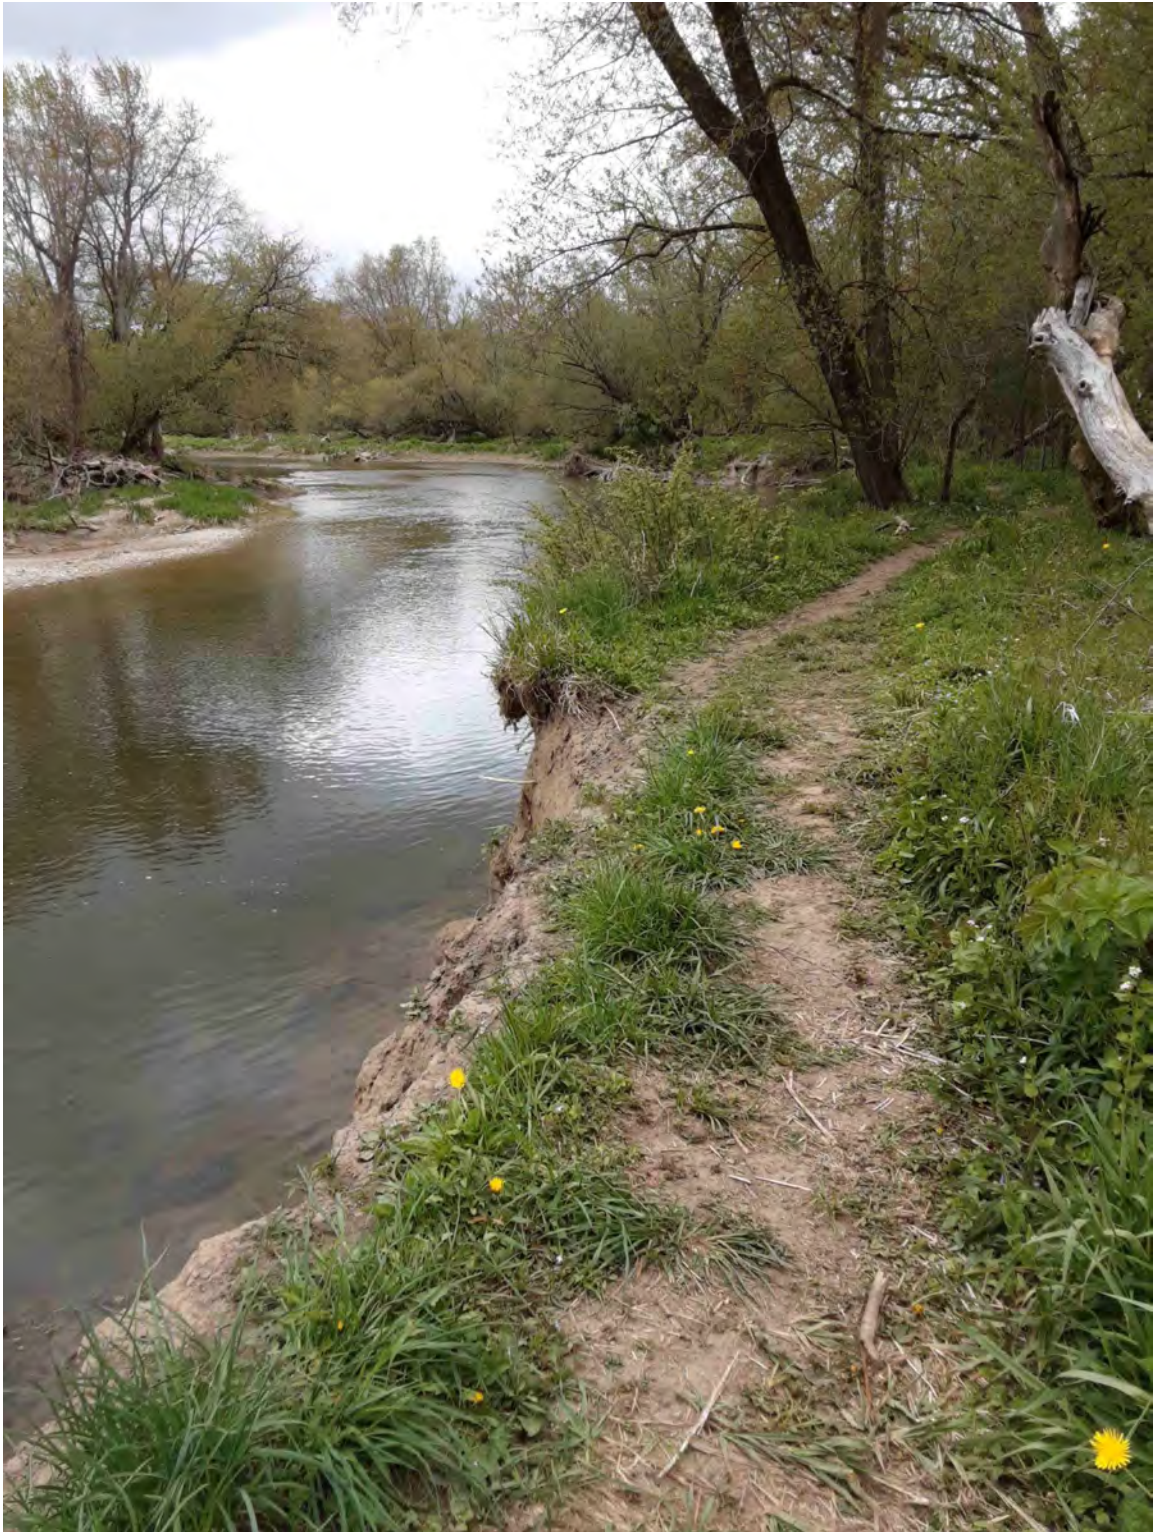
Nith River Section 2-2_Bank Undercutting_PS(3)_3.jpeg

Bank undercutting due to high flow volume and velocity at tight meander. Log debris in main channel. Established pedestrian train on top of bank being impacted by erosion.

EROSION TYPE(S)	SEVERITY	N	E	Z	PTID
Bank Undercutting	4- Safety Hazard	4792838.43	543322.48	279.79	13

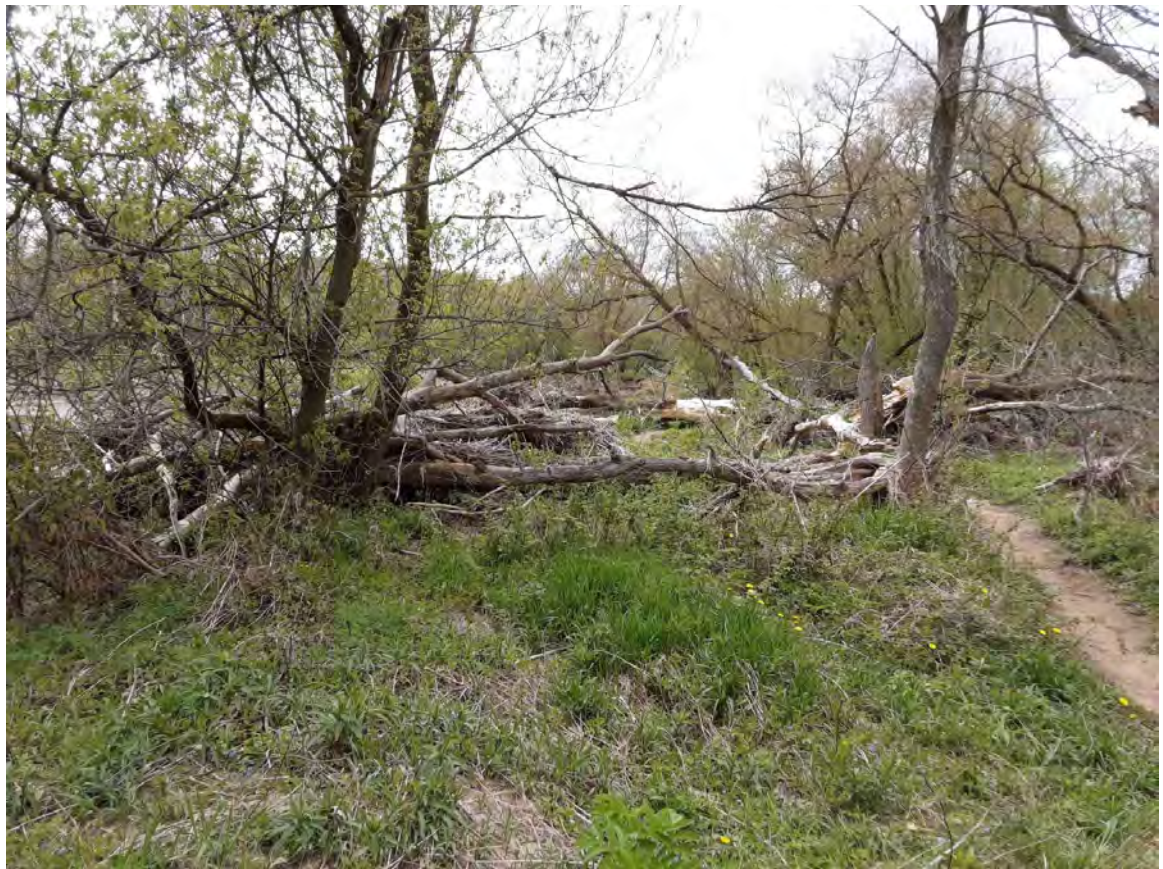
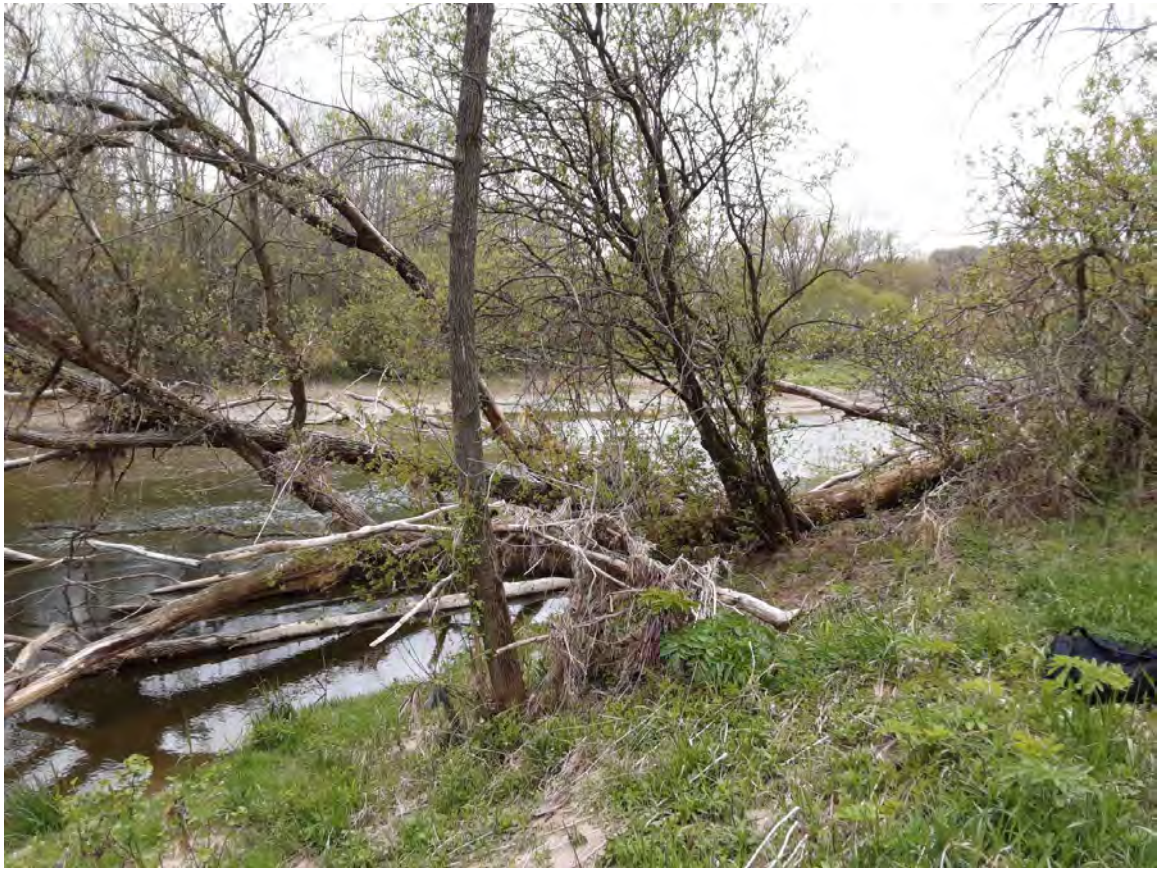
Trees falling over on north and south side of river will eventually fall in river causing severe blockages. Photos taken on north side. Debris on north side is more severe than south side. Fallen trees on north side are near the public path.

EROSION TYPE(S)	SEVERITY	N	E	Z	PTID
Log/Debris Jam	2 - Moderate	4792805.52	543415.93	281.99	14

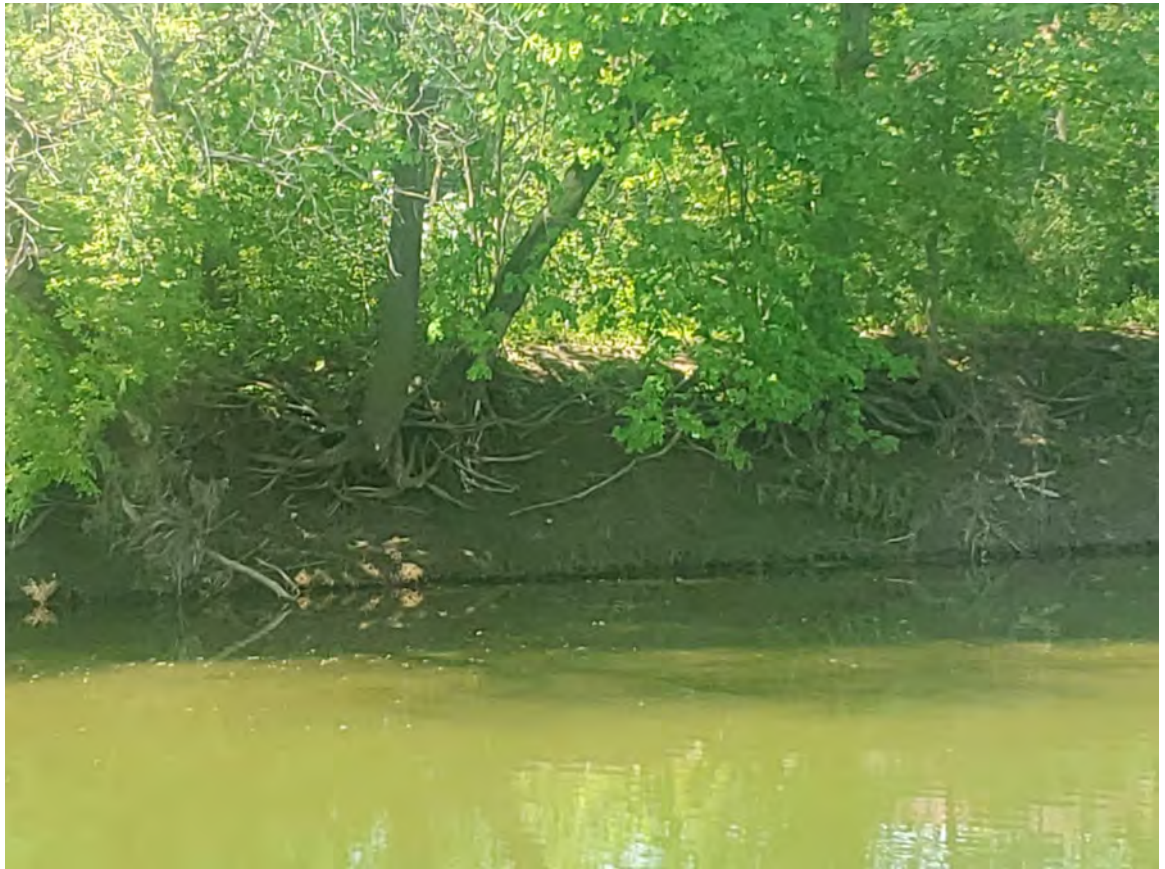
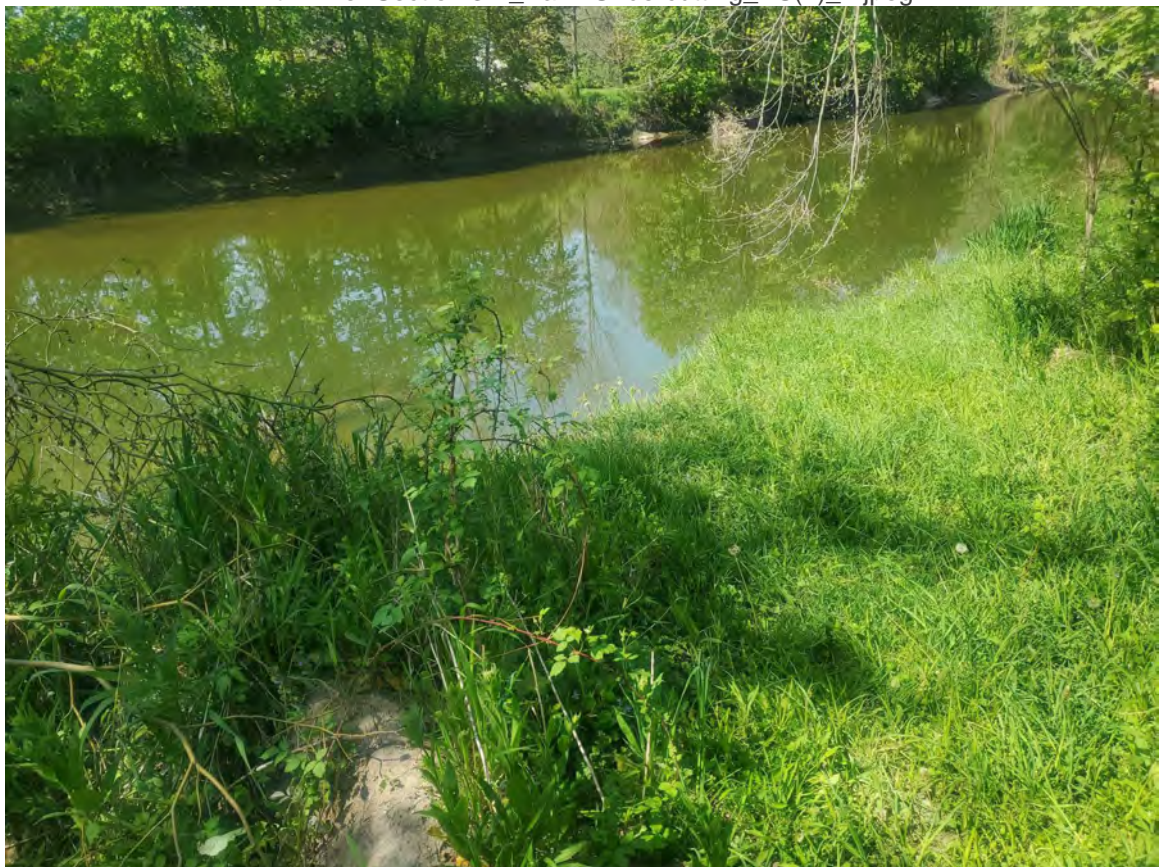
Significant bank undercutting. Loose sediment on banks erode with high flows leaving tree roots exposed. Photos taken of trees on south side of river. Man made path on north side of river is also eroding. Doesn't seem to be a public path but there is evidence of pedestrian traffic.

EROSION TYPE(S)	SEVERITY	N	E	Z	PTID
Bank Undercutting	3 - Major	4792666.79	544428.1	283.38	32

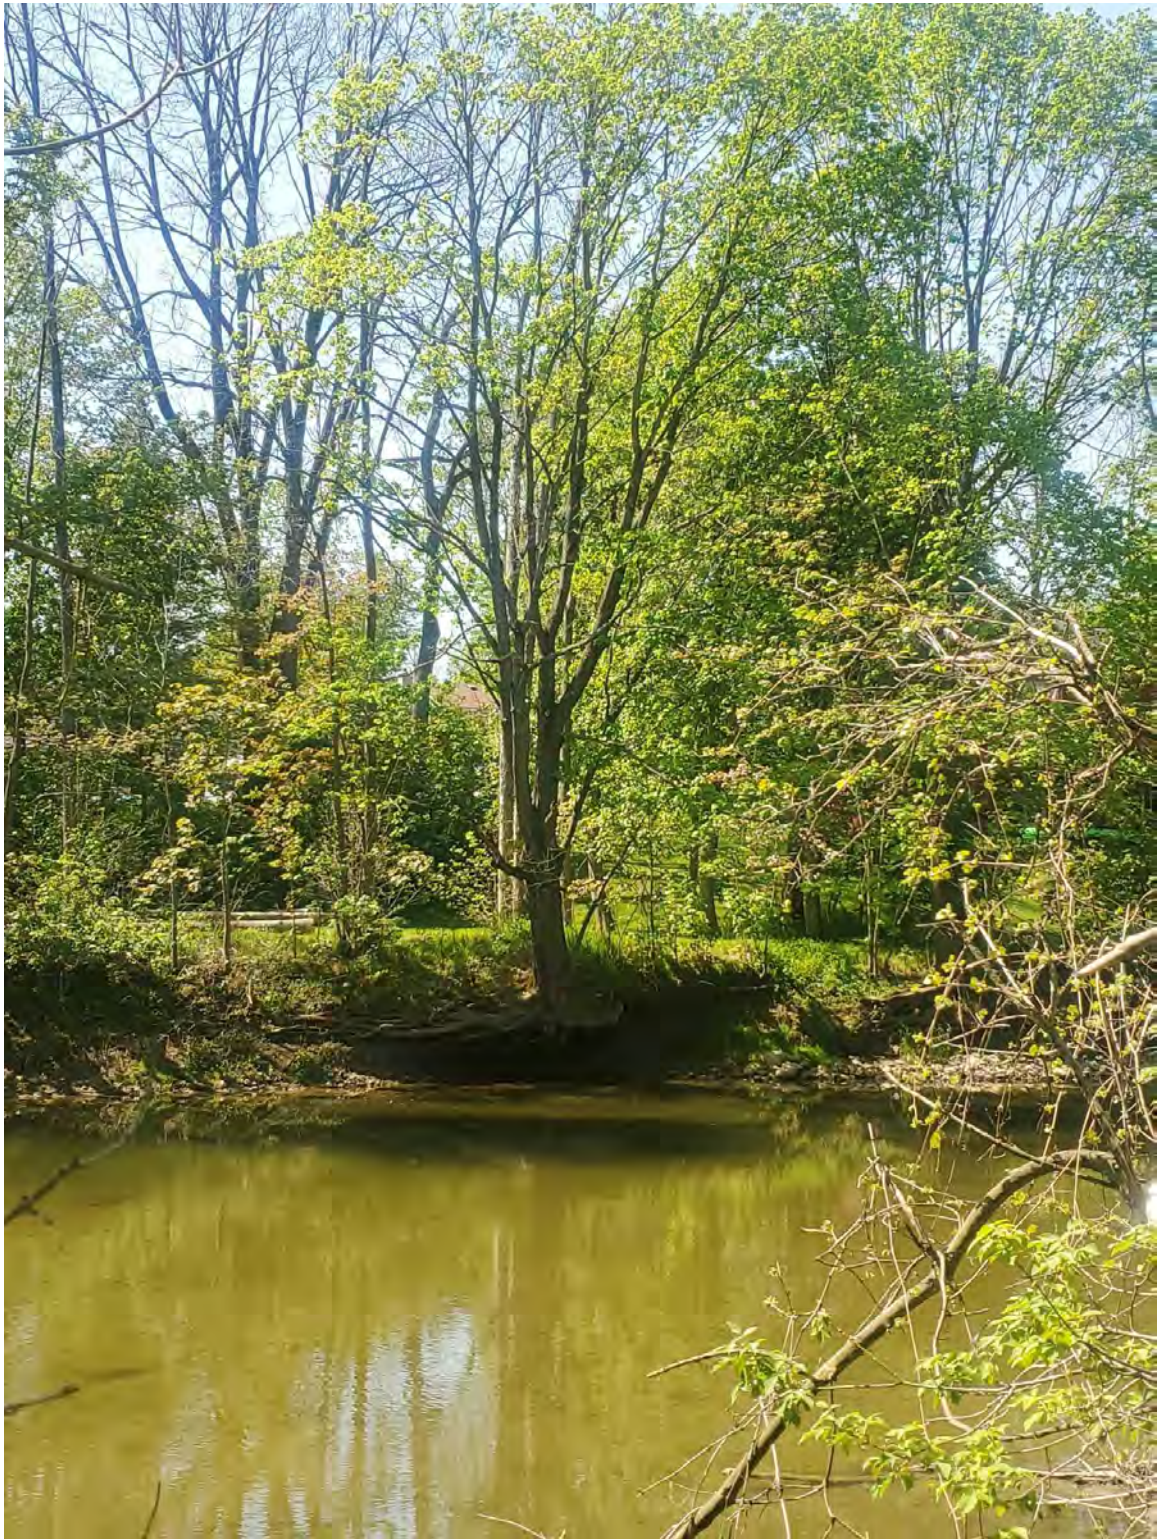
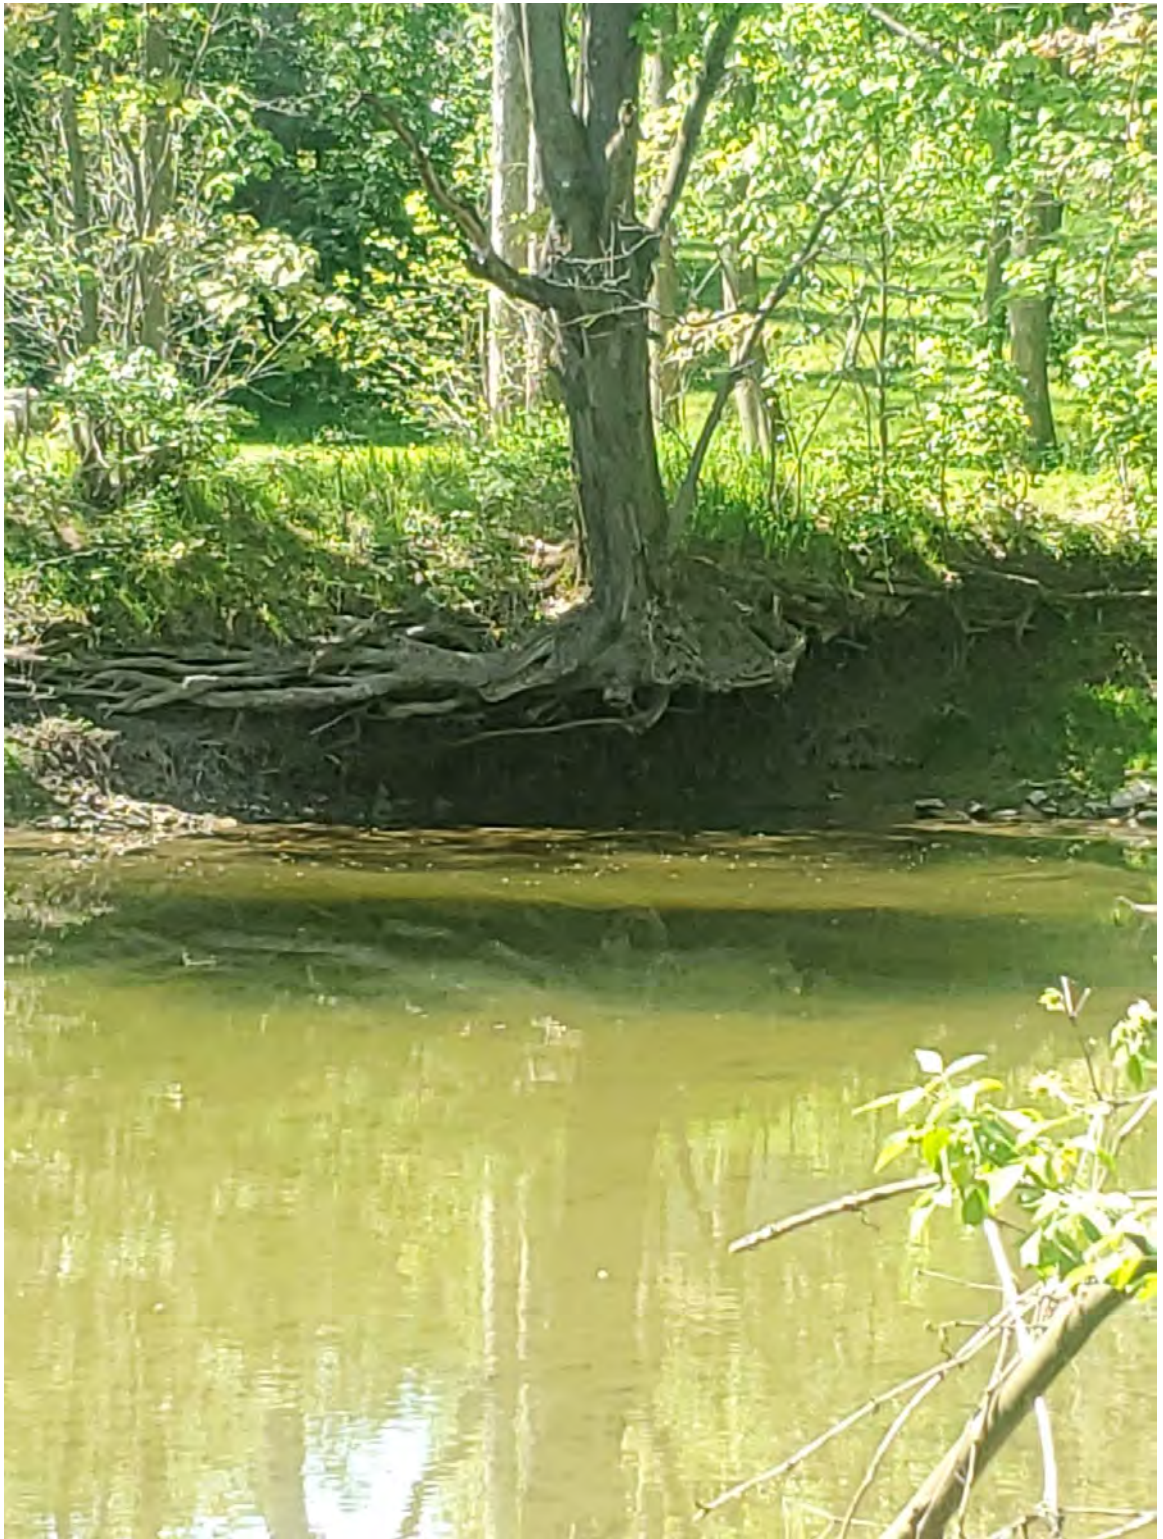
Additional information Significant bank undercutting causing tree roots to be exposed. Banks are

undercut throughout this entire section (see PTID32 to the east). North side has fallen trees that have caused some log/debris in river.

EROSION TYPE(S)	SEVERITY	N	E	Z	PTID
Bank Undercutting_LogDebris	3 - Major	4792724.41	544108.75	281.03	33

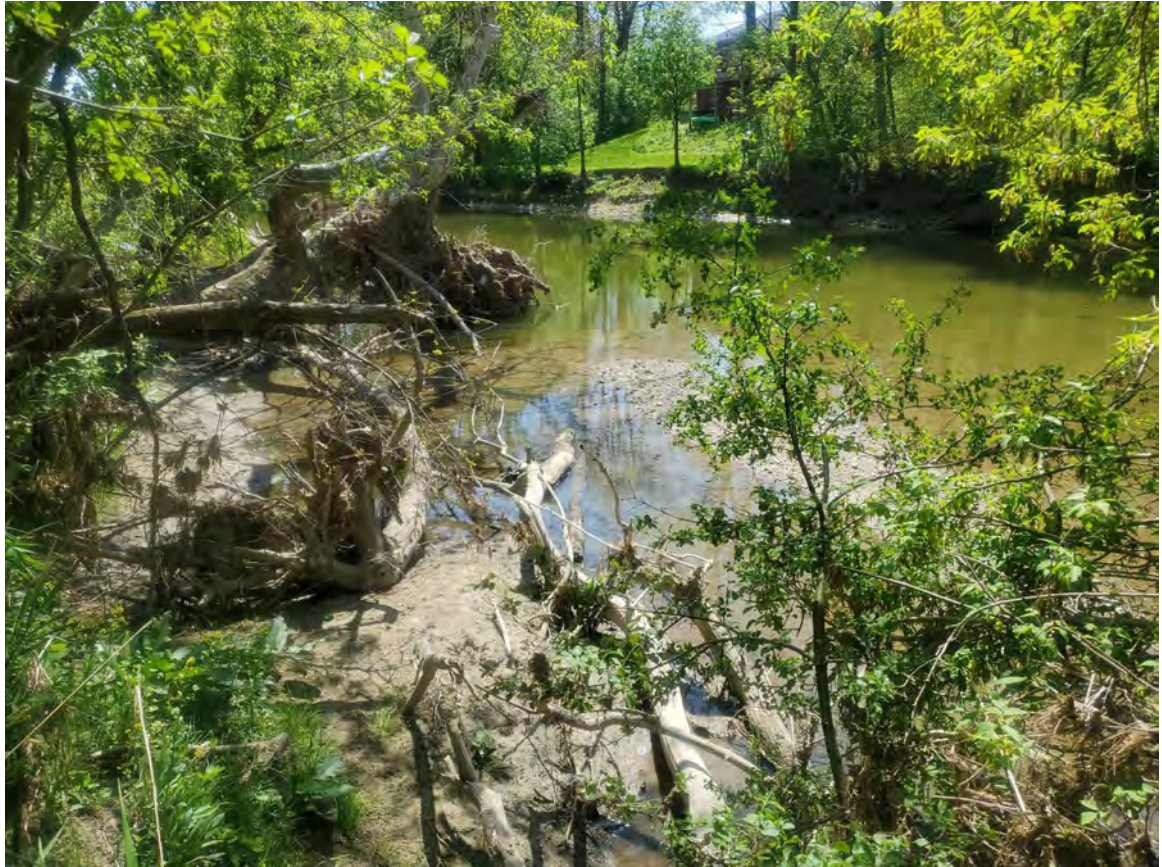
Nith River Section 3-1__PS(3)_1.jpeg

Log debris on north side of river channel.
