APPENDIX H

Erosion Inventory and Assessment Information

Ayr, ON - Watercourse Erosion Inventory and Assessment

Watercourse Erosion Inventory and Assessment
Ayr, ON
County of North Dumfries

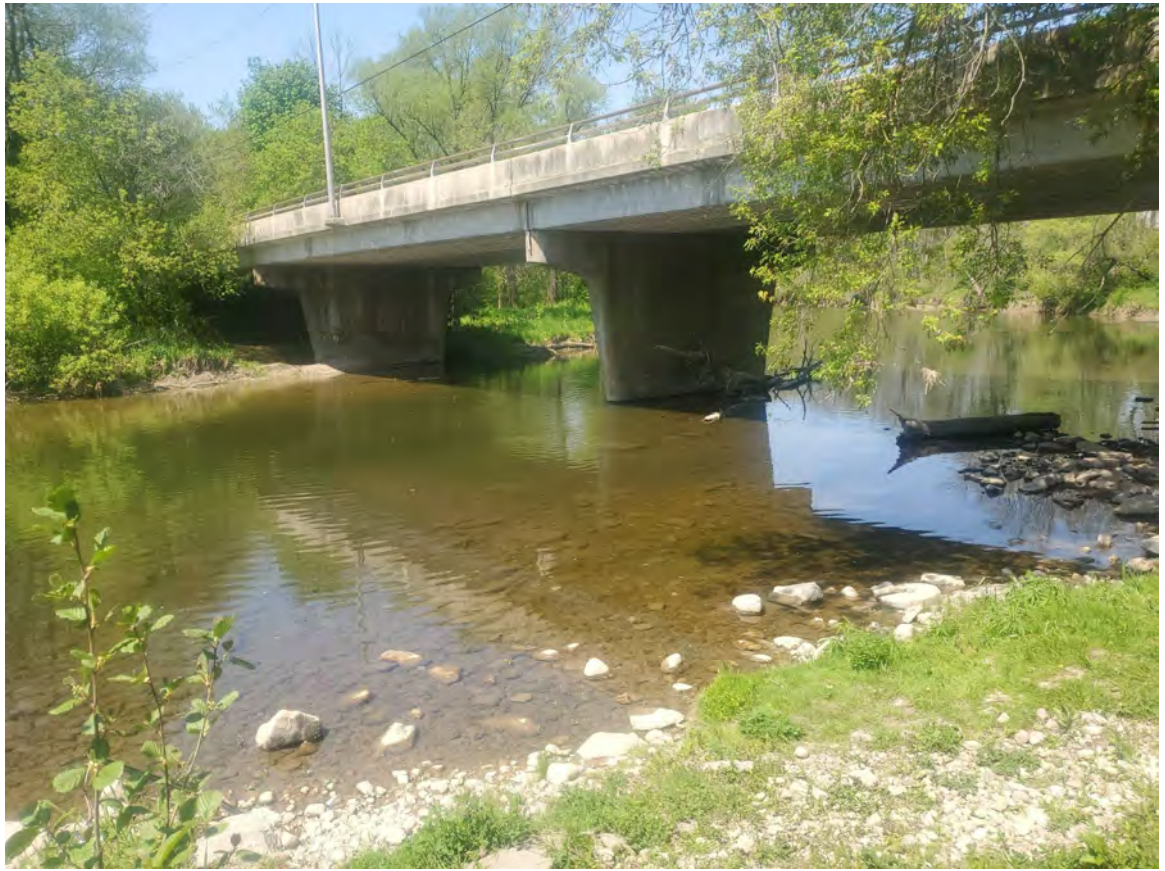
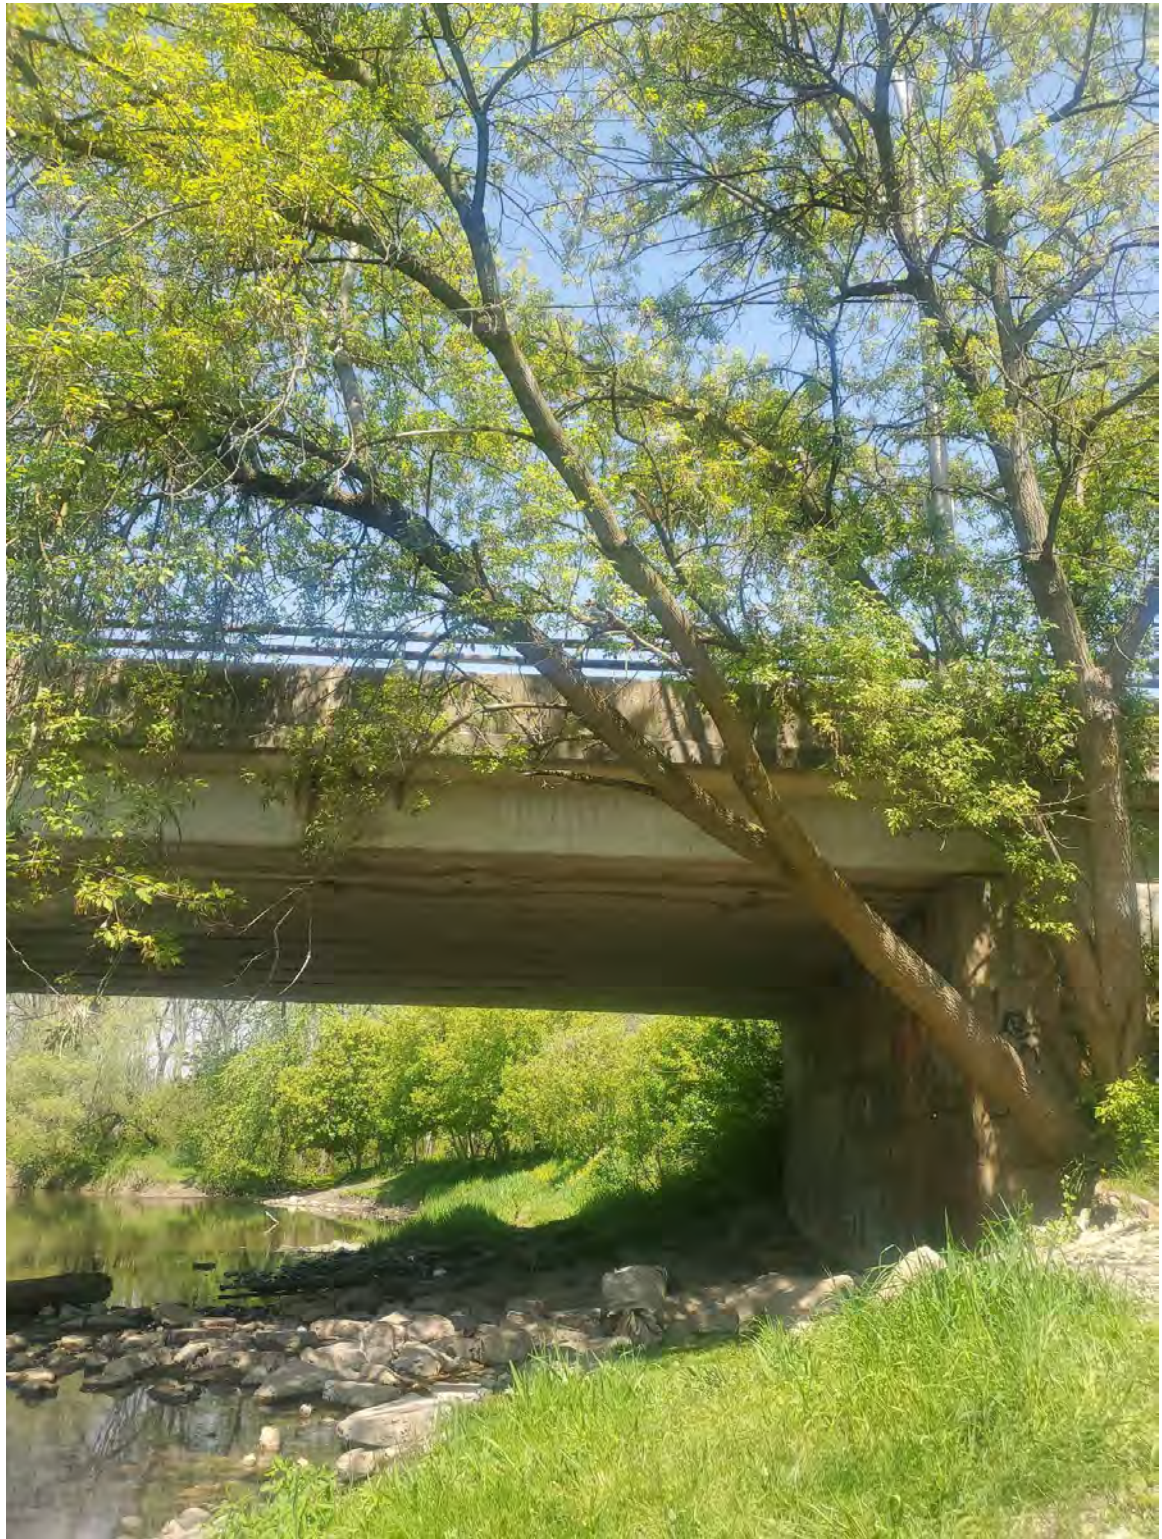
Stones moved out of place likely due to high flows. Tree trunk debris under bridge. Tree growing out of the side of the bridge is growing close to power lines on bridge.

EROSION TYPE(S)	SEVERITY	N	E	Z	PTID
Active Erosion	1- Minor	4792607.17	544489.25	279.88	34

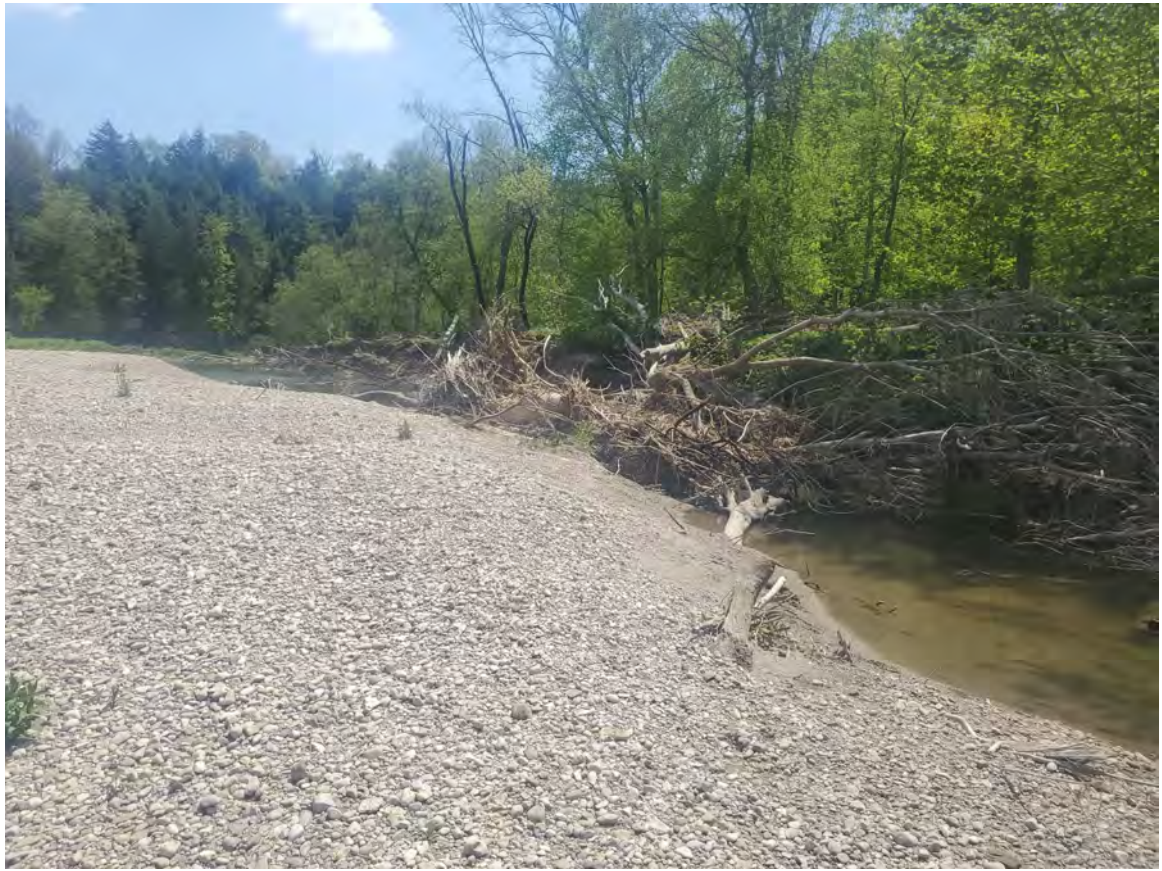
Nith River Section 4-1_Bank Undercutting and Log Jam _PS(1)_2.jpeg

High spring flows cause flooding of backyards at properties on Colonial Dr. High flows cause undercutting of bank and have created additional flow paths at meander. Significant flows caused trees to fall into river. Island (where tree debris found) may contribute to river backup into residential backyards.

EROSION TYPE(S)	SEVERITY	N	E	Z	PTID
Bank Undercutting and Log Jam	4- Safety Hazard	4792178.58	544501.53	278.9	37

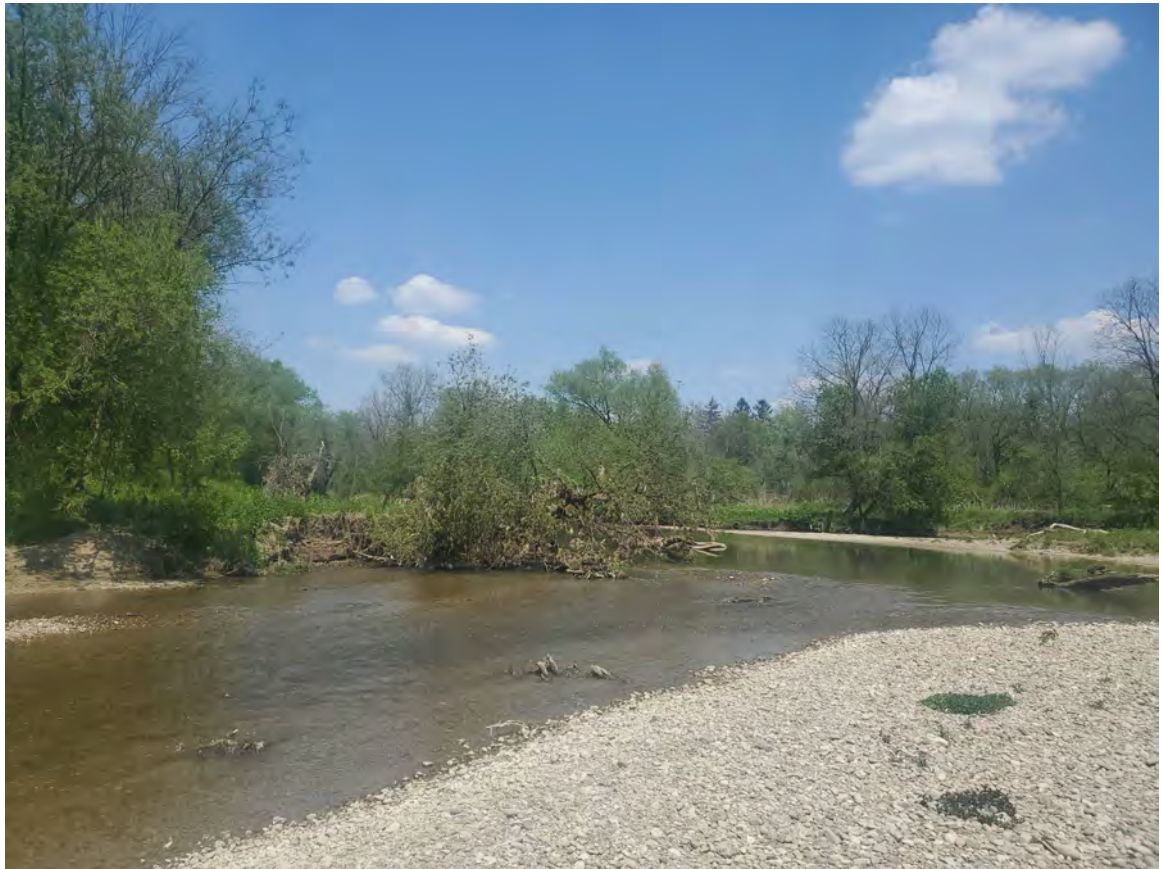
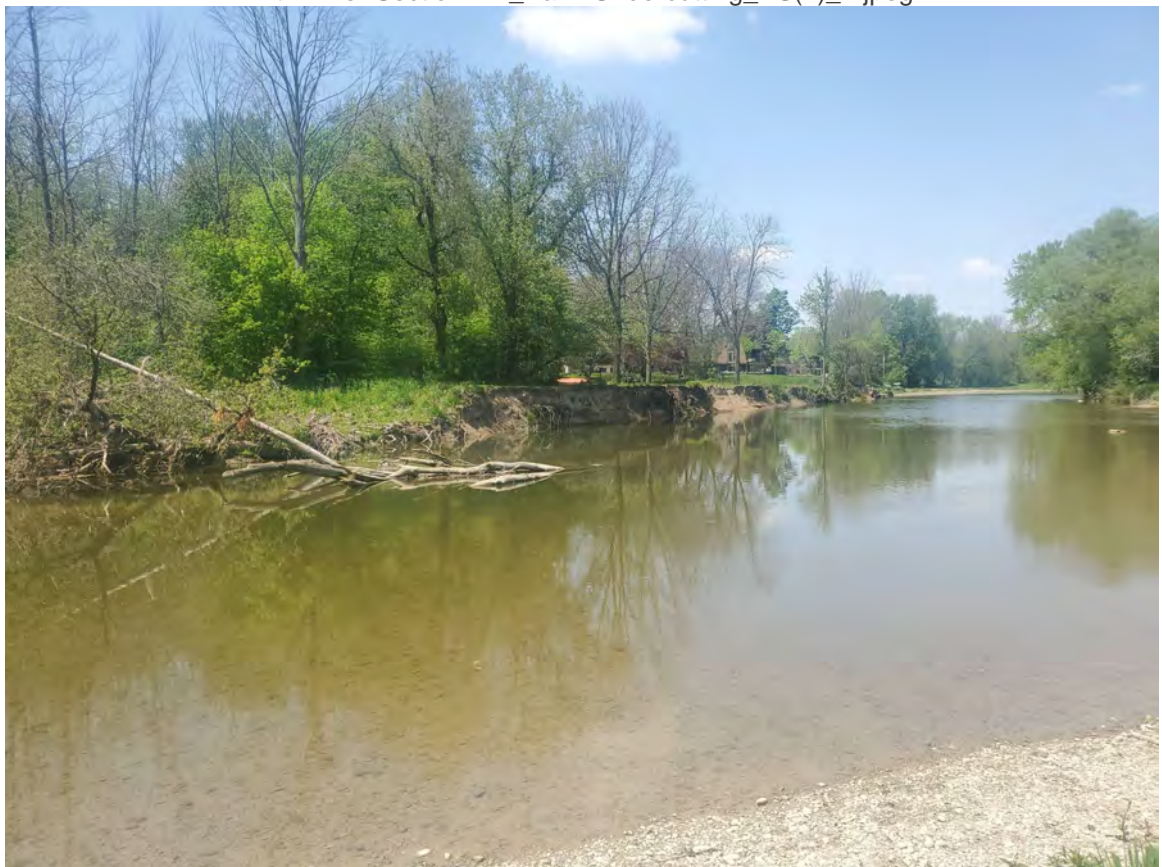
Additional information High flows cause bank erosion. Tree roots exposed. Spoke to one of the

EROSION TYPE(S)	SEVERITY	N	E	Z	PTID
Bank Undercutting	4- Safety Hazard	4792215.83	544546.65	278.88	38

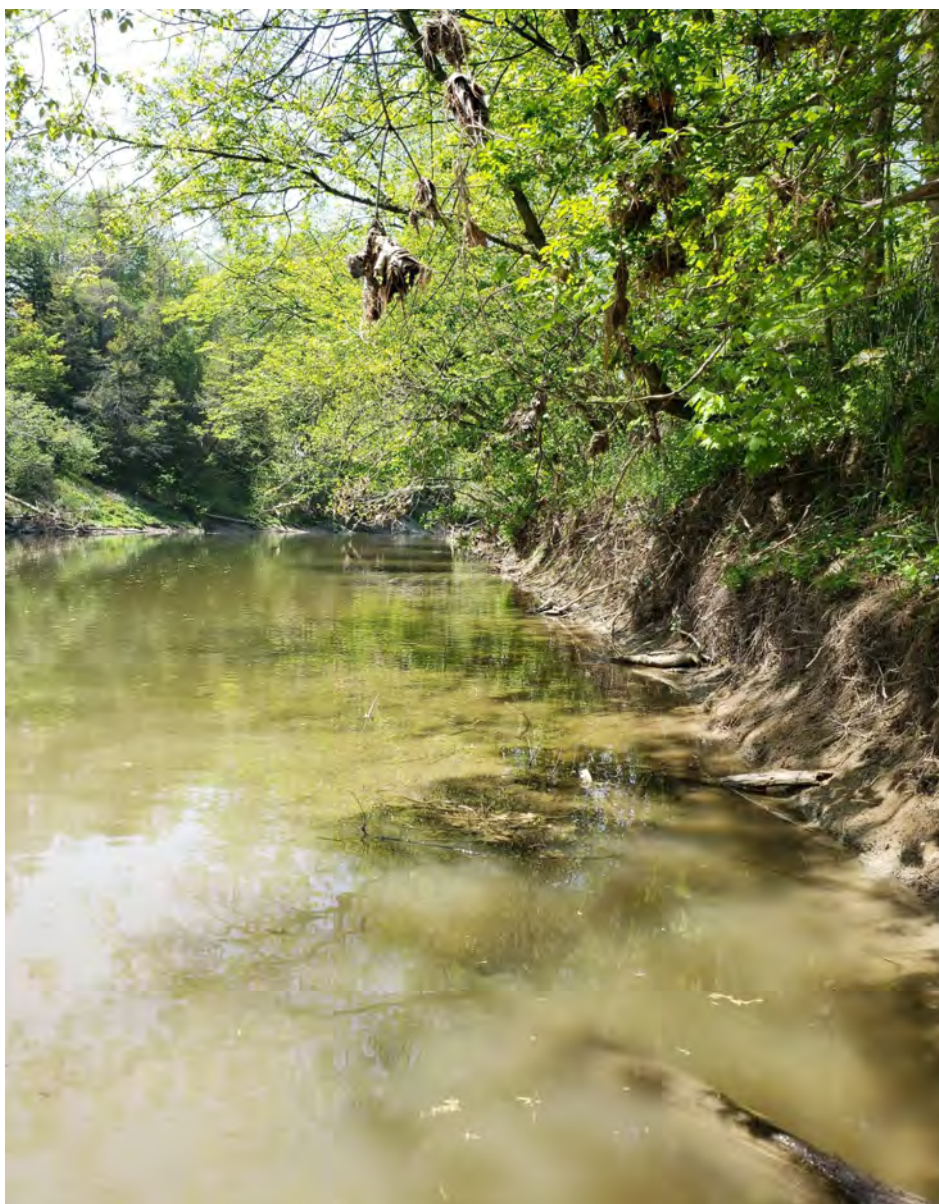
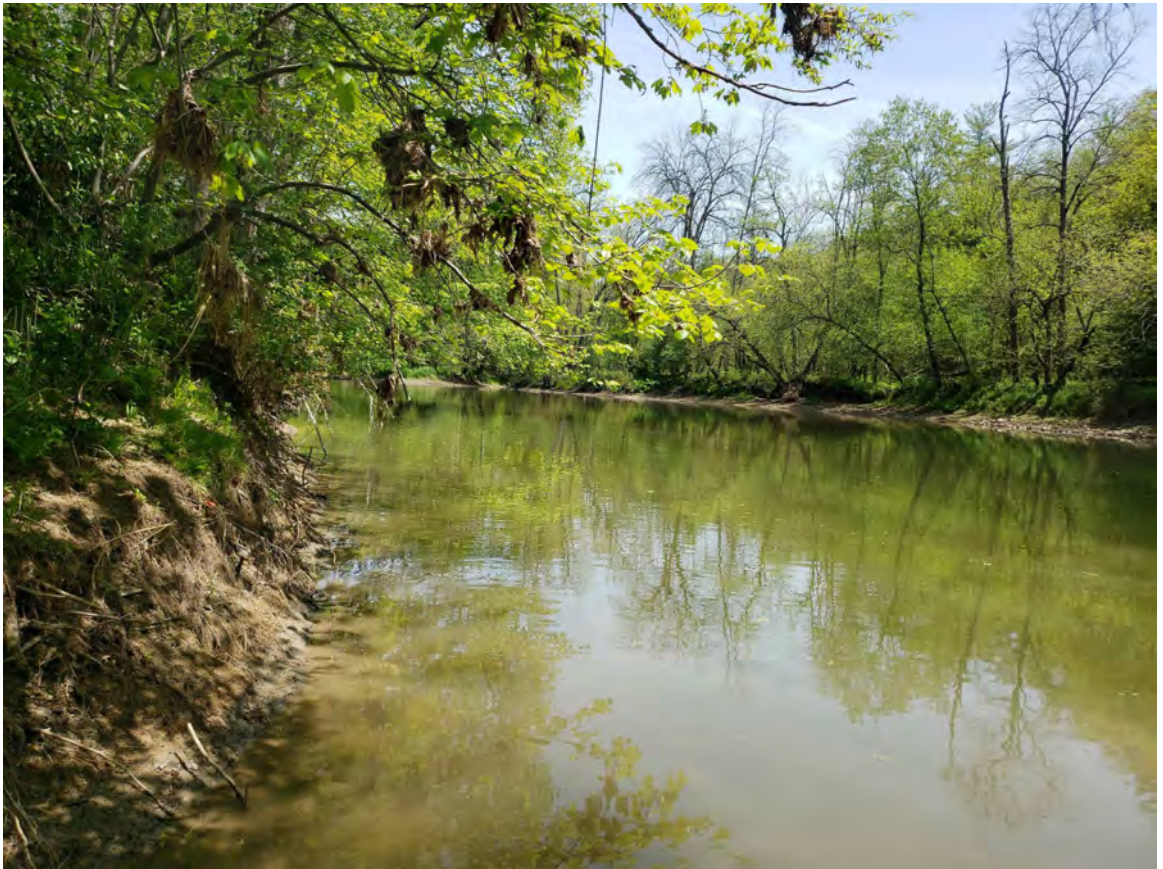
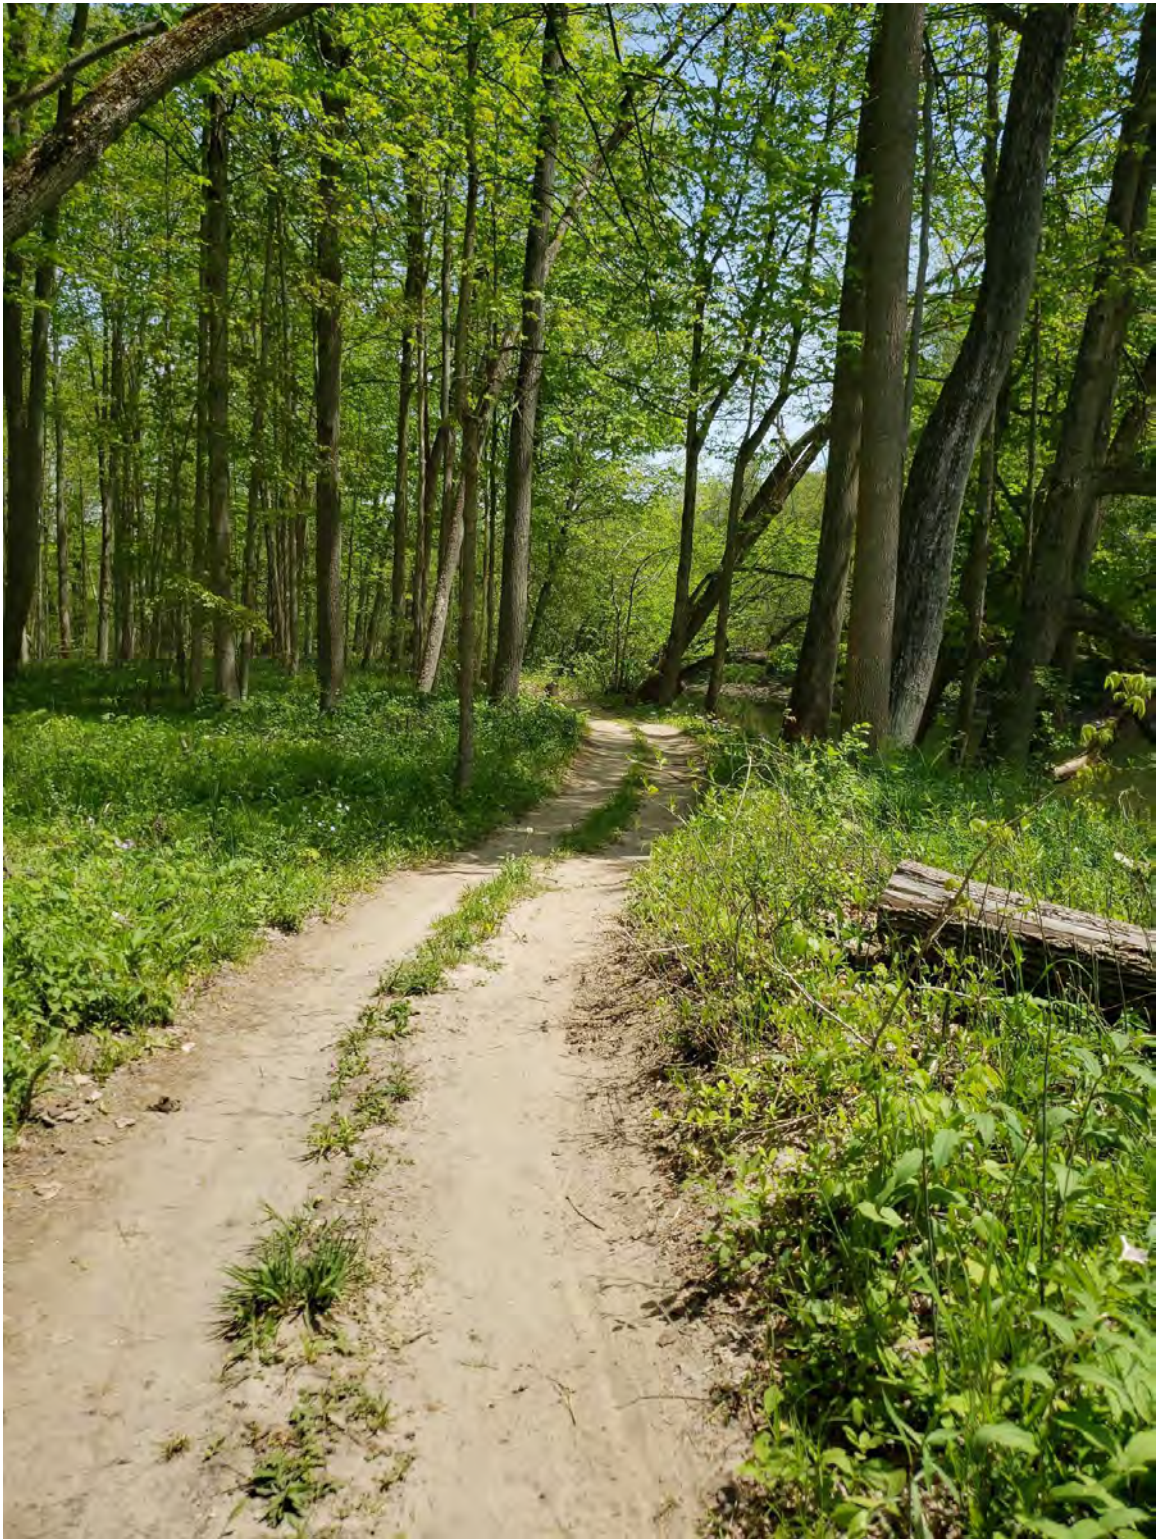
Additional information Erosion is near an ATV trail (possible private trail)

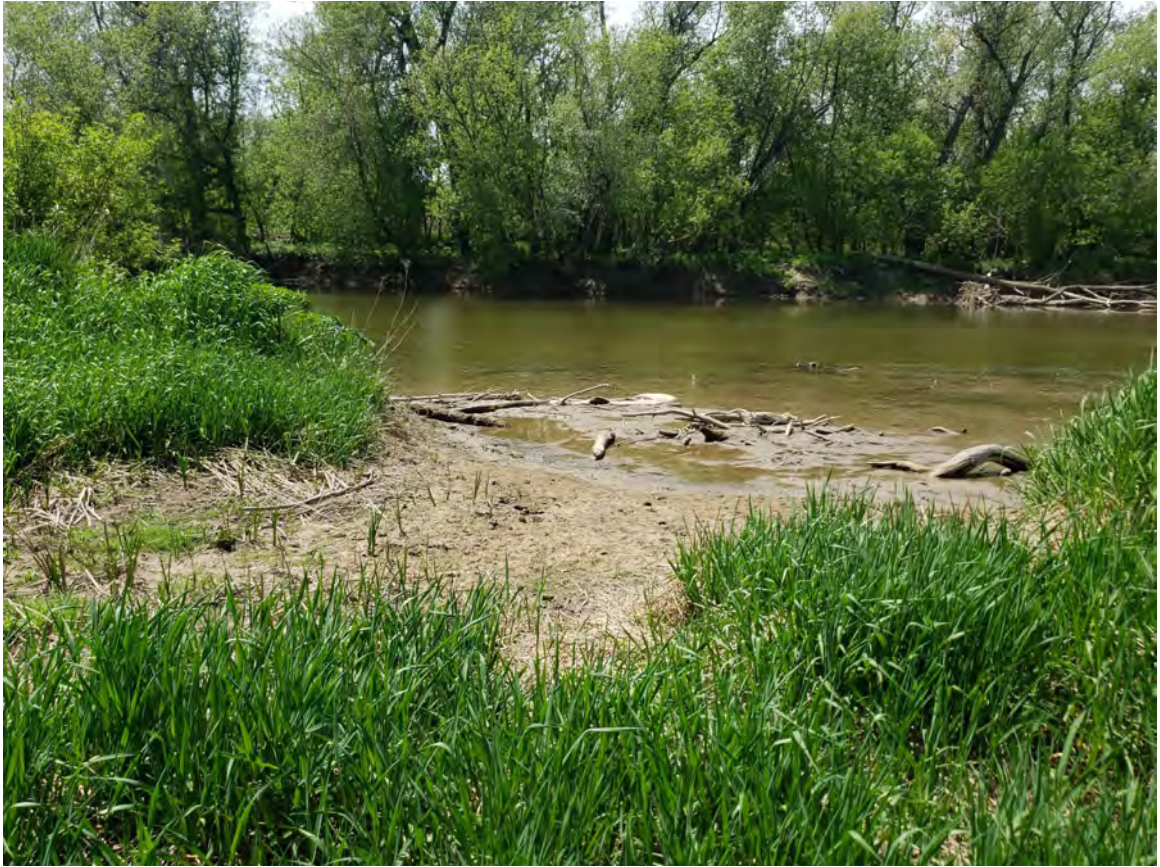
Nith River Section 4-3_Lateral Bank Erosion_PS(3)_1.jpeg

Additional information possibly causes flow inland.

EROSION TYPE(S)	SEVERITY	N	E	Z	PTID
Lateral Bank Erosion	2- Moderate	4792121.77	543982.59	278.221	46

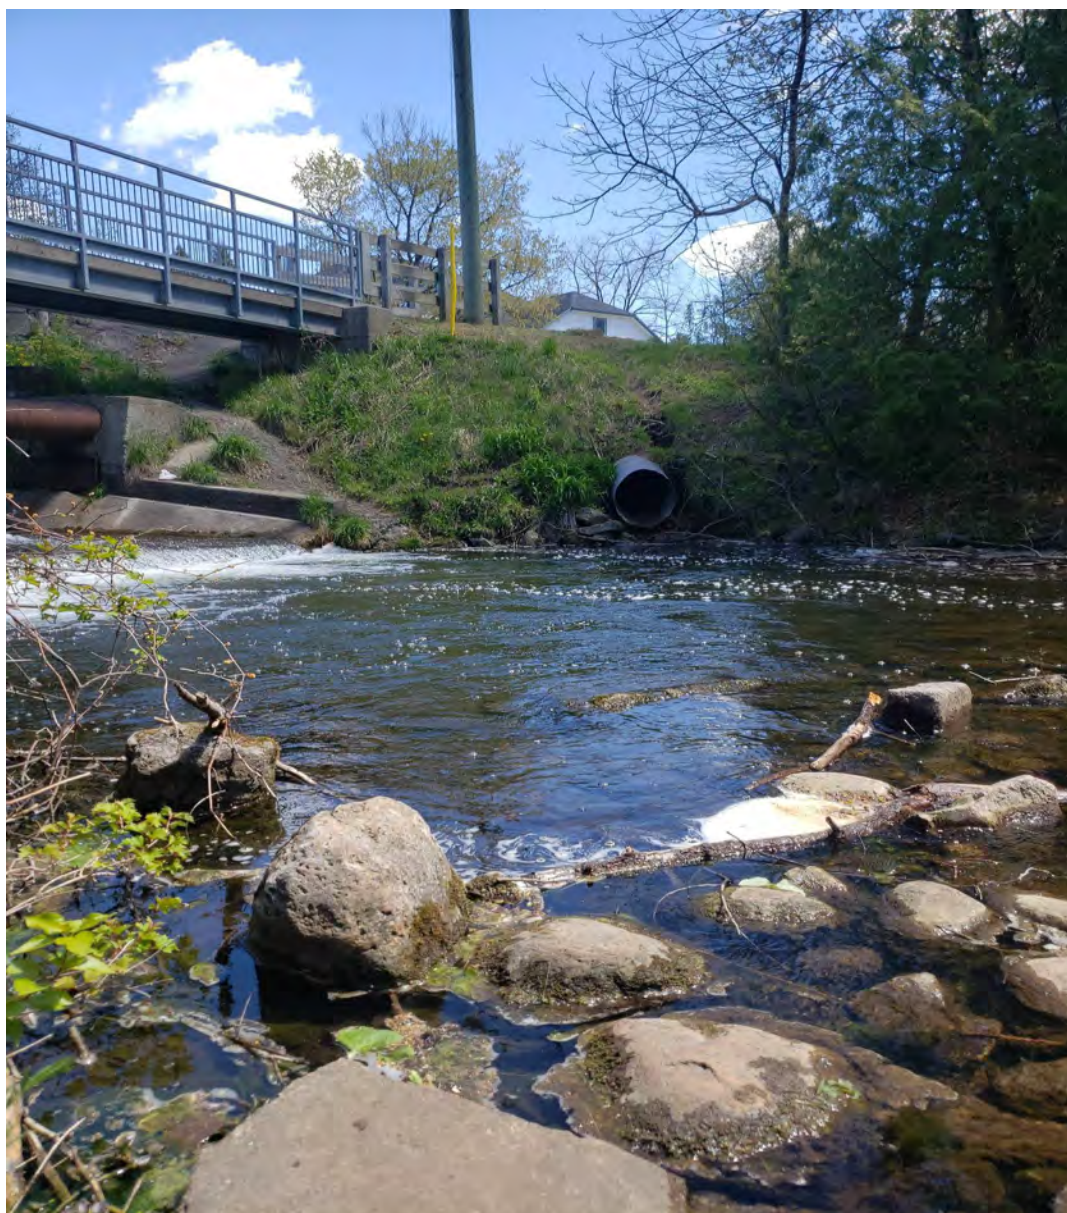
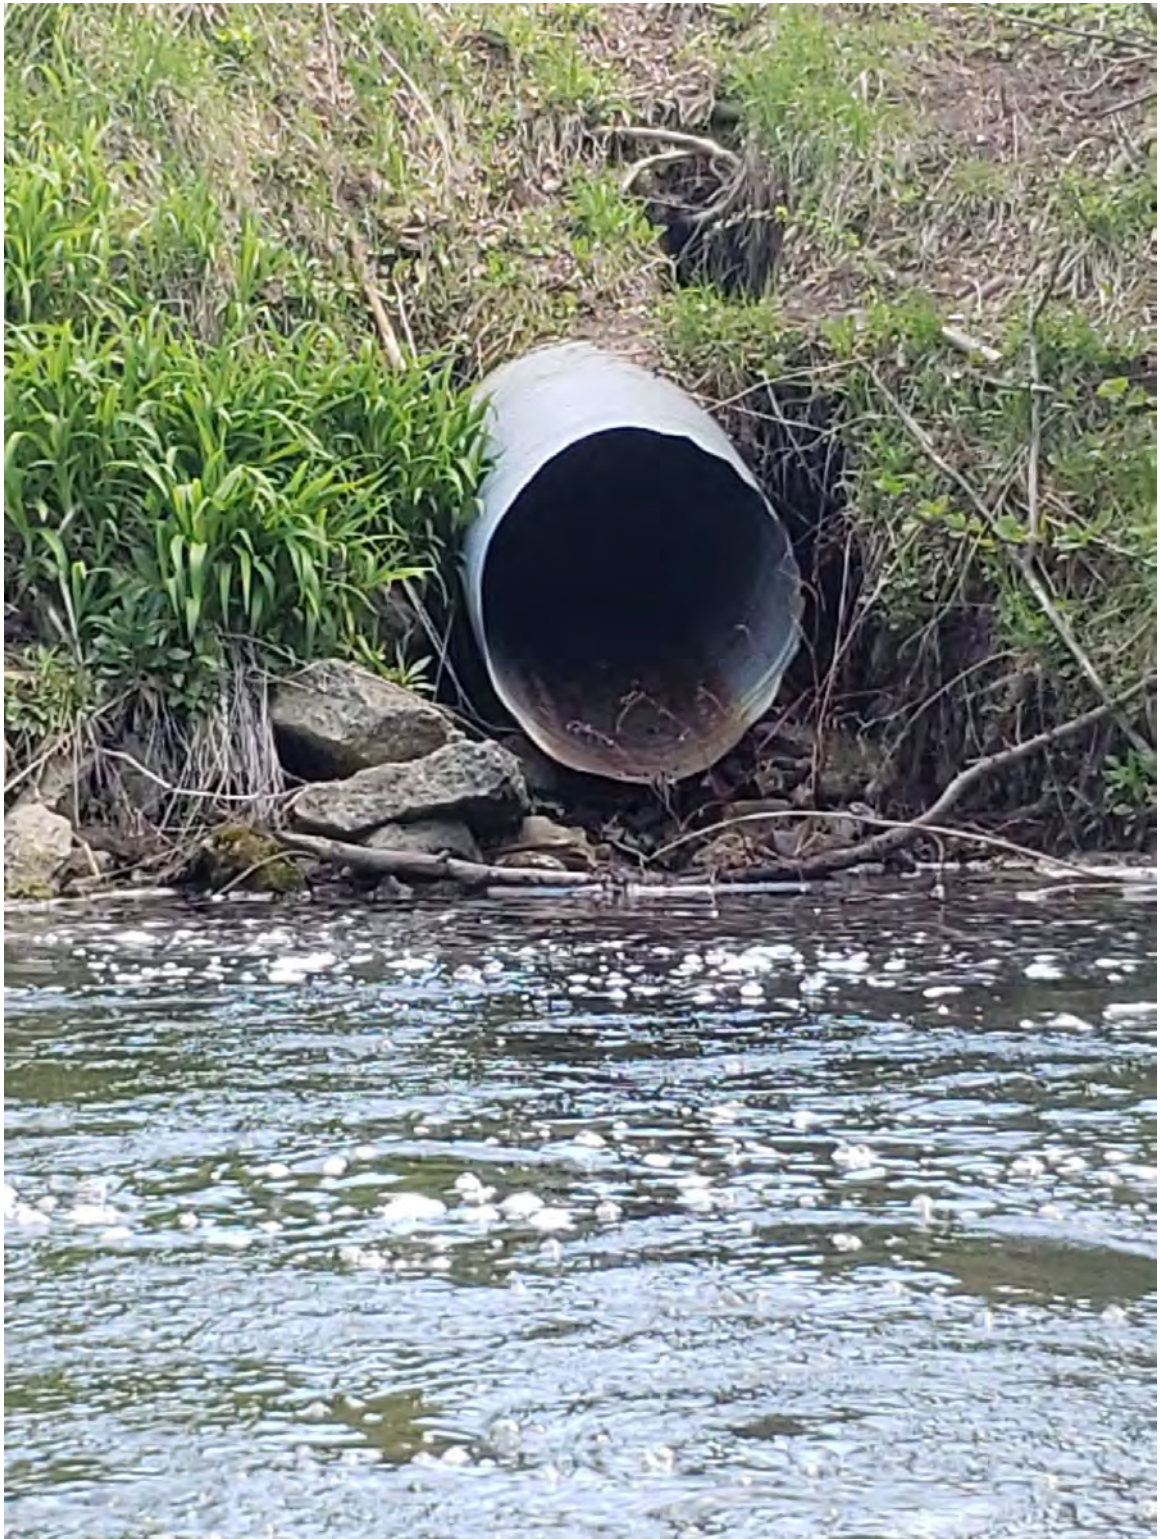
EROSION TYPE(S)	SEVERITY	N	E	Z	PTID
Perched Culvert	2 - Moderate	4793005.49	544861.12	286.636	22

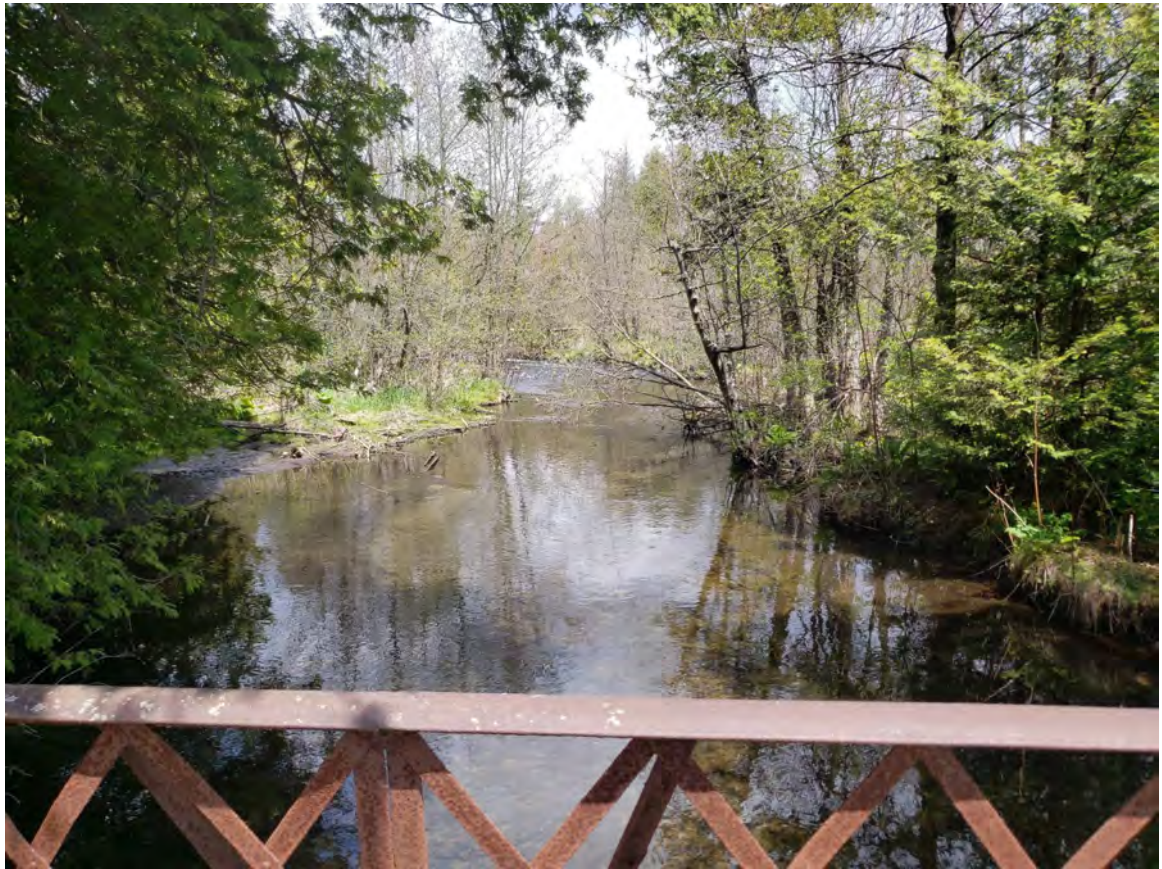
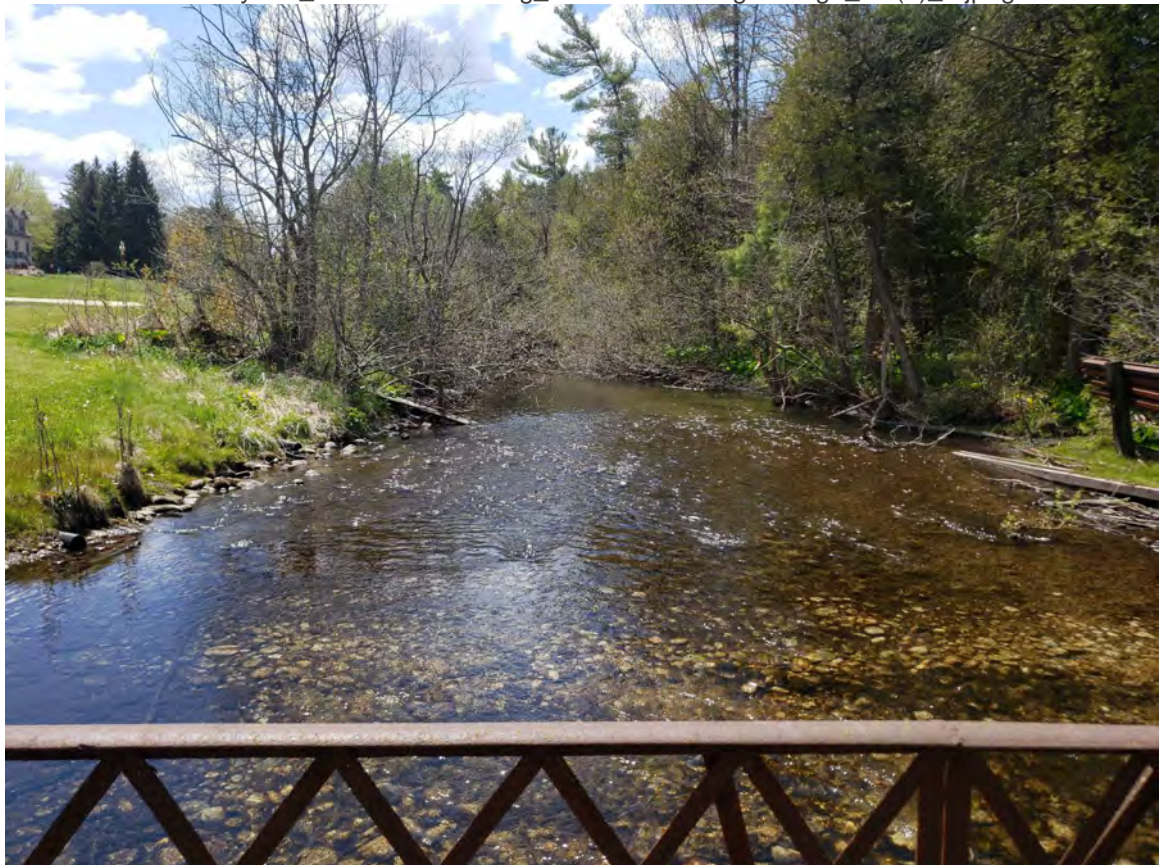
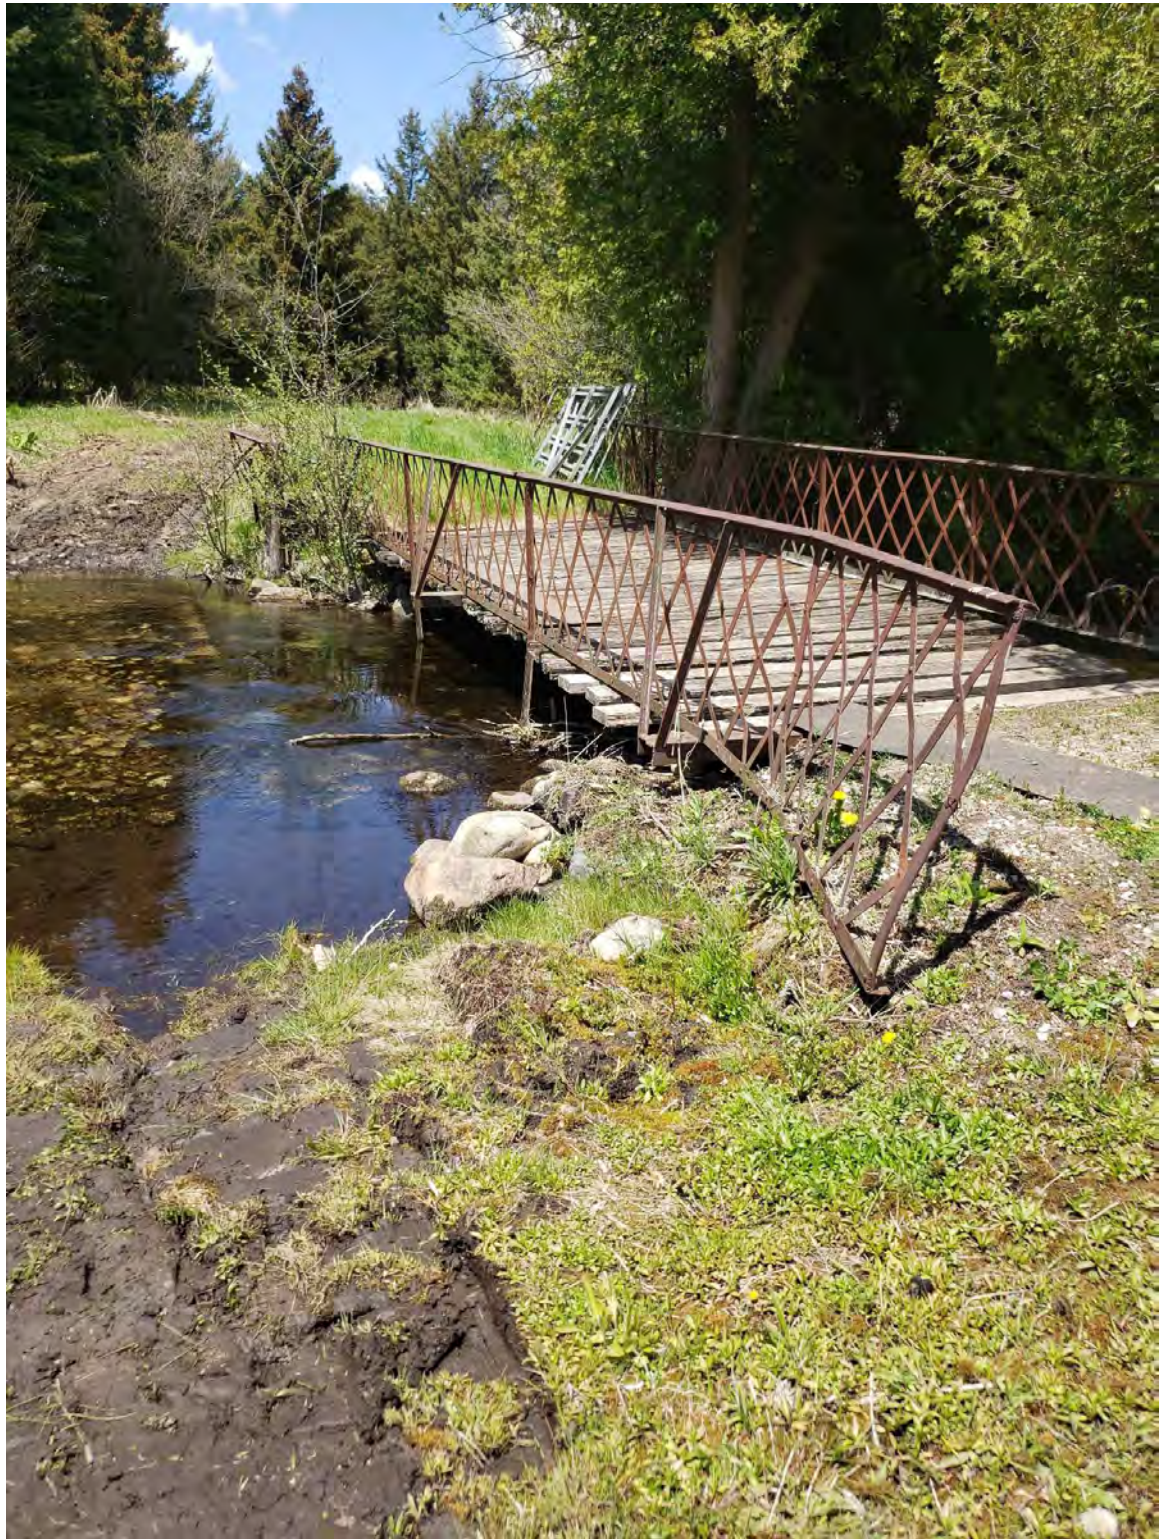
Slight undercutting on north side of river. bridge experiencing a slight lean, in poor condition - may be private property / privately owned bridge.

EROSION TYPE(S)	SEVERITY	N	E	Z	PTID
Bank Undercutting	4 – Safety Hazard	4793476.17	545293.98	287.479	31

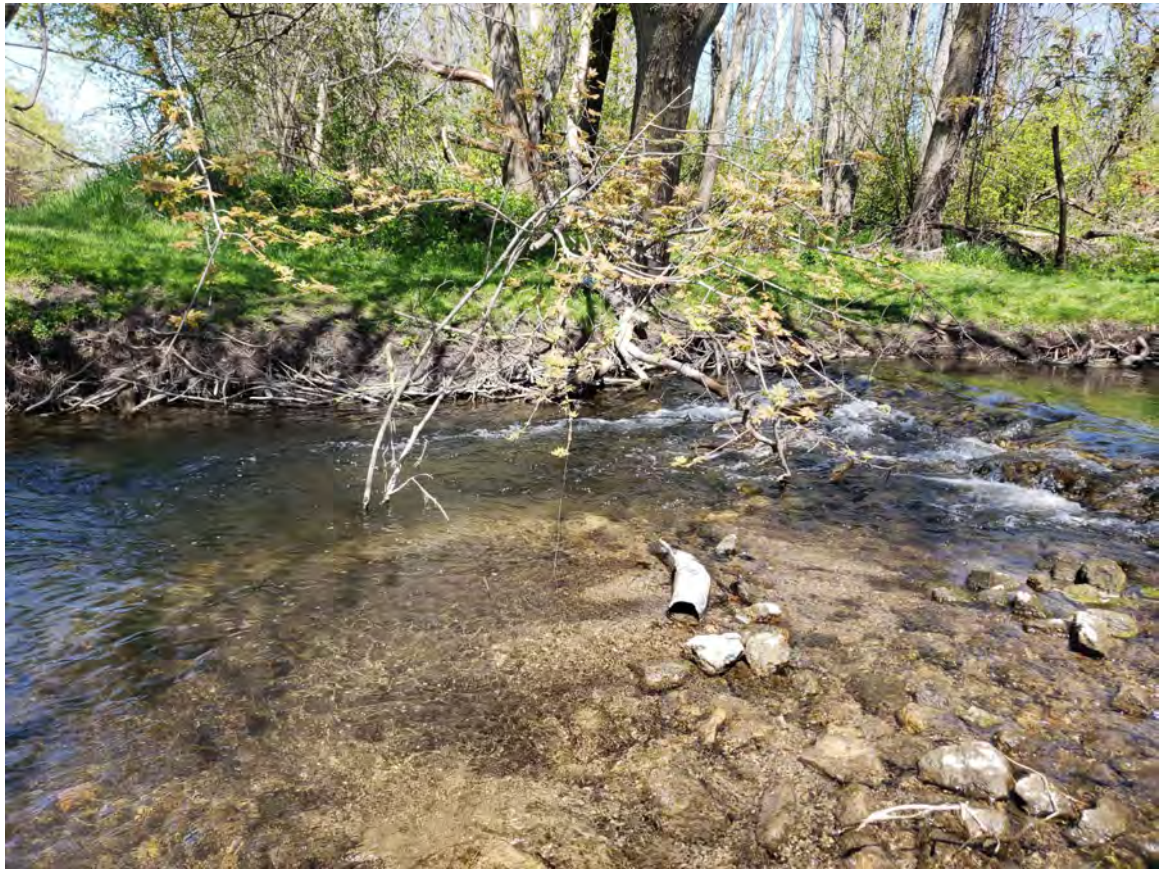
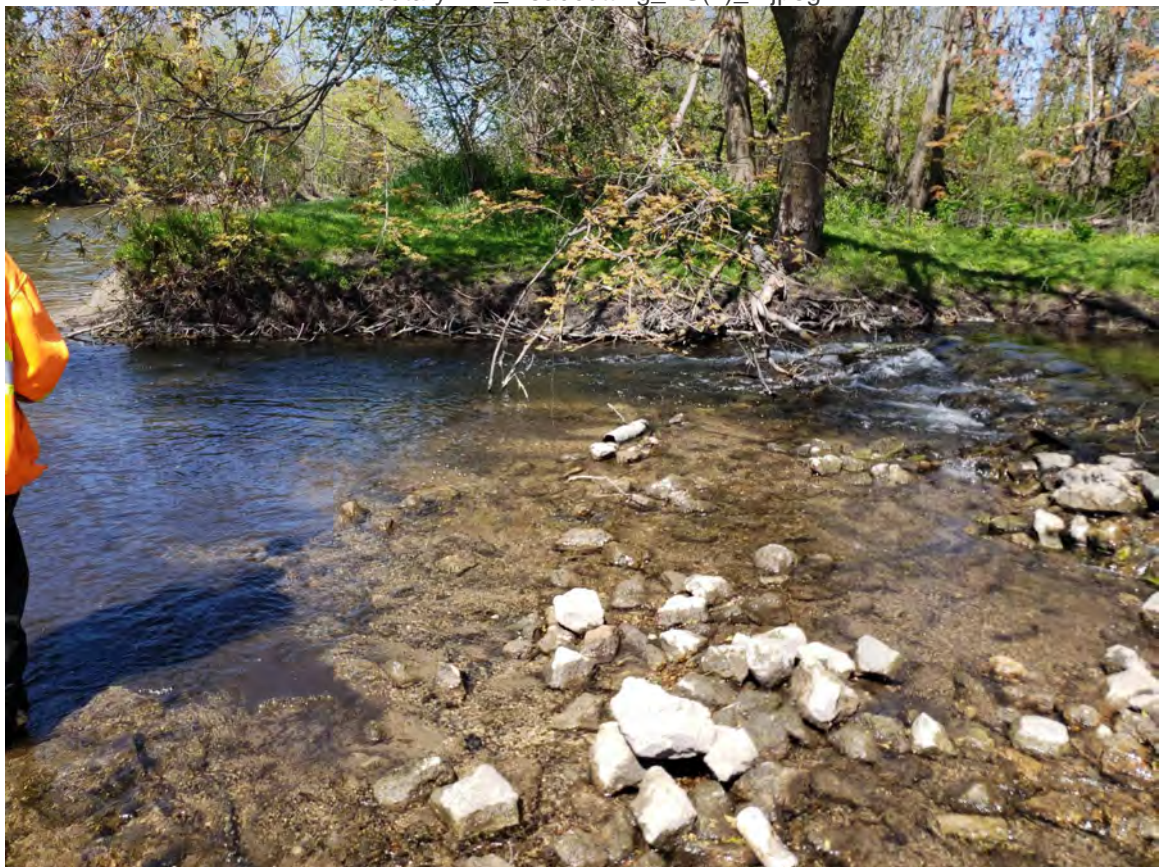
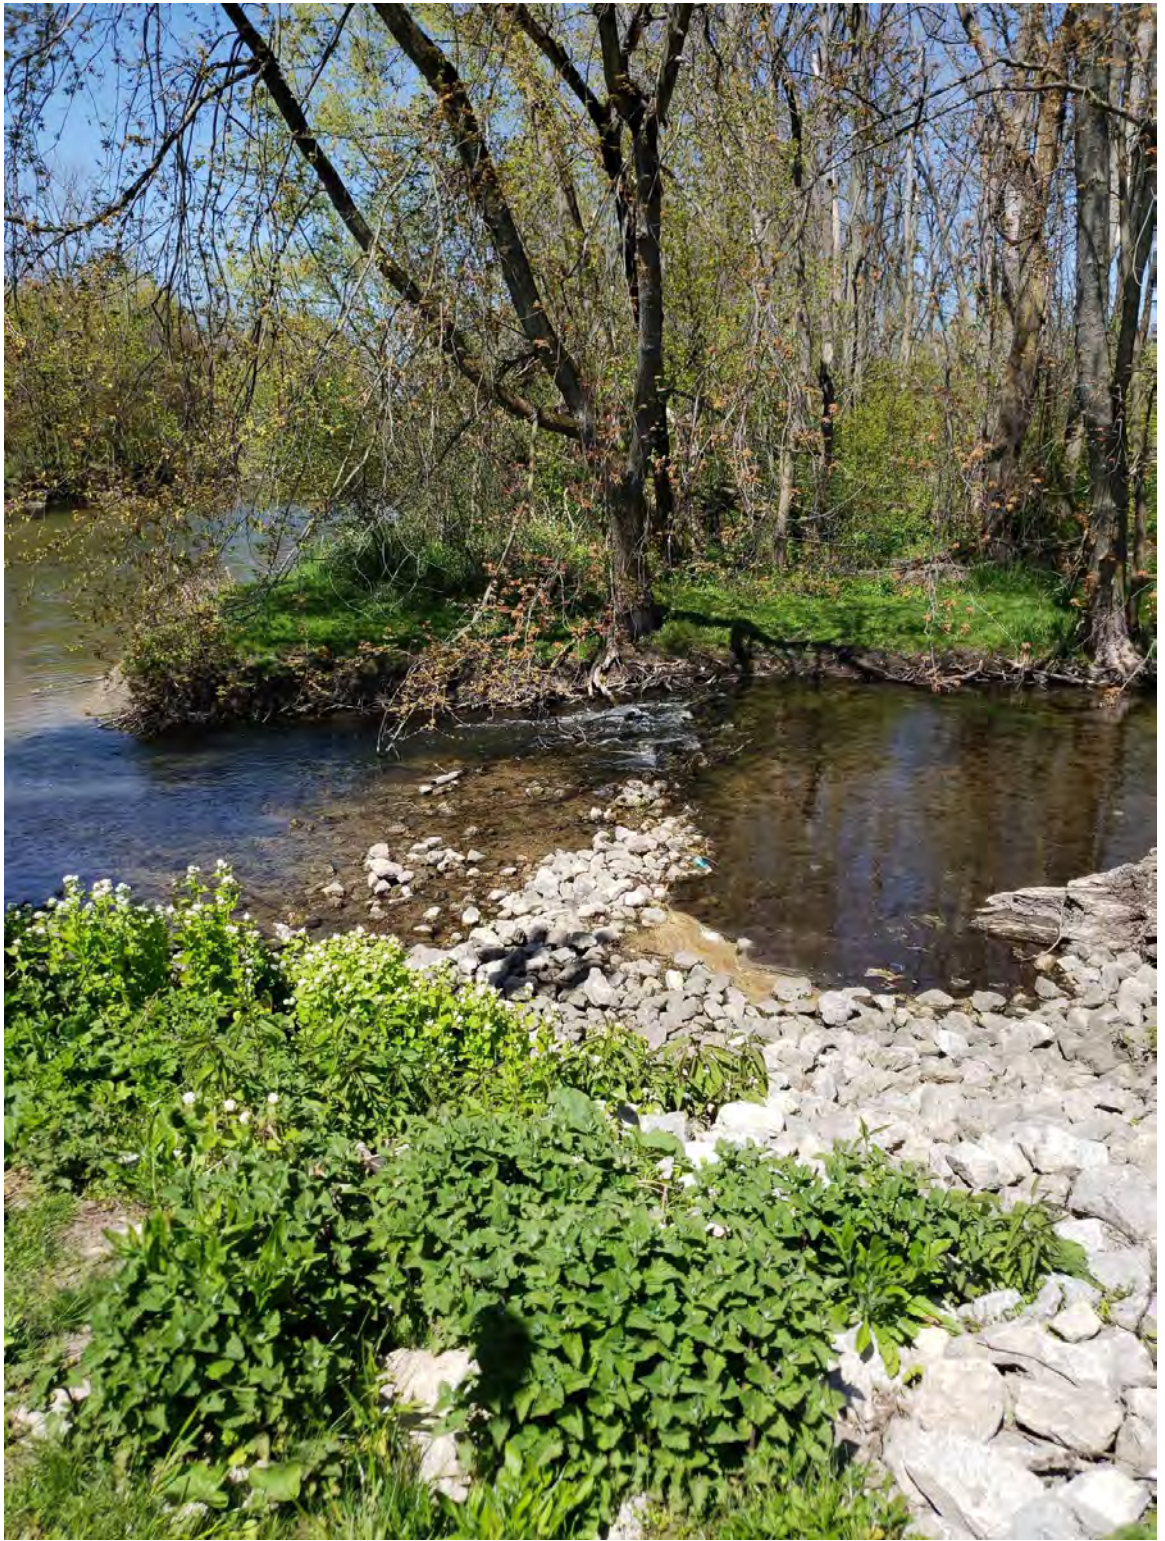
Riffle formation causing greater erosion near / on one side of the bank.

EROSION TYPE(S)	SEVERITY	N	E	Z	PTID
Headcutting	2 - Moderate	4792664.1	54453.91	218.13	26
