APPENDIX H

Erosion Inventory and Assessment Information

Ayr, ON - Watercourse Erosion Inventory and Assessment

Watercourse Erosion Inventory and Assessment
Ayr, ON
County of North Dumfries

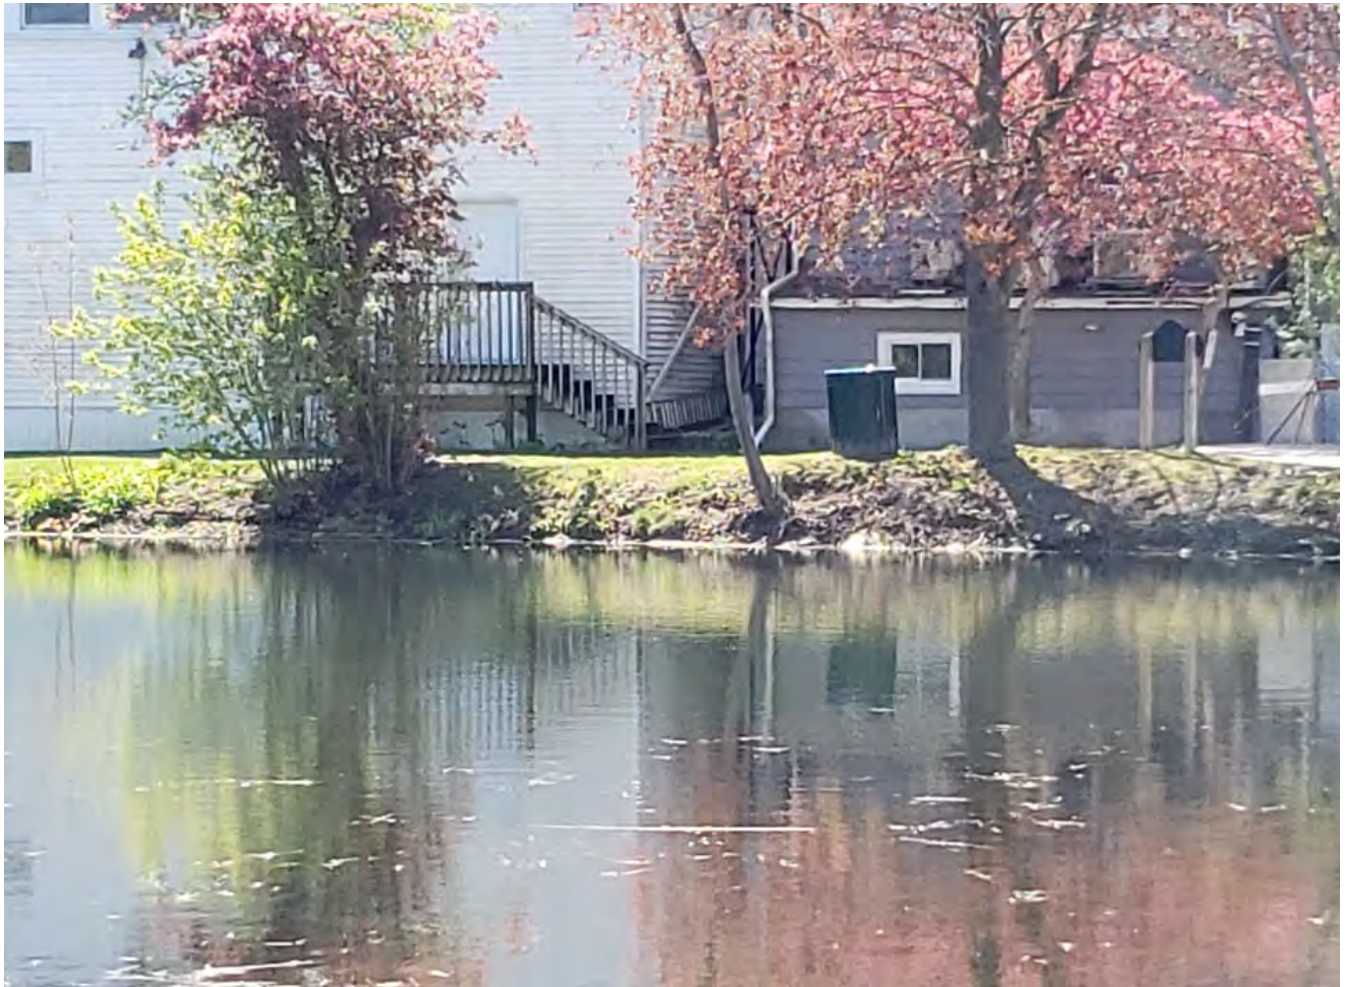
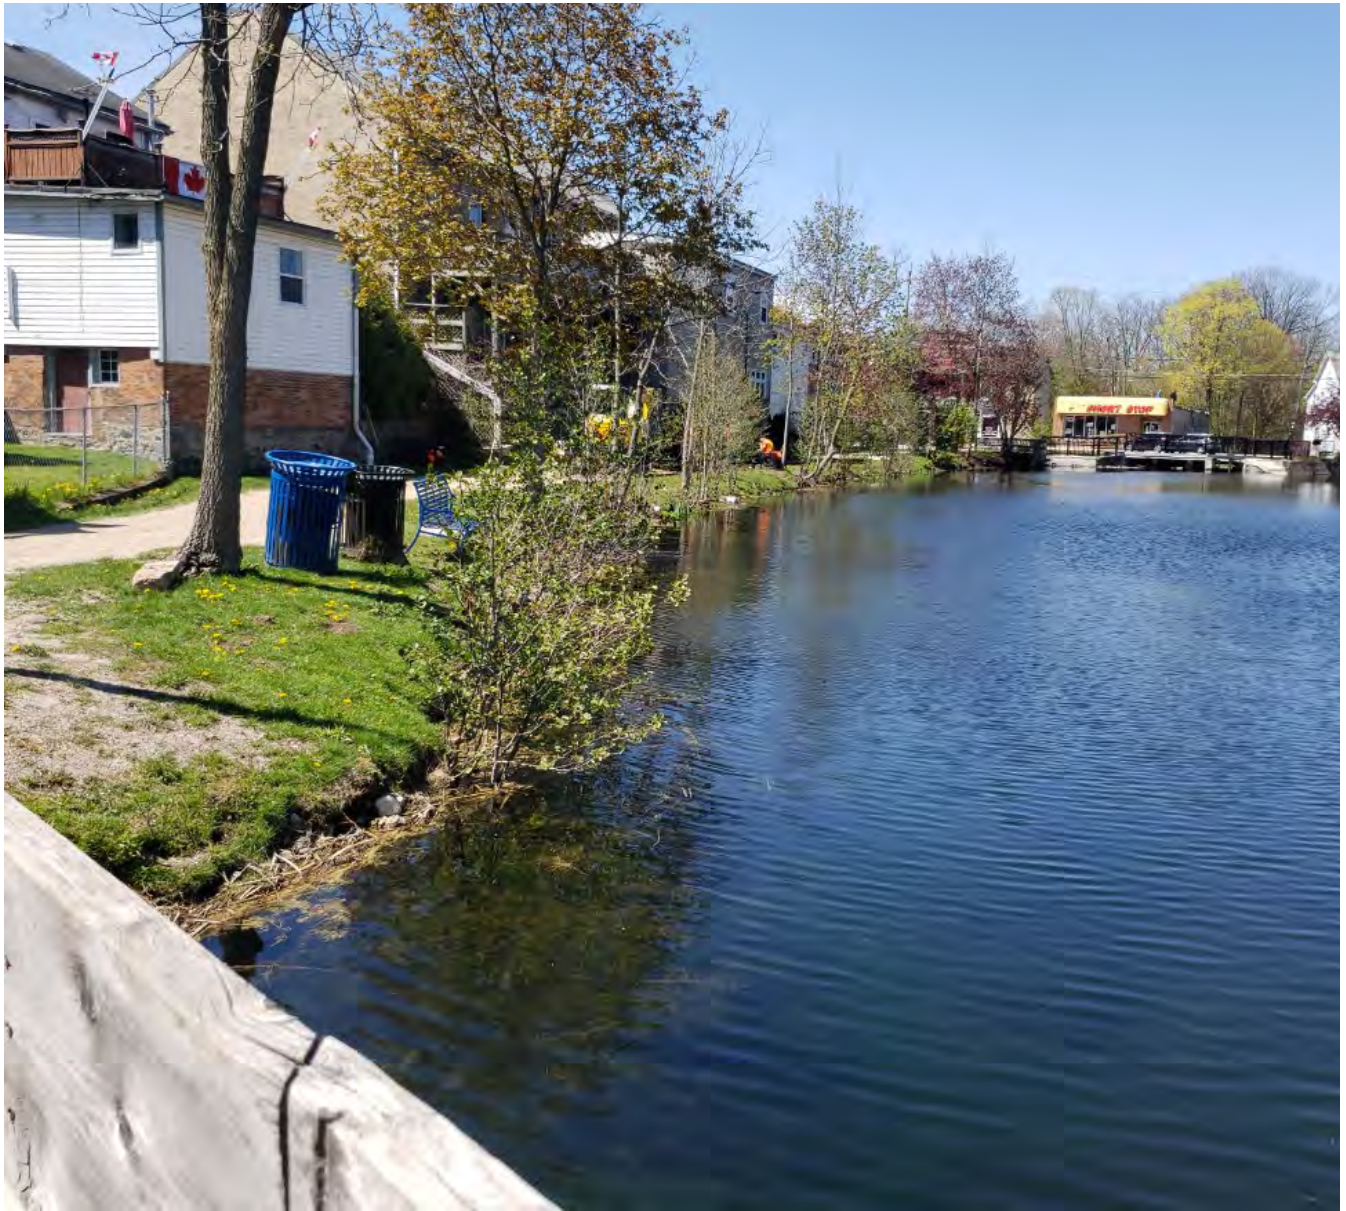
Some bank undercutting beginning south shore, close to private residences/property along
This stretch of bank. Bench is not level and deemed safety hazard as it is sloped towards water – likely result of erosion.

EROSION TYPE(S)	SEVERITY	N	E	Z	PTID
Bank Undercutting	4 – Safety Hazard	4792717.157	544638.6852	283.6701	39
