BUILDING CONDITION ASSESSMENT FOR

THE TOWNSHIP OF NORTH DUMFRIES

AYR PUBLIC LIBRARY

PROJECT NO:	GDR223-0353-00
SITE VISIT DATE:	June 9, 2023
REPORT DATE:	October 11, 2023

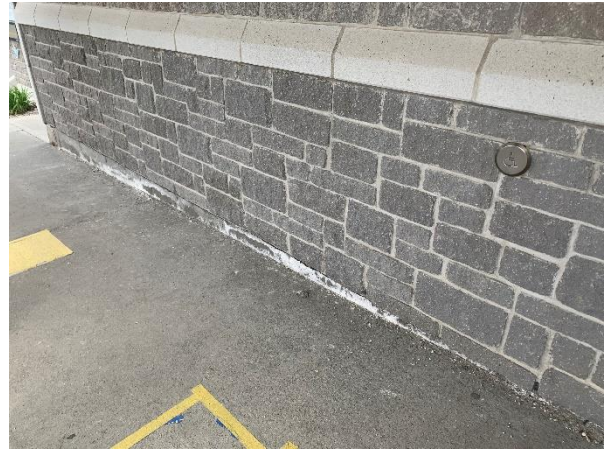
The foundation is comprised of poured concrete which support the building superstructure. A majority of the foundation is concealed below grade. Minor deterioration was noted at the main entrance, likely due to the use of de-icing salts. Allowance for periodic concrete repairs.

Photograph No. 4 - Minor foundation deterioration

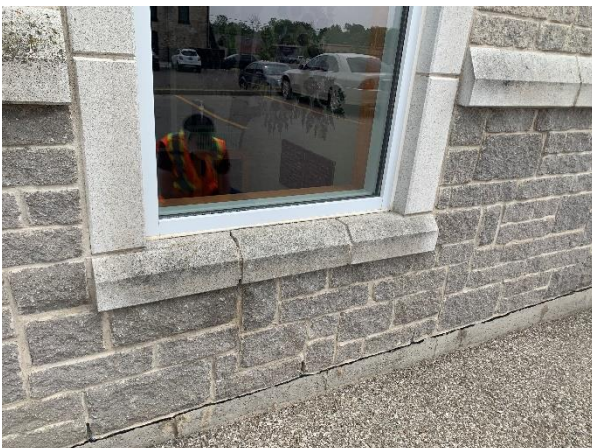
The exterior walls consist of stone veneer masonry. Weep holes were observed at the bottom of the wall, and at lintels over windows and doors. Erosion of mortar joints was observed below window sills. Repoint deteriorated mortar joints. Replace damaged masonry as required.

Photograph No. 5 Mortar joint erosion at window sill

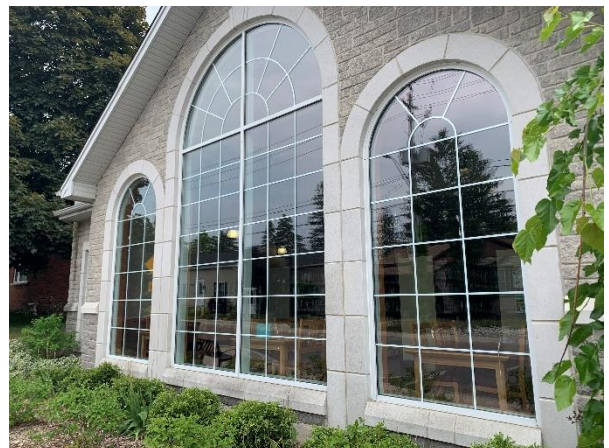
Metal framed fixed pane windows with sealed insulated glazing units. One window on the north elevation is reported to be leaking, and one has a fogged IGU. Major repairs and/or replacement is not anticipated within the study period.

Photograph No. 6 Exterior windows

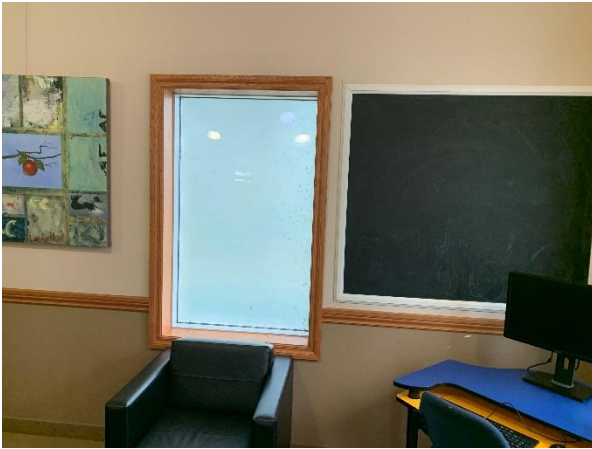
Photograph No. 7 Failed glazing seal in IGU

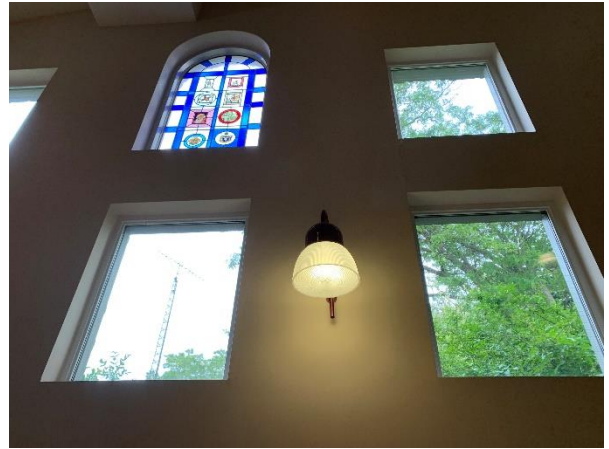
The wall finish throughout the building consists of painted gypsum wallboard. Localized damage was noted on the north wall below a window, reportedly due to a leaking window. A short-term allowance is included for repairing and repainting the damaged wall board. A further allowance is included for complete repainting.

Photograph No. 8 Water damage due to leaking window

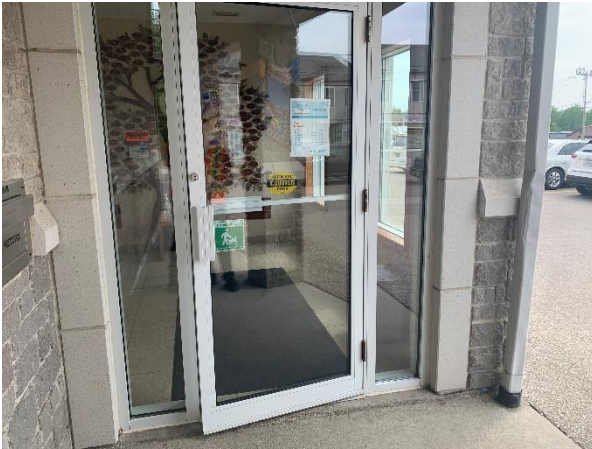
The two (2) main entrance vestibule doors consist of aluminum framed fully glazed doors with sidelites. The doors are equipped with button activated openers. No significant deficiencies were observed or reported at the time of the site review. Major repairs and/or replacement is not anticipated within the study period.

Photograph No. 9 Entrance vestibule

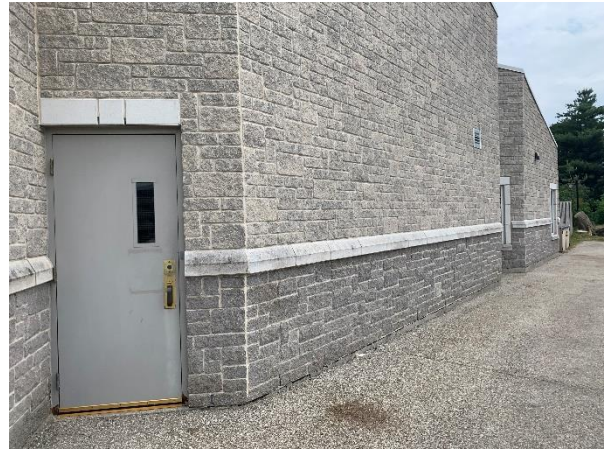
Three (3) exterior hollow metal doors provide egress for the building. Doors are equipped with panic bars and closers. Corrosion observed at the bottom of doors and at door frames Replace exterior hollow metal doors at the end of their expected service life.

Photograph No. 10 Service doors

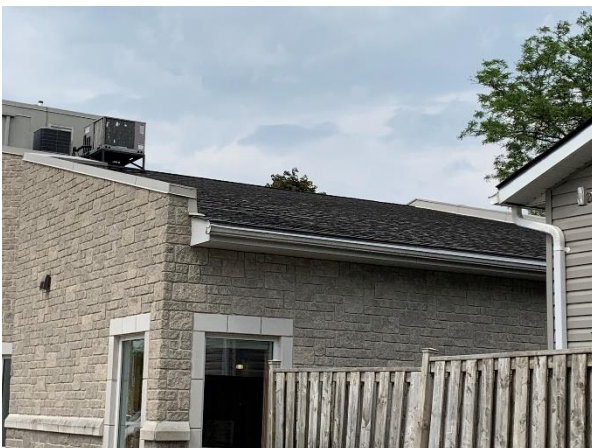
Sloped asphalt shingle roof with architectural shingles. Shingles on the south side of the building are aged with curling and degranulation observed. Replace asphalt shingles at the end of their expected service life.

Photograph No. 11 Aged and curled asphalt shingles

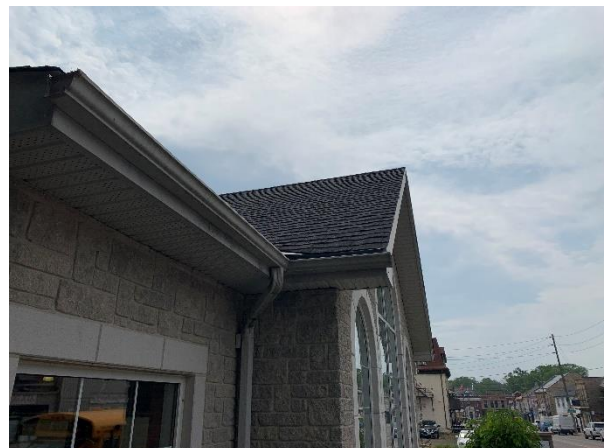
Sloped asphalt shingle roof with architectural shingles. Shingles on the north side have been recently replaced and are in good condition. Major repairs and/or replacement is not anticipated within the study period.

Photograph No. 12 New asphalt shingles

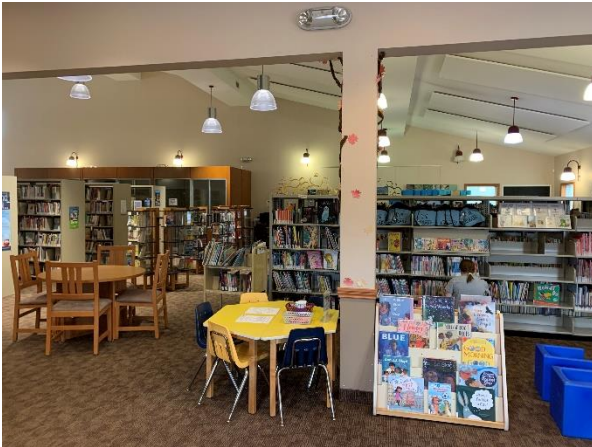
Photograph No. 13 Painted gypsum walls, carpet flooring

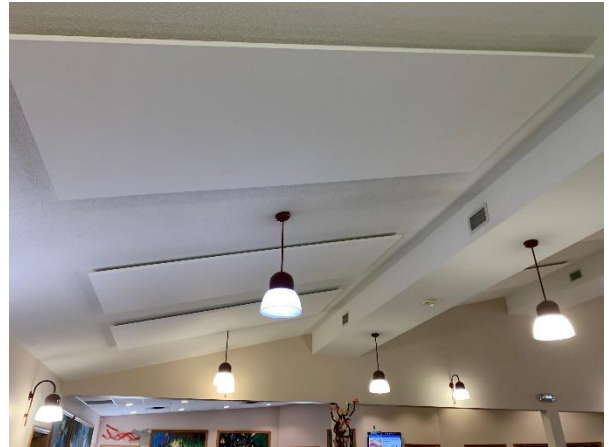
Photograph No. 14 Painted gypsum ceilings, acoustical panels

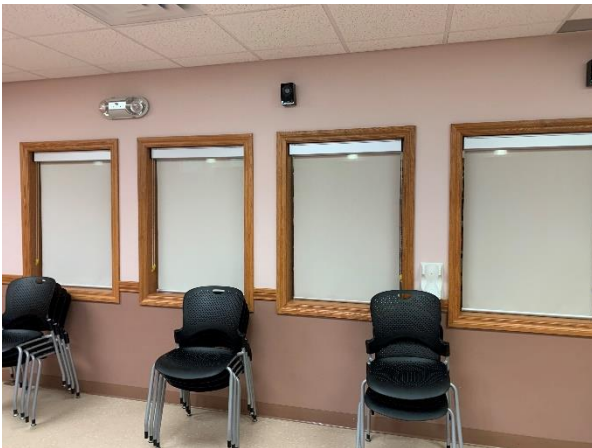
Six (6) fixed pane windows on the interior. No significant deficiencies were observed or reported at the time of the site review. Major repairs and/or replacement is not anticipated within the study period.

Photograph No. 15 Interior glazing

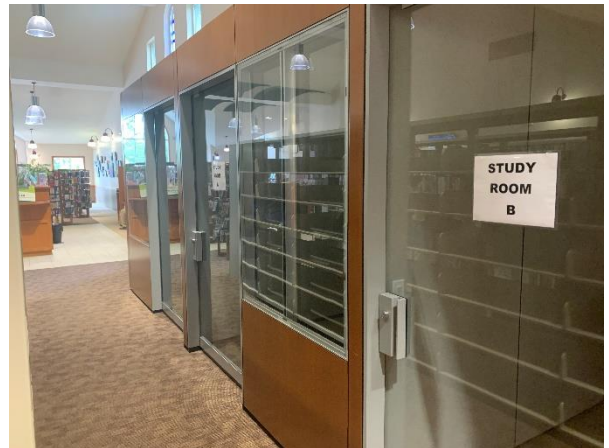
There are three (3) stand-alone study rooms comprised of laminated wall panels on the exterior walls, sliding glass doors, operable sliding window, acoustic ceiling tiles and acoustic wall panels in the interior are installed in the library. No significant deficiencies were observed or reported at the time of the site review. Major repairs and/or replacement is not anticipated within the study period.

Photograph No. 16 Study room

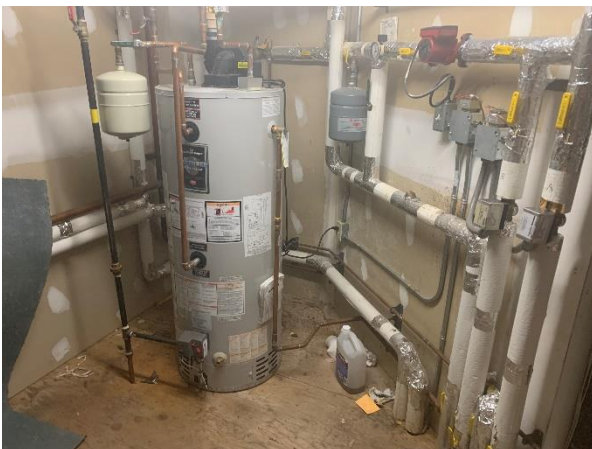
A natural gas fired domestic water tank heater is installed in the mechanical room which supplies hot water to the various fixtures throughout the building and the in-floor heating system. The water heater was manufactured in 2012 (gas-fired; 45 gal.; 67,0 No significant deficiencies were observed or reported at the time of the site review. Replace domestic hot water heater at end of service life.

Photograph No. 17 Domestic water tank heater

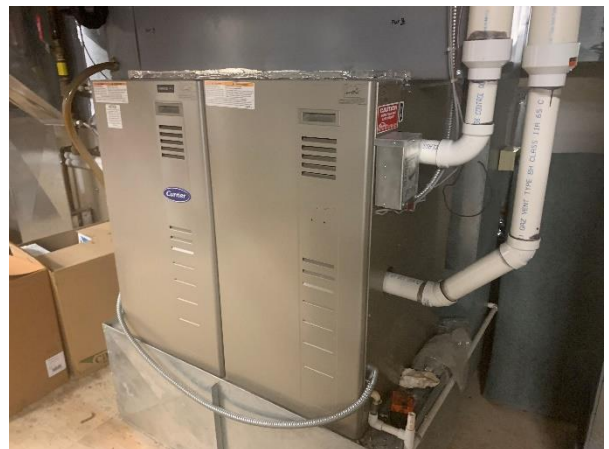
Photograph No. 18 Forced air furnace.

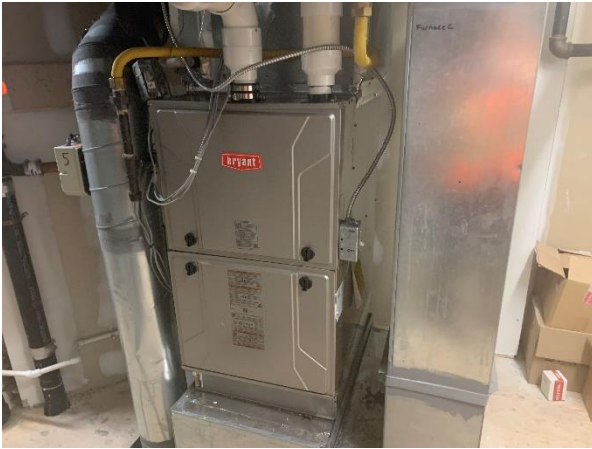
Photograph No. 19 New forced air furnace

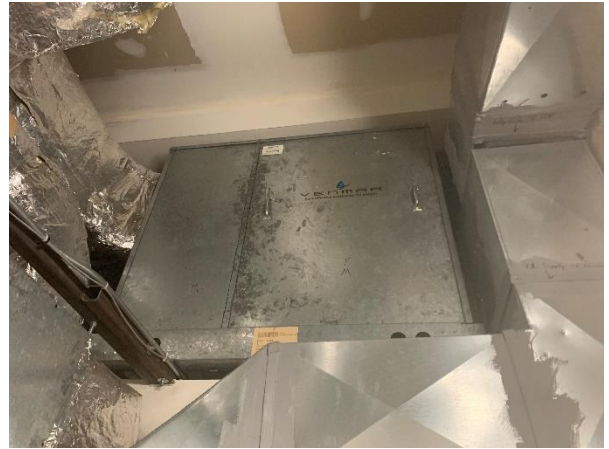
Photograph No. 20 ERV

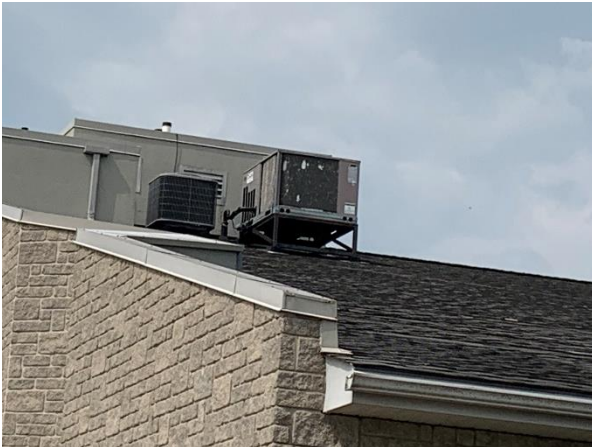
A natural gas fired packaged HVAC unit is located on the roof. The unit was not accessible at the time of the site review. The HVAC unit provides heating and cooling. No significant deficiencies were observed or reported at the time of the site review. Replace packaged HVAC unit at the end of its expected service life.

An air conditioning condensing unit is located on the roof. The unit was not accessible at the time of the site review. It provides cooling for the forced air furnaces. No significant deficiencies were observed or reported at the time of the site review. Replace air conditioner at the end of its expected service life.

Photograph No. 21 Packaged rooftop HVAC unit and air conditioner

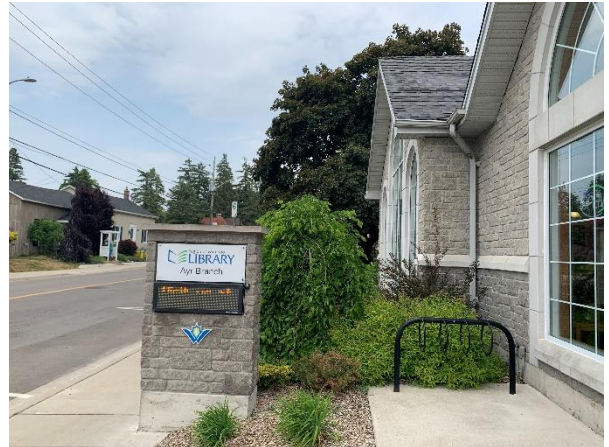
A concrete walkway leads from Stanley Street to the main entrance of the library. No significant deficiencies were observed or reported at the time of the site review. Allow to repair concrete walkways as required.

Photograph No. 22 Concrete walkway

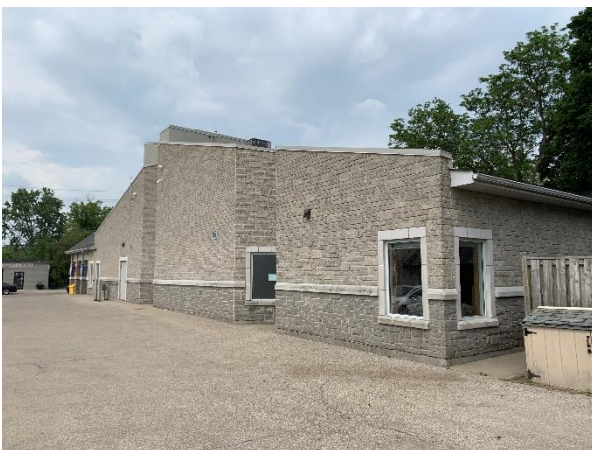
An asphalt paved parking lot/roadway is installed on site. Localized cracking was noted. Short term allowance for localized asphalt repairs. Long term allowance for full replacement at end of service life.

Photograph No. 23 Asphalt pavement

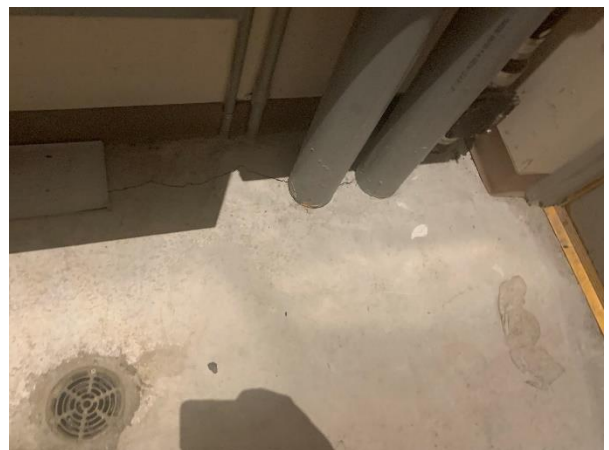
The ground floor is a cast-in-place concrete slab-on-grade. A crack was noted in the floor of the mechanical room near the exit door. The crack does not appear to be of structural concern; however it should be repaired. A short-term allowance is included to repair the crack in the mechanical room.

Photograph No. 24 Floor crack in mechanical room
