December 2, 2016

Reference No. 11116995

Re: 2016 OSIM Inspections for Municipal Bridges and Culverts Larger Than 3 Metres

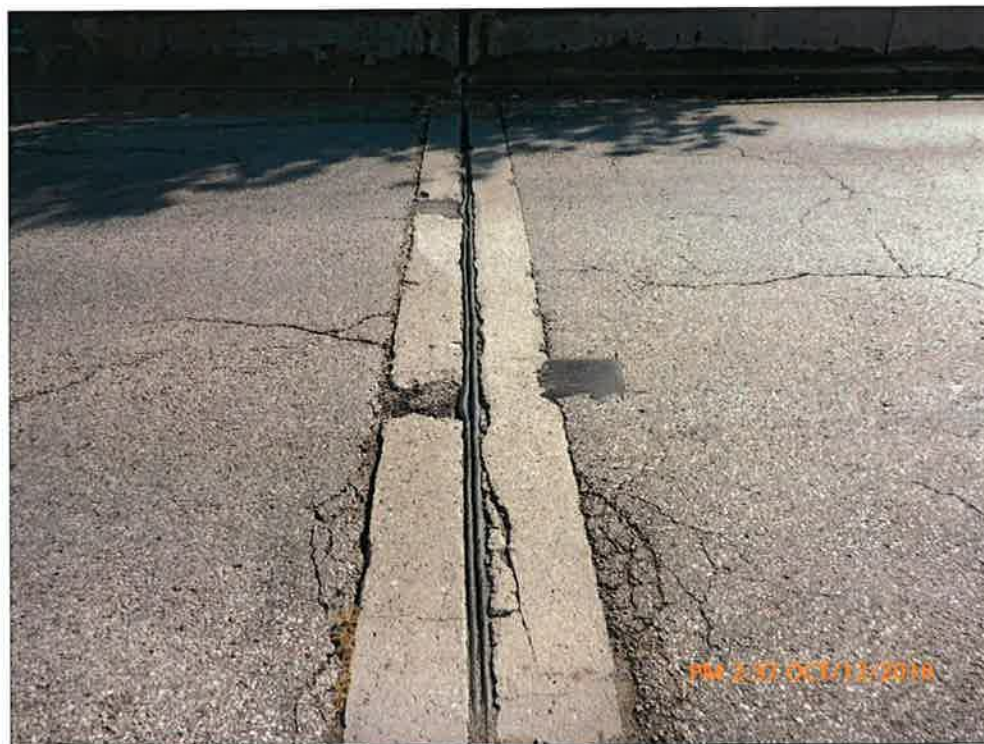
Wide Cracks on Deck Wearing Surface

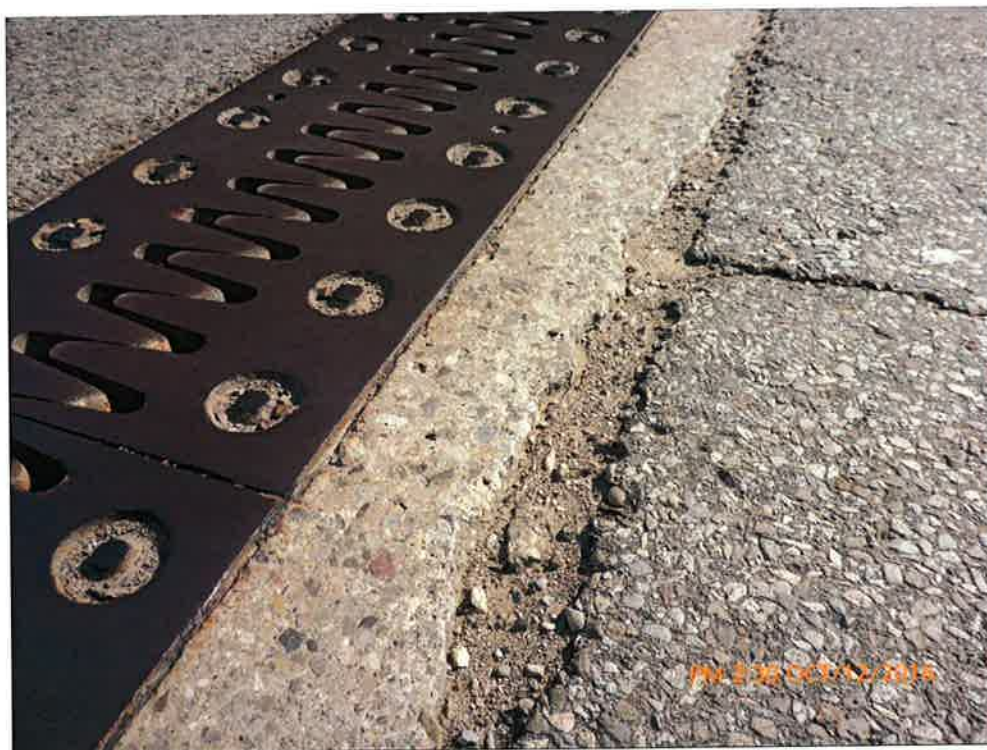
Light Corrosion on Finger Joint

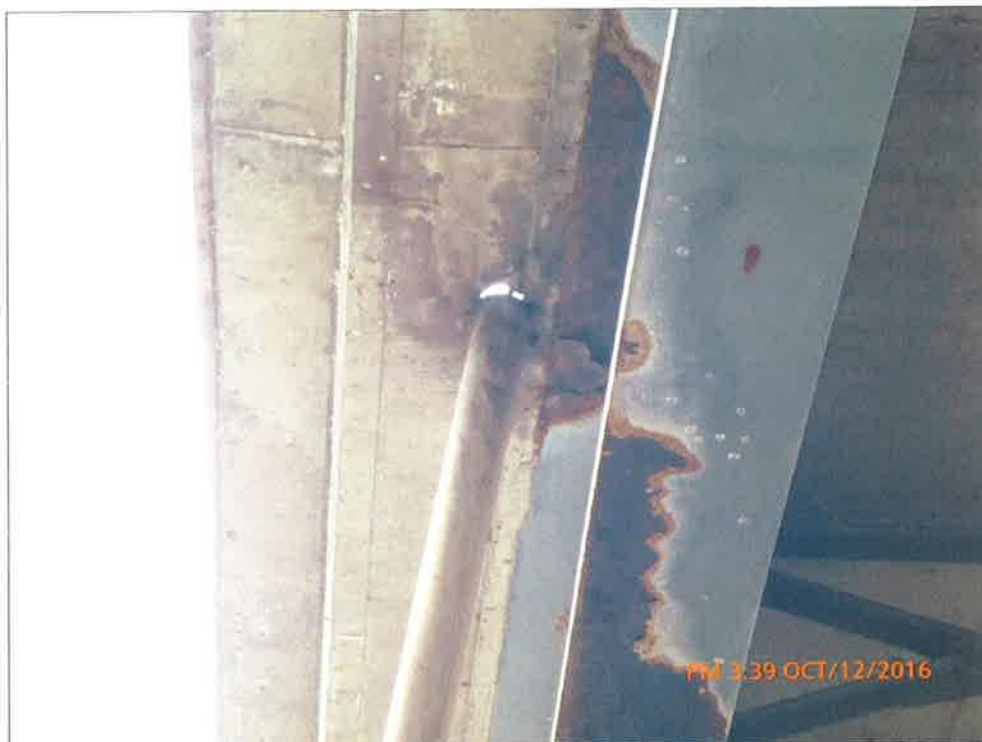
Light Corrosion on Deck Drain

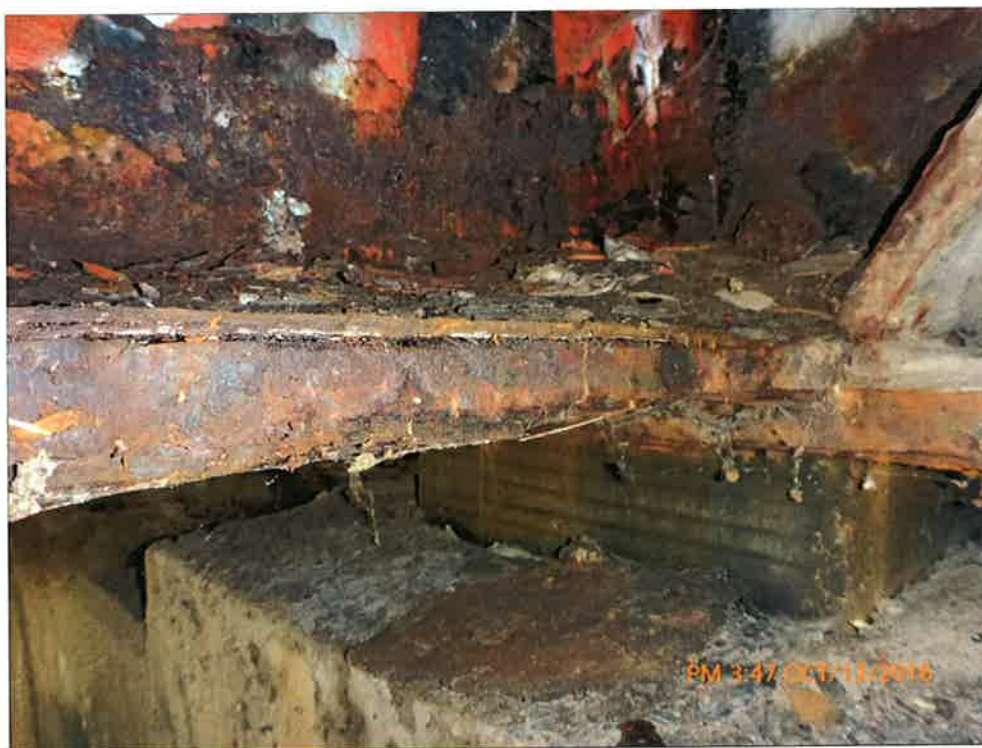
Breakdown of Protective Coating

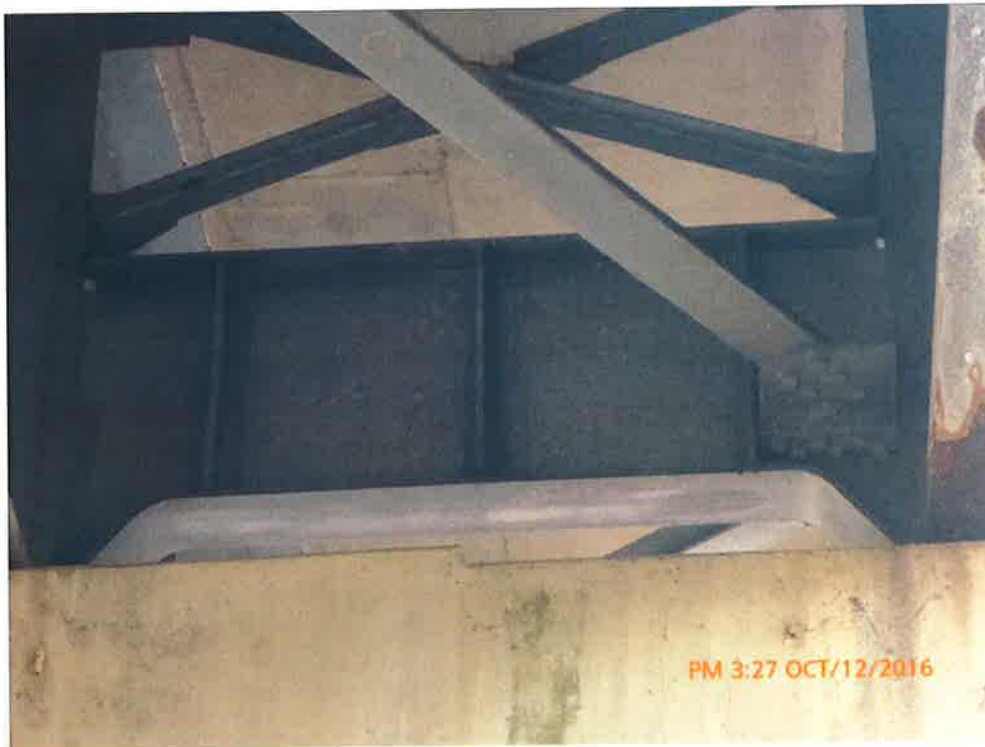
Medium Corrosion on End Diaphragm

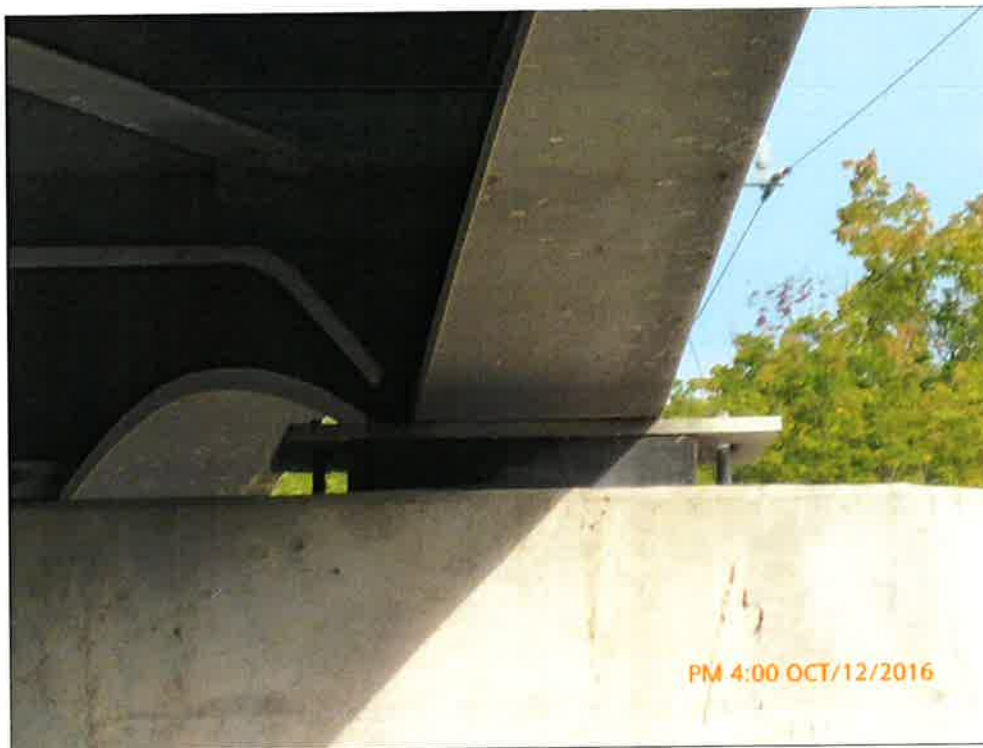
Narrow Stained Crack on Pier

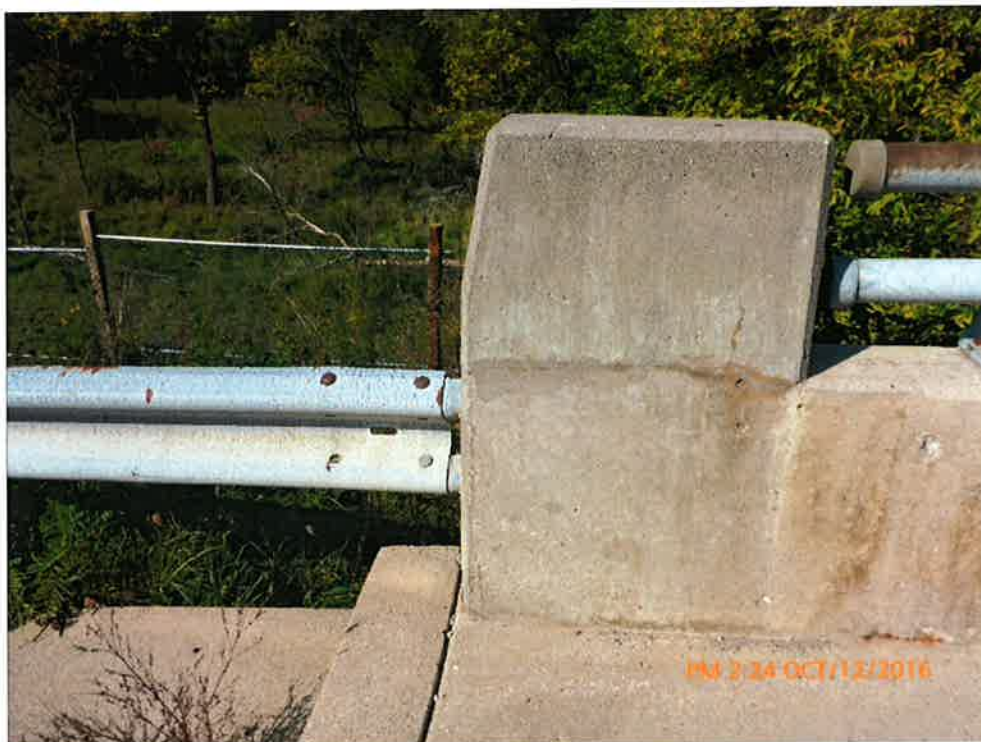
Missing Bolts on Guiderail

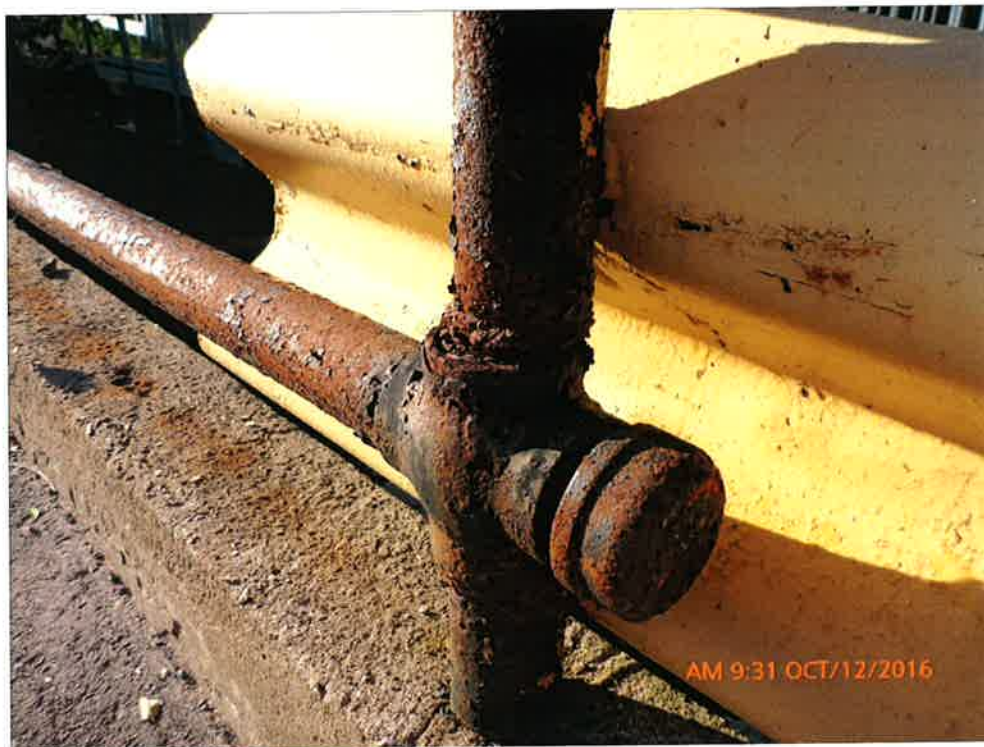
Flaking of Protective Coating on Handrail

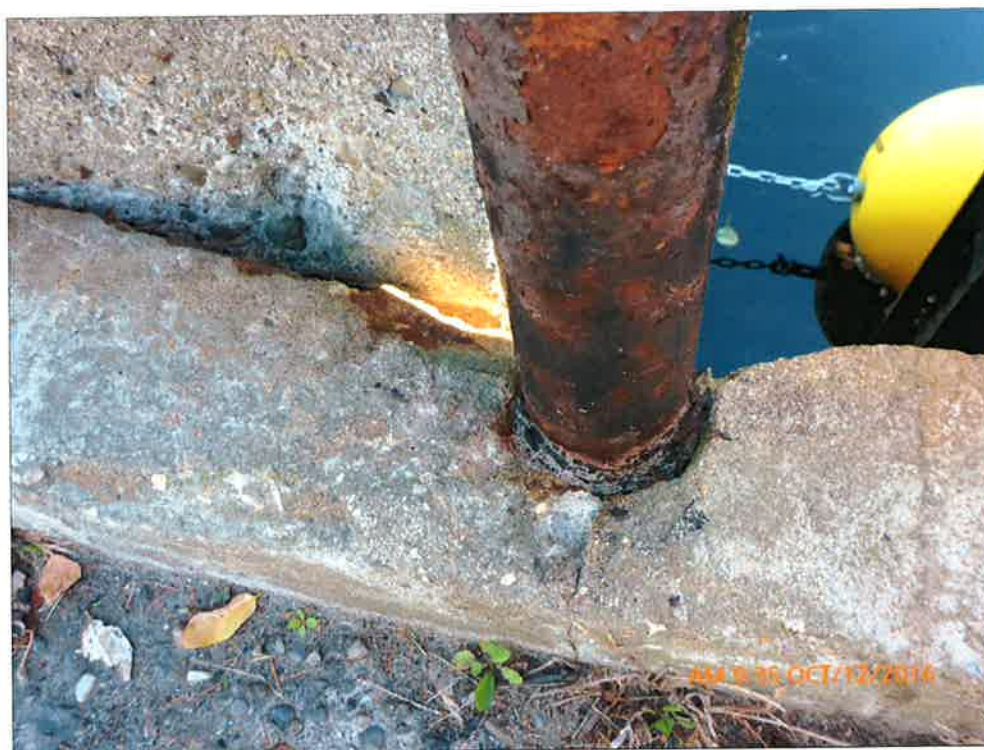
Broken Handrail in Northwest

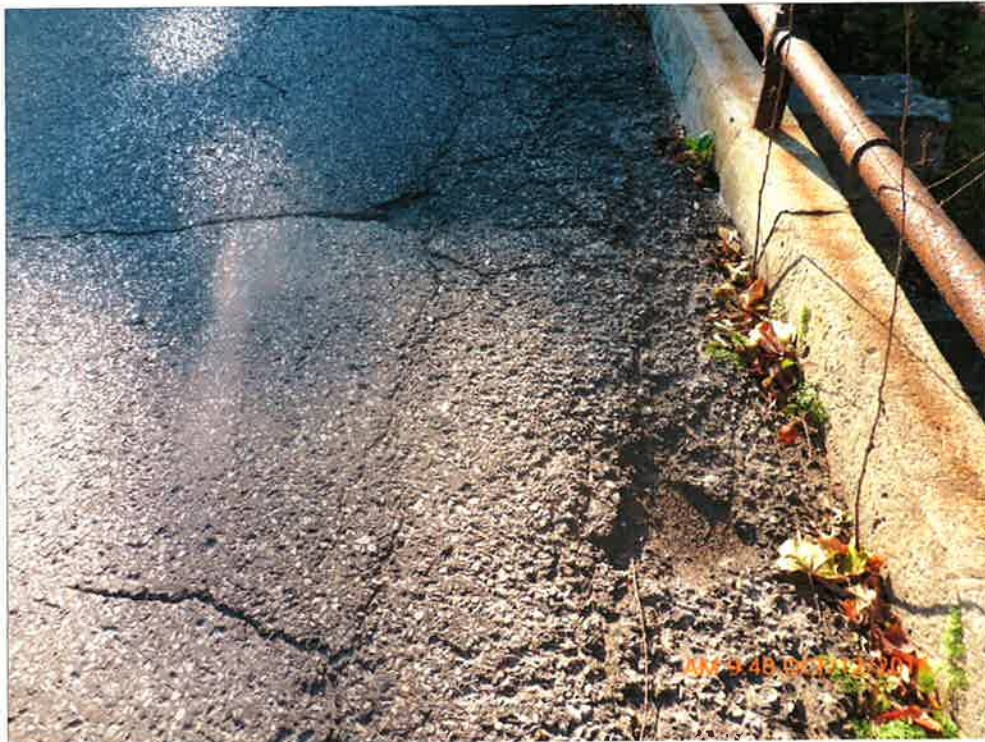
Light Spill on Curb

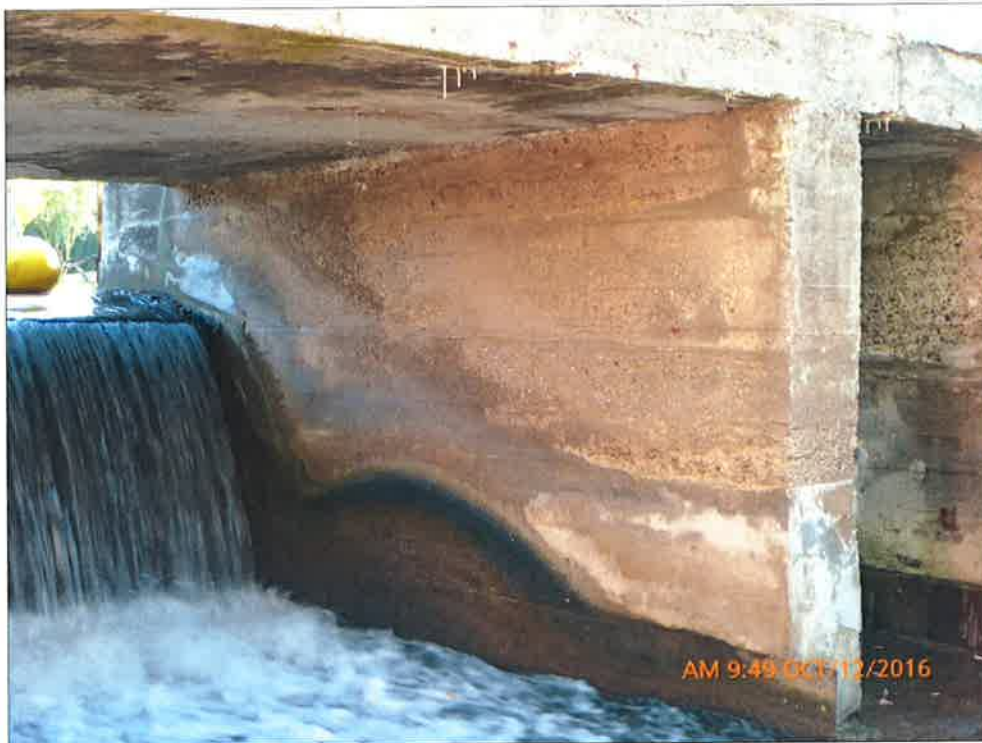
Light Spall on Exterior Soffit

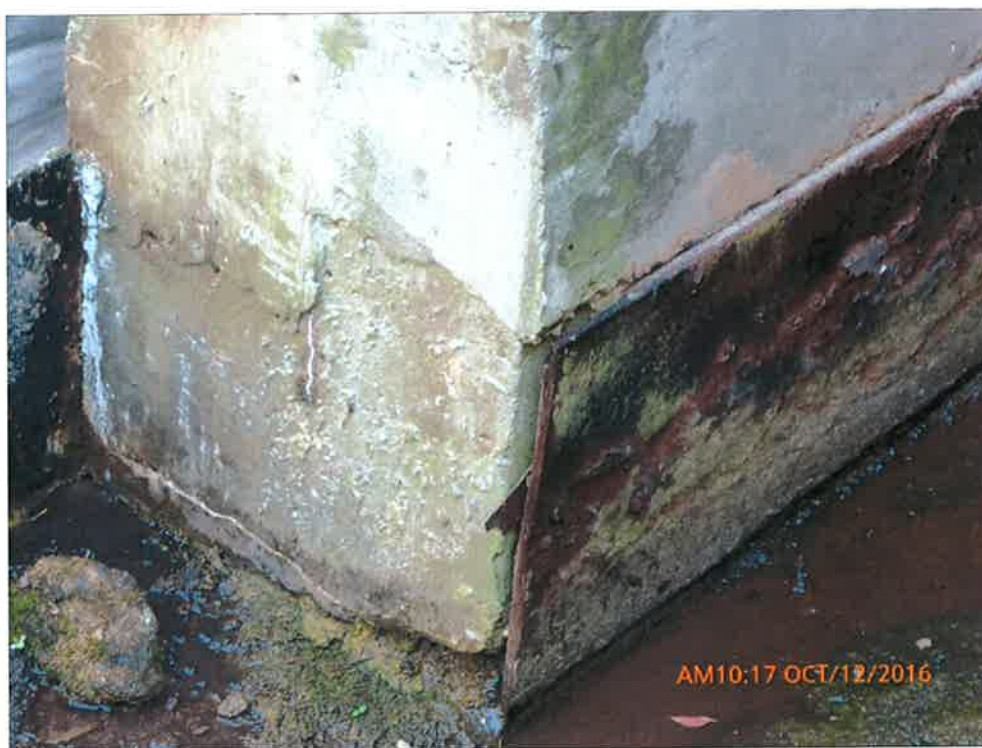
Severe Delamination on Pier

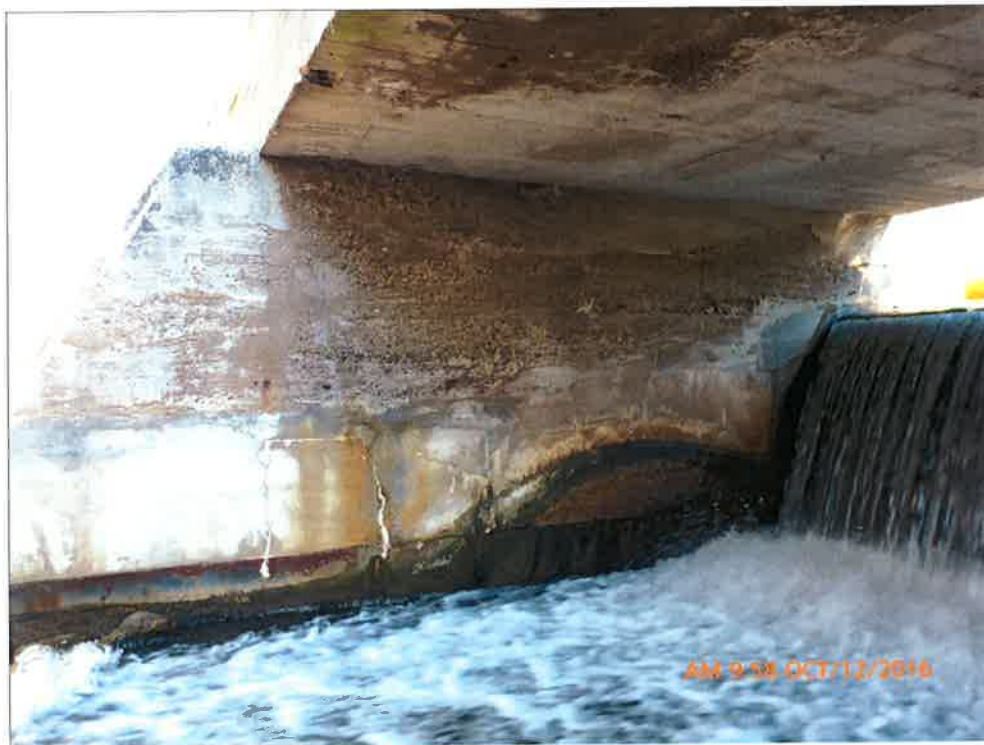
Light Corrosion on Splash Guard

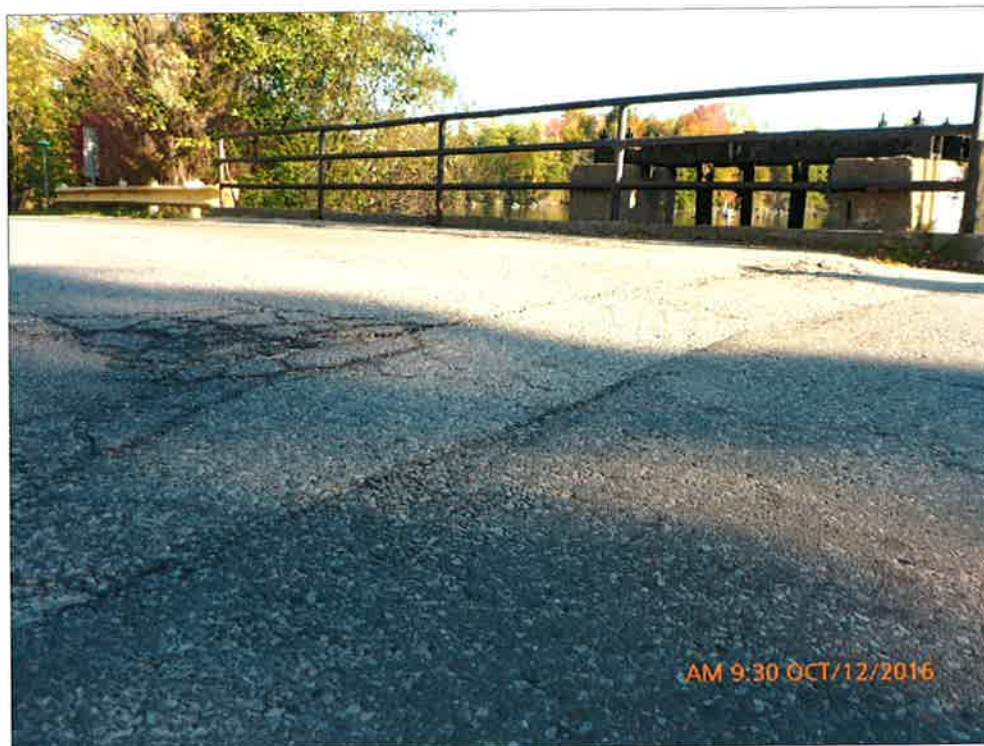
Wide Crack in Approach Wearing Surface

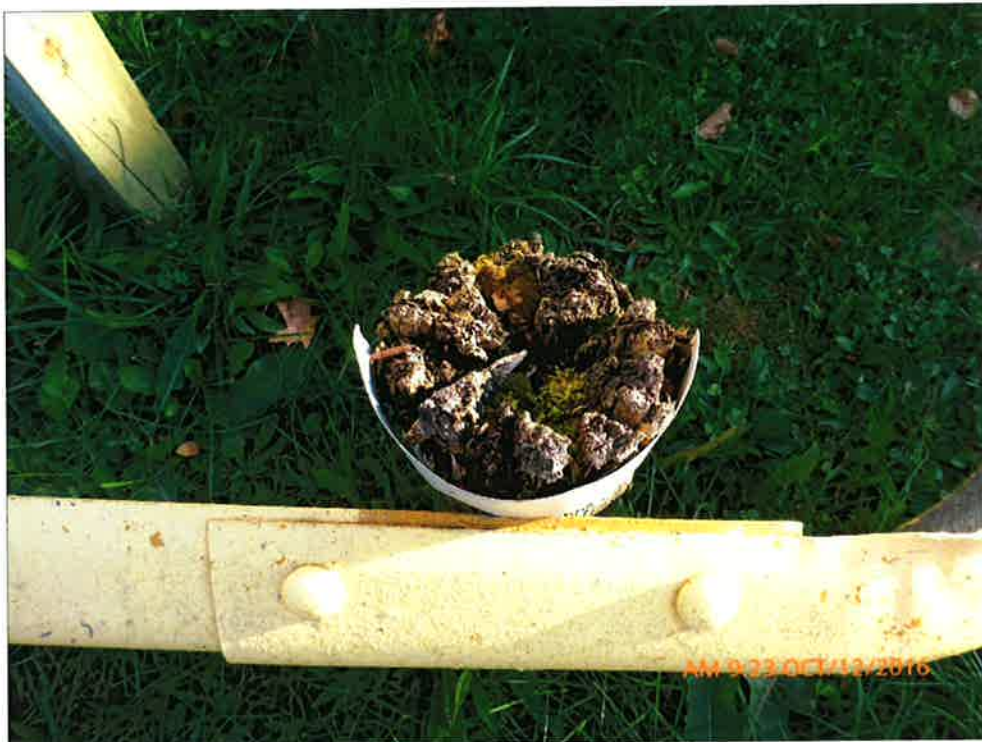
Guiderail Not Attached to Post

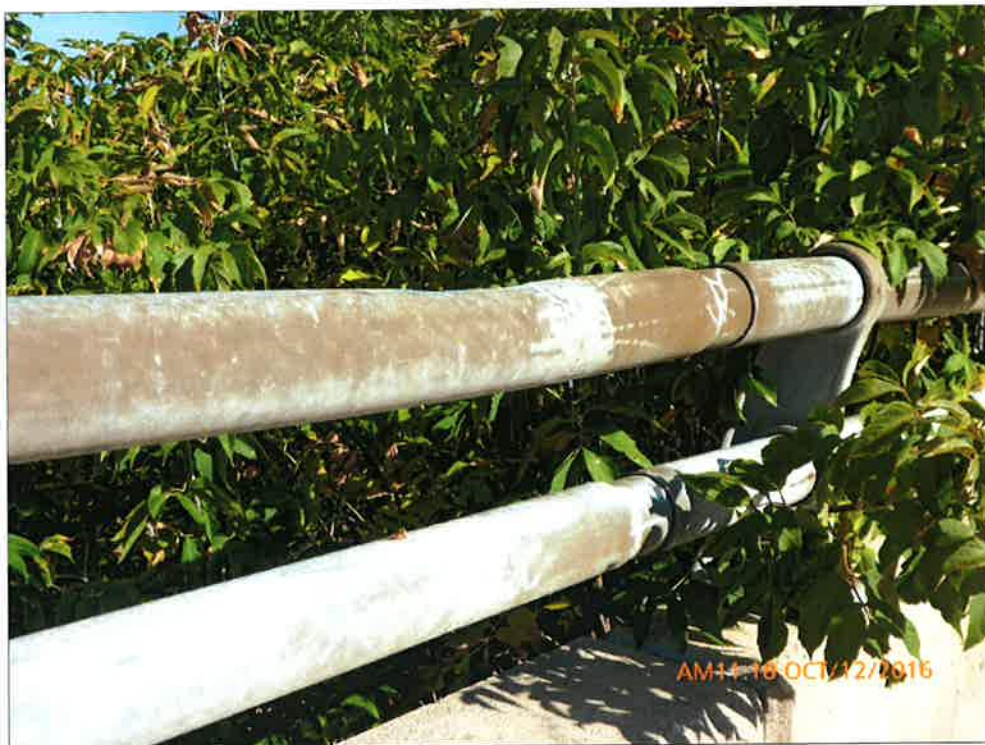
Breakdown of Protective Coating

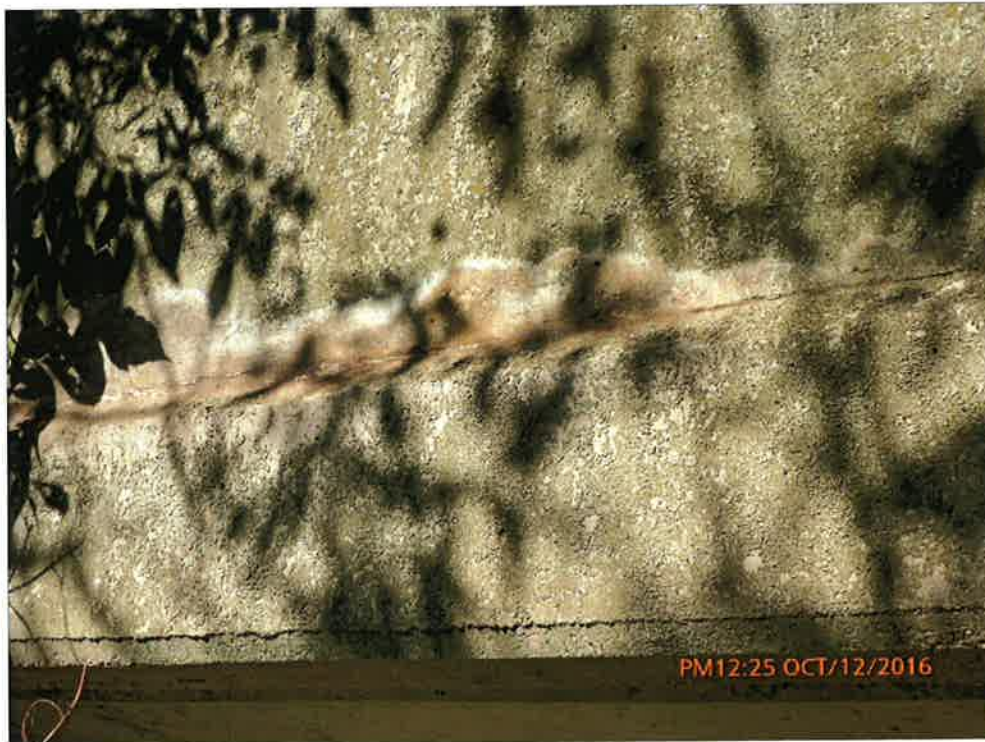
Narrow Stained Crack on Interior Parapet Wall

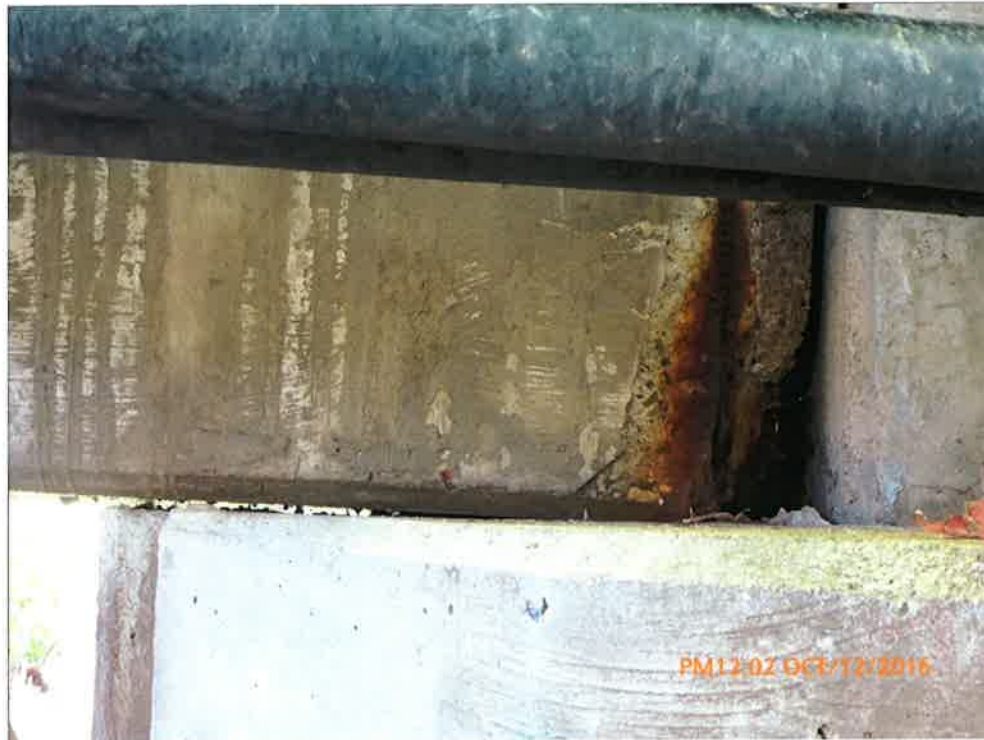
Rust Stains on Abutment Wall

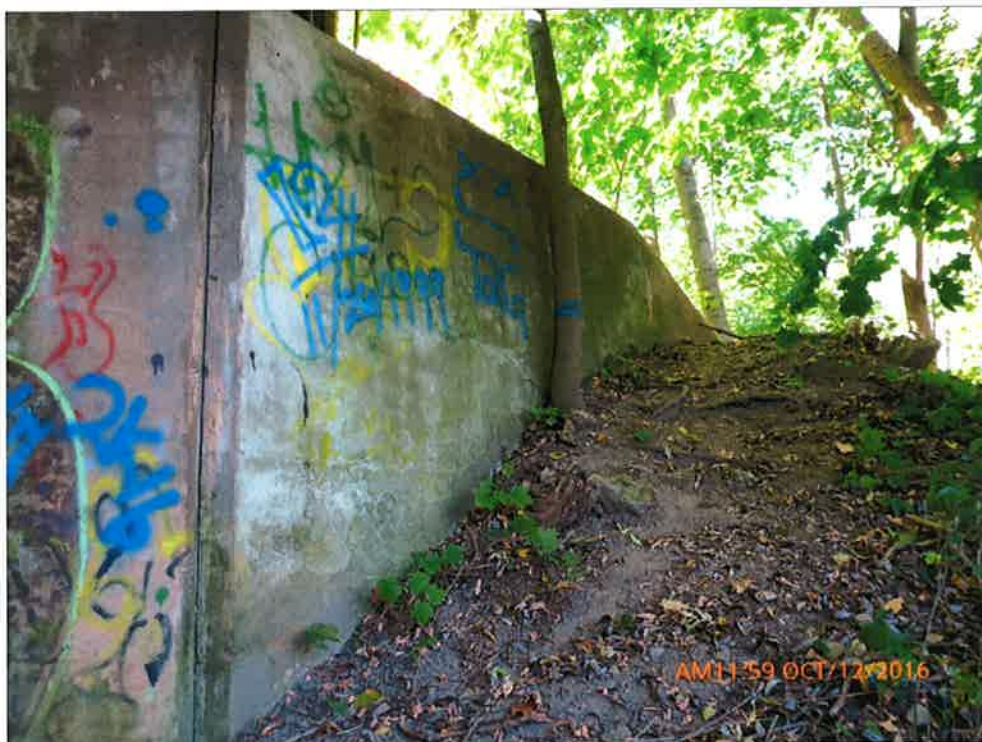
Narrow Stained Crack on Southeast Wingwall

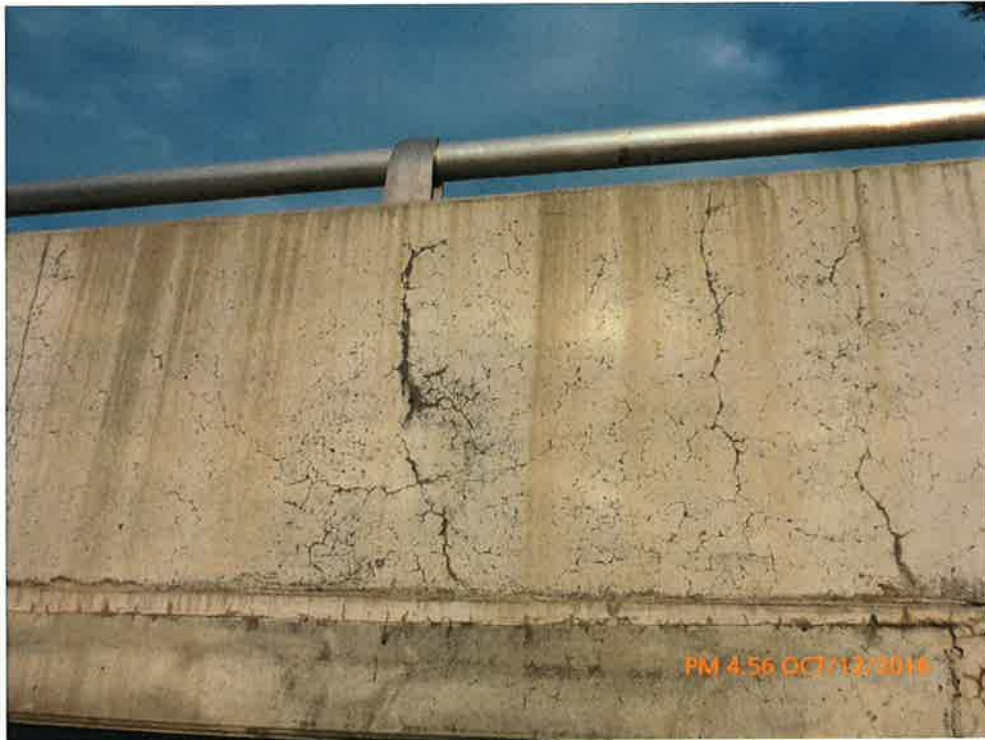
Narrow Stained Cracks on Interior Parapet Wall

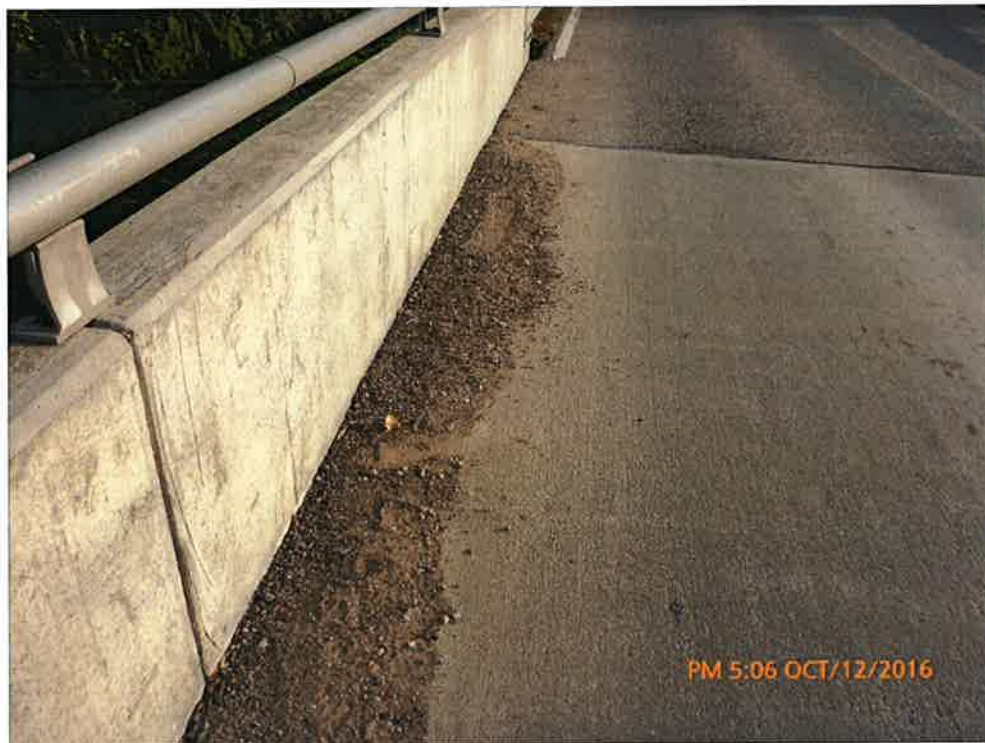
Narrow Stained Cracks on Exterior Parapet Wall

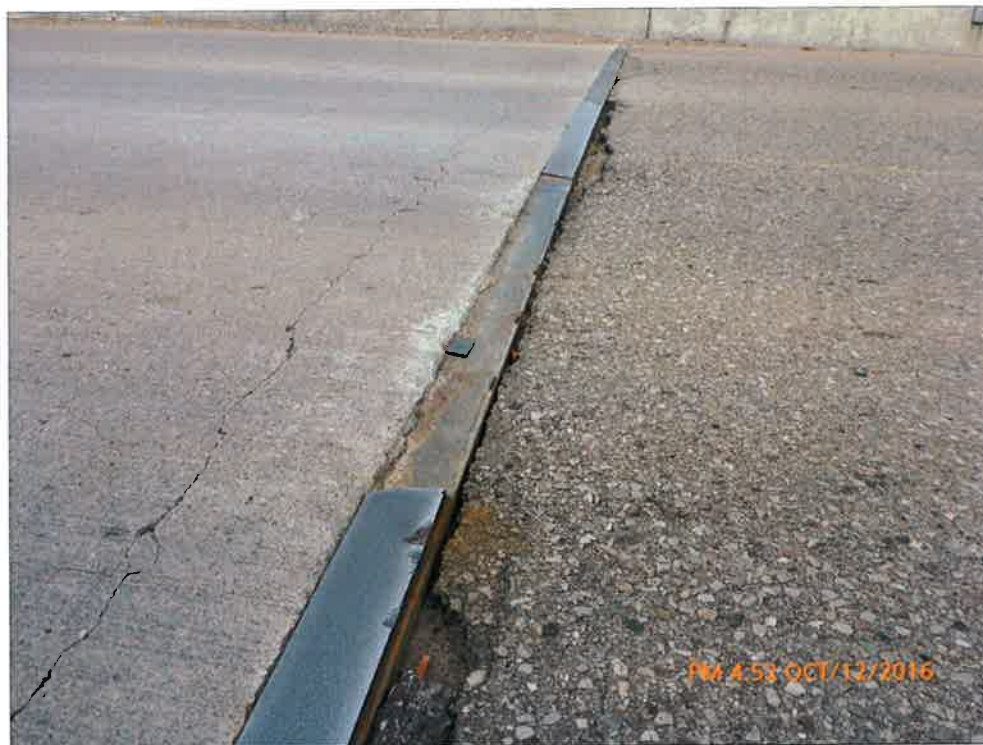
Wide Crack on Exposed Concrete Deck

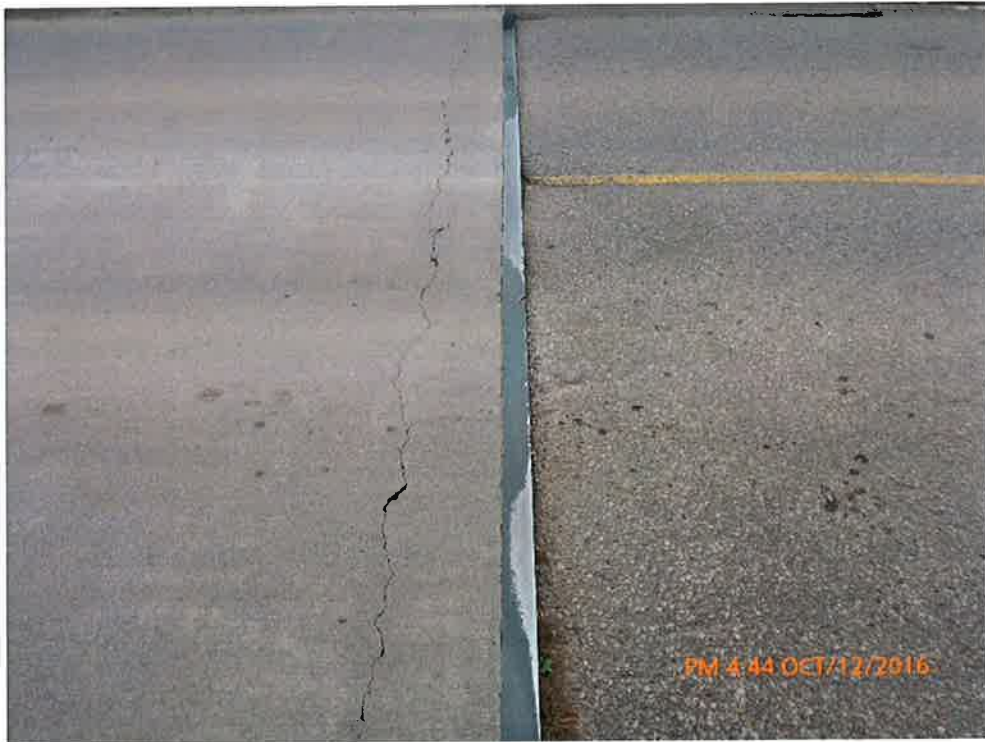
Missing Section of Armoring Angle

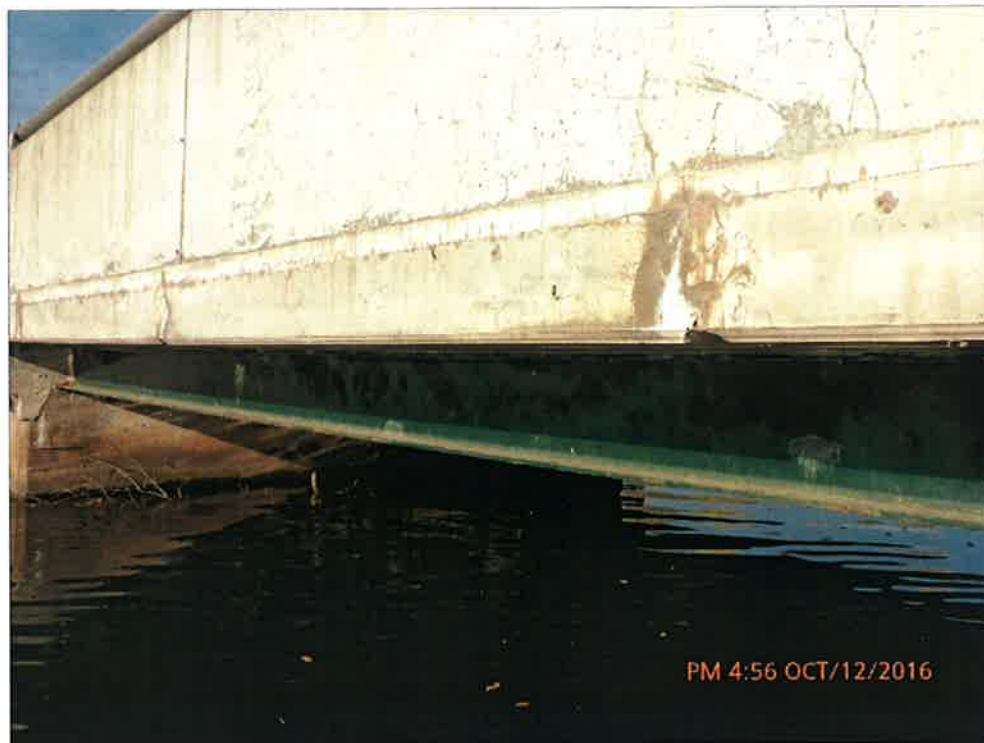
Narrow Stained Crack on Interior Soffit

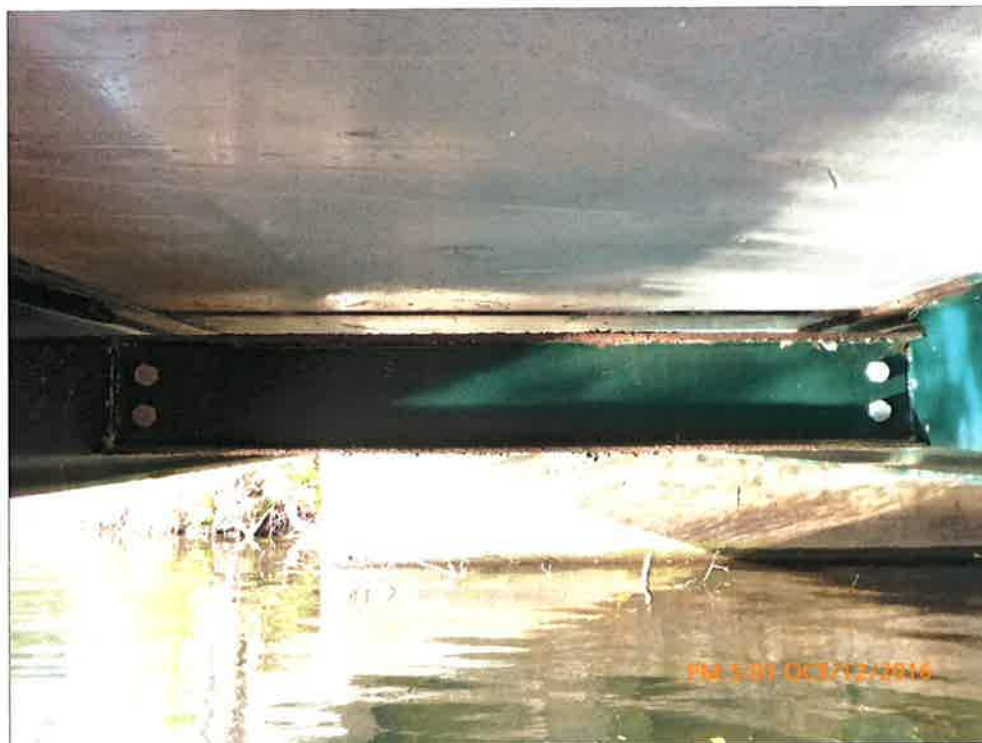
Light Corrosion on Girder

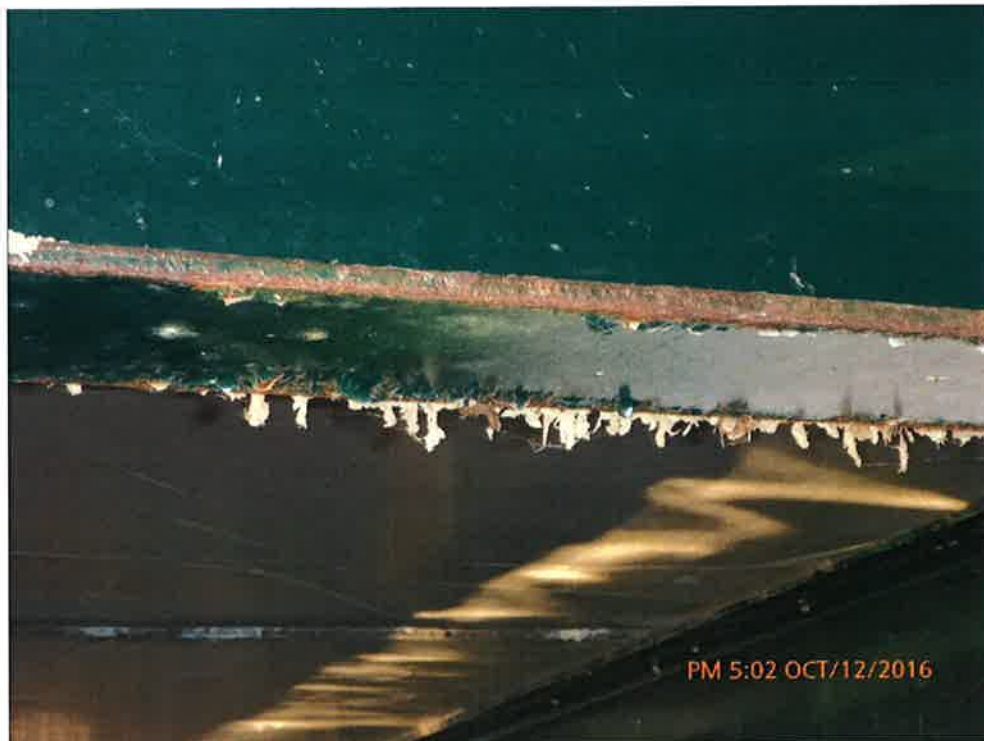
Light Corrosion on Diaphragm

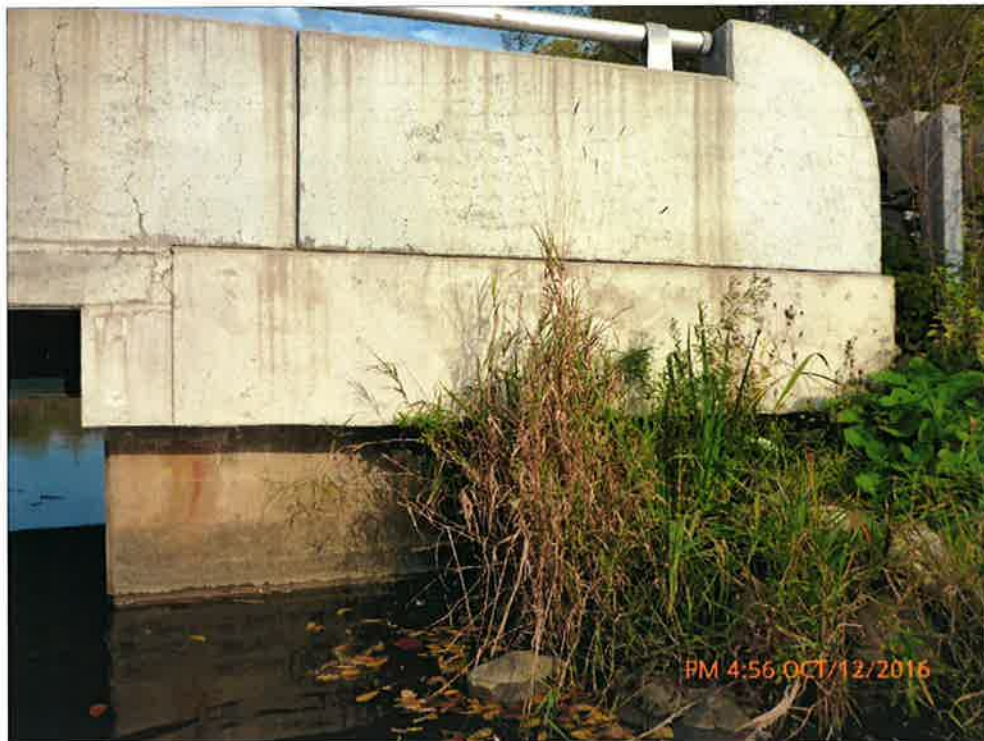
Light Spall on Abutment Below Girders
