# 2022 OSIM Inspections for Municipal Bridges and Culverts larger than 3 meters

Township of North Dumfries

**MEDA Engineering and Technical Services**

**31 May 2022**

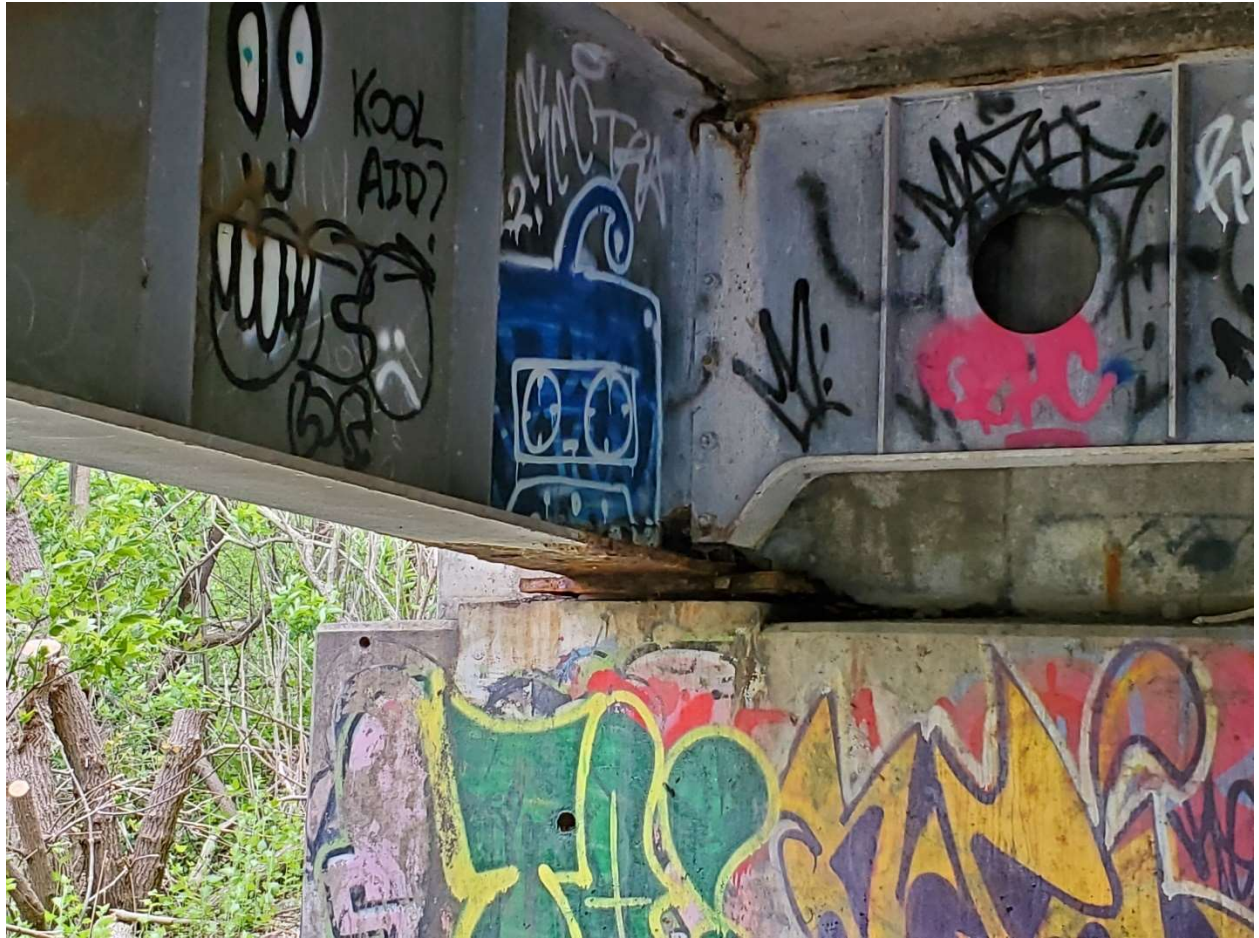
Rusting observed at the abutment

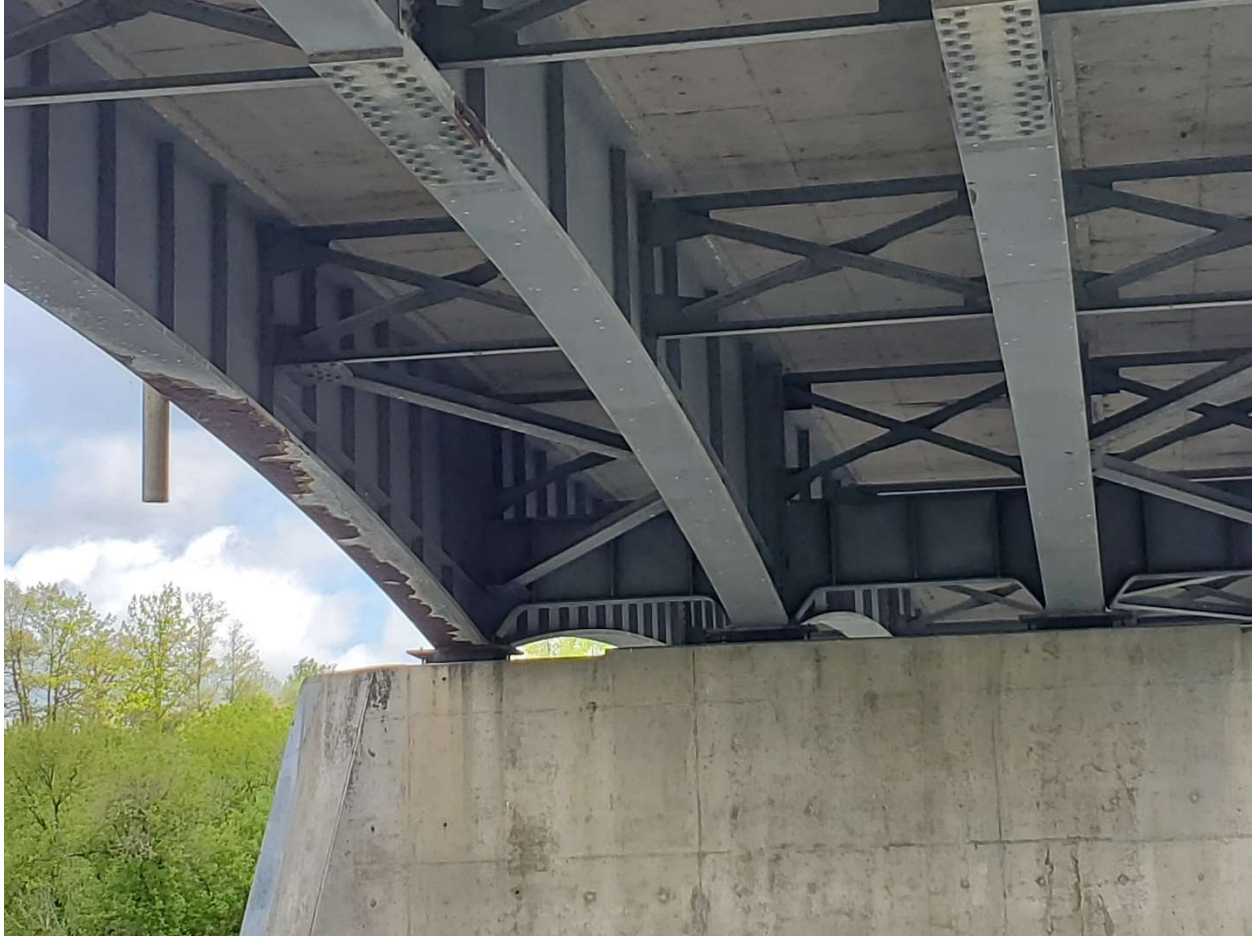
Rusting observed in one of the bridge girders

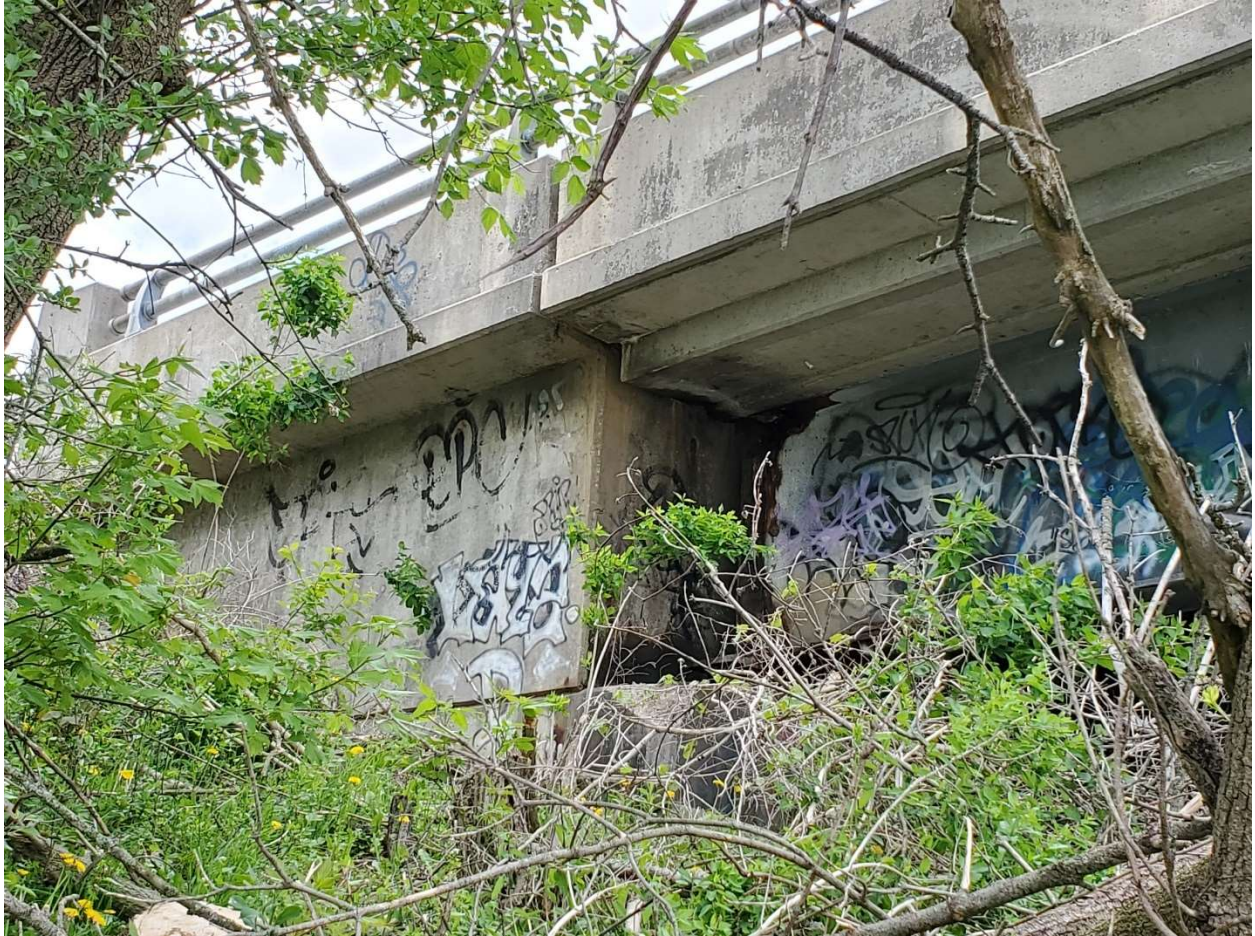
Rusting observed at the steel girders at the abutment

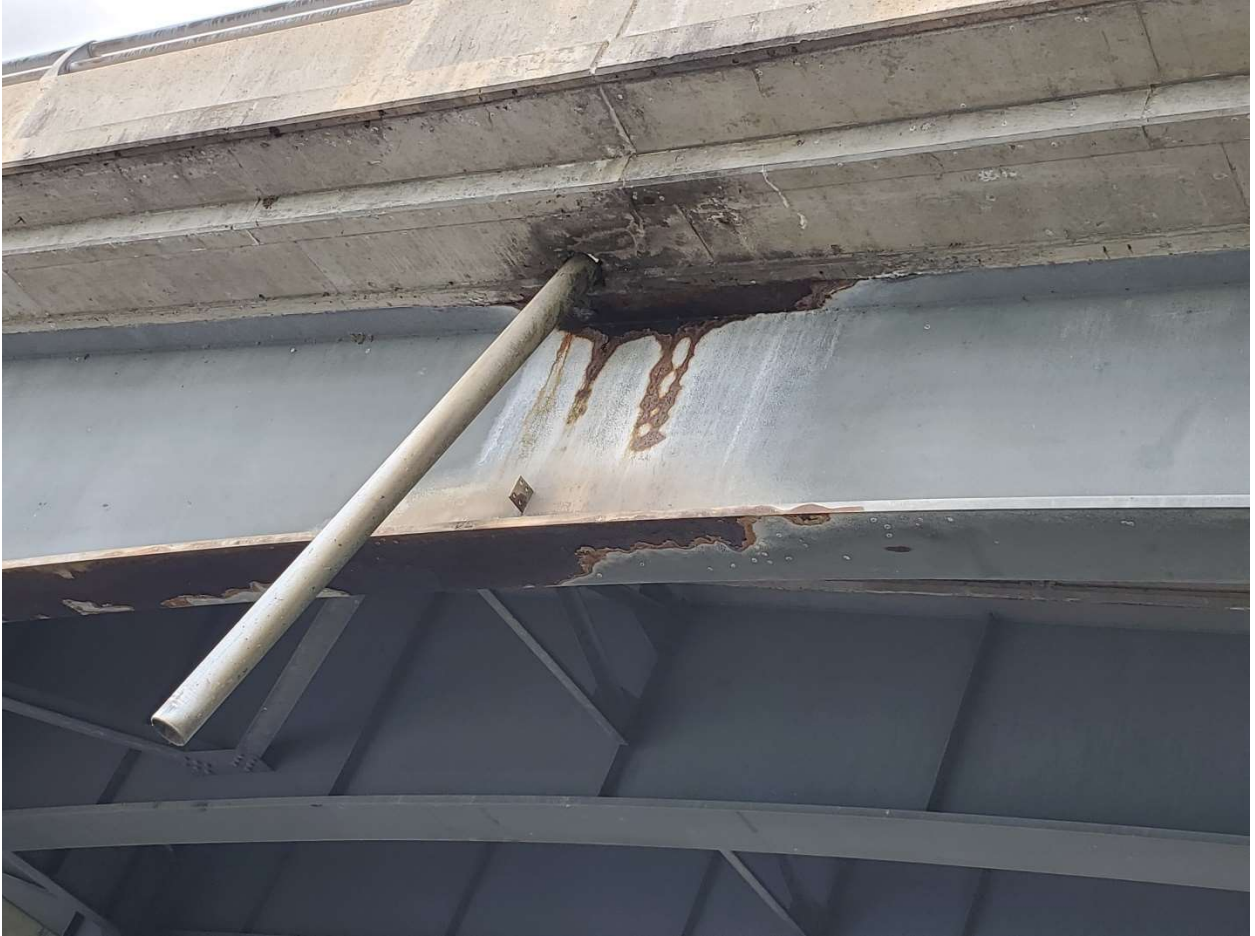
Damaged drain pipe and corrosion in the surrounding area

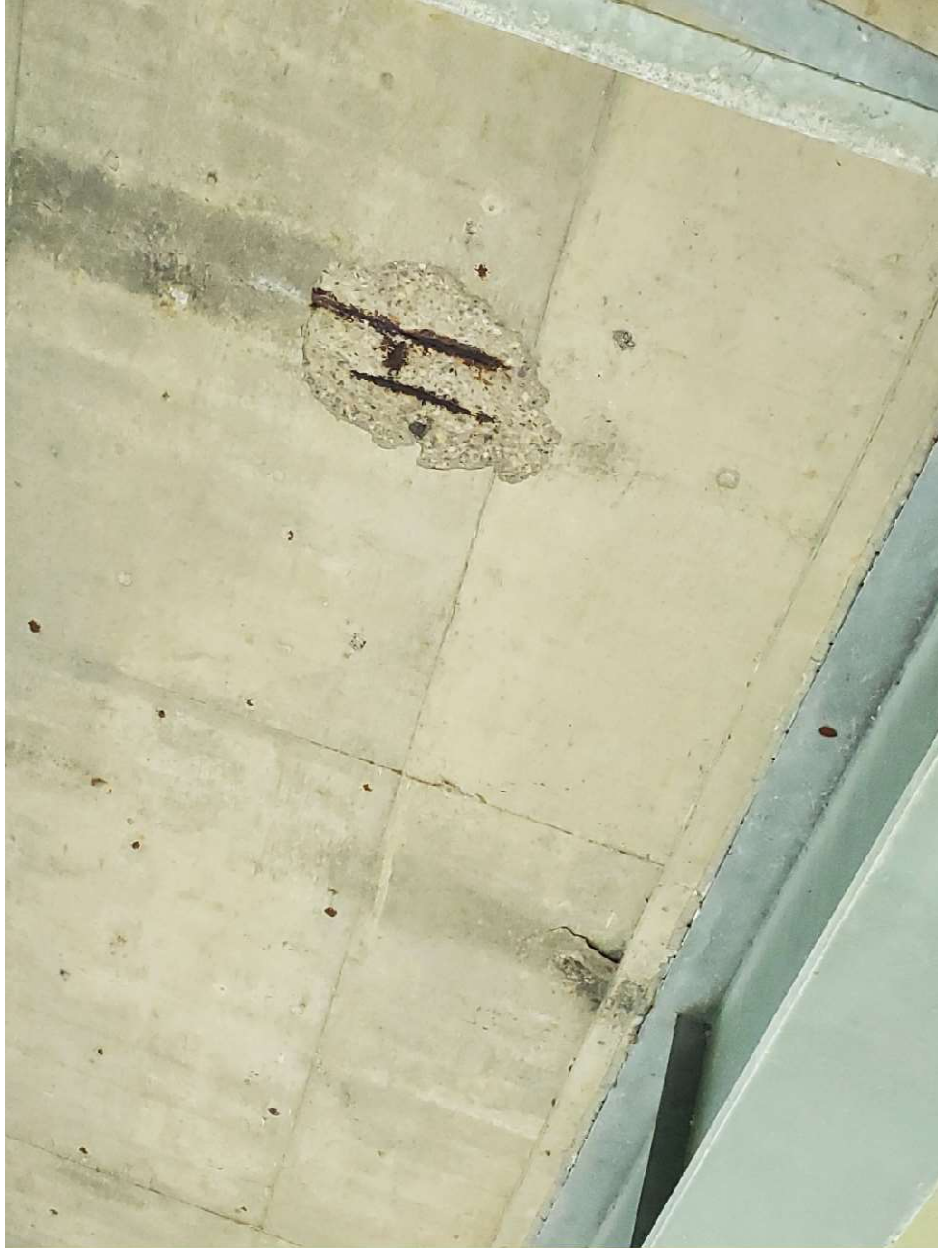
Spalling of concrete/ Exposed Rebar observed in Soffit

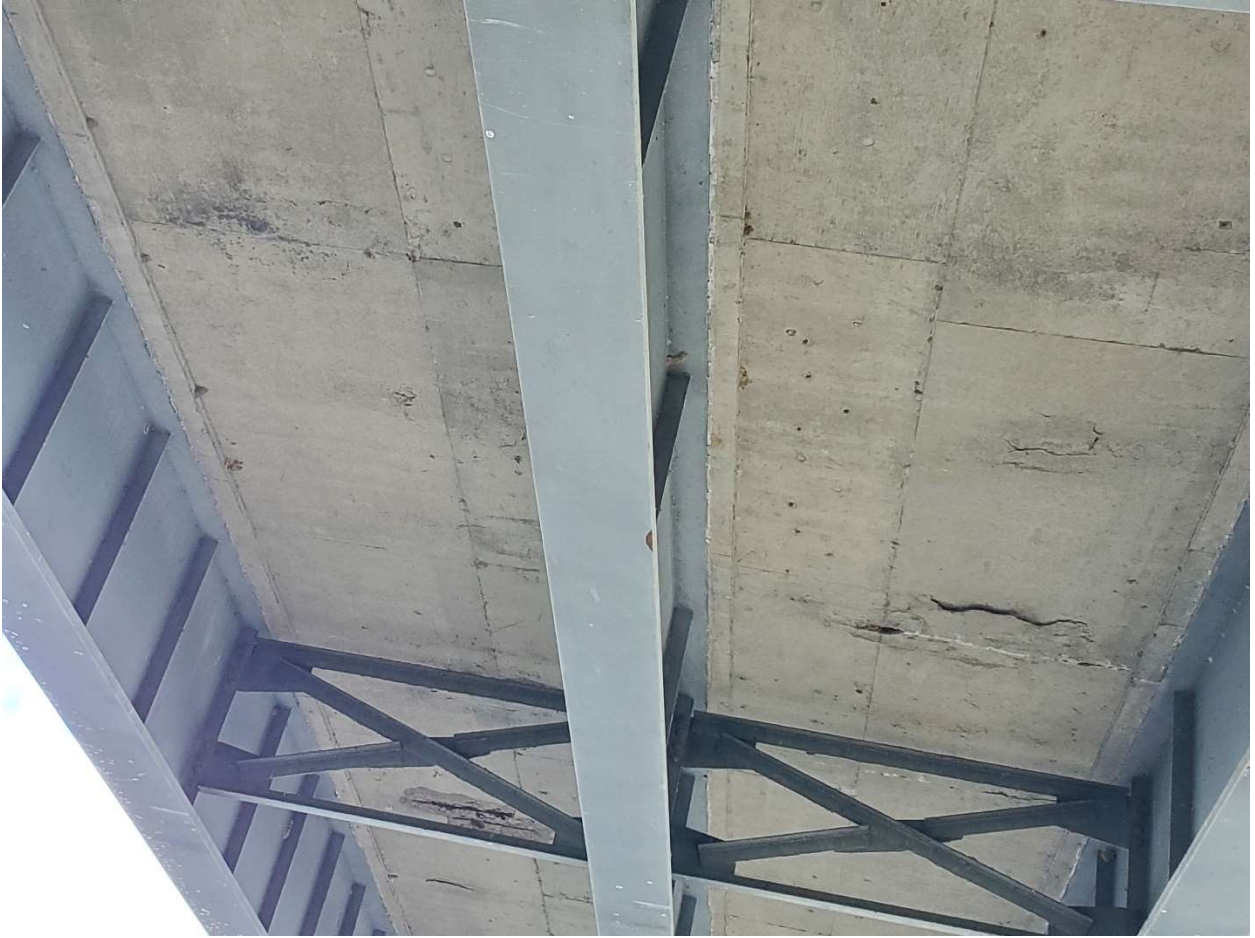
Spalling of concrete observed in Soffit

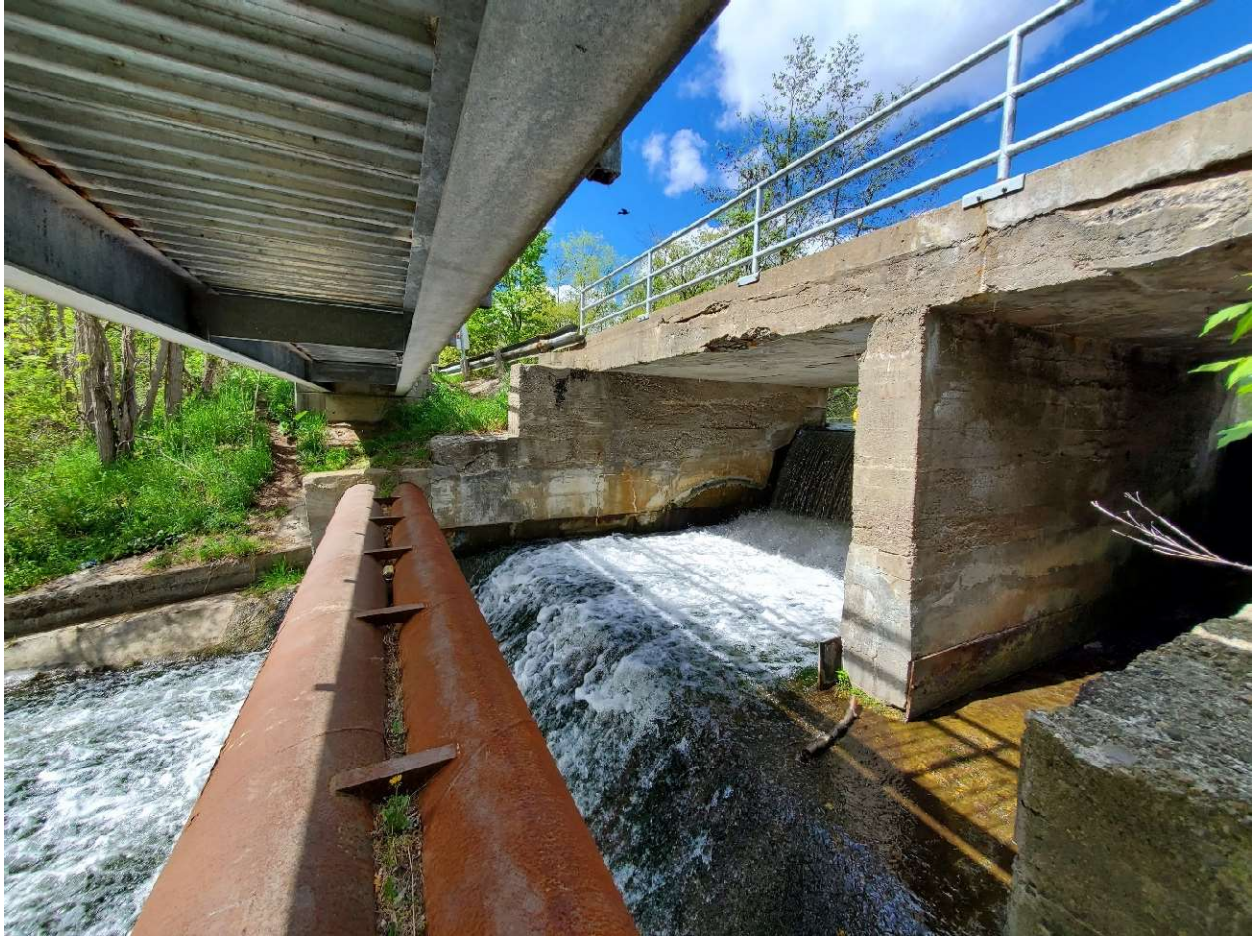
Damage observed on the slab of the bridge

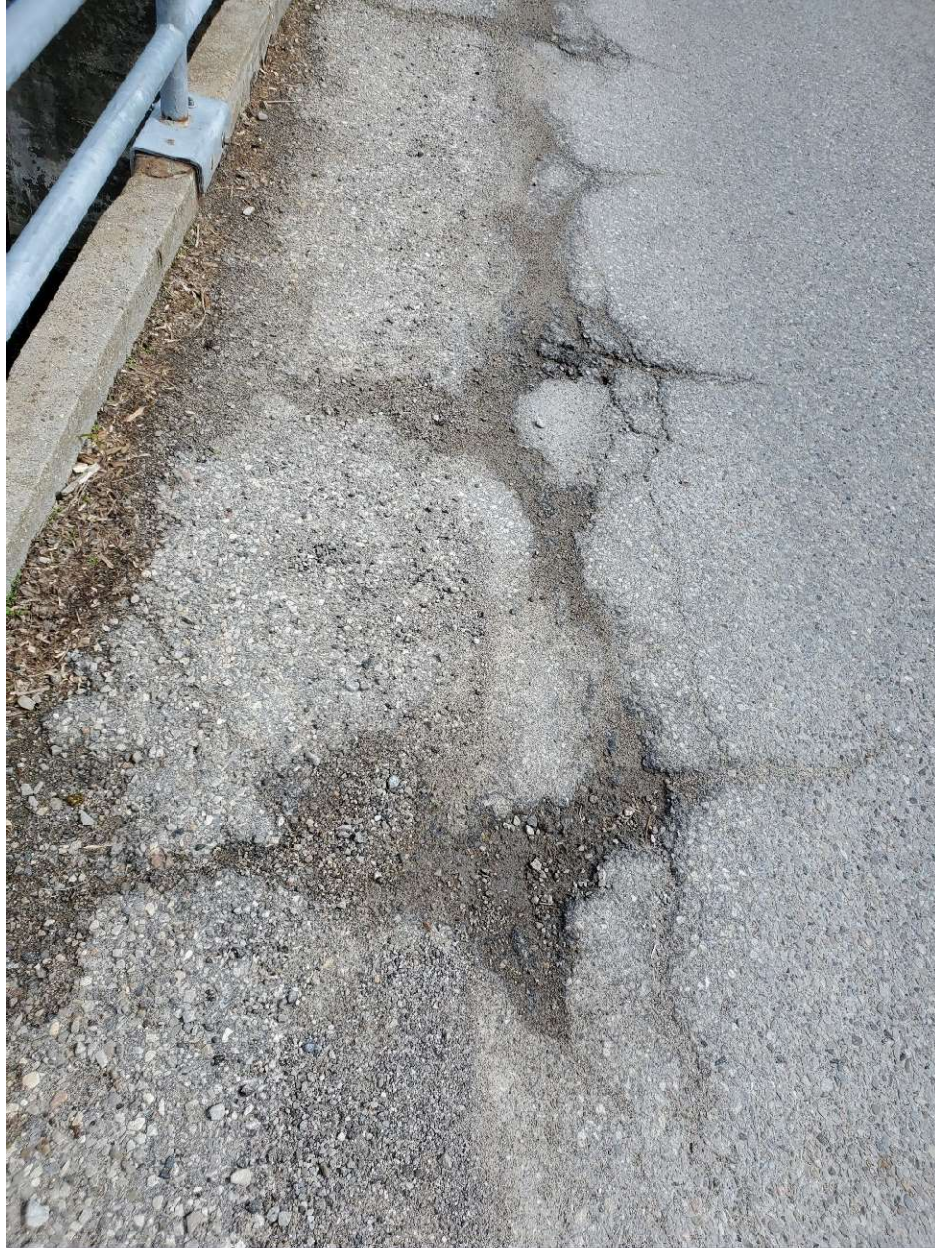
Damage observed on the wearing surface of the bridge

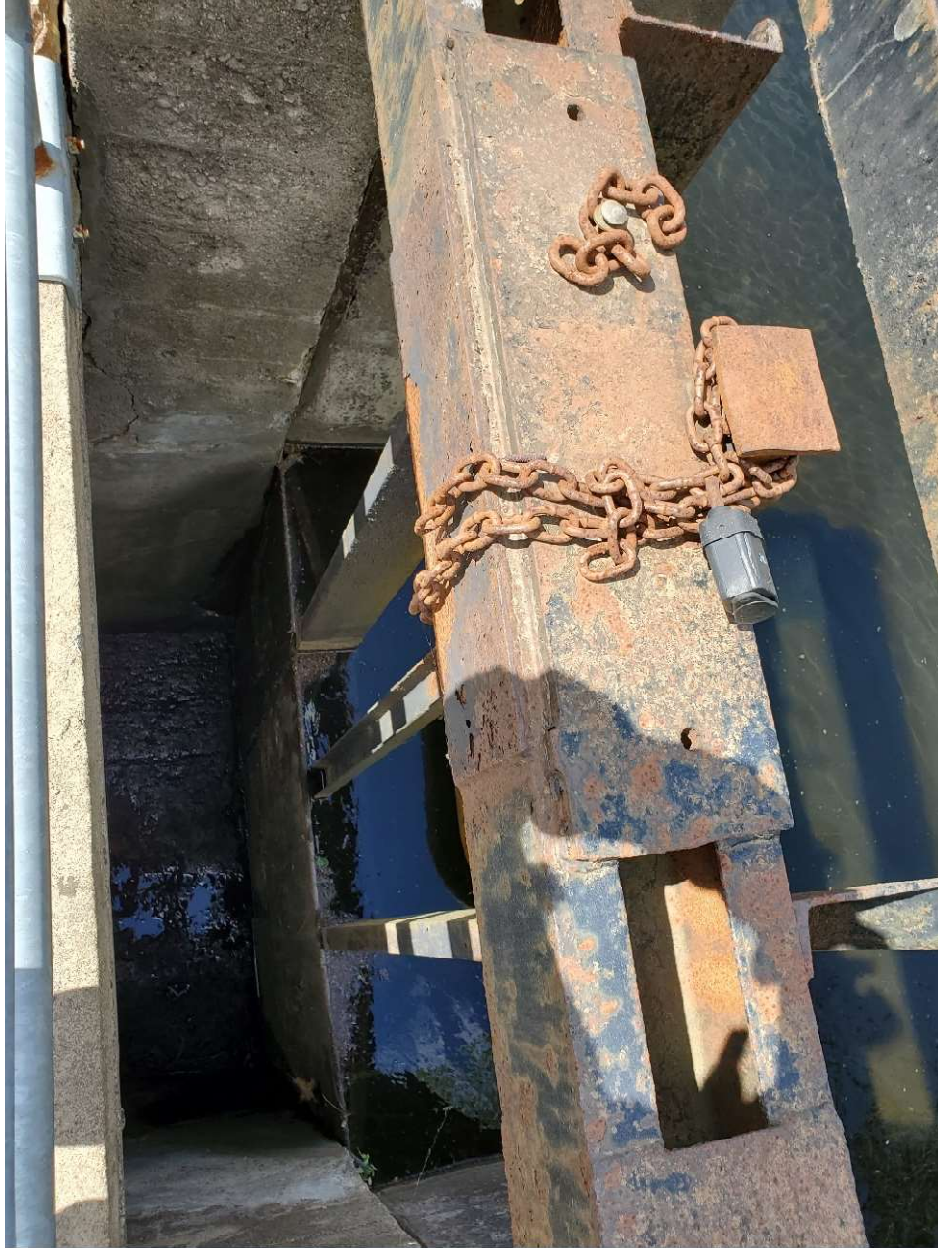
Rusting observed on the lock gate

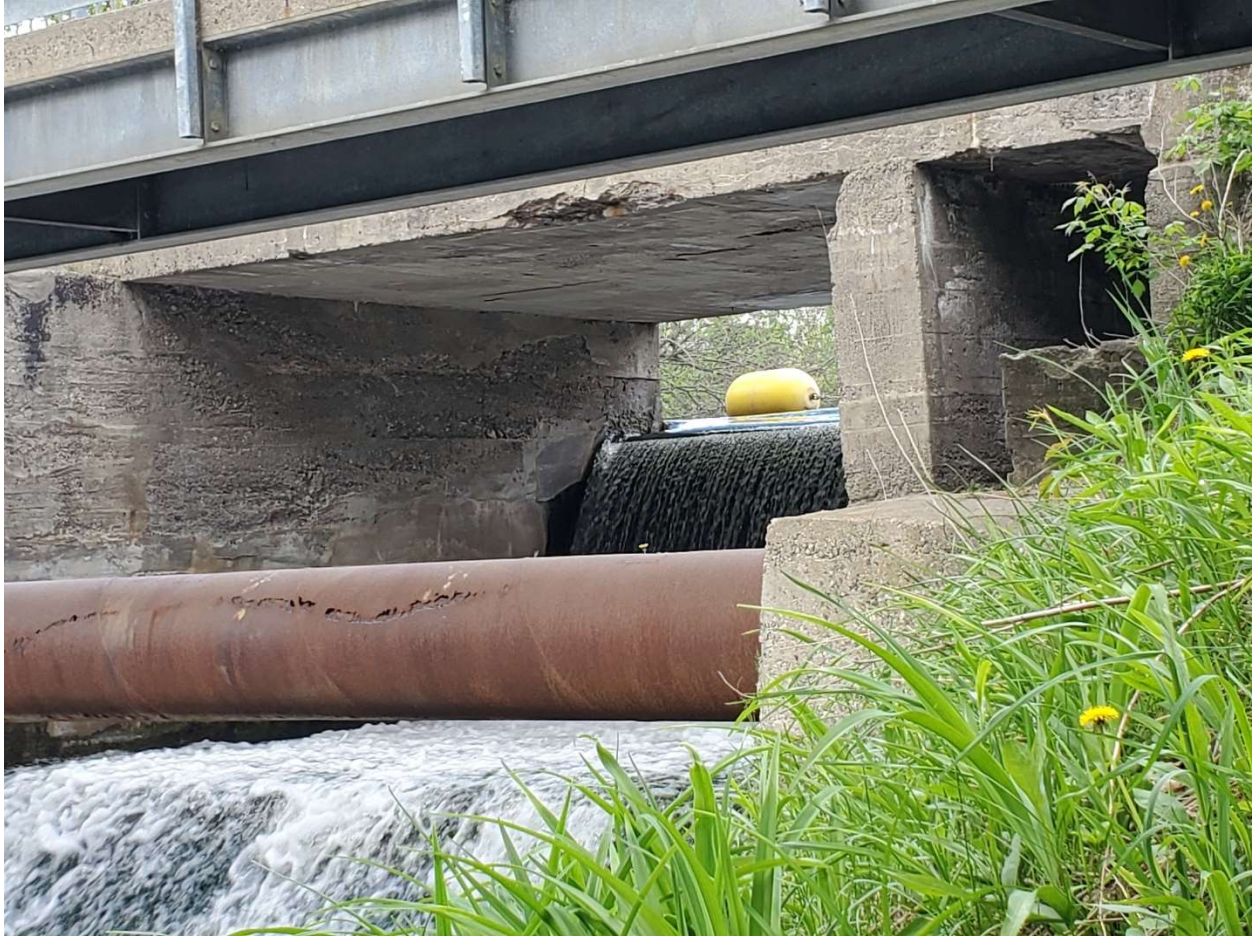
Crack and spalling observed in the concrete slab

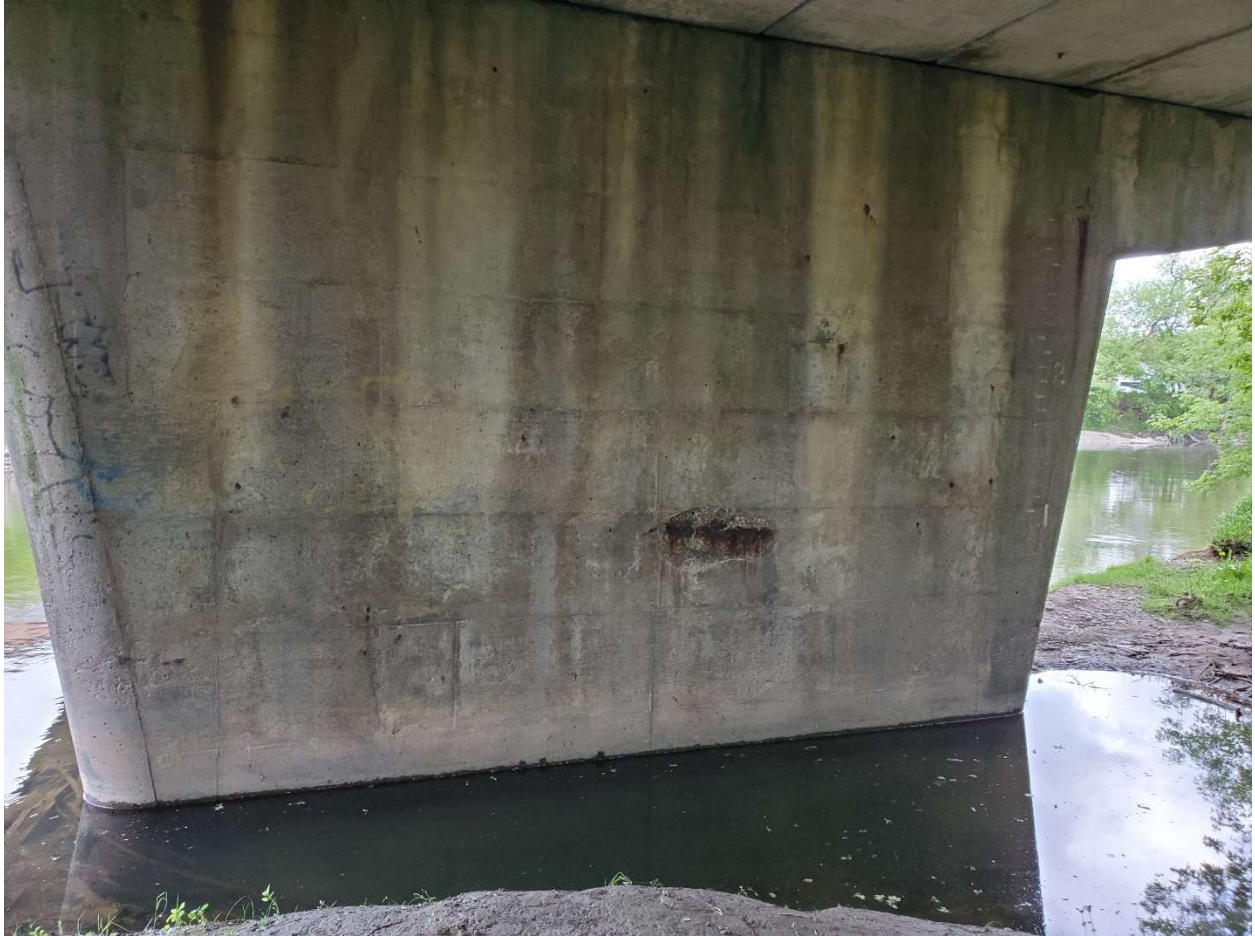
Exposed reinforcement and spalling at the East pier

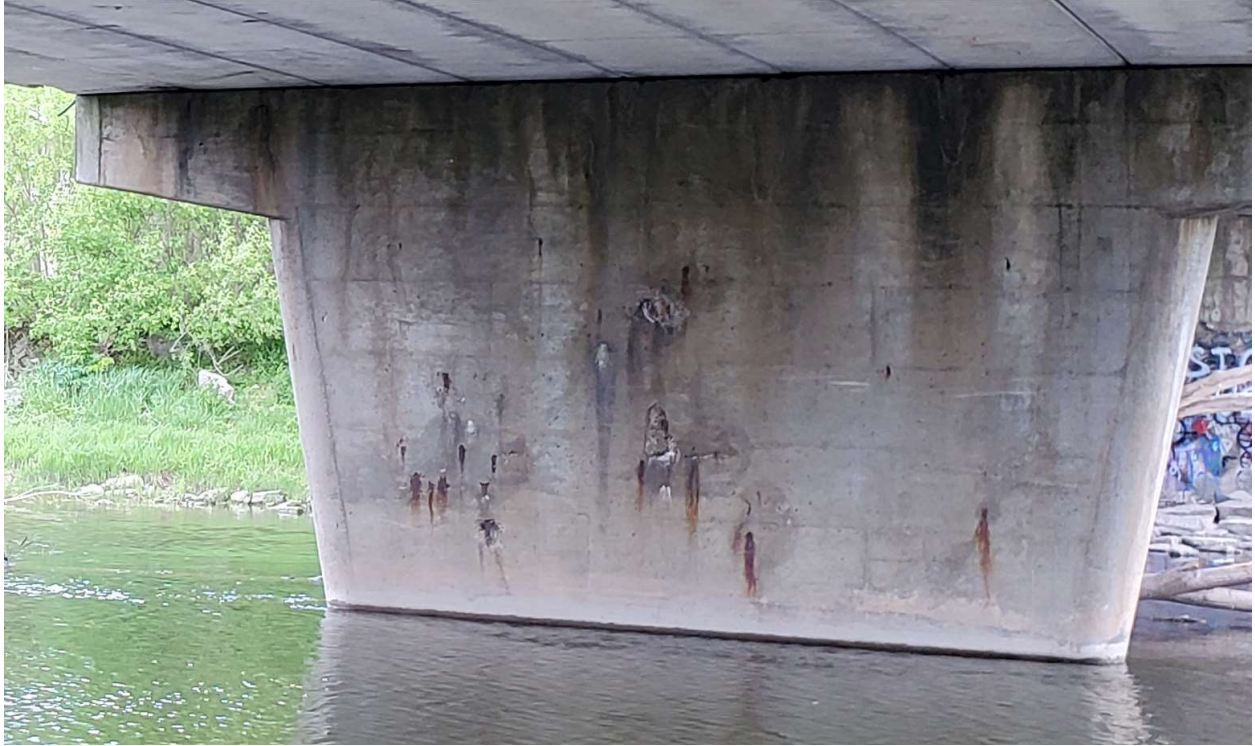
Exposed reinforcement and spalling at the West pier

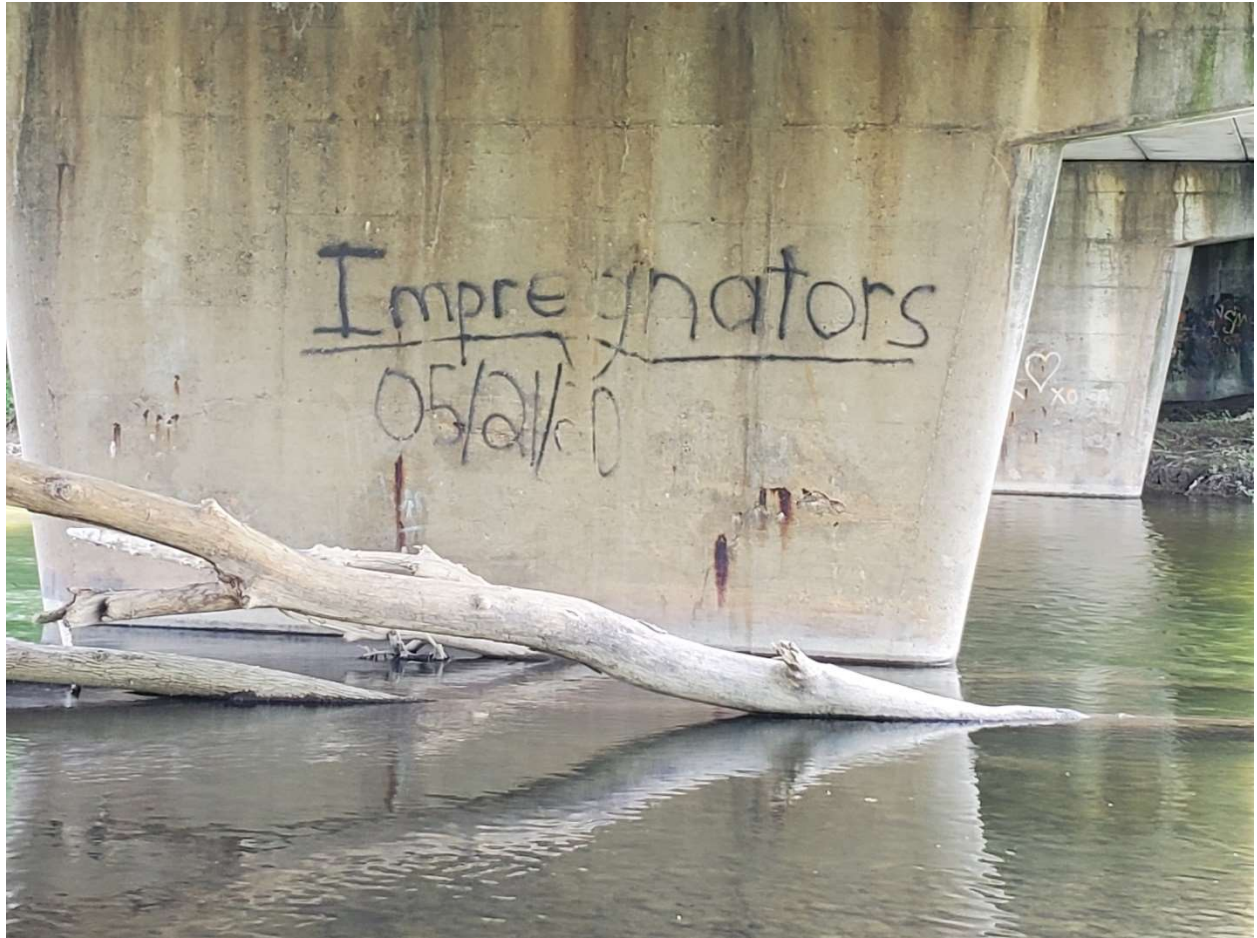
Tree debris at the East Pier

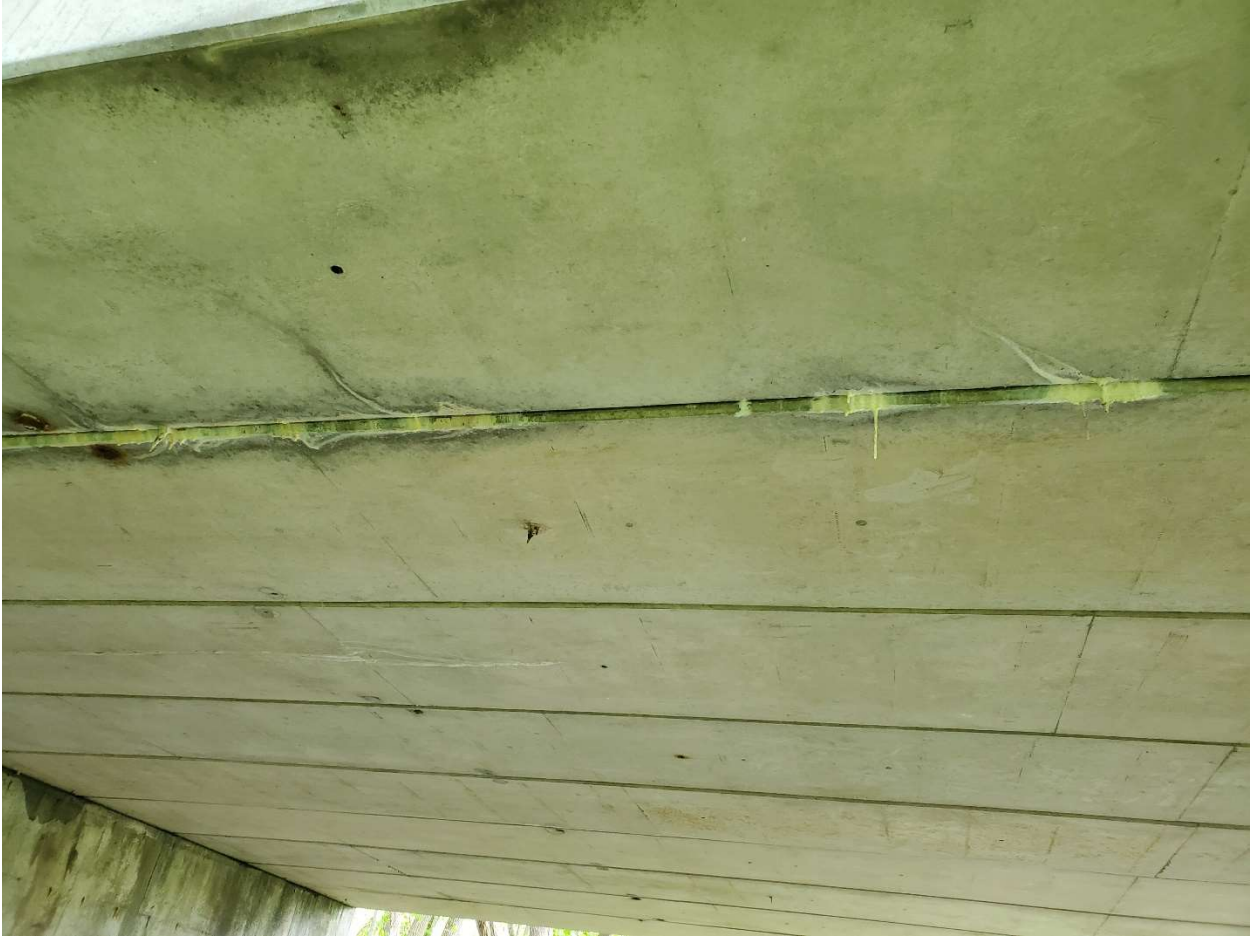
Damages observed at the soffit

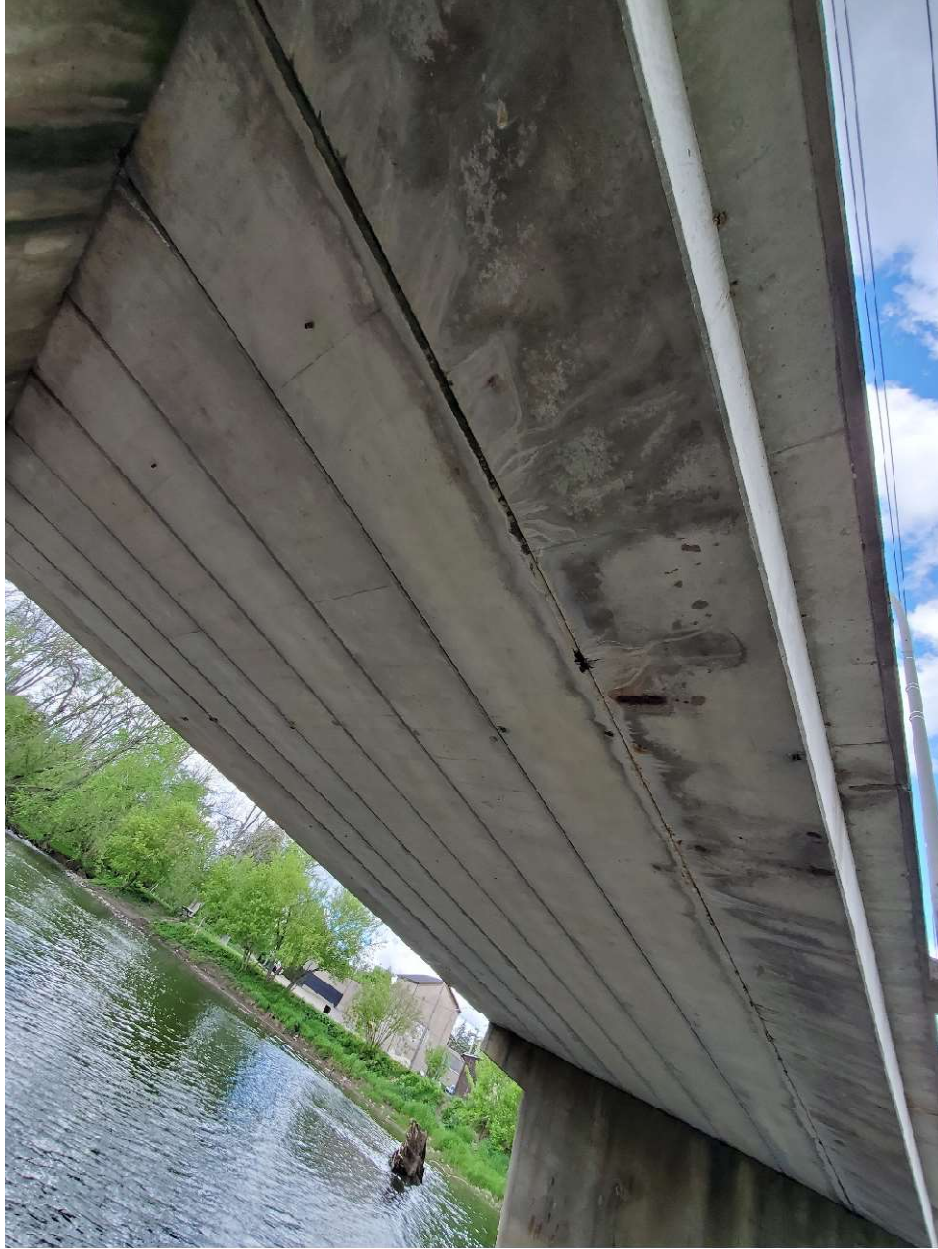
Damages observed at the soffit

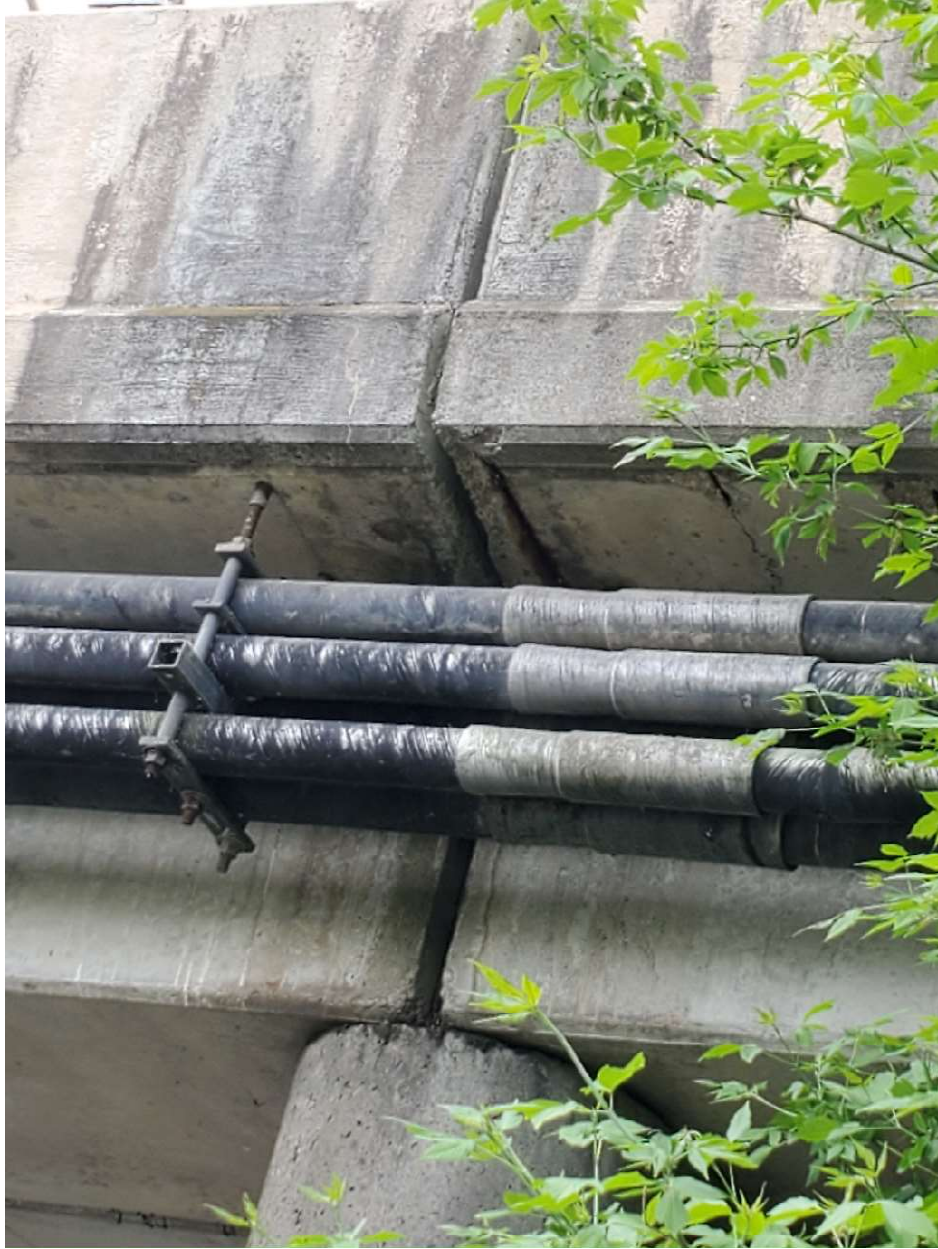
Damages observed at the Abutment

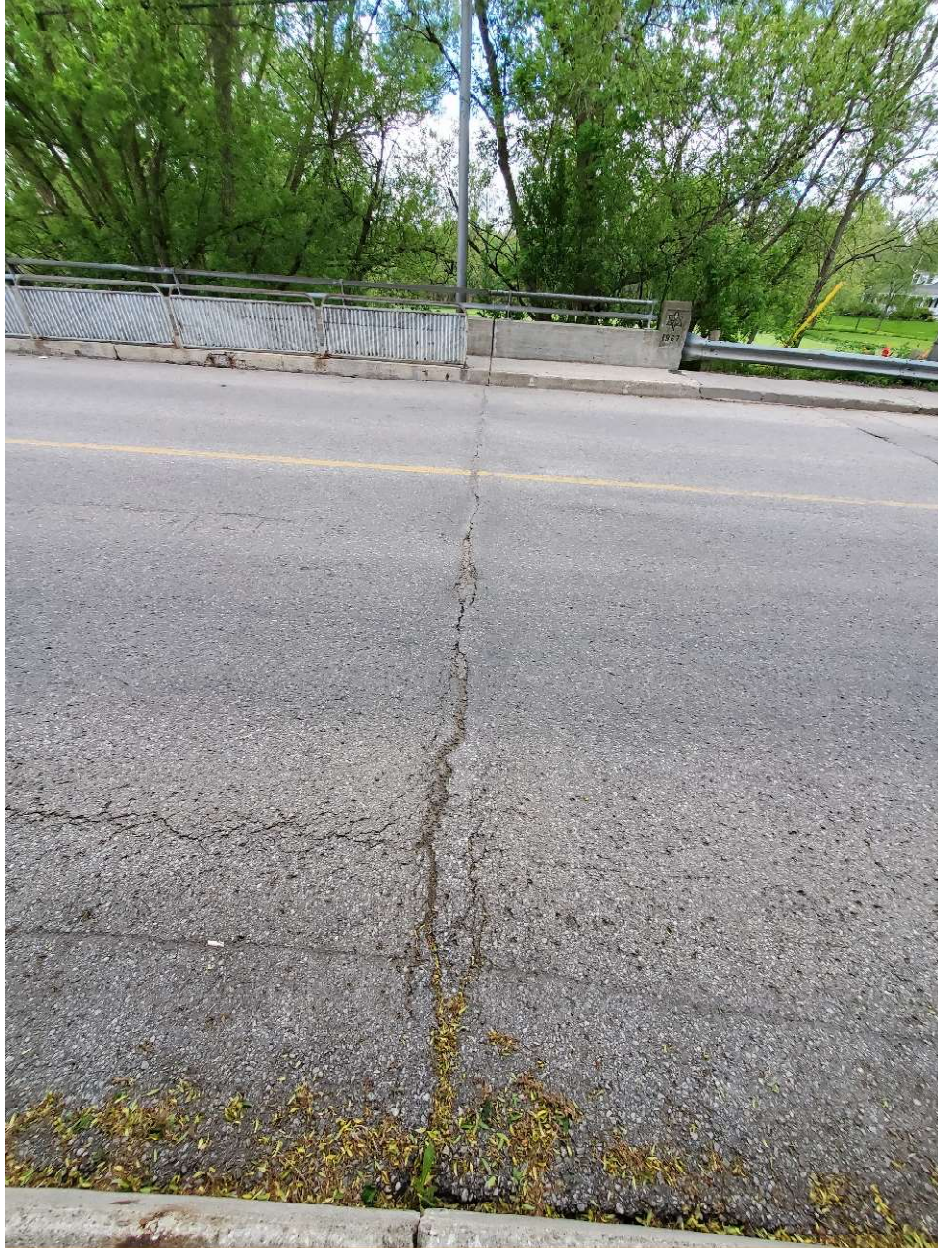
Deterioration the deck surface

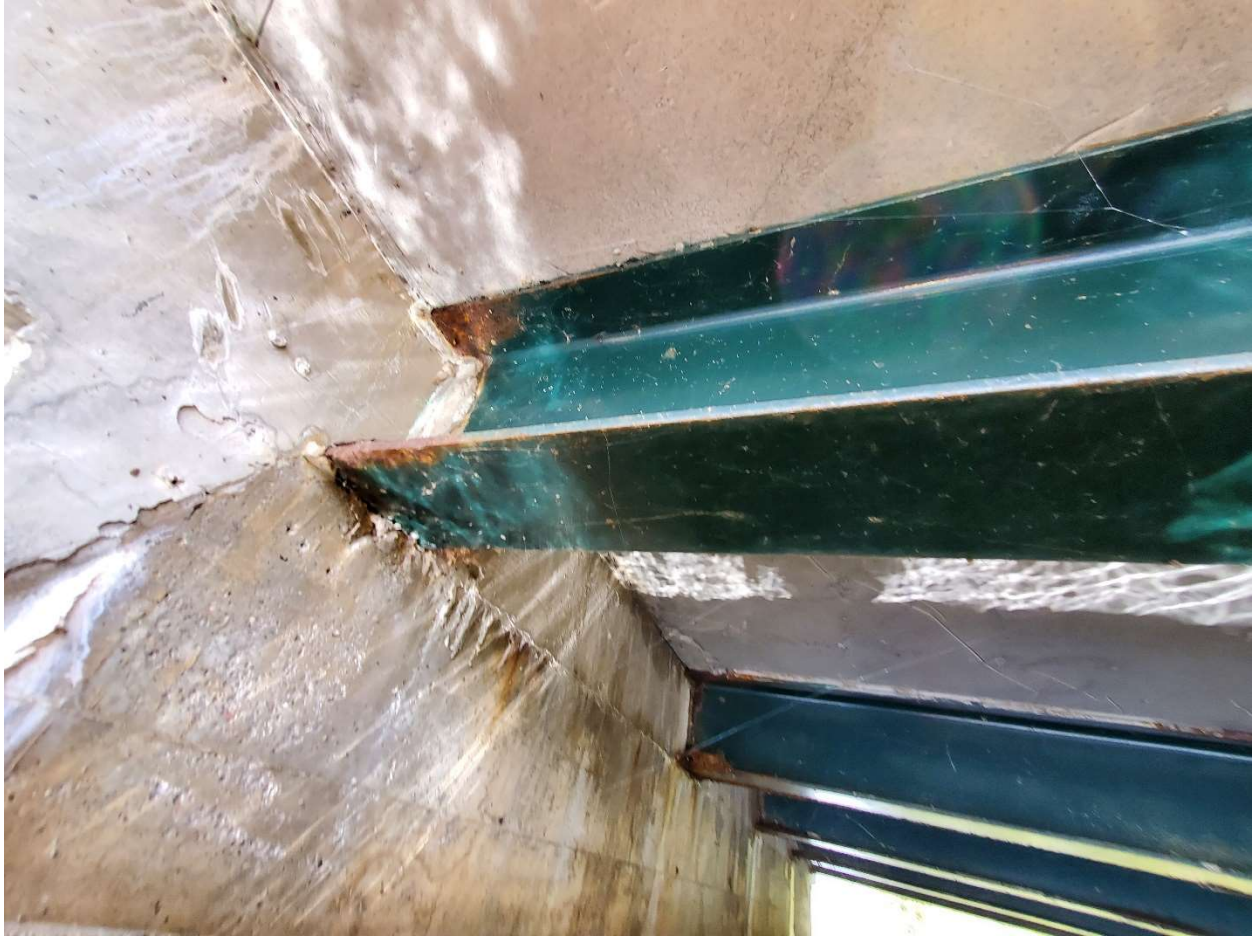
Rusting observed at the girder ends

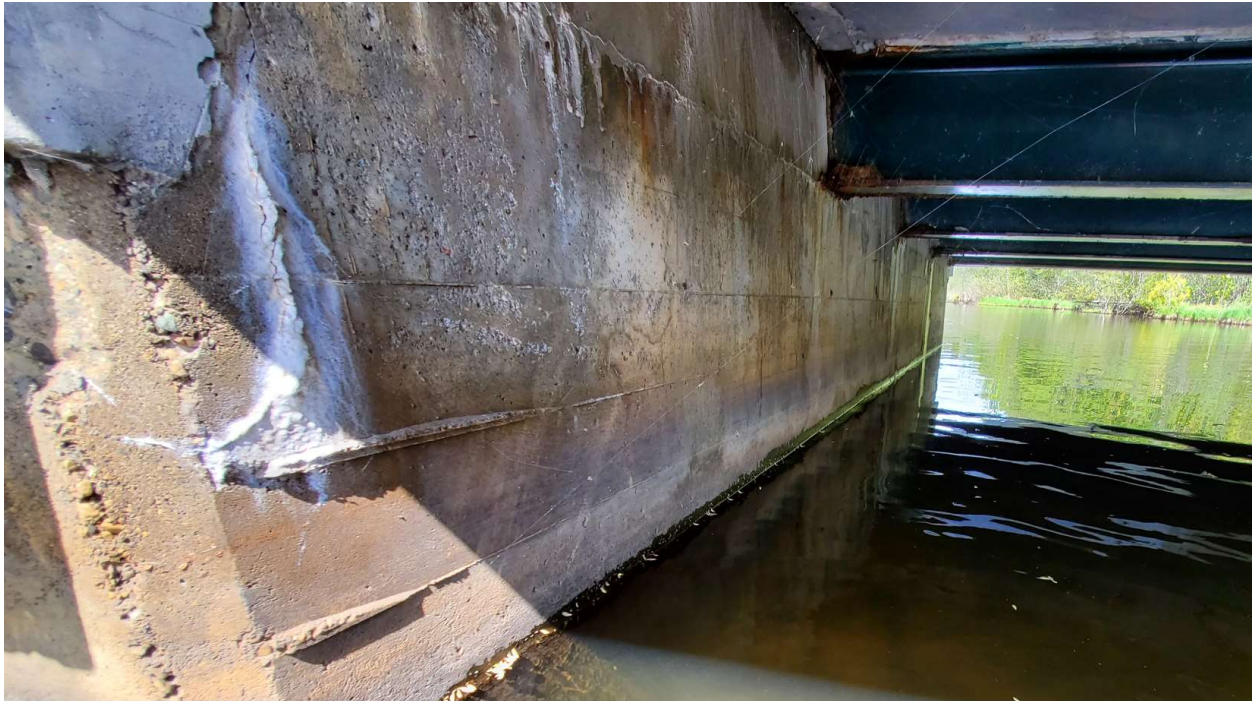
Some concrete deterioration observed at the abutment

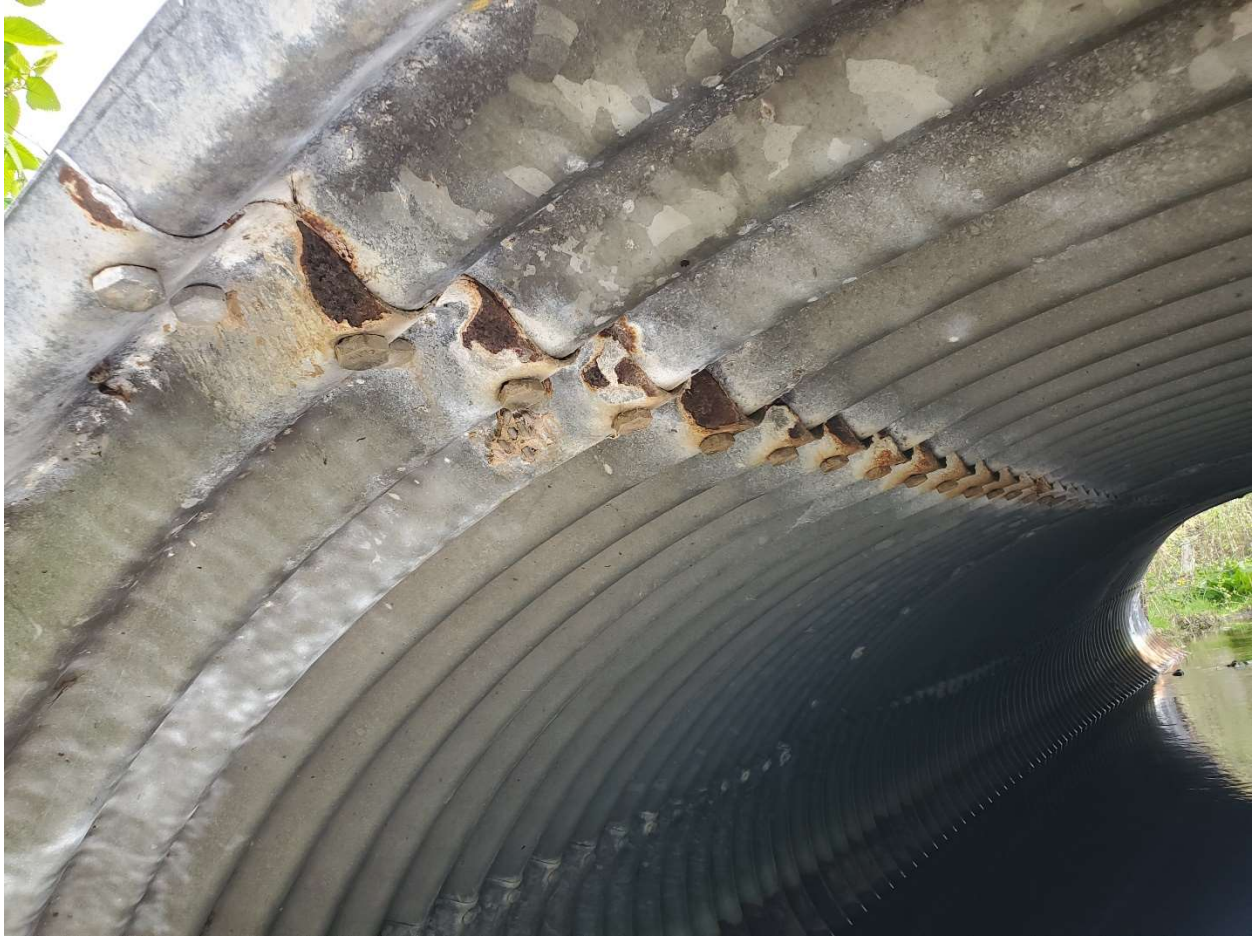
Rusting observed at Culvert joints
