# 2022 OSIM Inspections for Municipal Bridges and Culverts larger than 3 meters

Township of North Dumfries

**MEDA Engineering and Technical Services**

**31 May 2022**

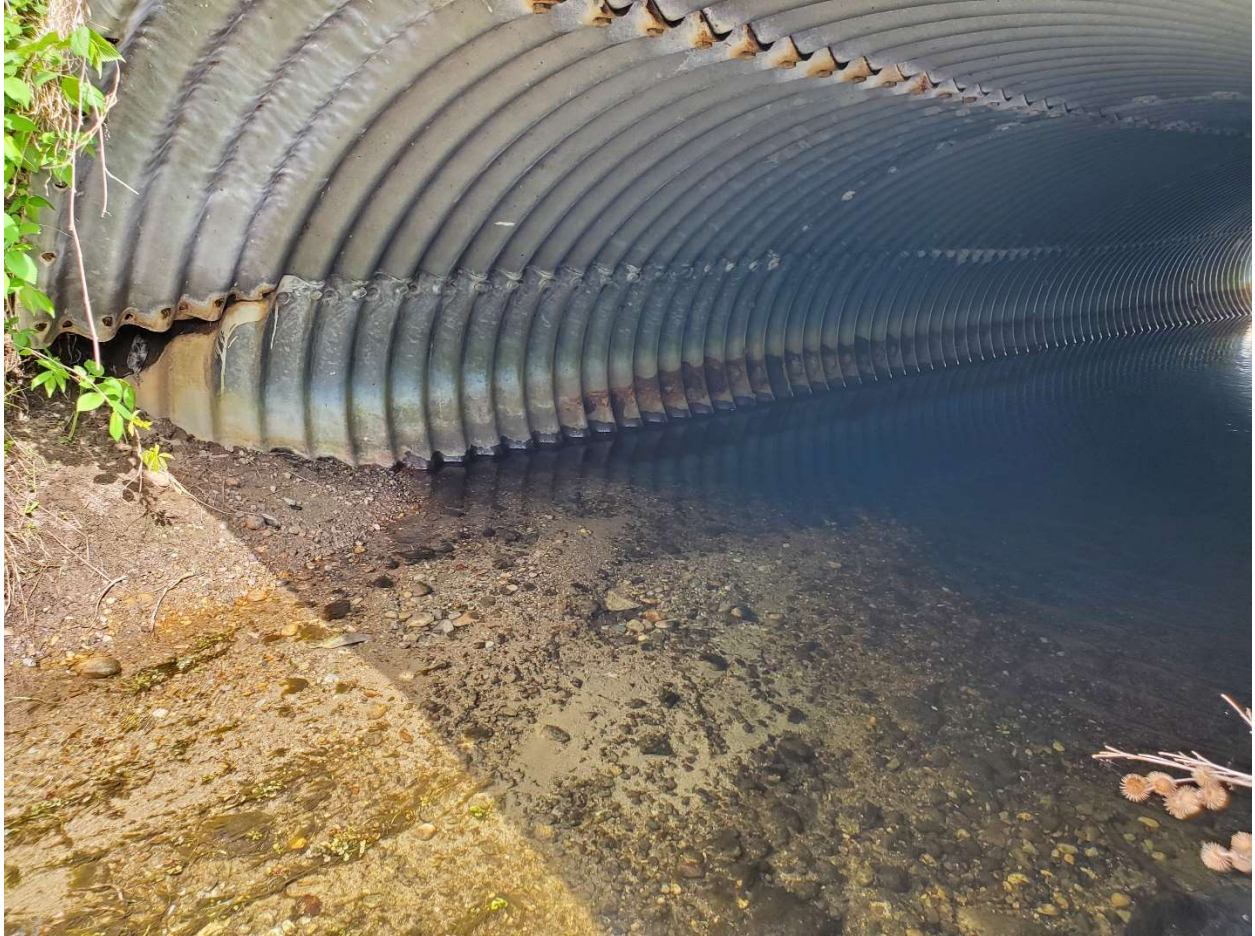
Rusting observed at Culvert joints

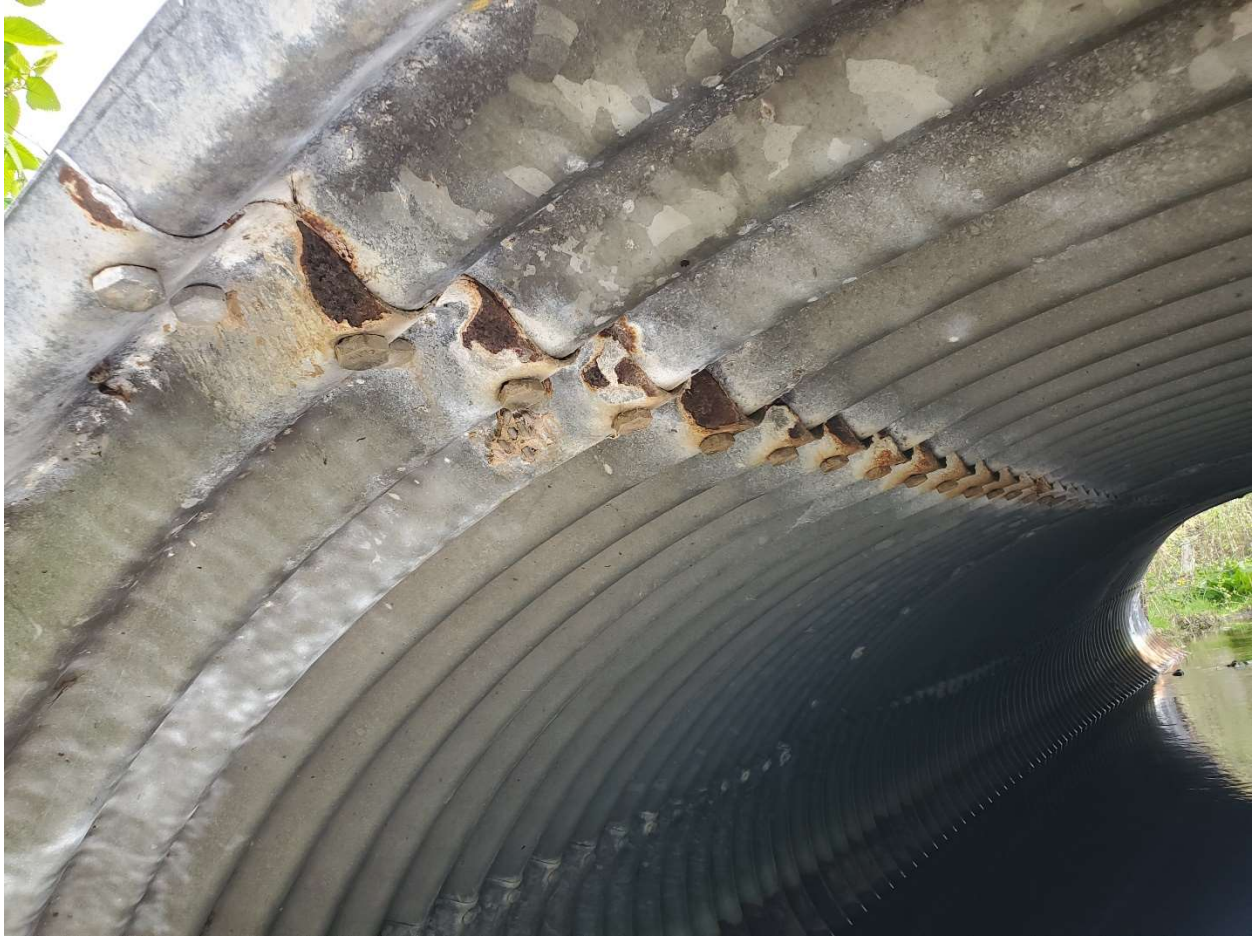
Rusting observed at Culvert joints

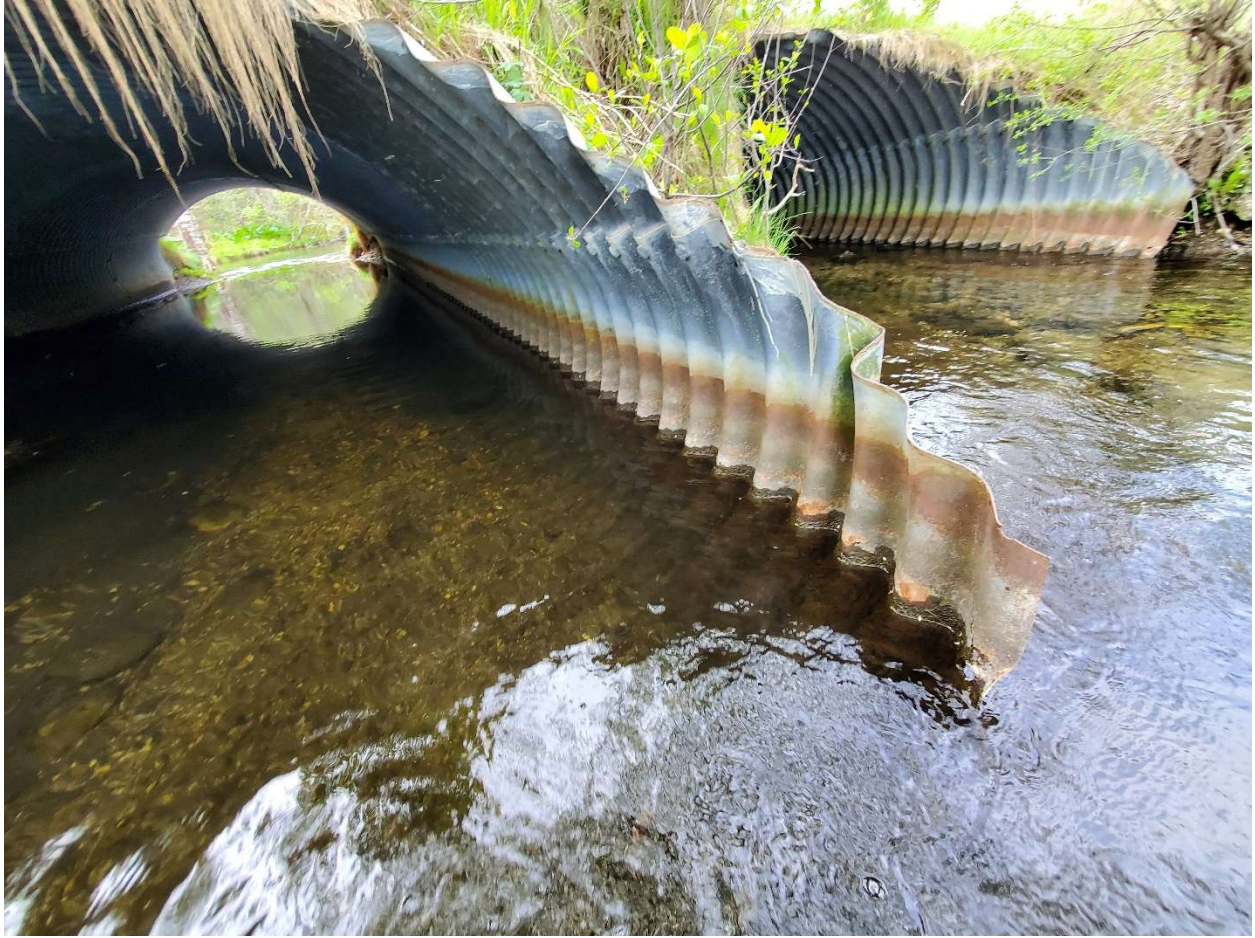
Rusting observed at Culvert bottom portion

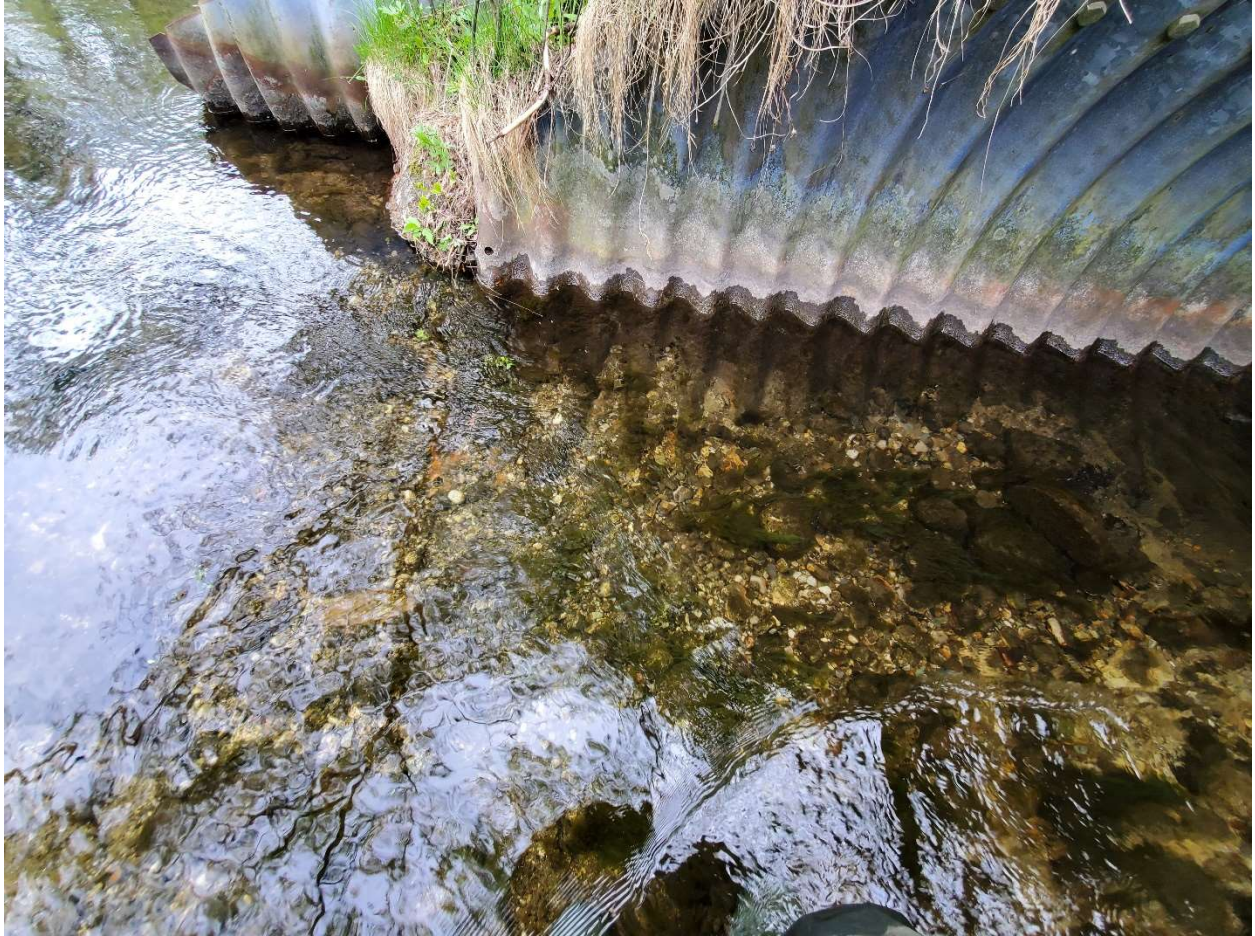
Rusting observed at Culvert bottom portion

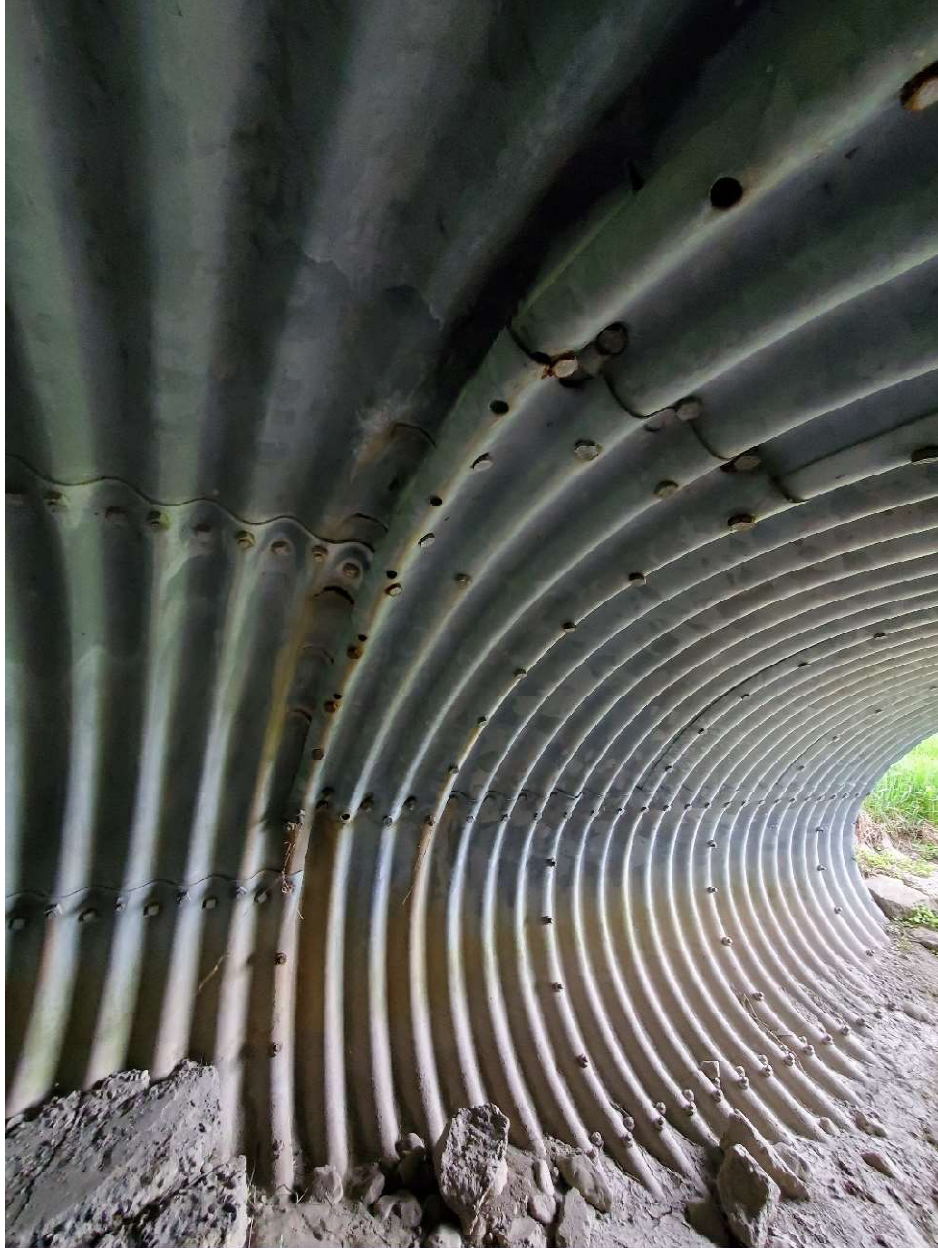
Minor Rusting observed

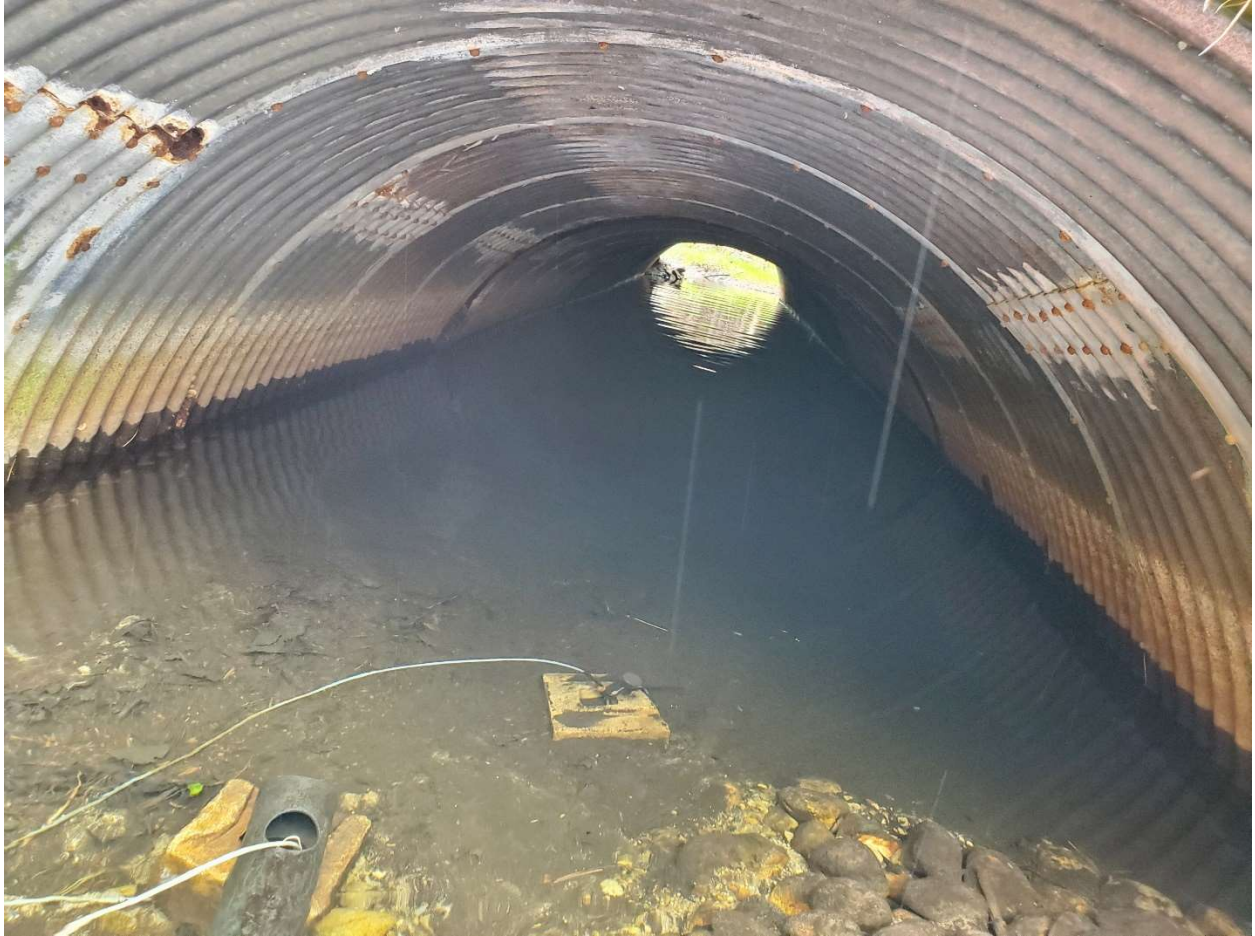
Some rusting observed in the culvert

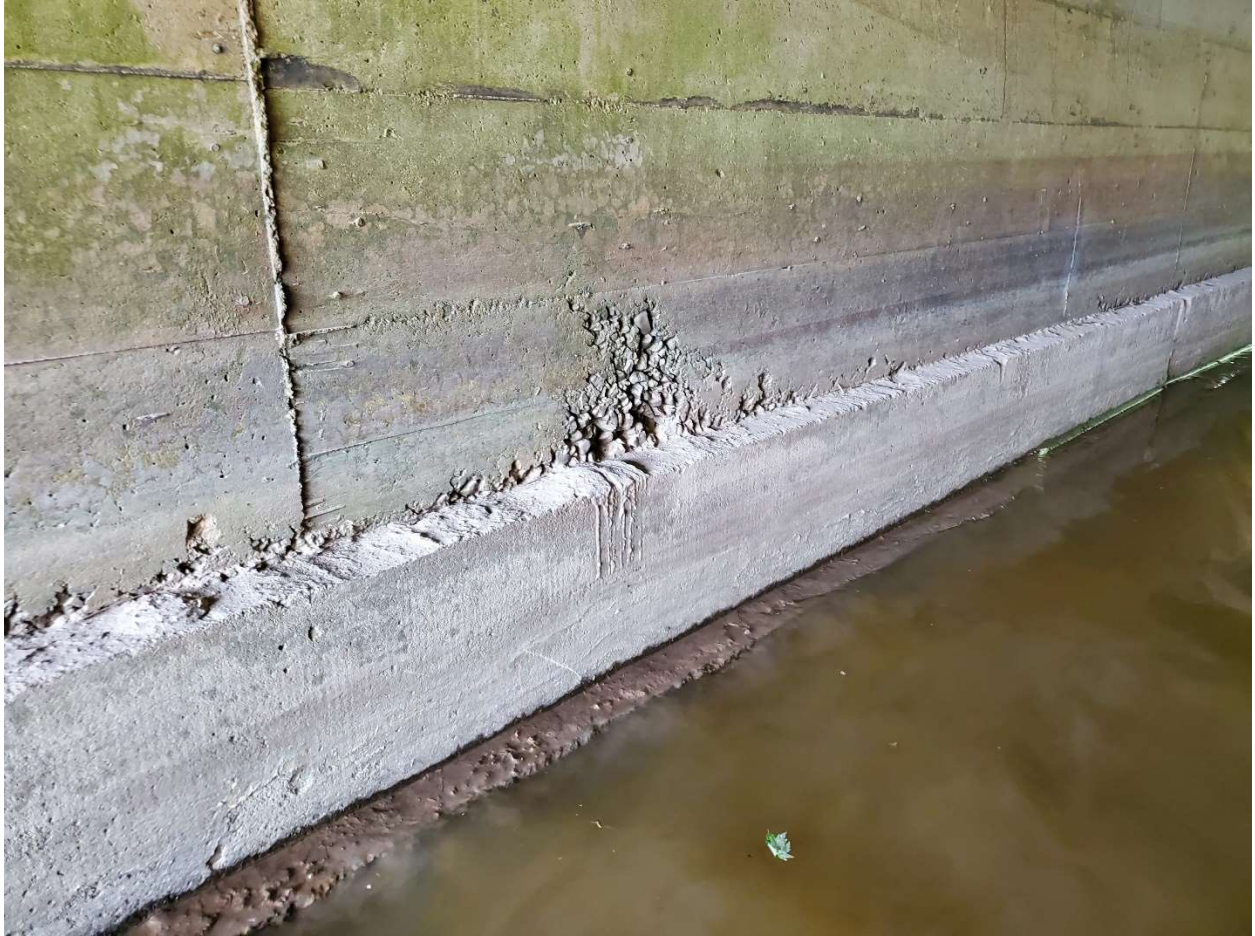
Concrete damages inside the culvert

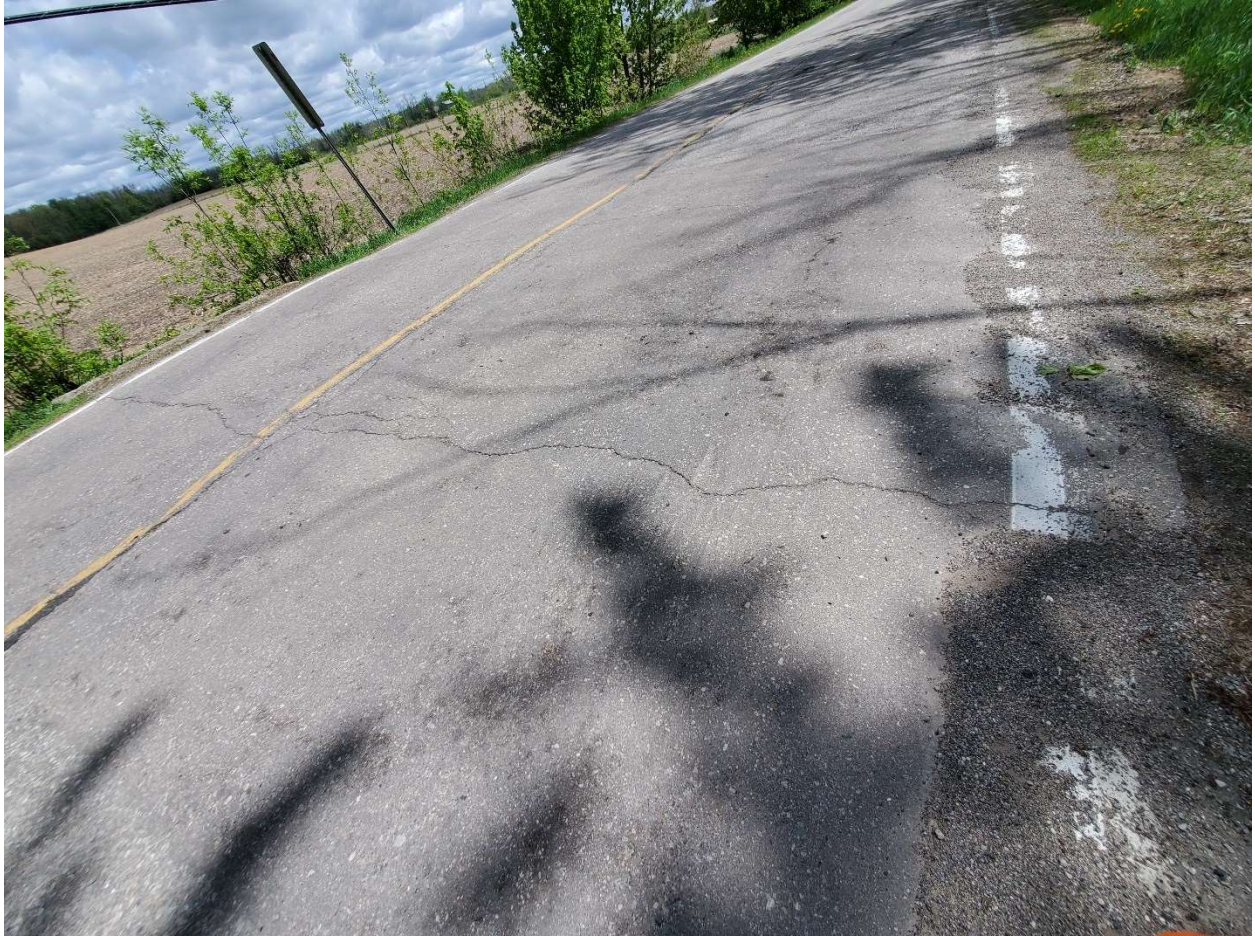
Some cracks observed in the wearing surface of the road

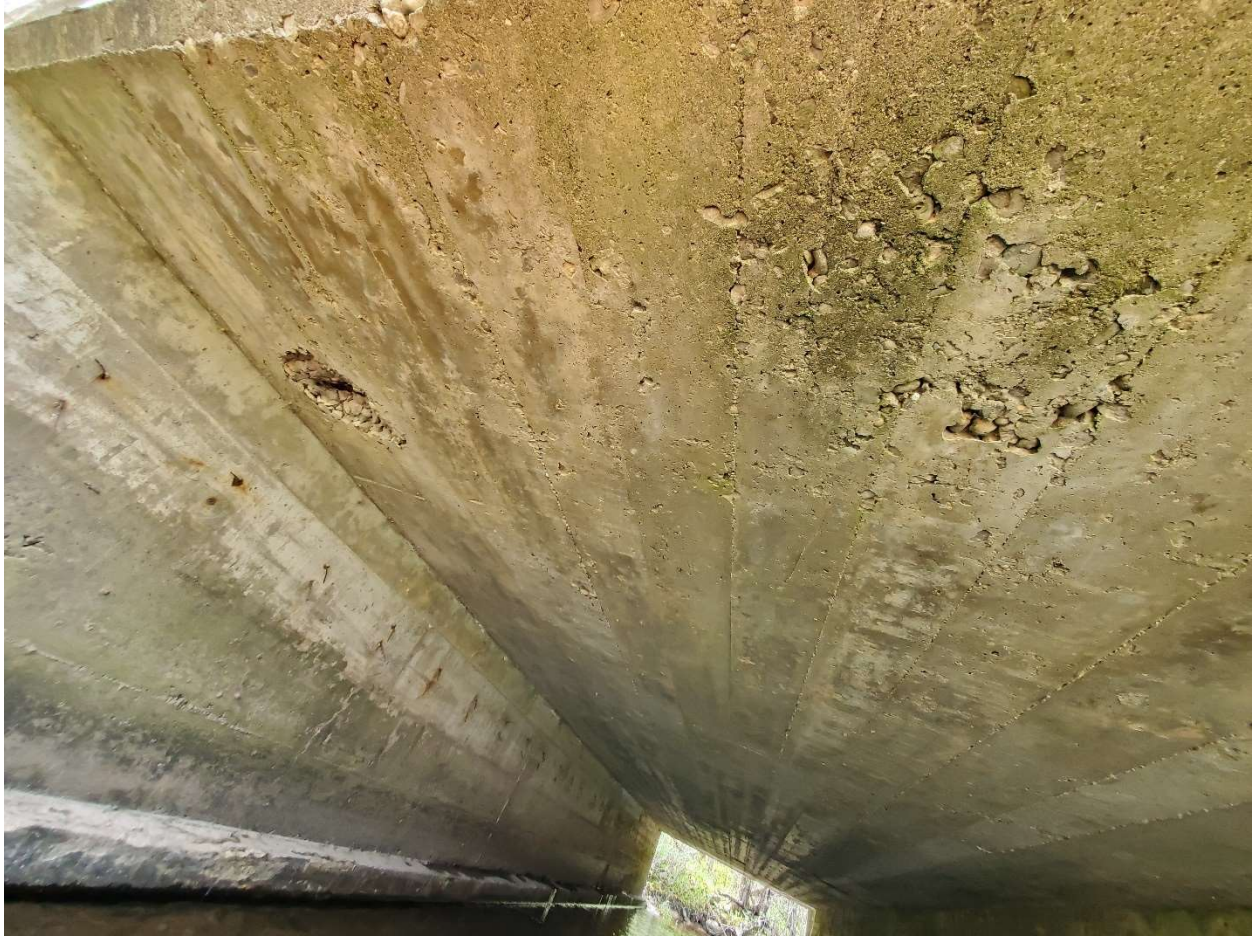
Concrete honeycomb and spalling observed inside the culvert

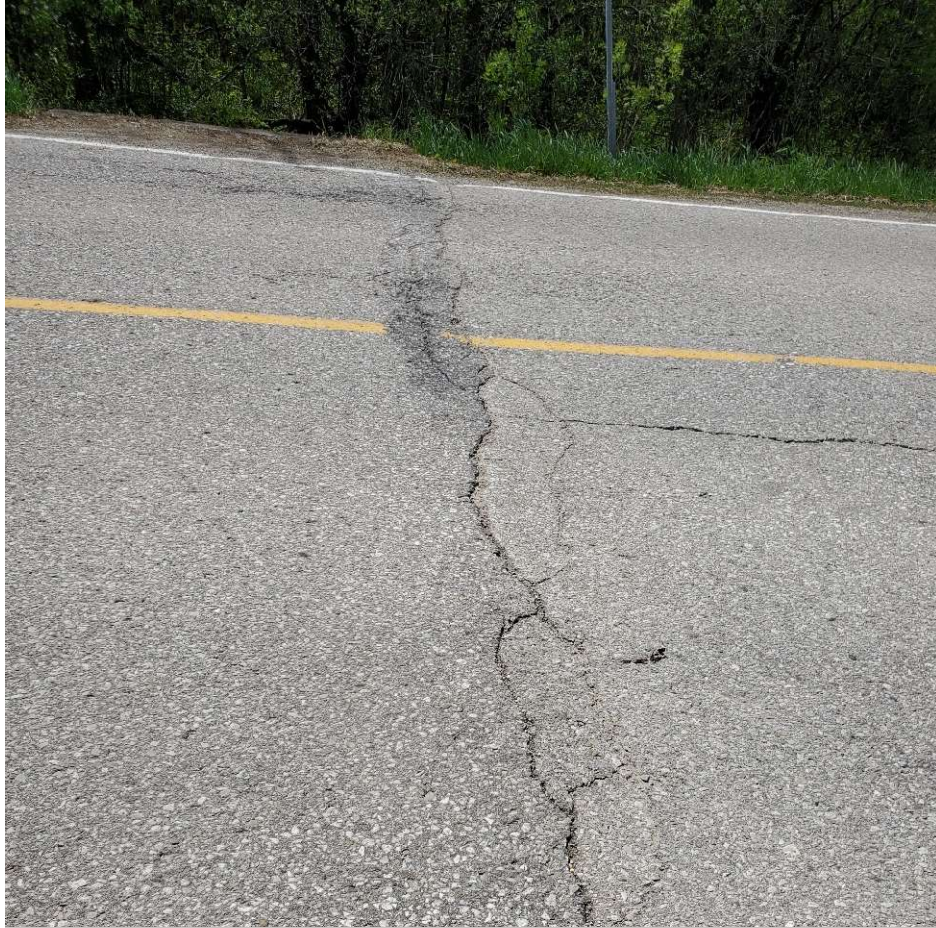
Some cracks observed in the wearing surface of the road

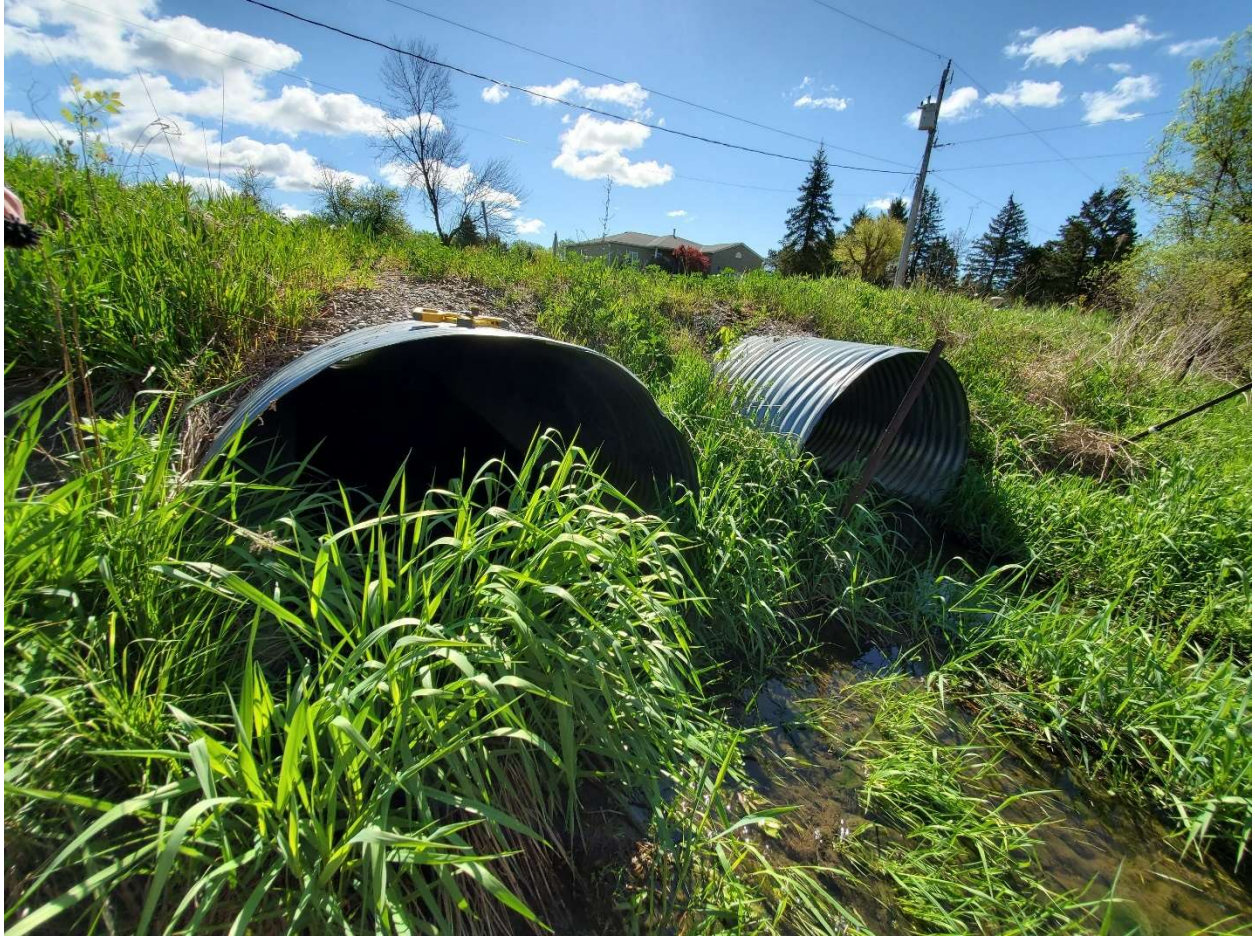
Elevation view 1 of the culvert/ Obstruction observed at the culvert

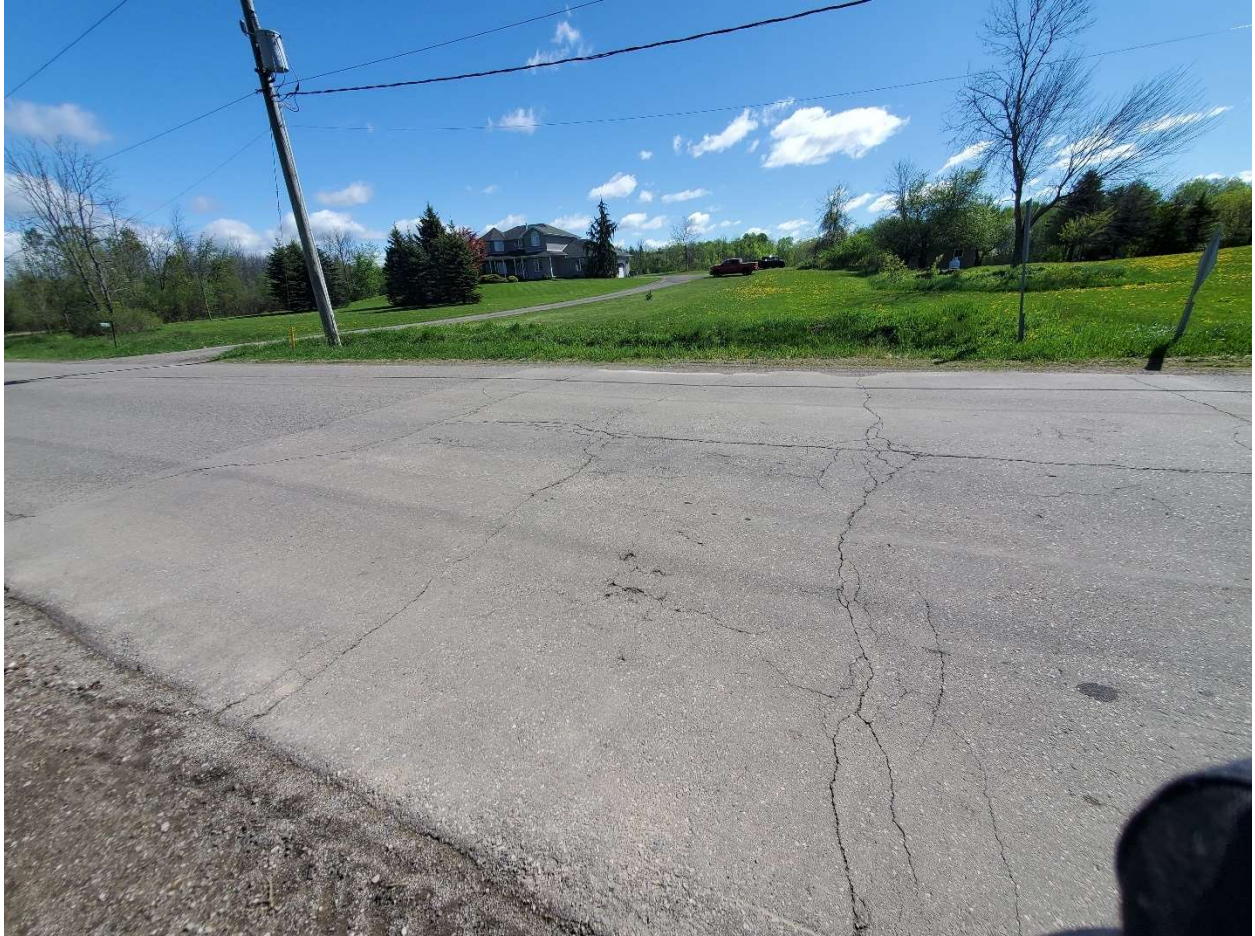
Some cracks observed in the wearing surface of the road

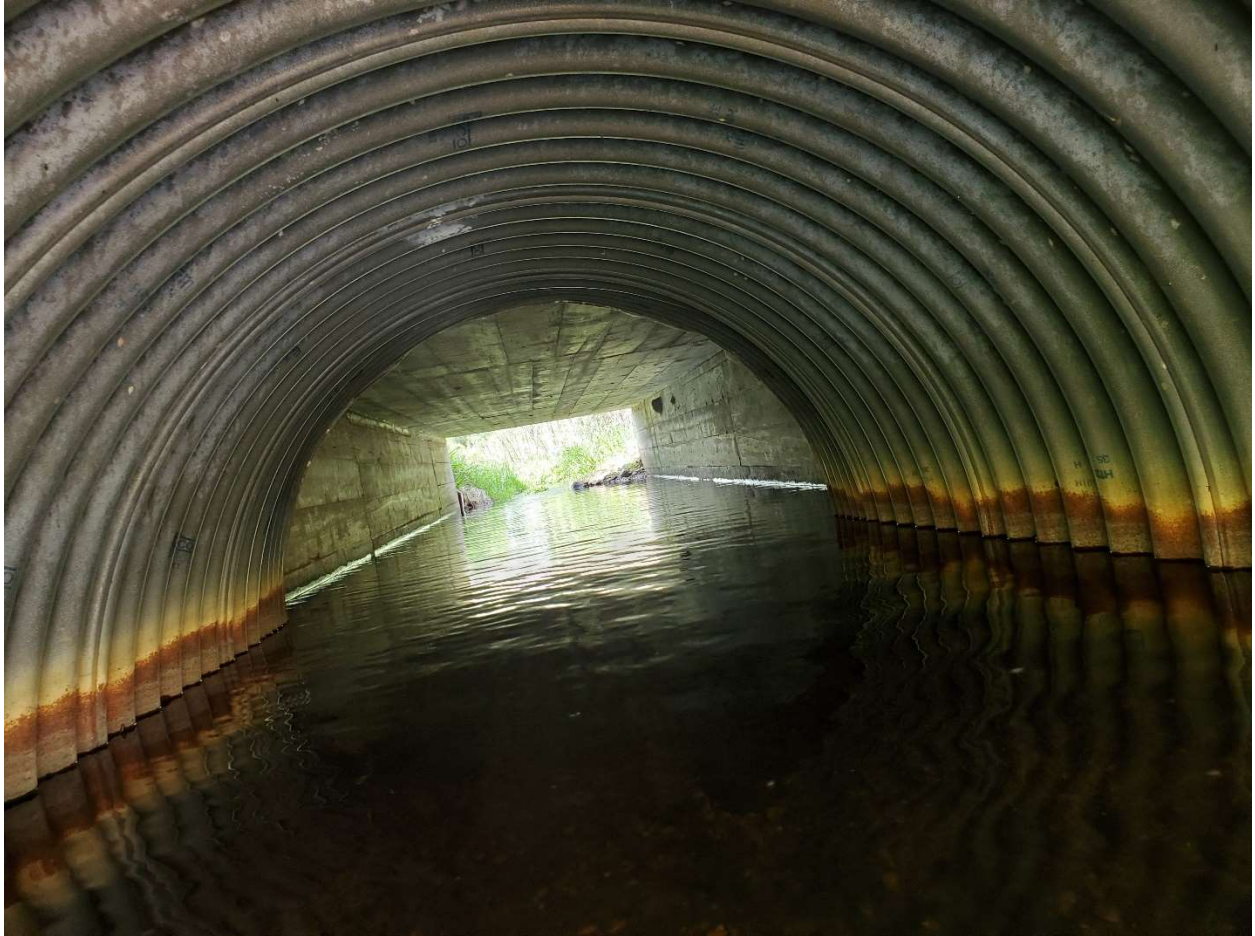
Rusting observed at the culvert bottom

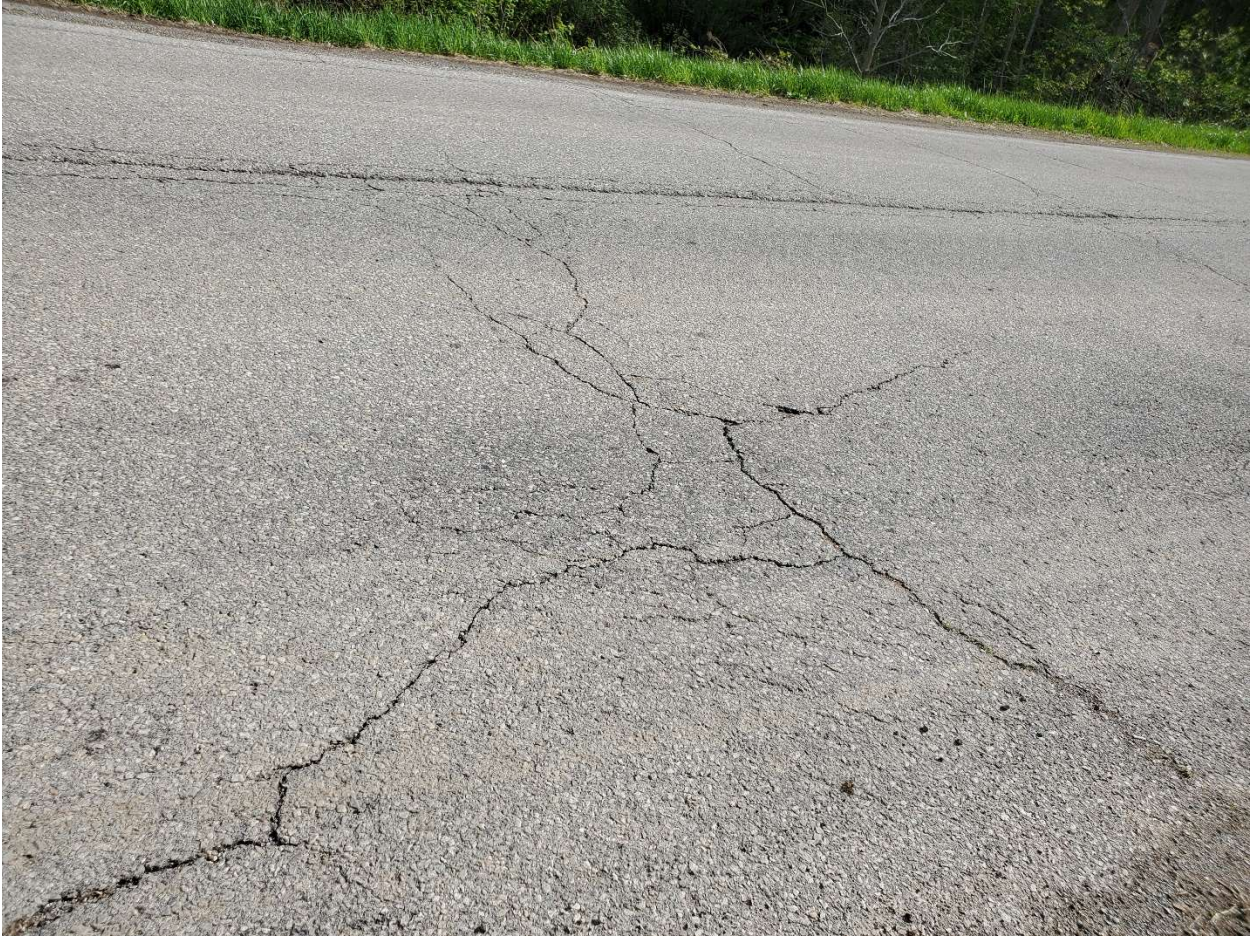
Crack observed at the road surface

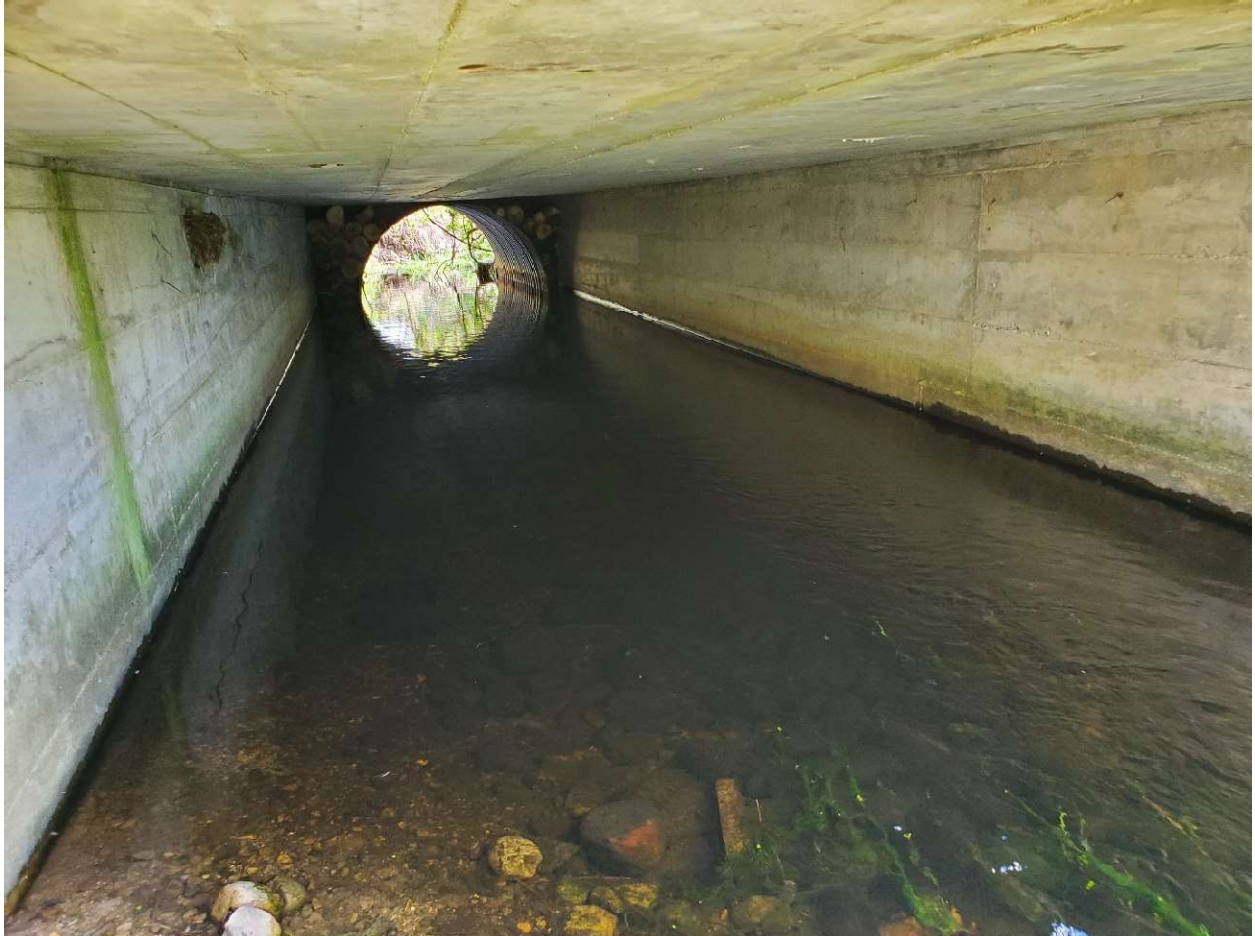
Some spalling of concrete observed at the box culvert

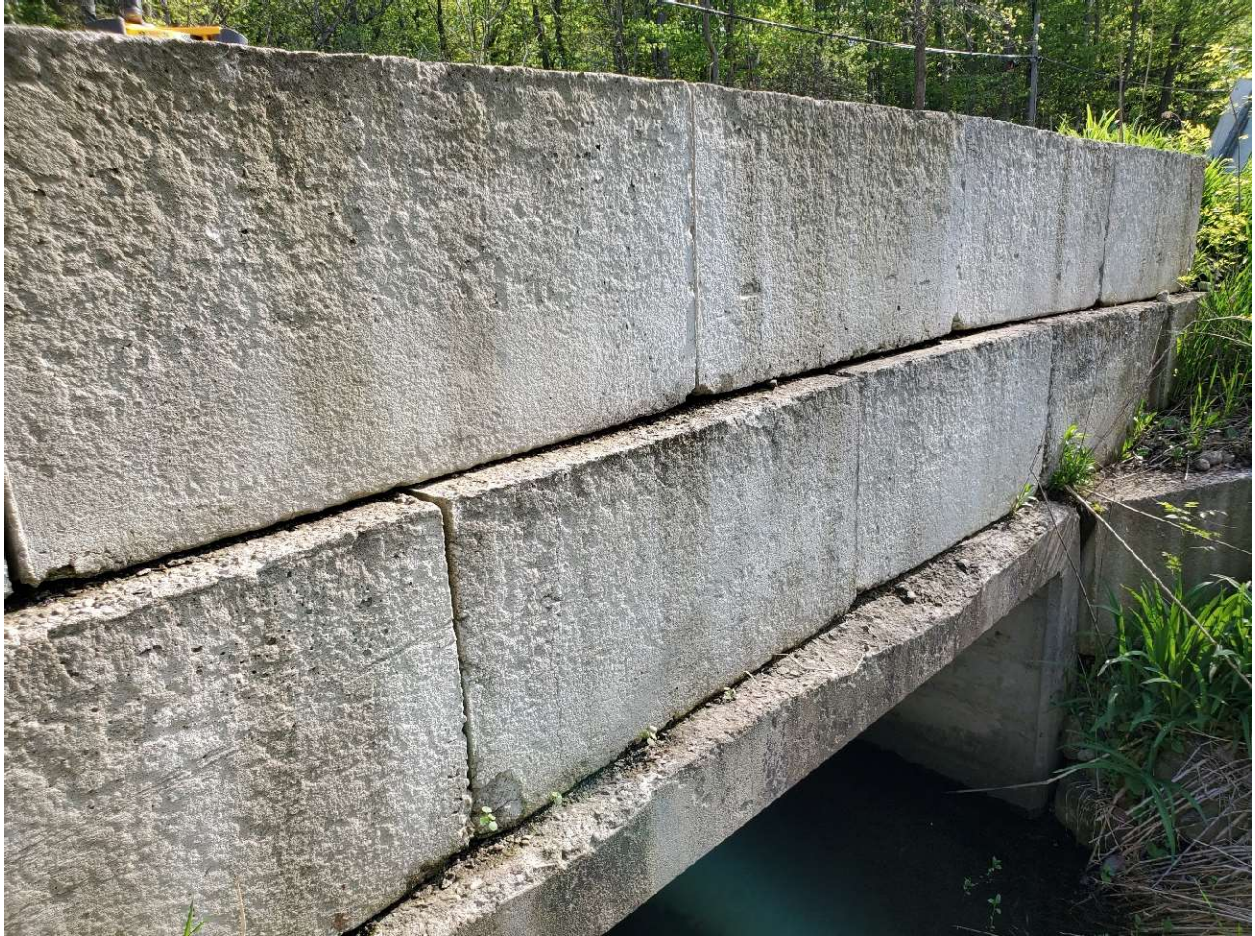
Concrete deterioration/wearing at the culvert top

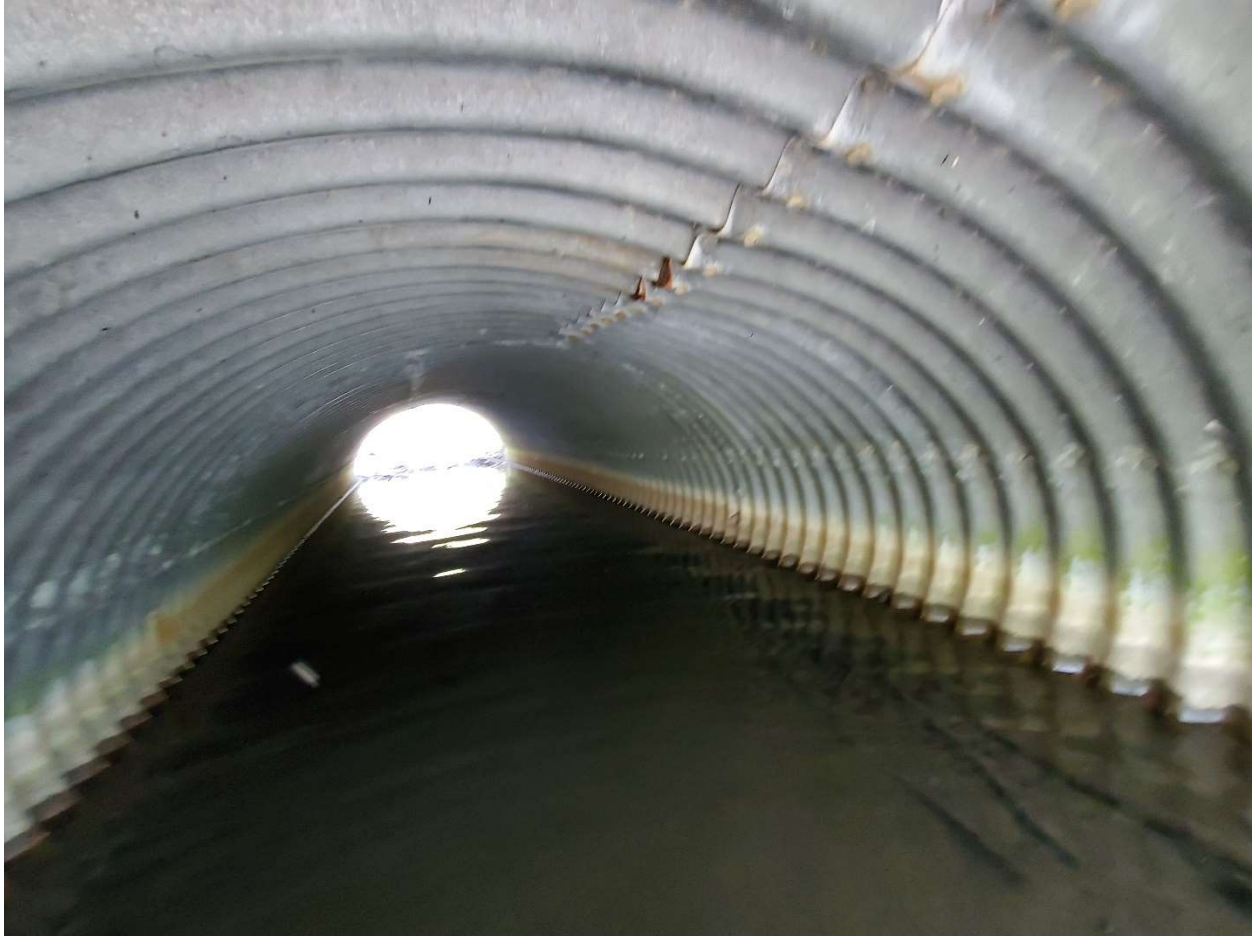
Some rusting observed at the culvert joints

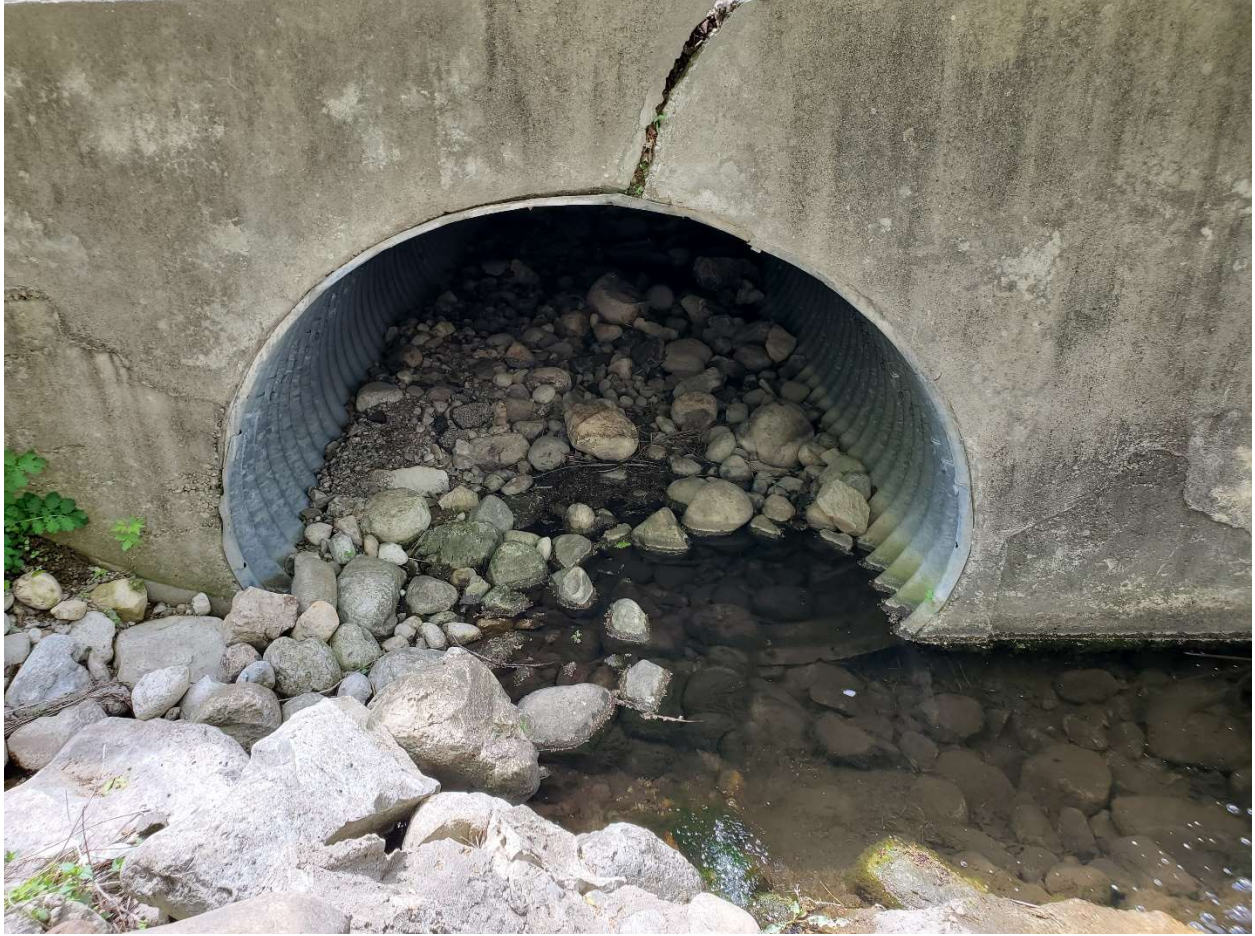
Large crack observed on the concrete

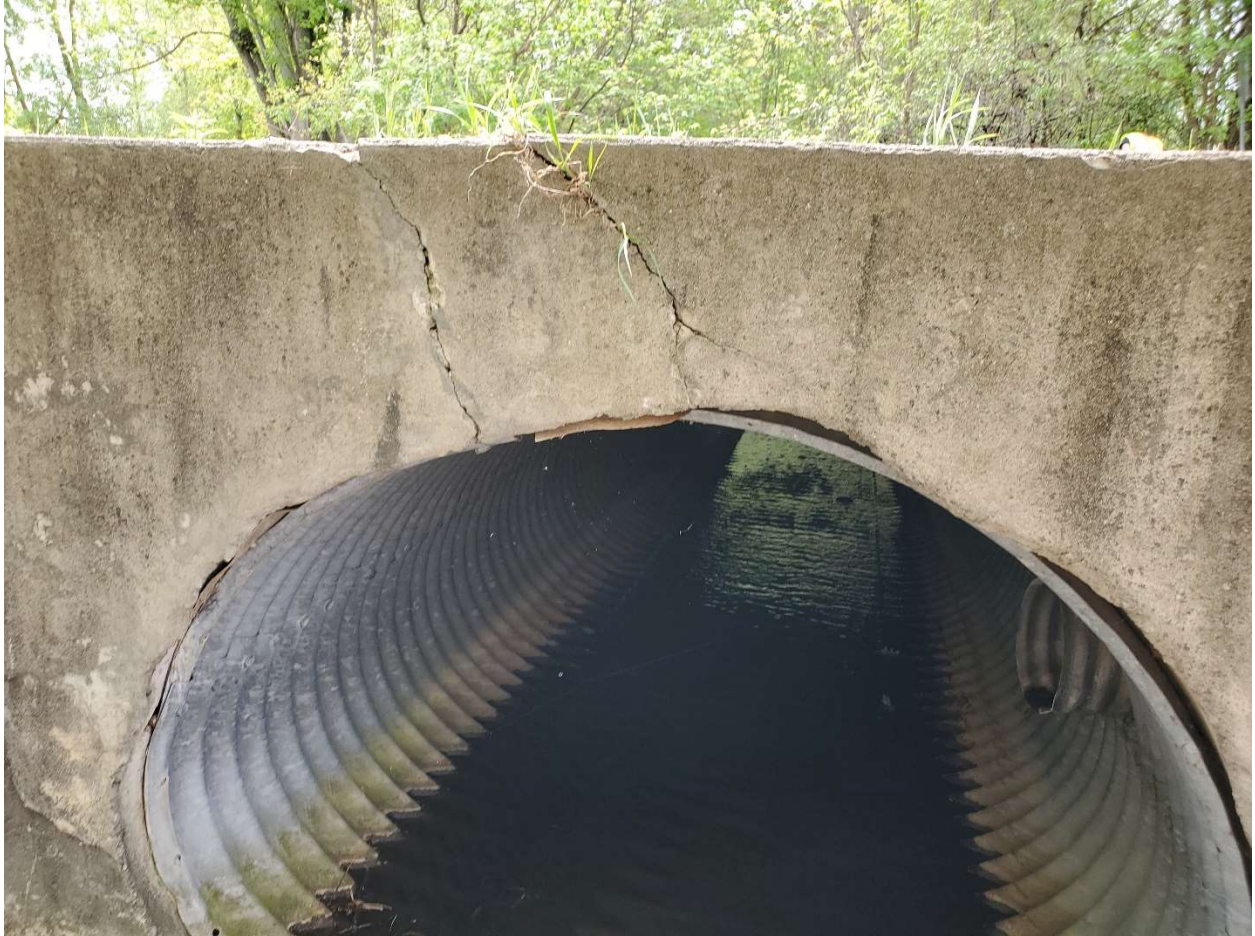
Multiple cracks observed in the concrete
