# 2022 OSIM Inspections for Municipal Bridges and Culverts larger than 3 meters

Township of North Dumfries

**MEDA Engineering and Technical Services**

**31 May 2022**

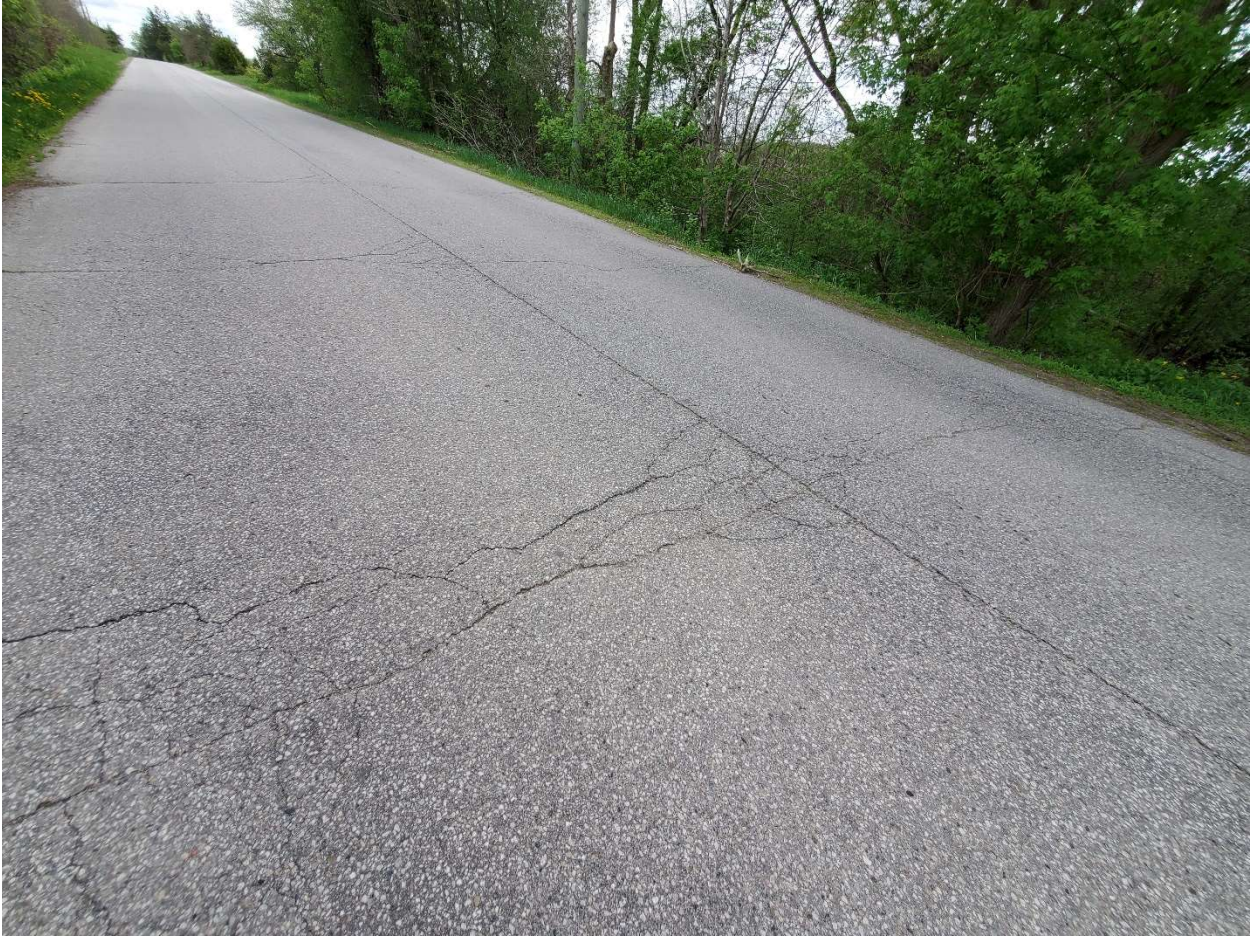
Cracks observed on the road surface

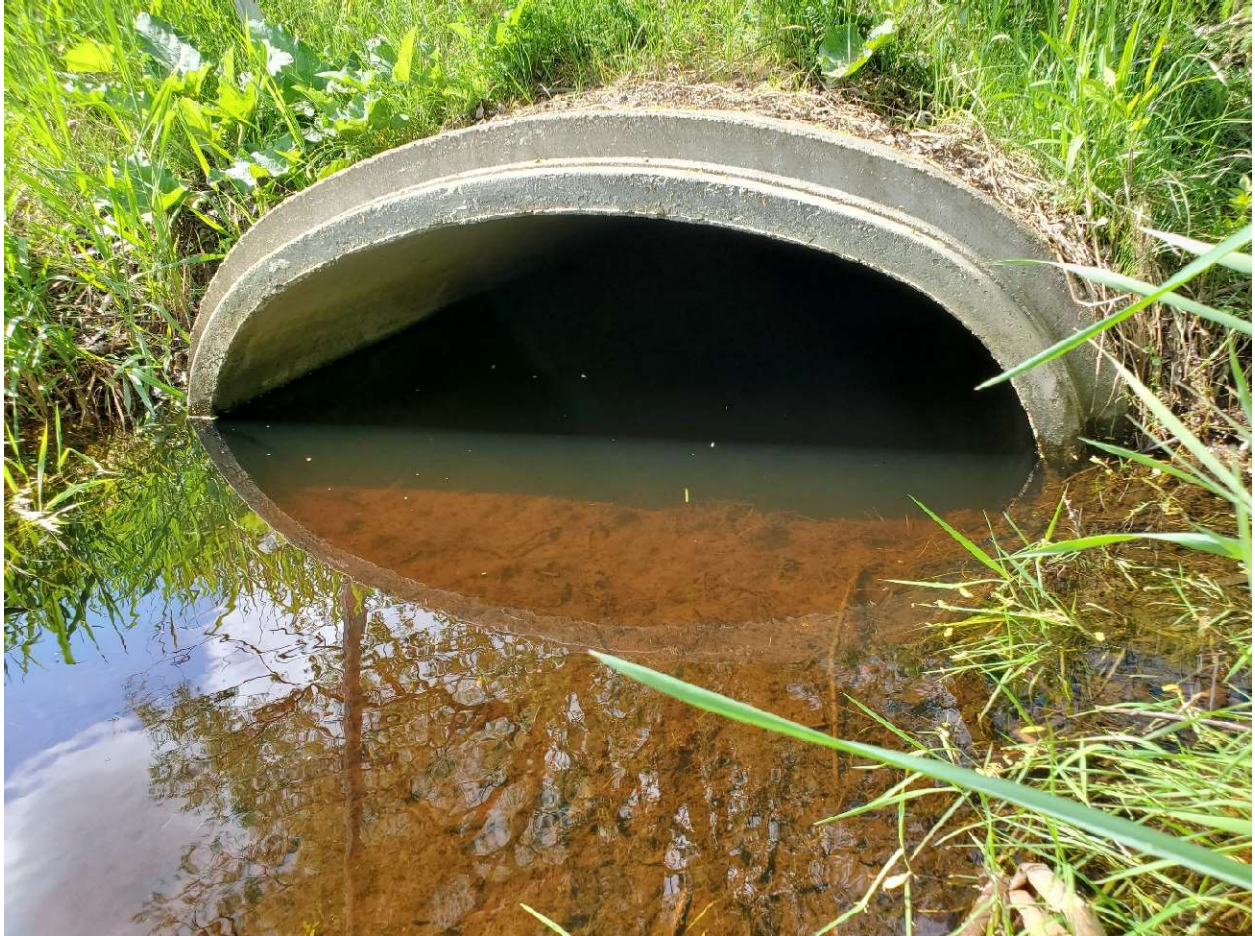
Elevation of the culvert (Some water obstruction observed)
