GEOTECHNICAL INVESTIGATION

EROSON AND SLOPE STABILITY AT PIPER STREET, AYR, NORTH DUMFRIES,

THE CORPORATION OF THE TOWNSHIP OF NORTH DUMFRIES

July 2022

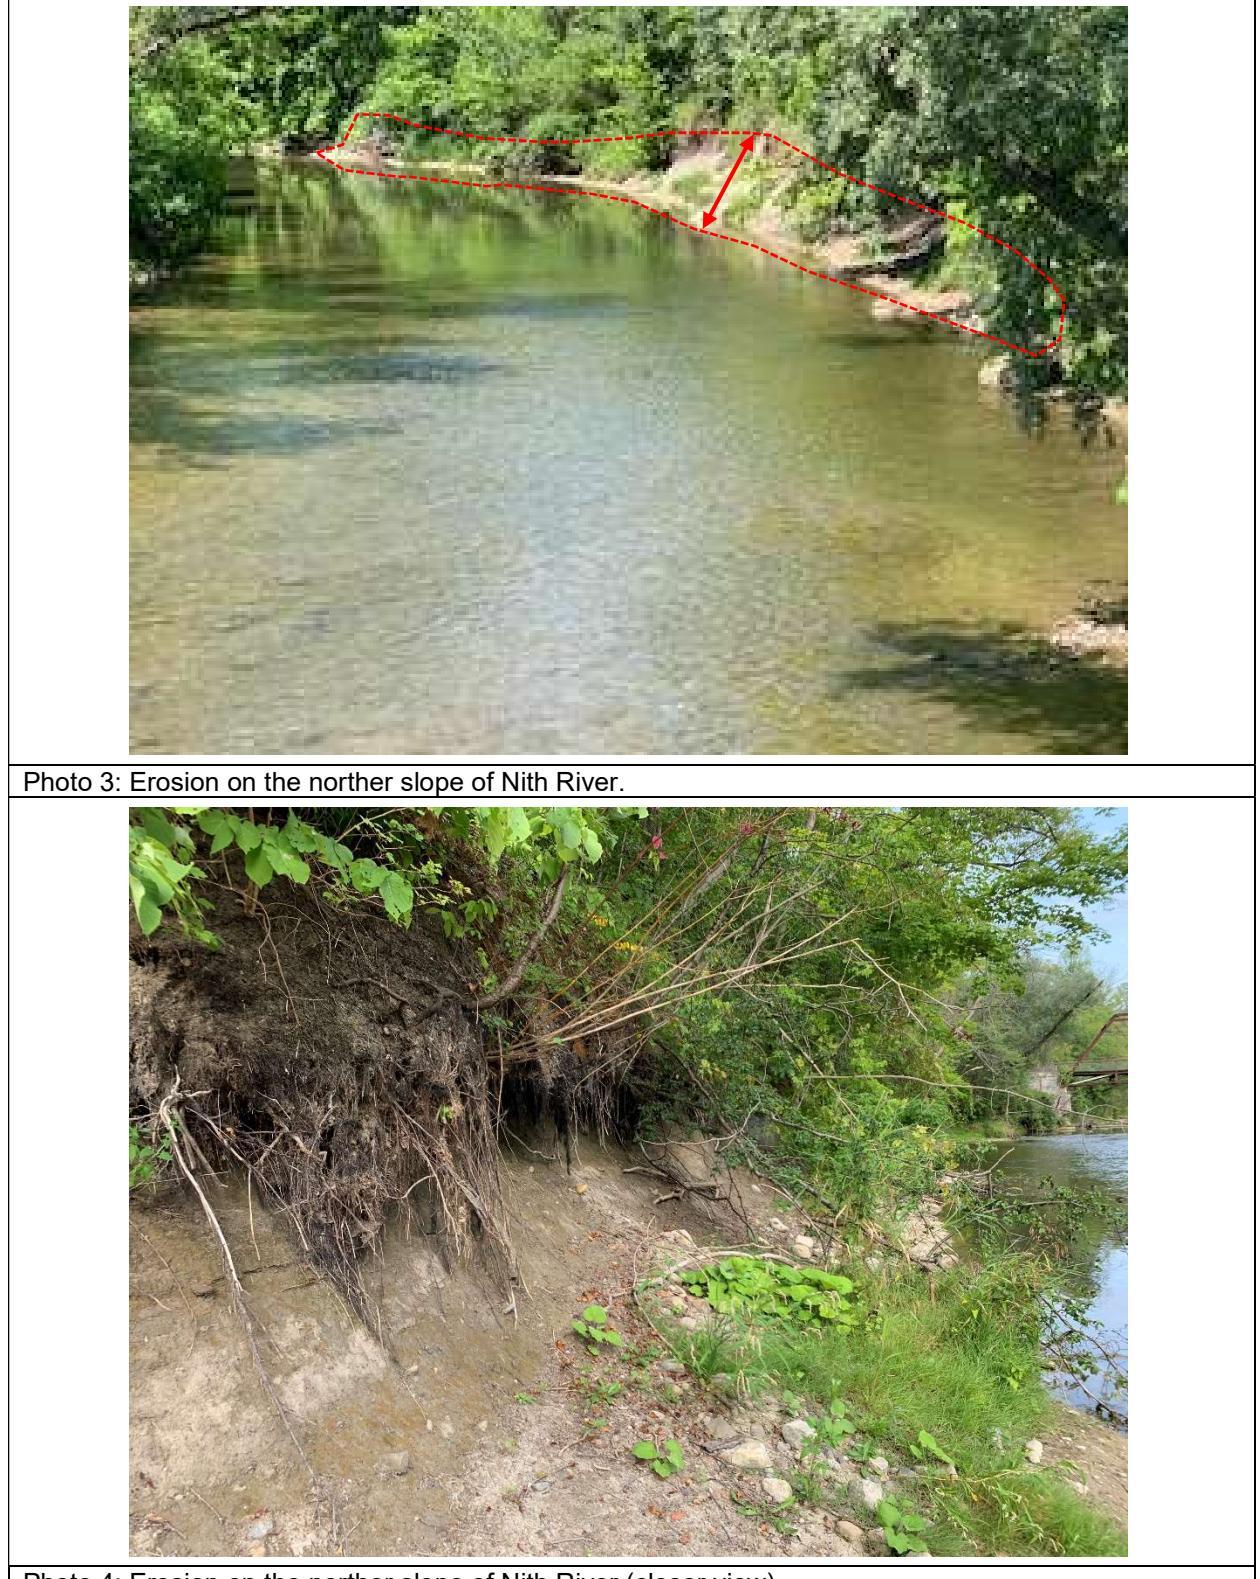
A ramp is located on the east side of the project site that gives access to the abandoned suspension bridge over the Nith River. SAFFA used this access ramp to reach the toe of the slope. At the toe, localized erosion was noticeable at various locations. The erosion was most prominent in the slope section from 80 m downstream to 130 m downstream of the suspension bridge. It was also noted that the erosion was in the vertical zone of 3 m starting from river water level (measured in September 2021) and upward. The extent of erosion is sizable and may contribute to larger slide failure if the measures are not taken in timely manner. The extent of erosion can be seen in a photos (**Photos 3 and 4**)

Photo 4: Erosion on the norther slope of Nith River (closer view).

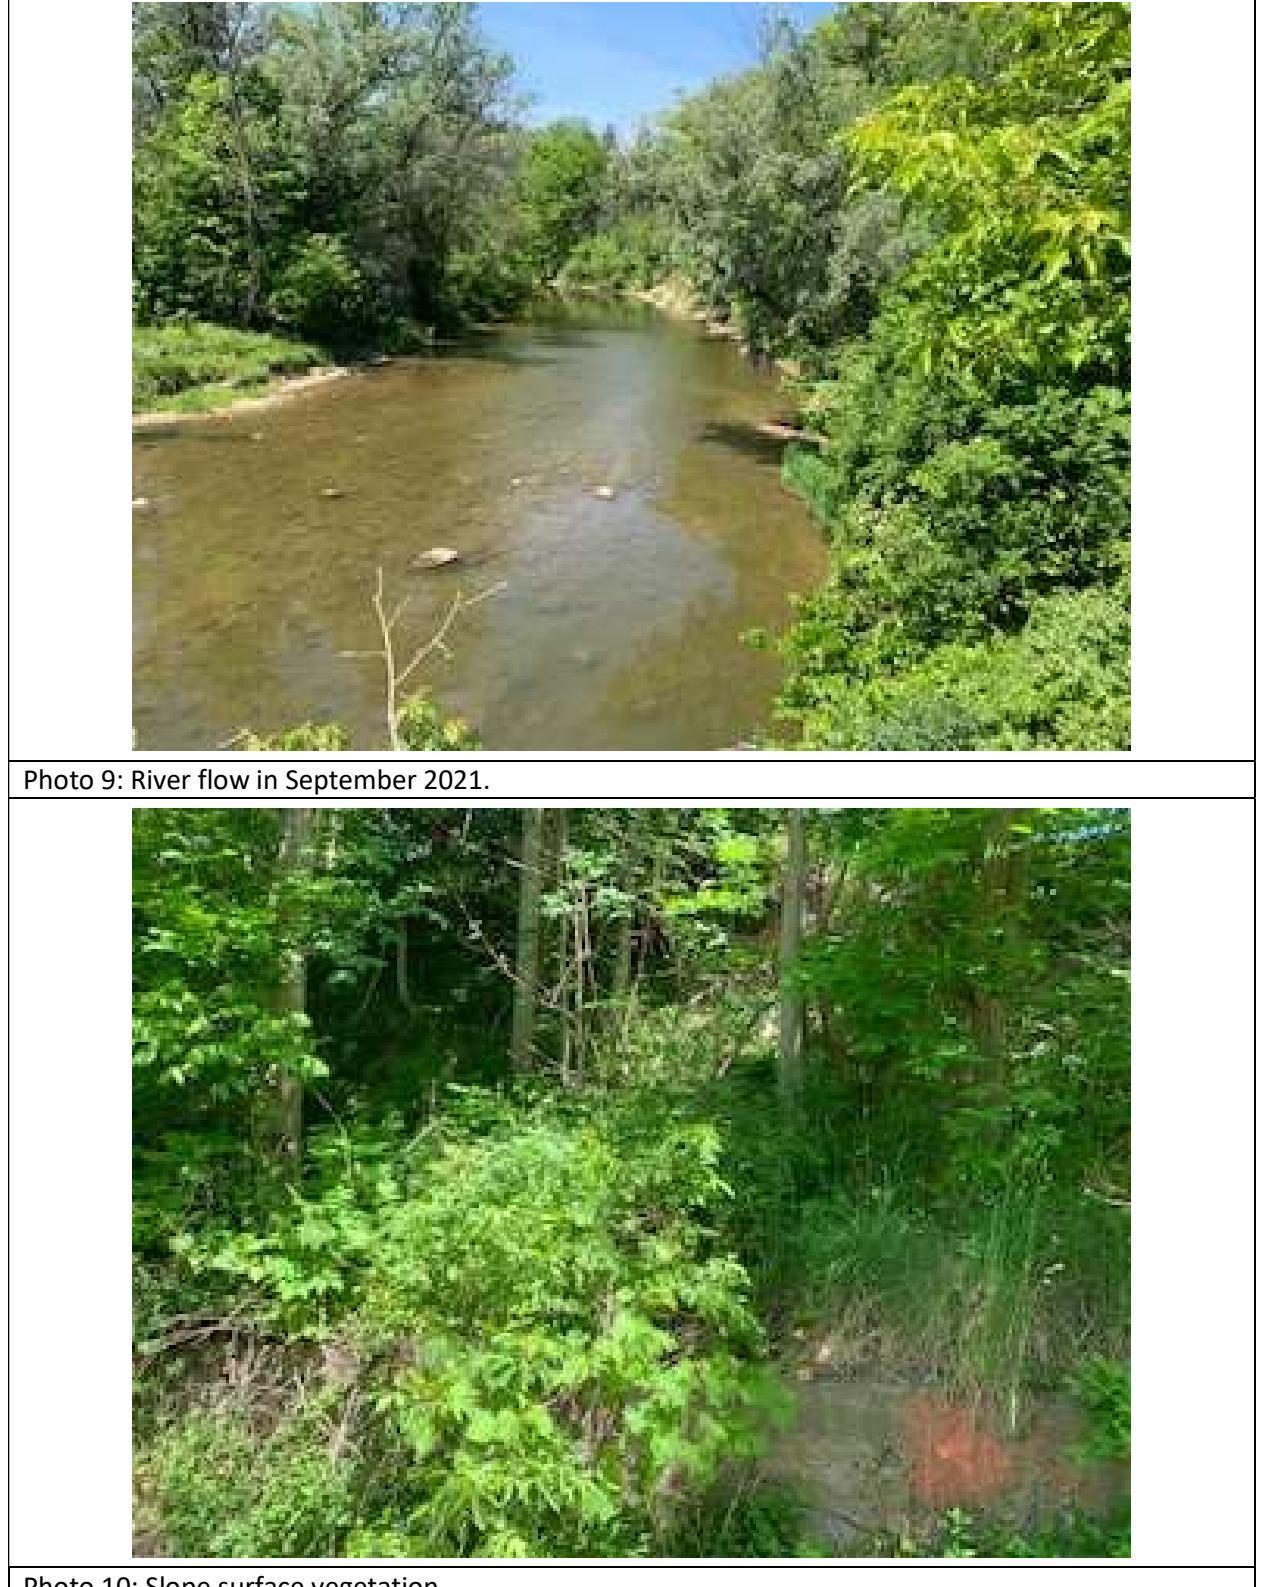
Photo 10: Slope surface vegetation.

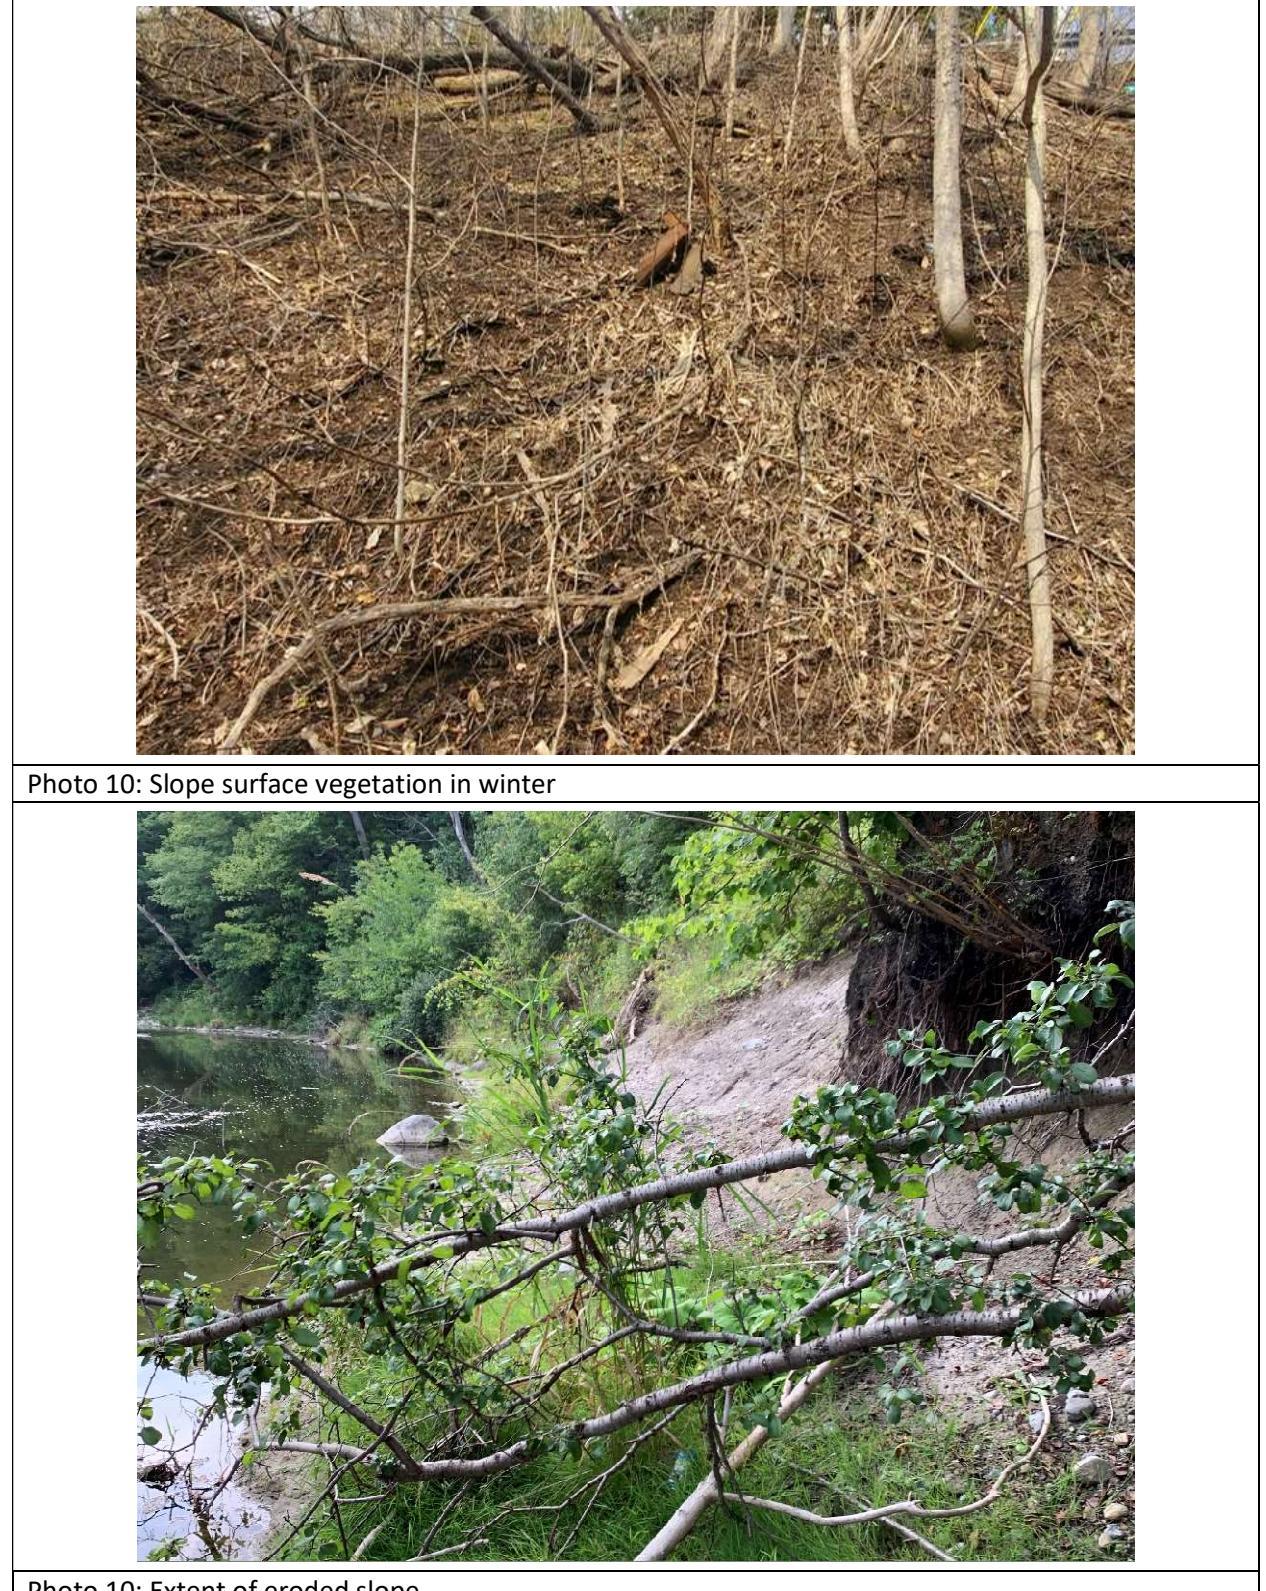
Photo 10: Extent of eroded slope.

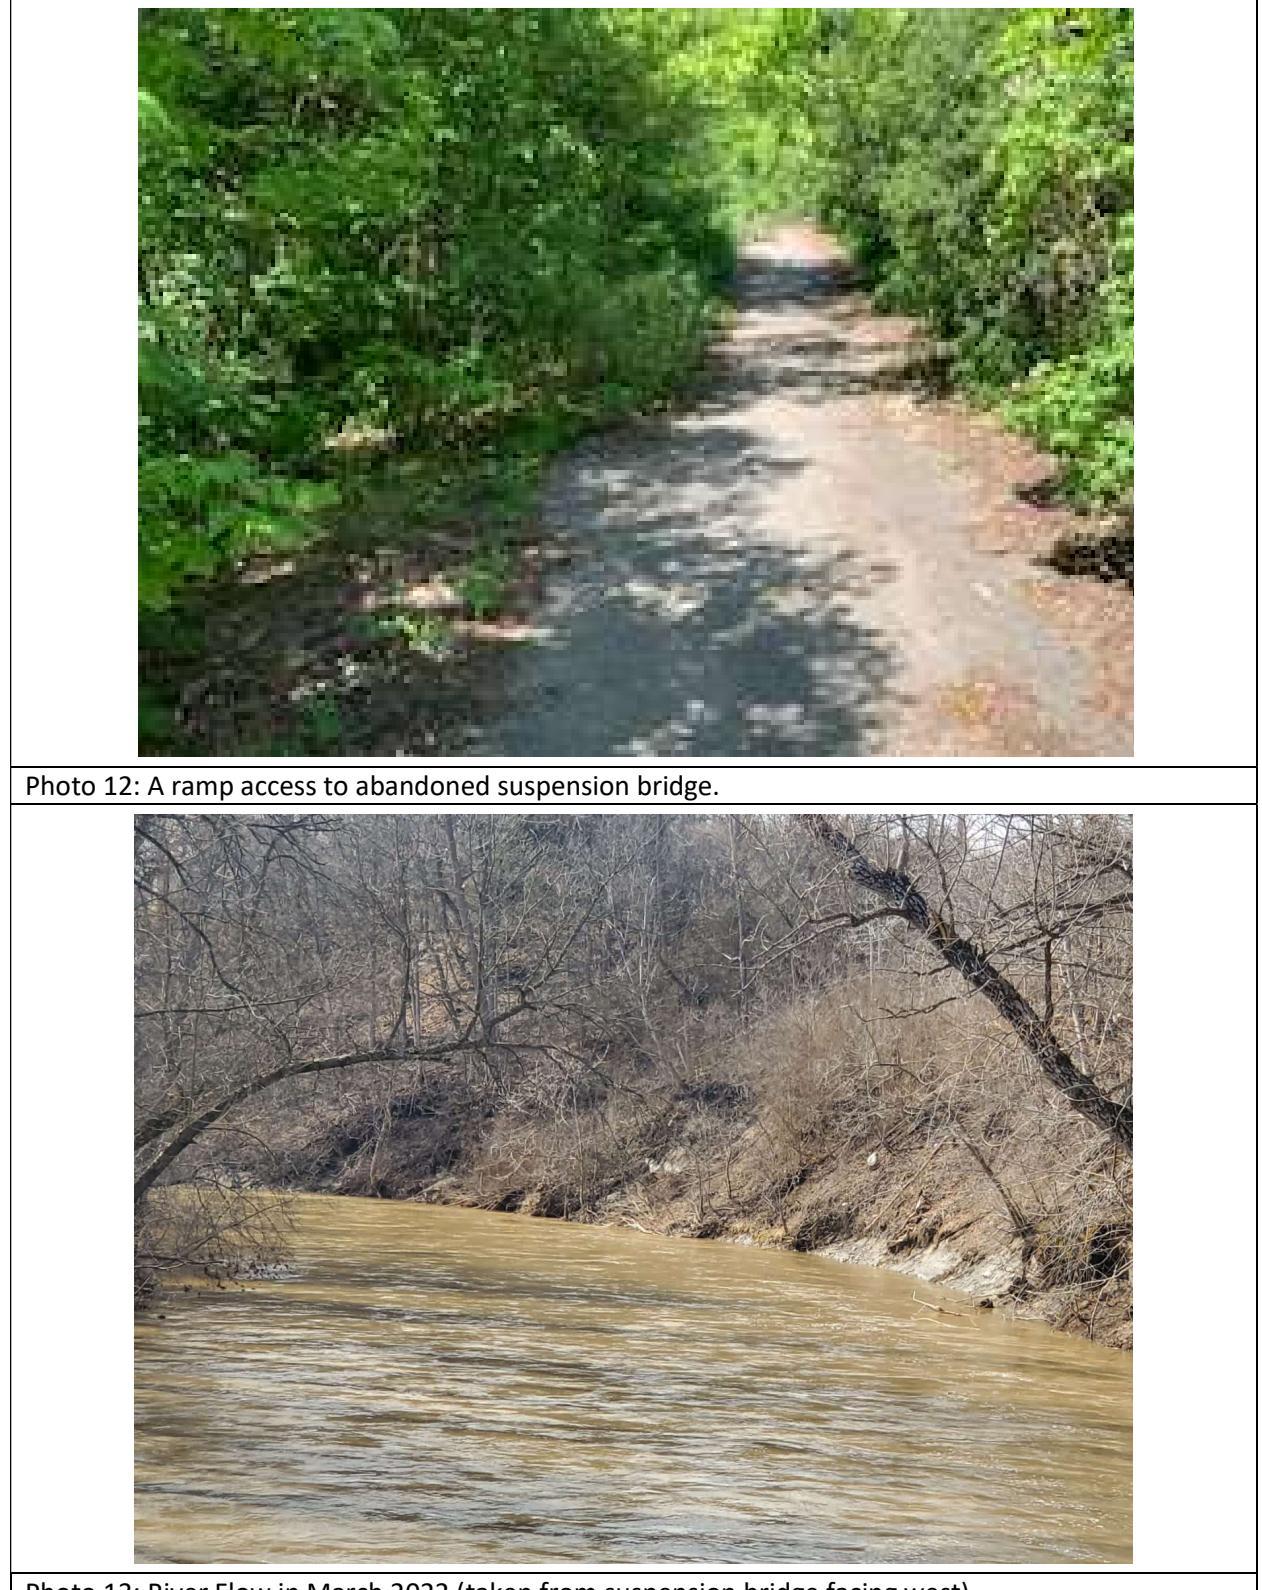
Photo 13: River Flow in March 2022 (taken from suspension bridge facing west)

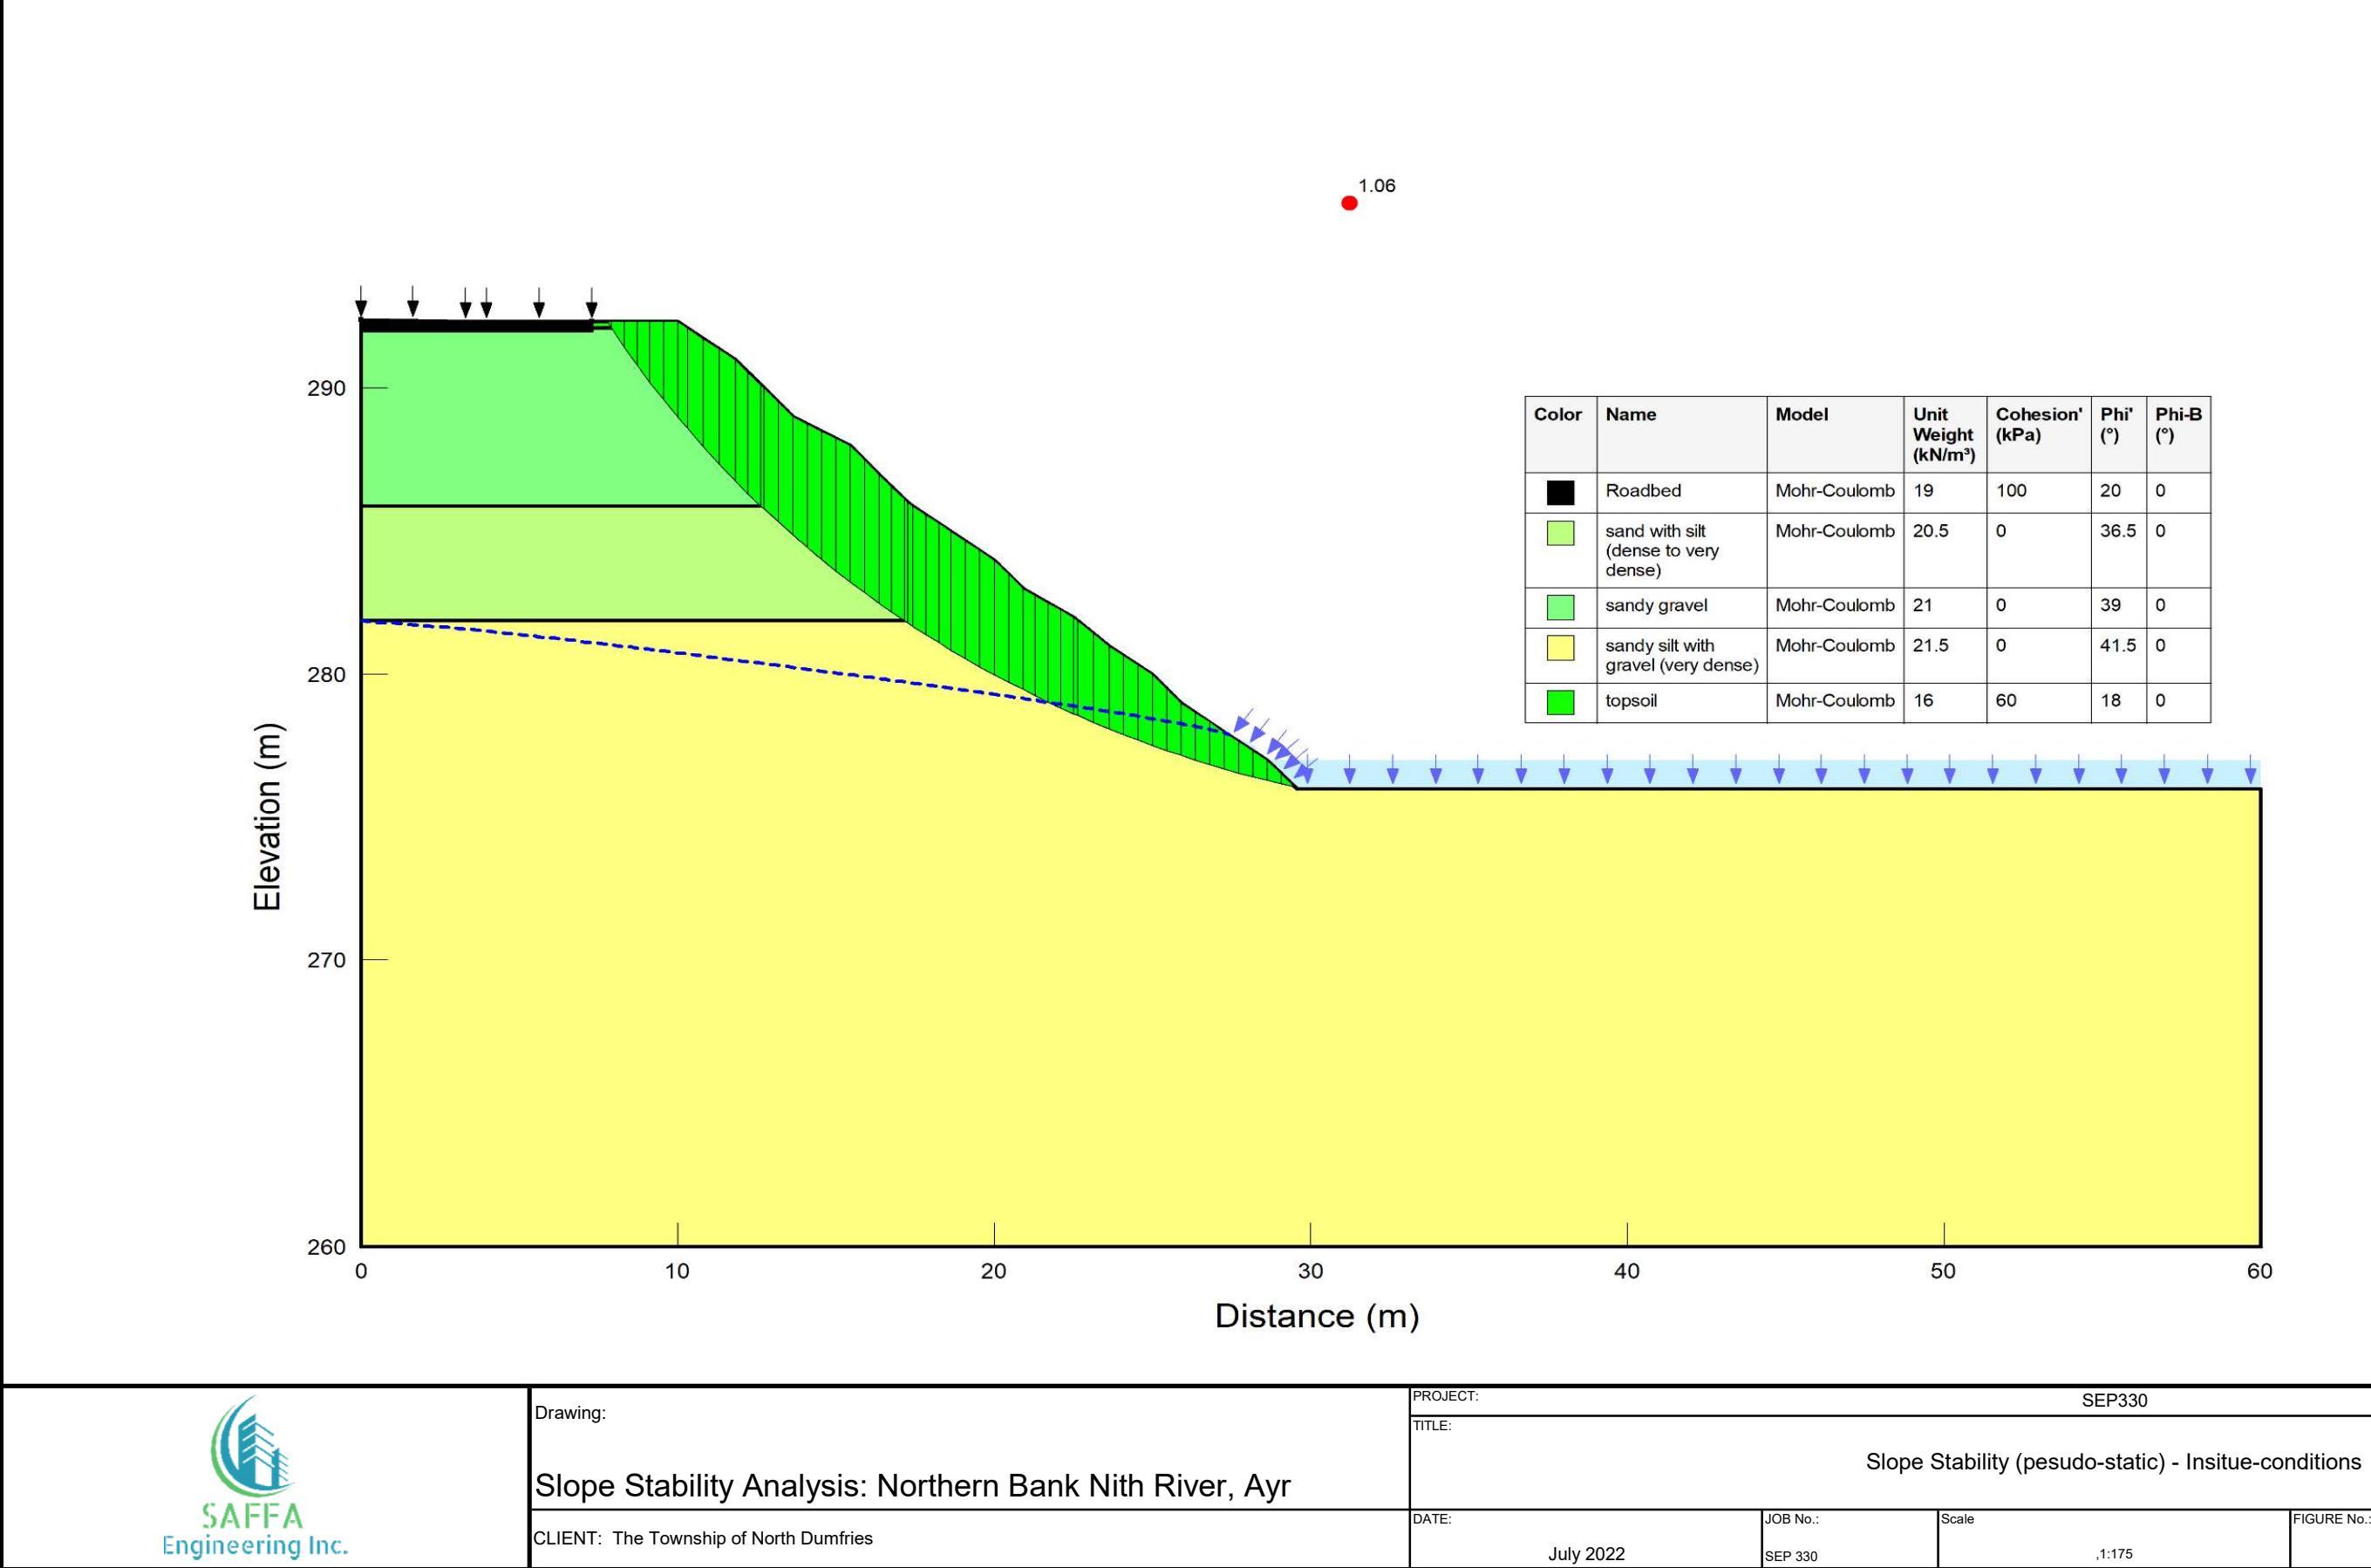
The results of the stability analyses, considering long-term parameters, indicate that the FOS against instability of a failure surface initiating near the crest of the slope at the site is over unity (1.15).

The results of these slope stability analyses are displayed on **Figure 2 and Figure 3** in Appendix E. Stability analyses was carried out for short-term pseudo-static and long-term conditions.

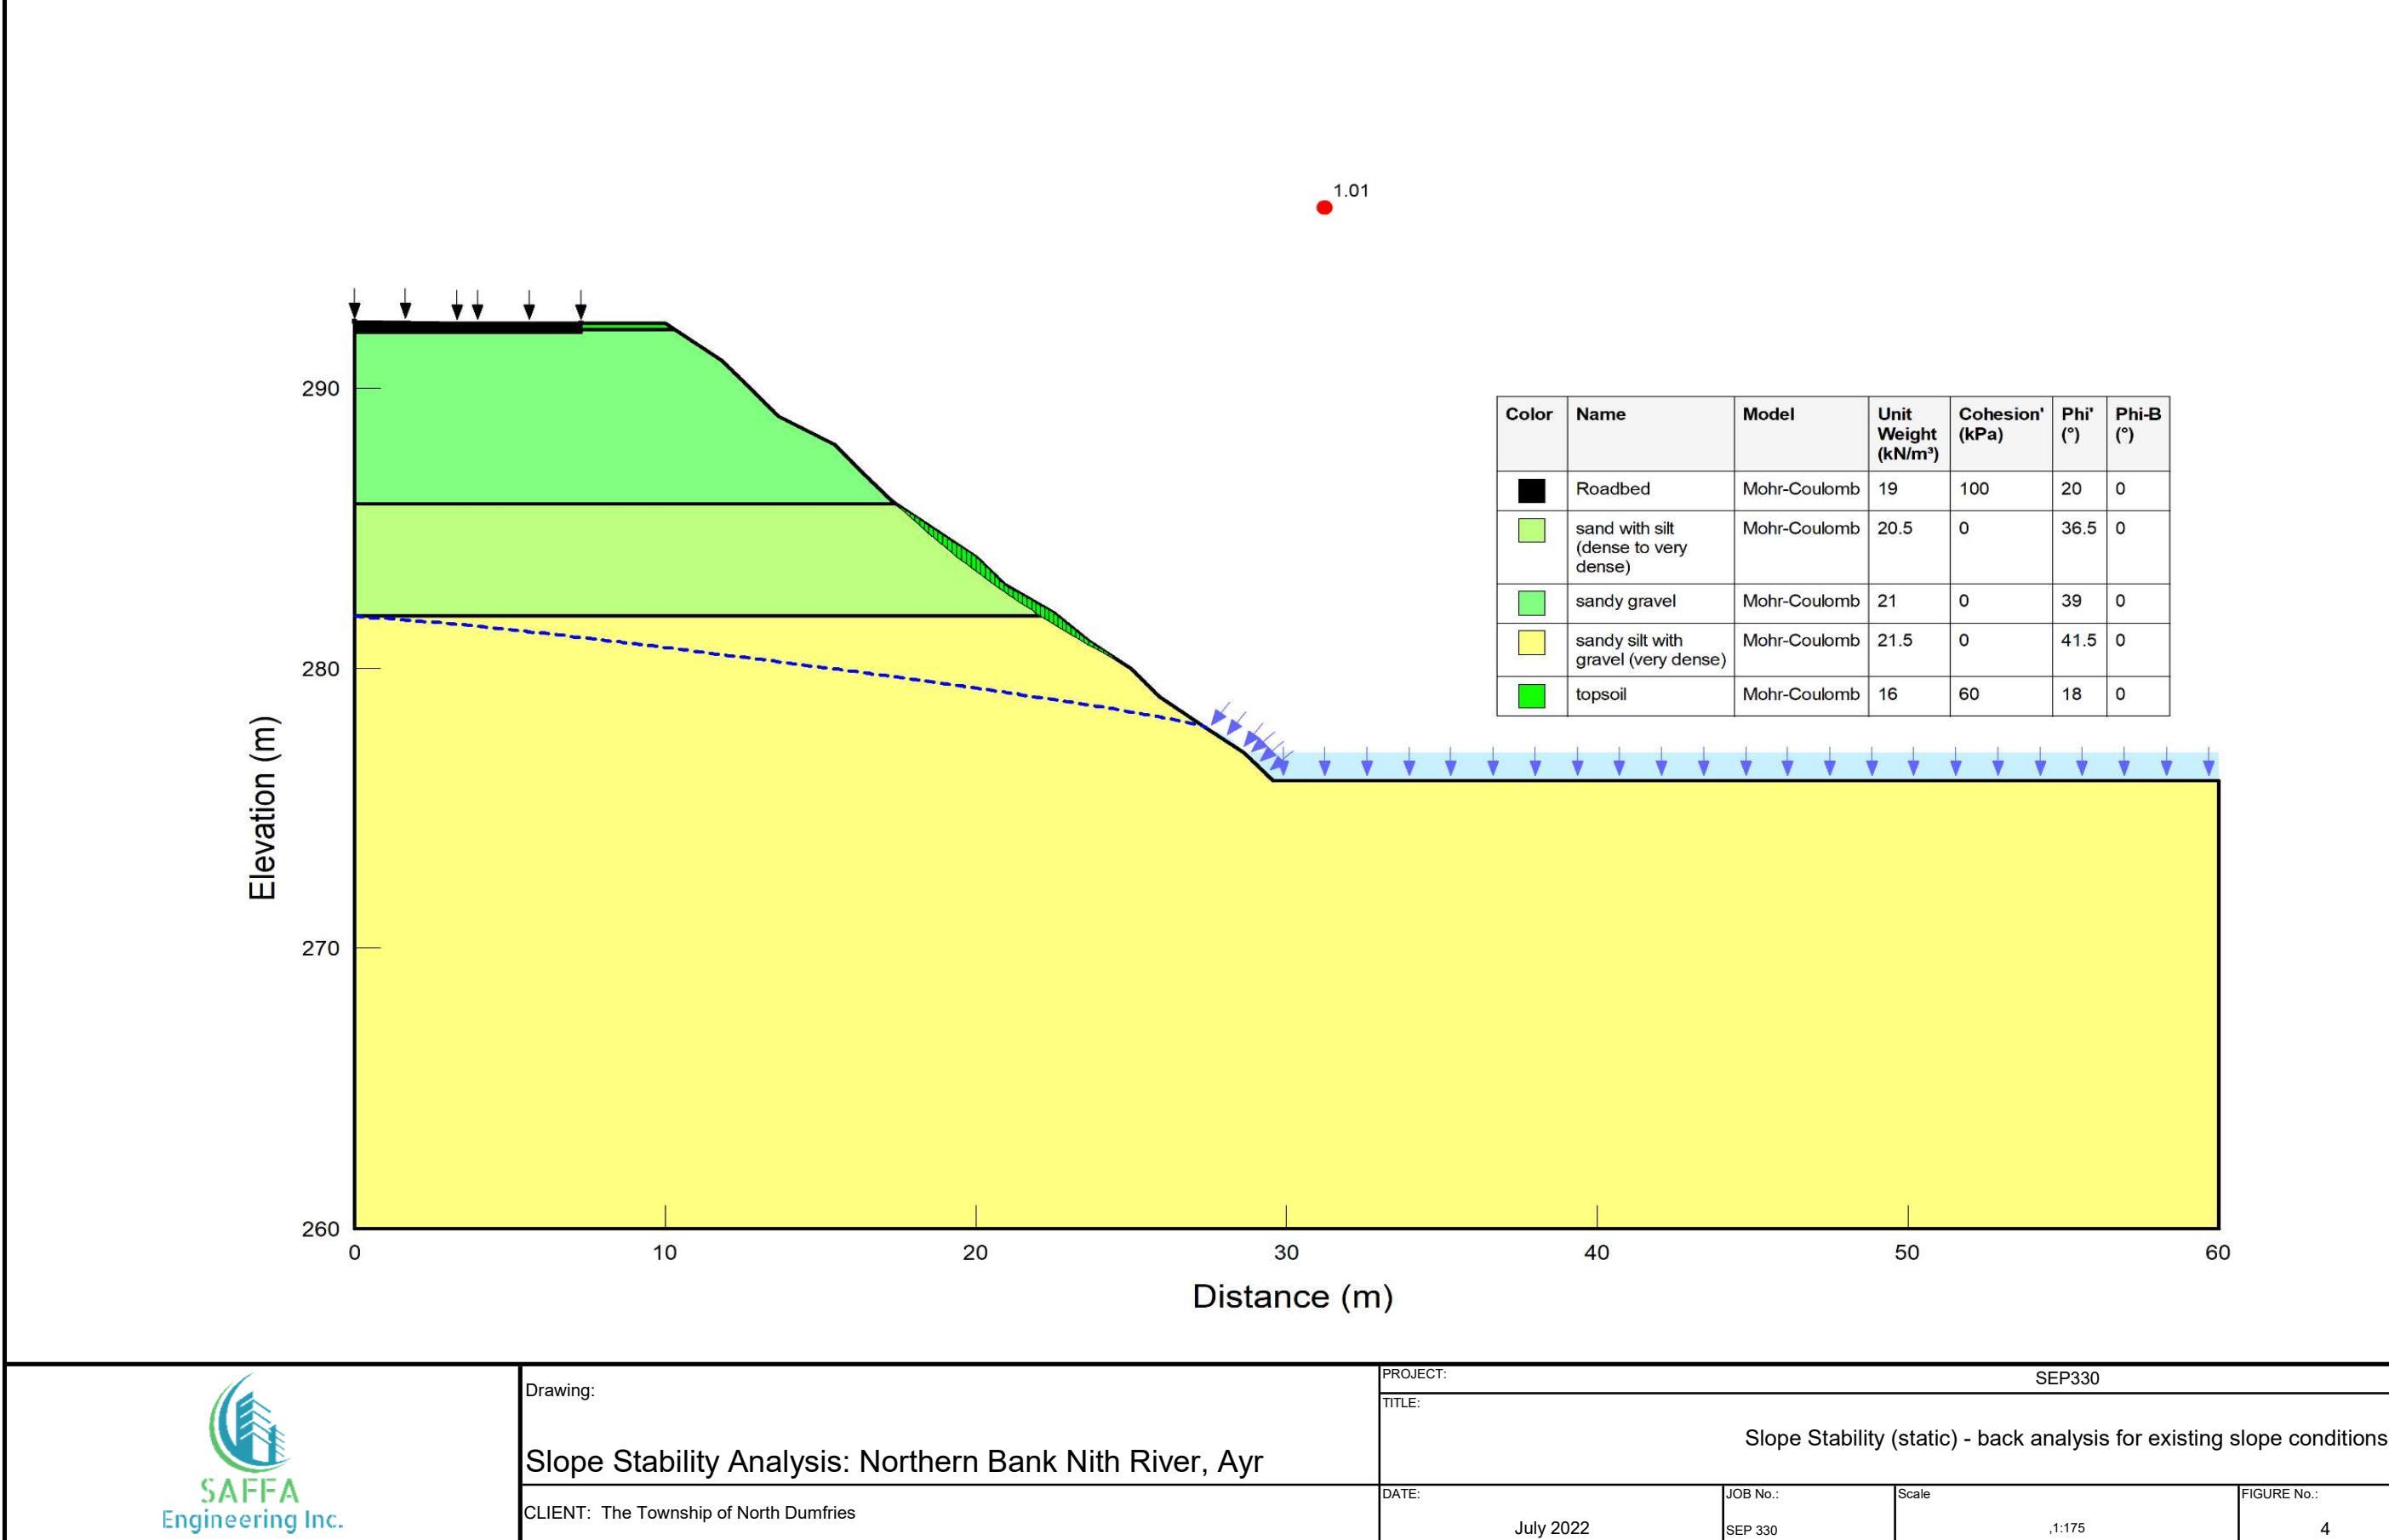
| SEP330 | |
|--|--|
| ack analysis for existing slope conditions | |

The site reconnaissance identified an area of slope instability/sloughing at toe of the bank slope generally all along the proposed section. The slope face along the proposed section is steep (generally varies between 1.10H:1V to 1.30H:1V) which is considered to be the primary factor leading to the observed sloughing near the toe. Other factors (e.g. river flow, saturation of the surficial materials due to precipitation, loss of strength due to freeze-thaw cycles, etc.) may also have contributed to the instability. The results of the stability analyses (**Figure 4**, Appendix E) indicate that the FOS against instability for a failure surface similar to the area of instability noted at the site is slightly over unity.

Based on the slope configuration and the results of the stability analyses, the slope southern bank slope is considered to be susceptible to ongoing instability in the future. This may include continuing slope movement in the area of the currently identified instability and/or sloughing/instability of the slope face in new areas. Although the currently noted sloughing is relatively shallow in nature, ongoing instability may cause the failure surface(s) to retrogress (i.e. extend further back into the embankment) which could generate deep seated failure. The deep-seated failure may destroy the Piper Street completely/partially, depending upon the curvature and initiation point of the failure line. Therefore, remedial works are recommended to improve the long-term stability of the slope.
