APPENDIX H

Erosion Inventory and Assessment Information

Ayr, ON - Watercourse Erosion Inventory and Assessment

Watercourse Erosion Inventory and Assessment
Ayr, ON
County of North Dumfries

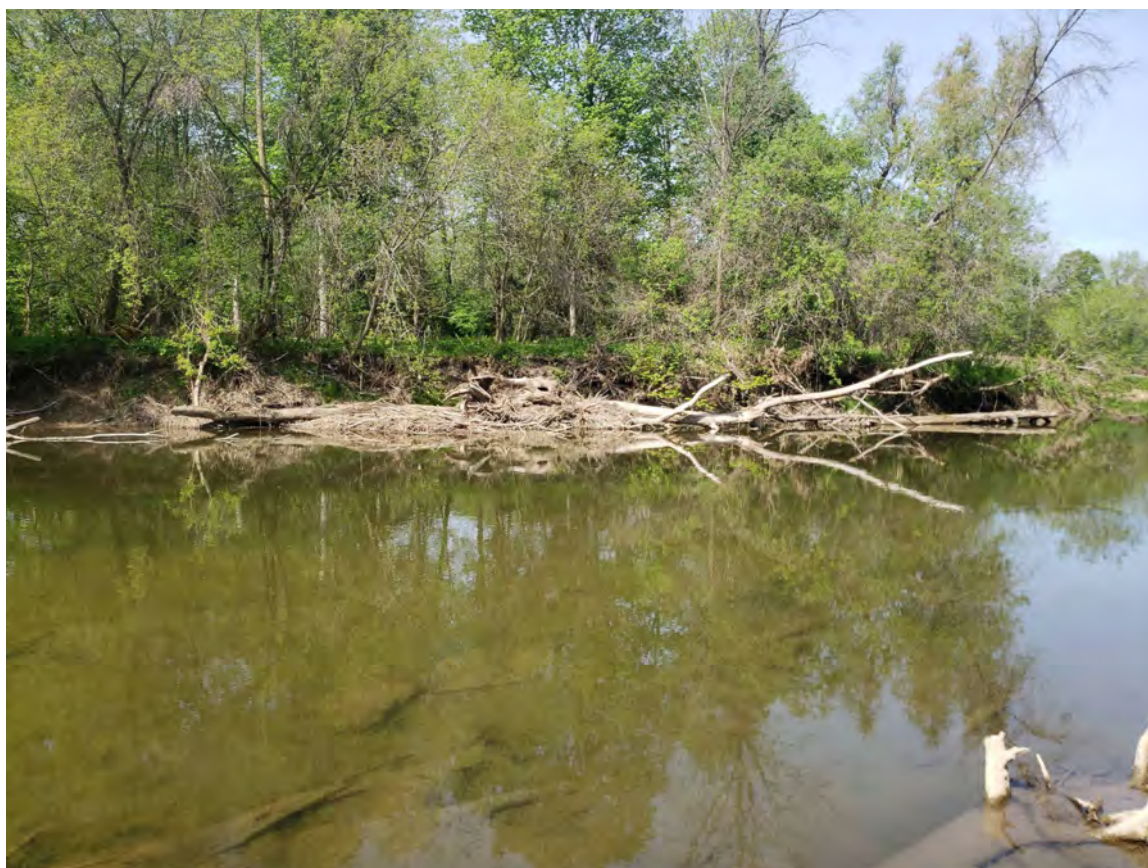
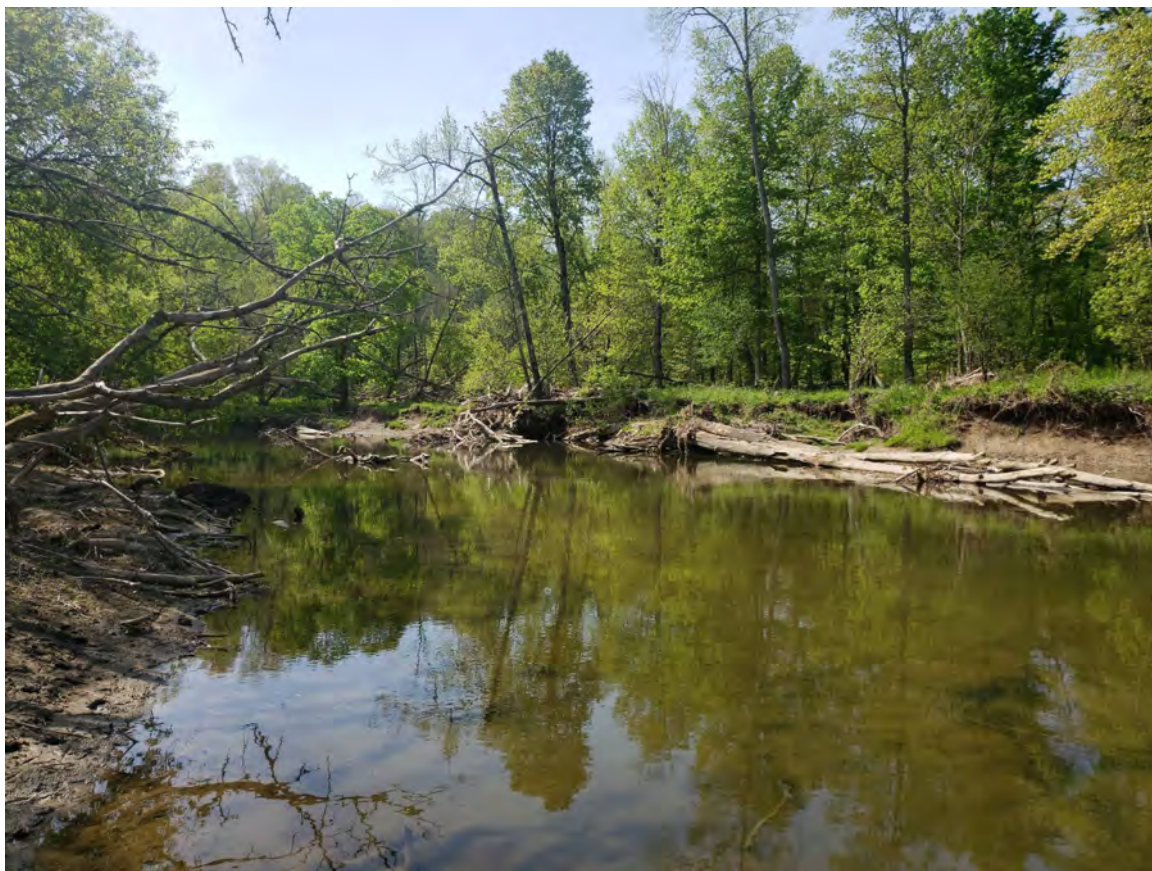
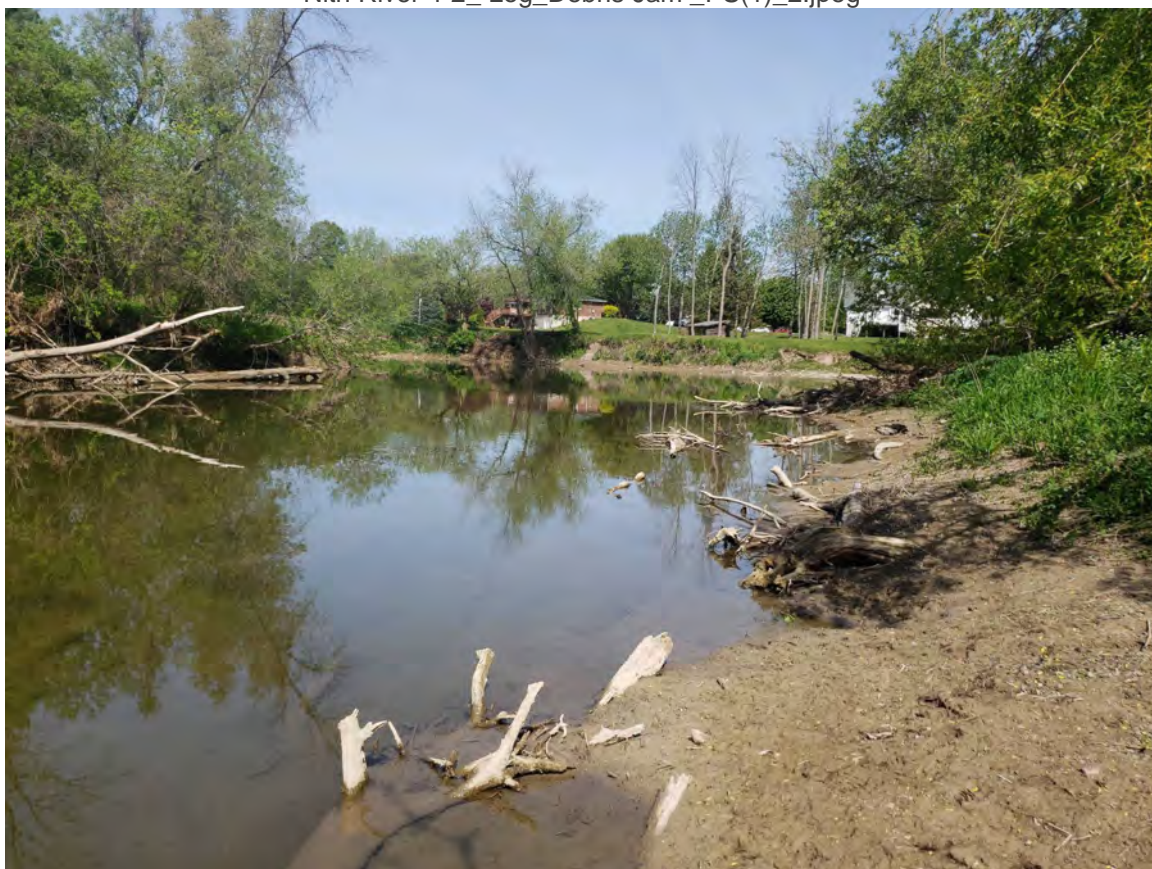
Nith River 4-2

Significant build up on both banks- at certain parts, logs jam up ~1/4 of river

width.

EROSION TYPE(S)	SEVERITY	N	E	Z	PTID
Log/Debris Jam	2- Moderate	4792027.81	544398.57	278.557	40

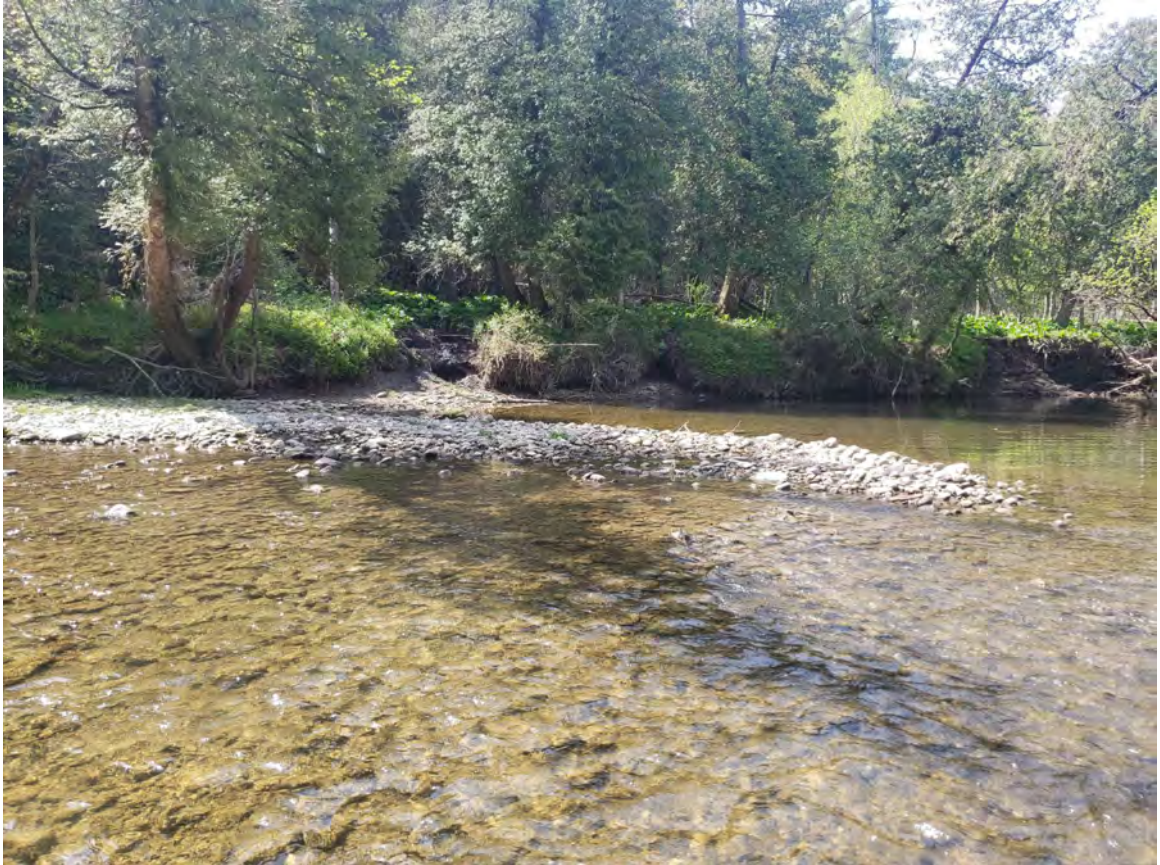
Nith River 4-2_Bank Undercutting_PS(2)_1.jpeg

undercutting occurs on the south side of the river. river very shallow at this area, ~1/2 foot at deepest.

EROSION TYPE(S)	SEVERITY	N	E	Z	PTID
Bank Undercutting	3 - Major	4791987.41	544502.61	278.359	41

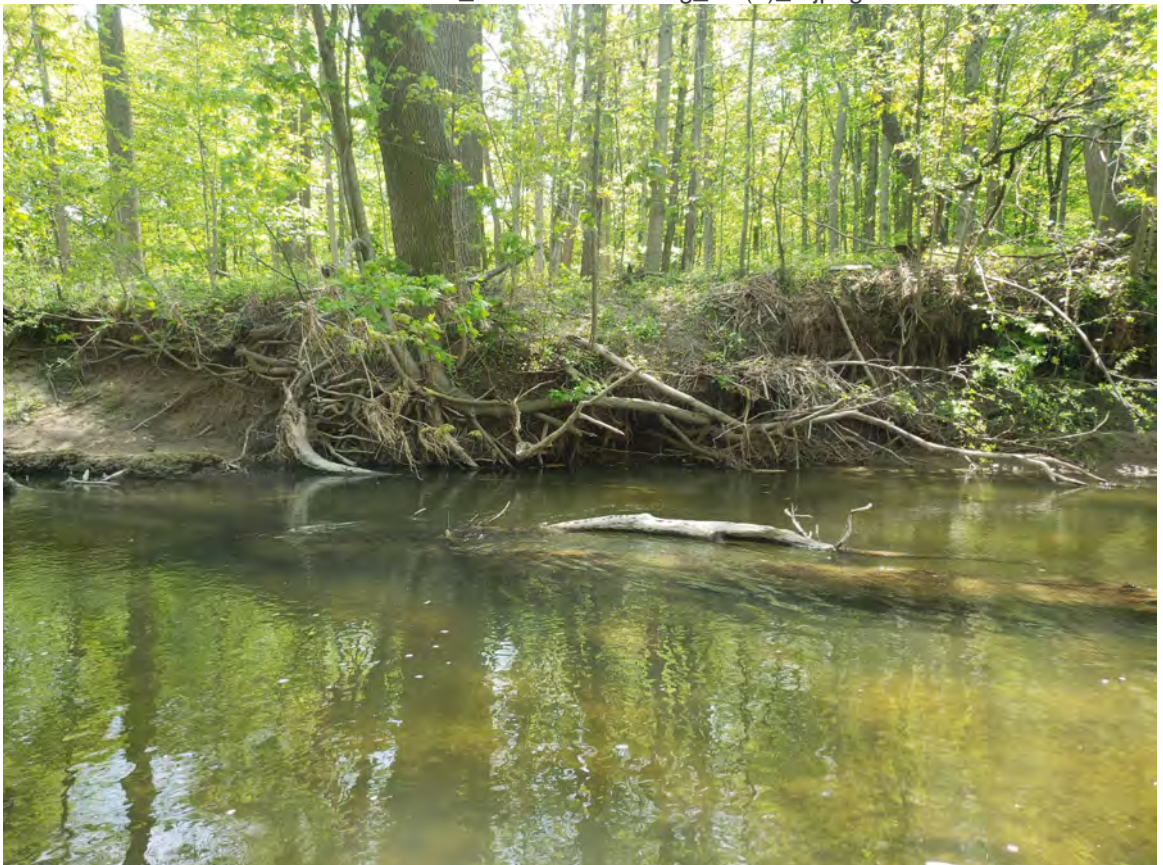
Nith River 4-2_Bank Undercutting_PS(3)_2.jpeg

bank undercutting occurs on both sides of the bank. Northside is connected to homeowner's backyard.

EROSION TYPE(S)	SEVERITY	N	E	Z	PTID
Bank Undercutting	3-Major	4792144.96	544430.19	277.642	42

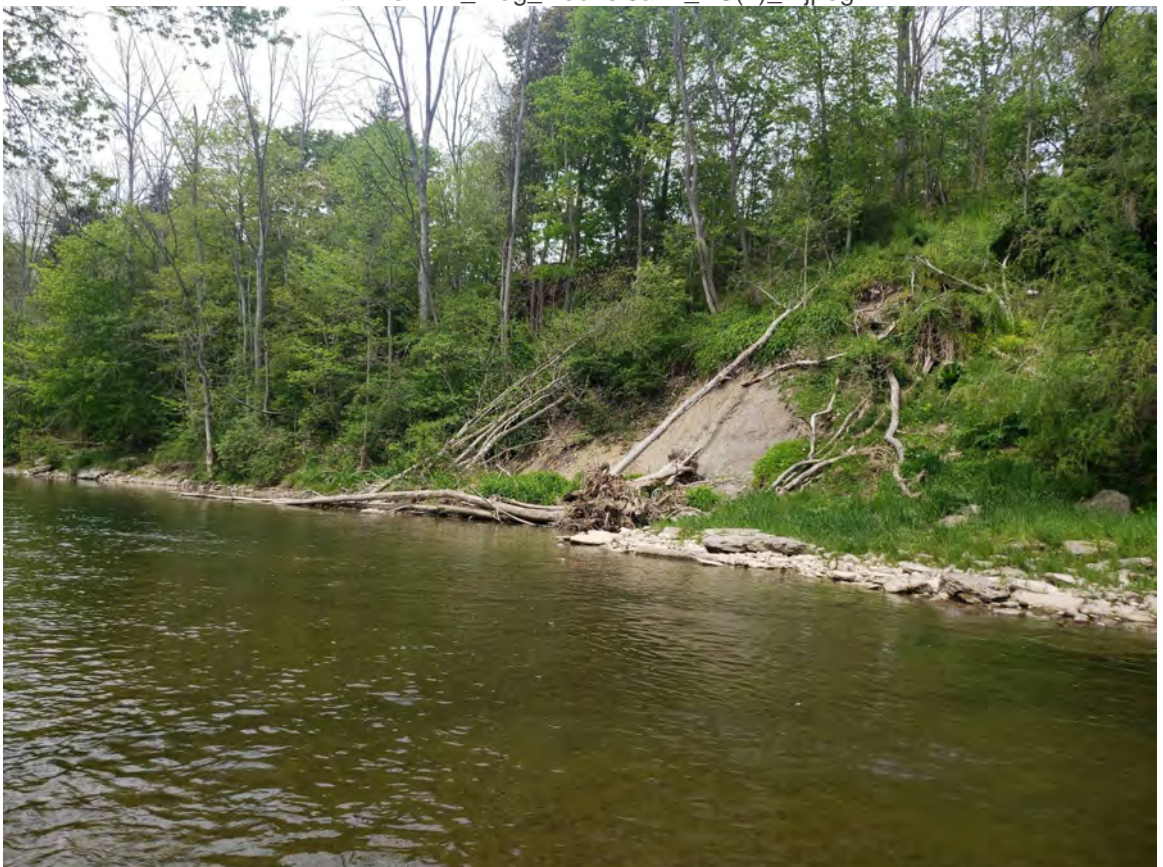
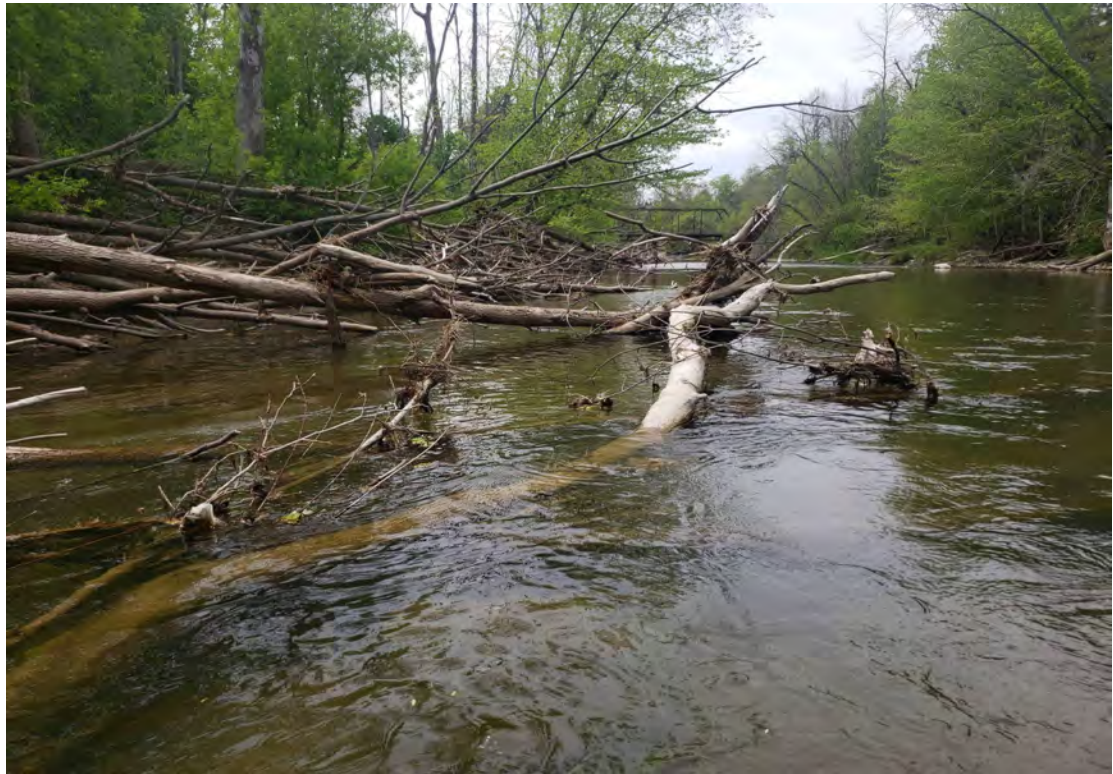
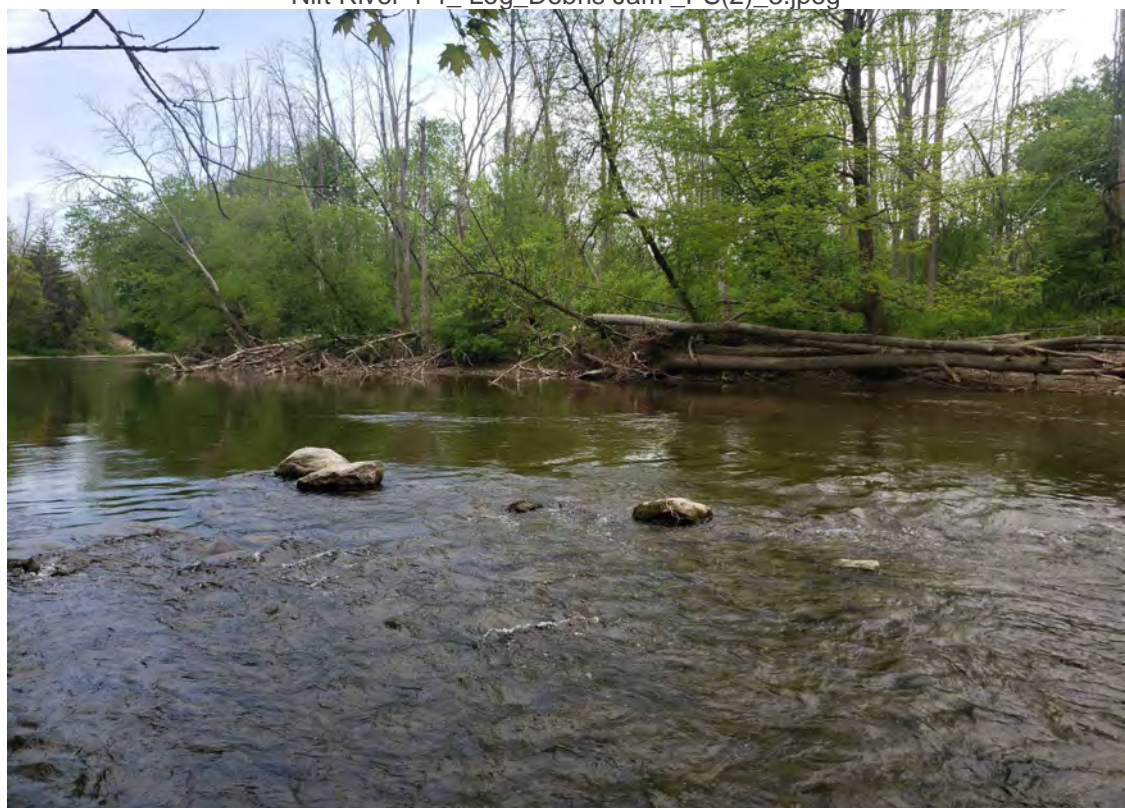
log debris take up approximately 1/3 of the width of the river. Some bank undercutting /active bank erosion also beginning in this location with signs of bank instability.

EROSION TYPE(S)	SEVERITY	N	E	Z	PTID
Log/Debris Jam	3- Major	4792449.49557	543808.213585		49

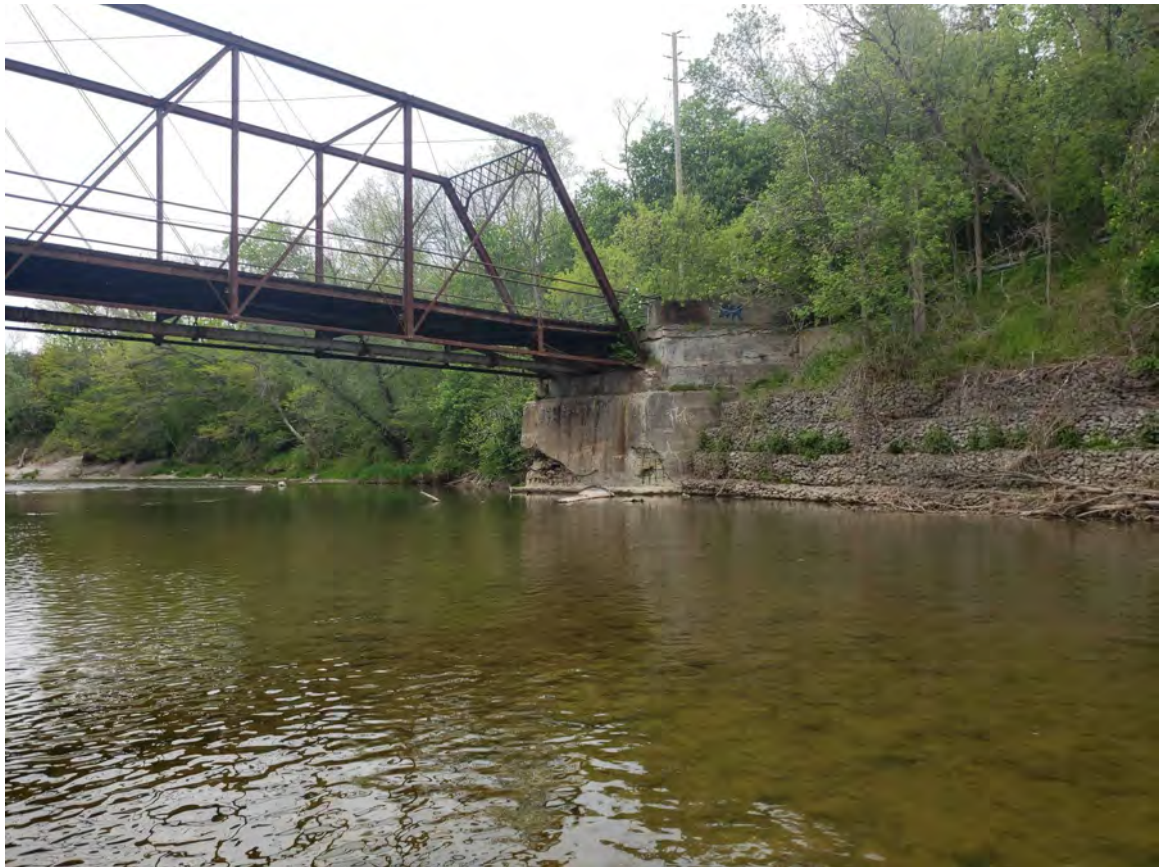
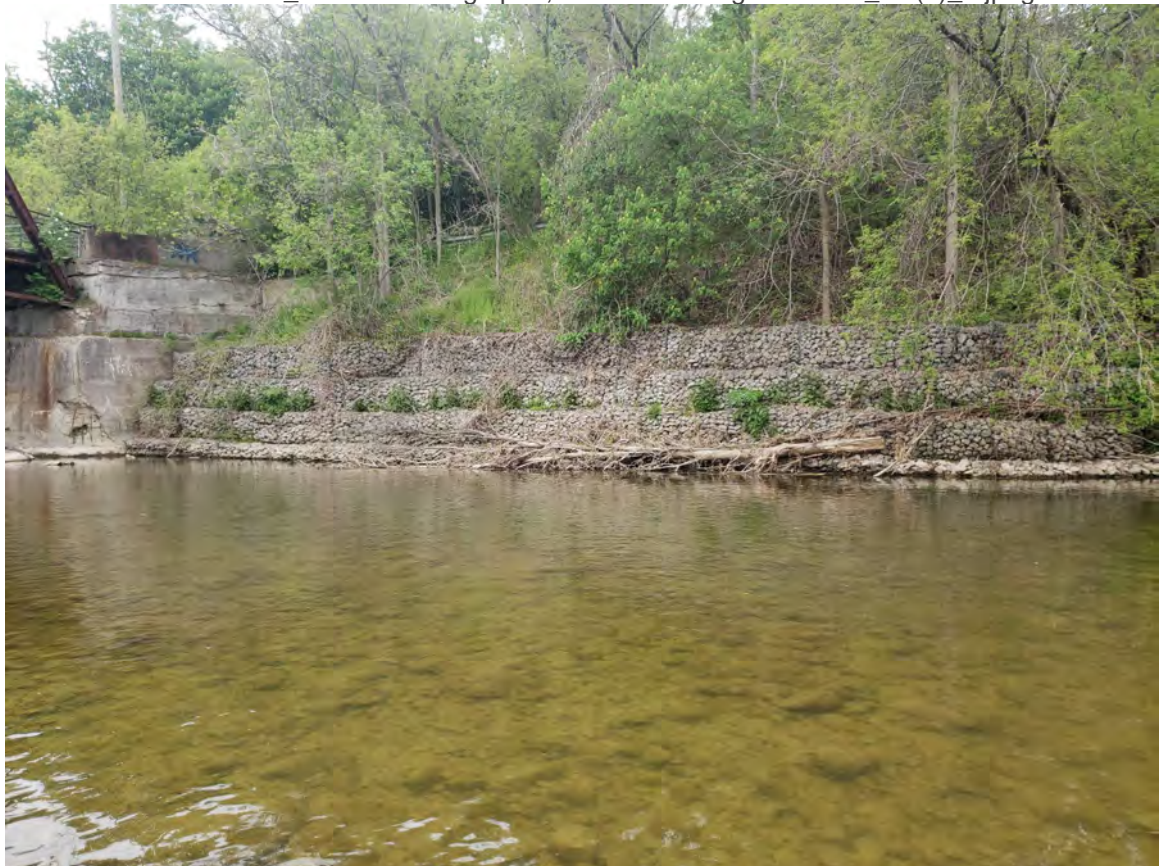
Bridge in state of disrepair – structural damage to concrete footings. Tree debris and vegetation taking root on gabion wall on south side of bridge.

EROSION TYPE(S)	SEVERITY	N	E	Z	PTID
Structural damage - bridge	4- Safety Hazard	4792503.58827	543594.352237		50

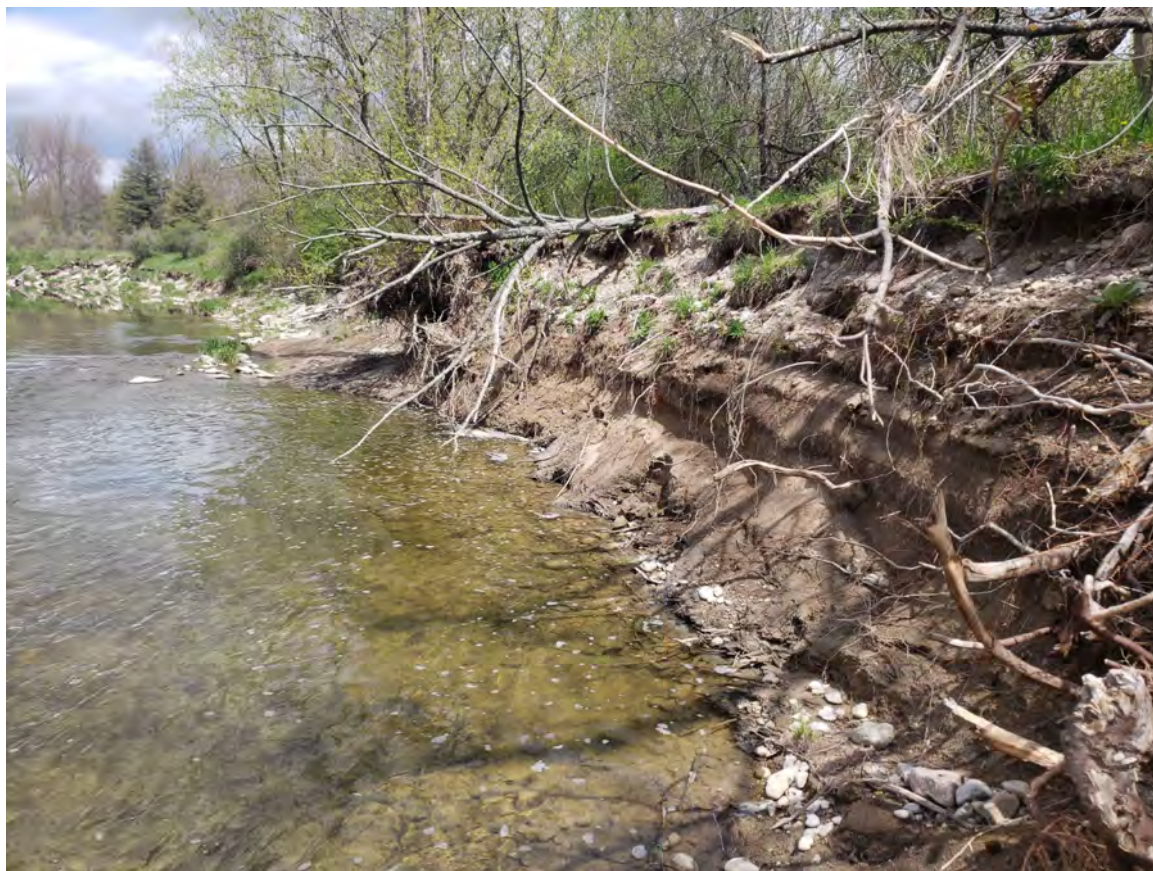
Ayr Section 1-2_Bank Undercutting_PS(1)_1.jpeg

EROSION TYPE(S)	SEVERITY	N	E	Z	PTID
Bank Undercutting	4- Safety Hazard	4793696.07	543169.09	284.412	1

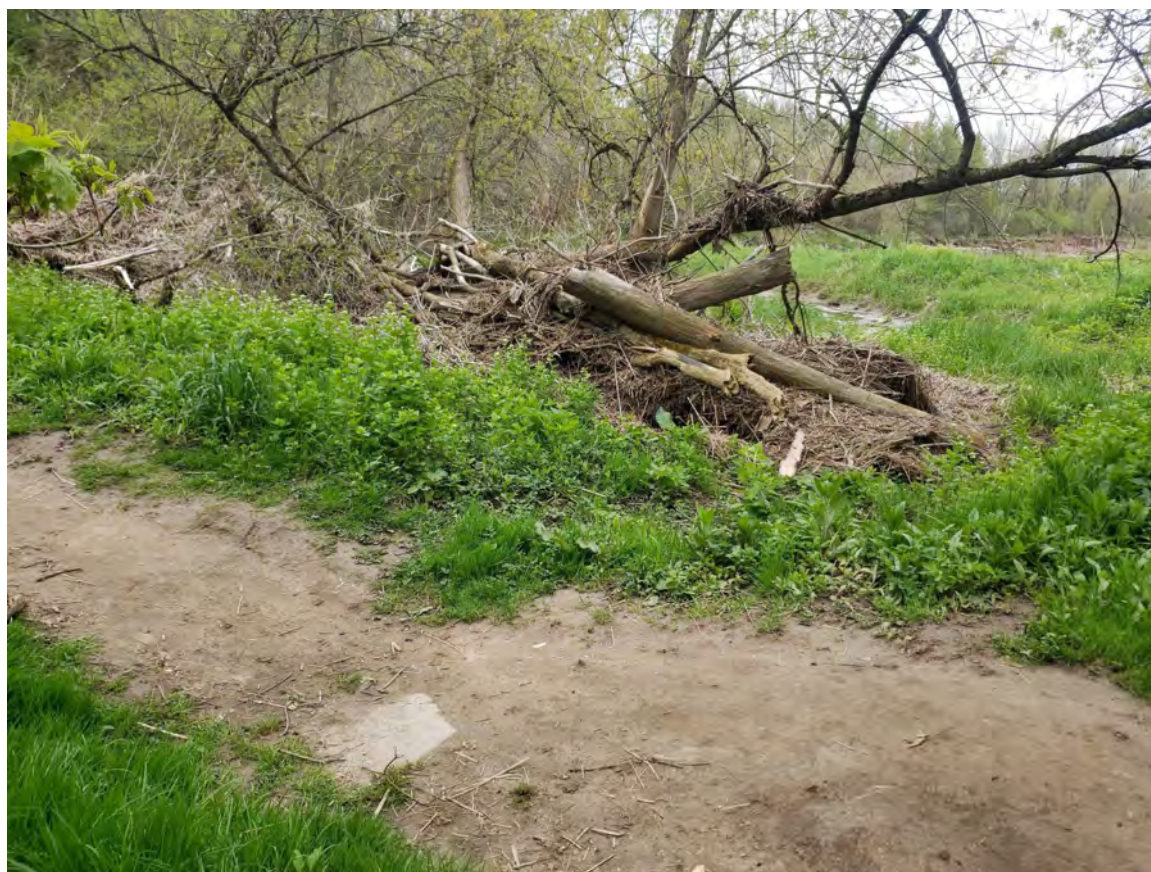
Ayr Section 1-1_Bank Scour_PS(1)_1.jpeg

Additional information Erosion found on south bank of river. Minor log debris fallen into main channel from bank.

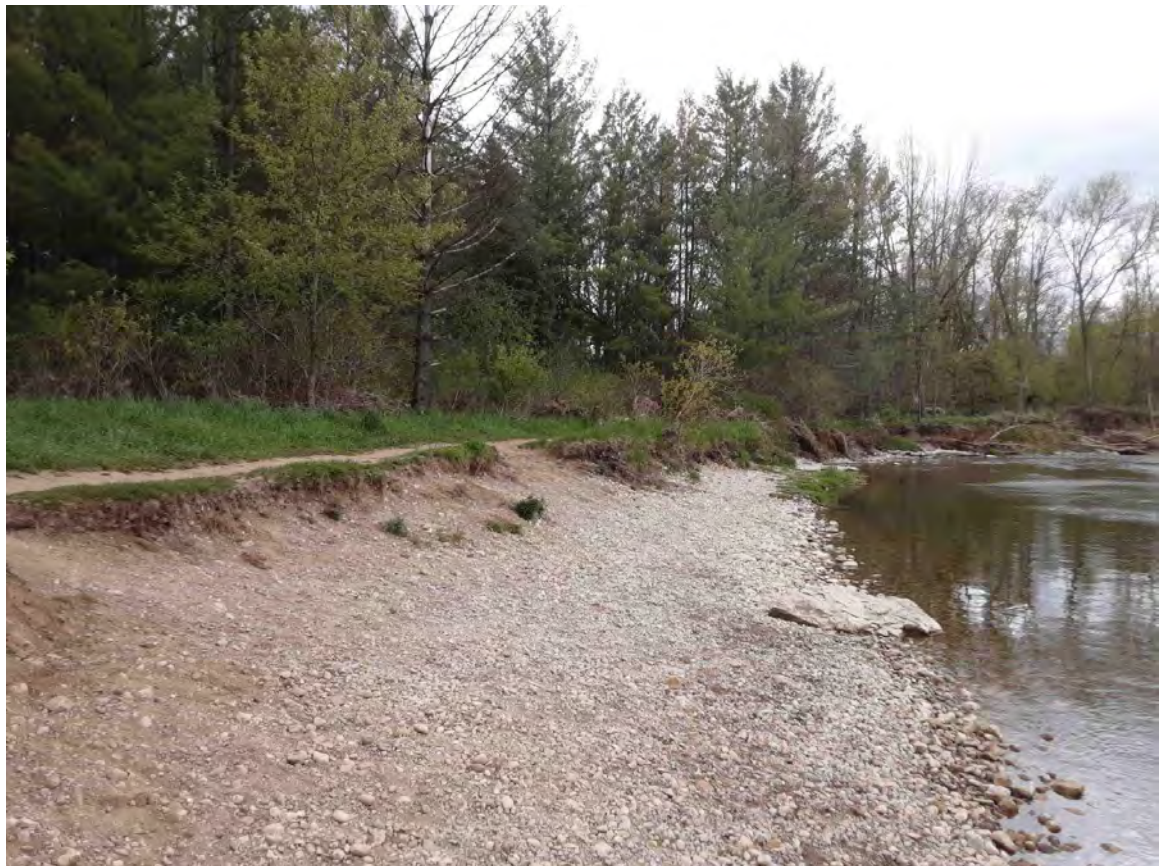
Nith River Section 2-1_Bank Undercutting_PS(1)_1.jpeg

Some erosion near and affecting some parts of established pedestrian trail during period of high flow / water level. Unstable ground could be potential safety hazard for trail users.

EROSION TYPE(S)	SEVERITY	N	E	Z	PTID
Bank Undercutting	4- Safety Hazard	4793006.95	543027.41	282.01	8

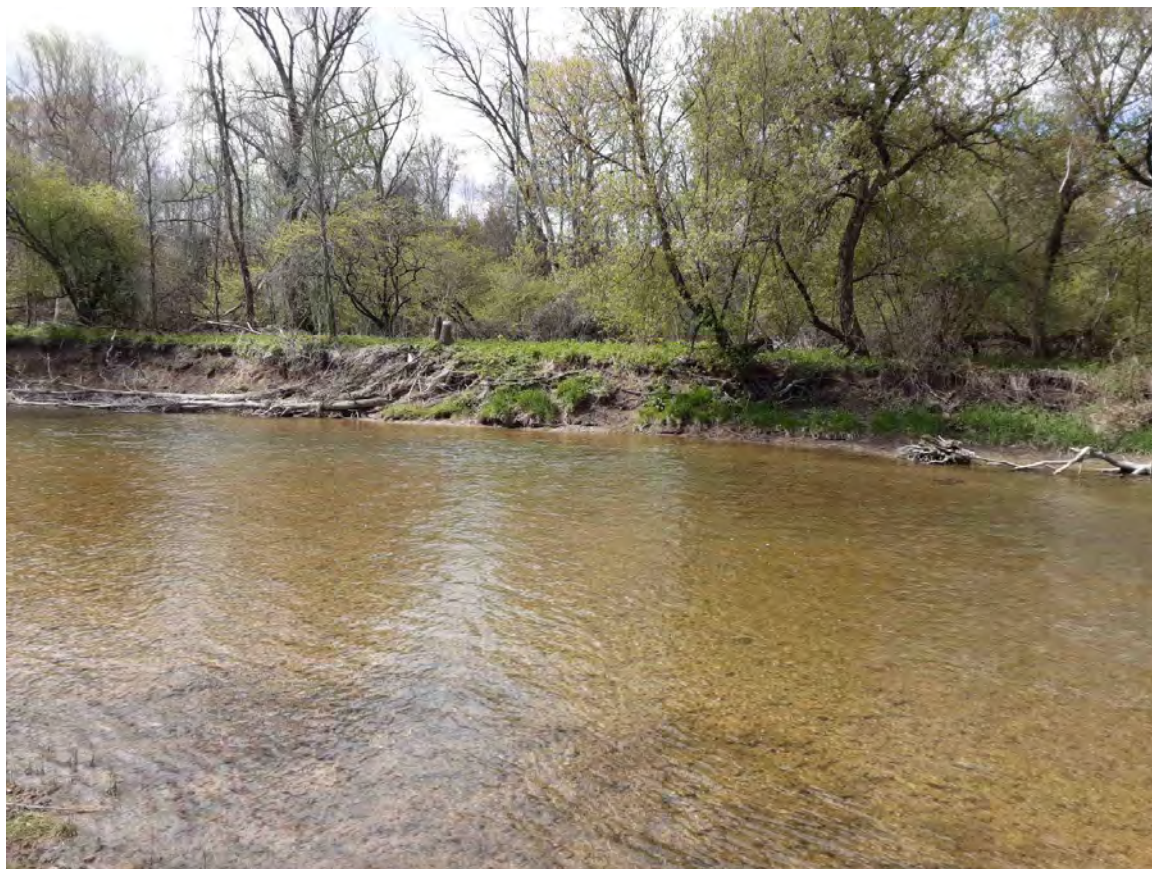
Nith River Section 2-1_Bank Undercutting_PS(3)_1.jpeg

Additional information Heavy erosion observed on south side of river eroding due to high flow volume

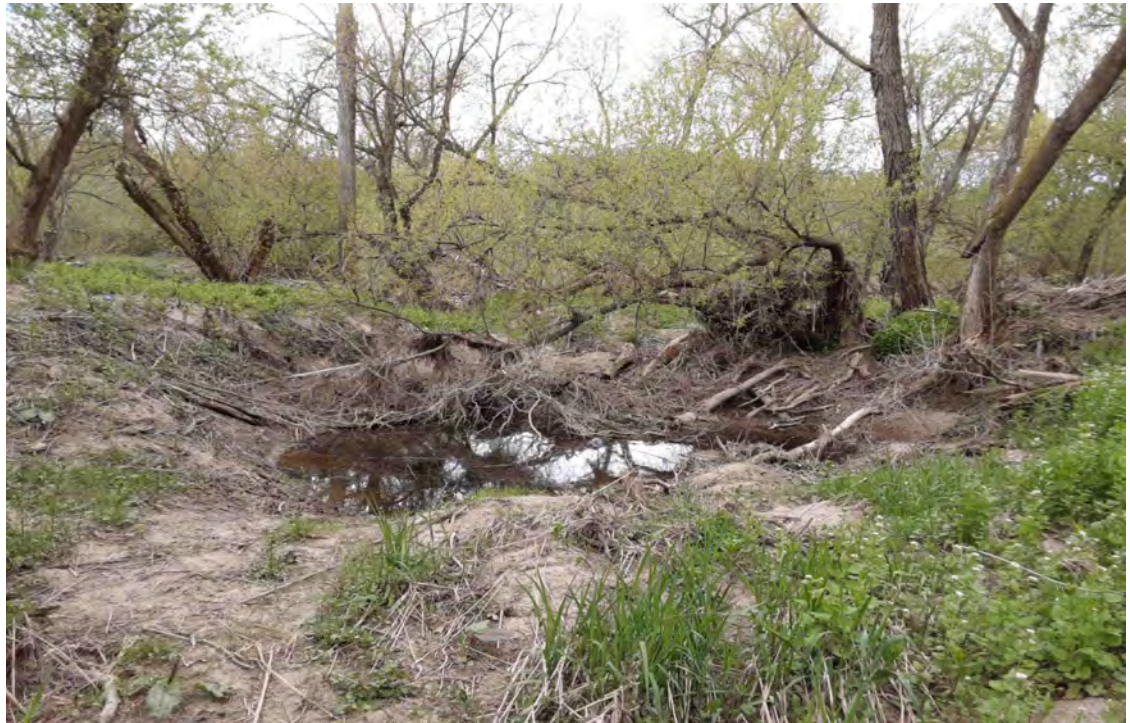
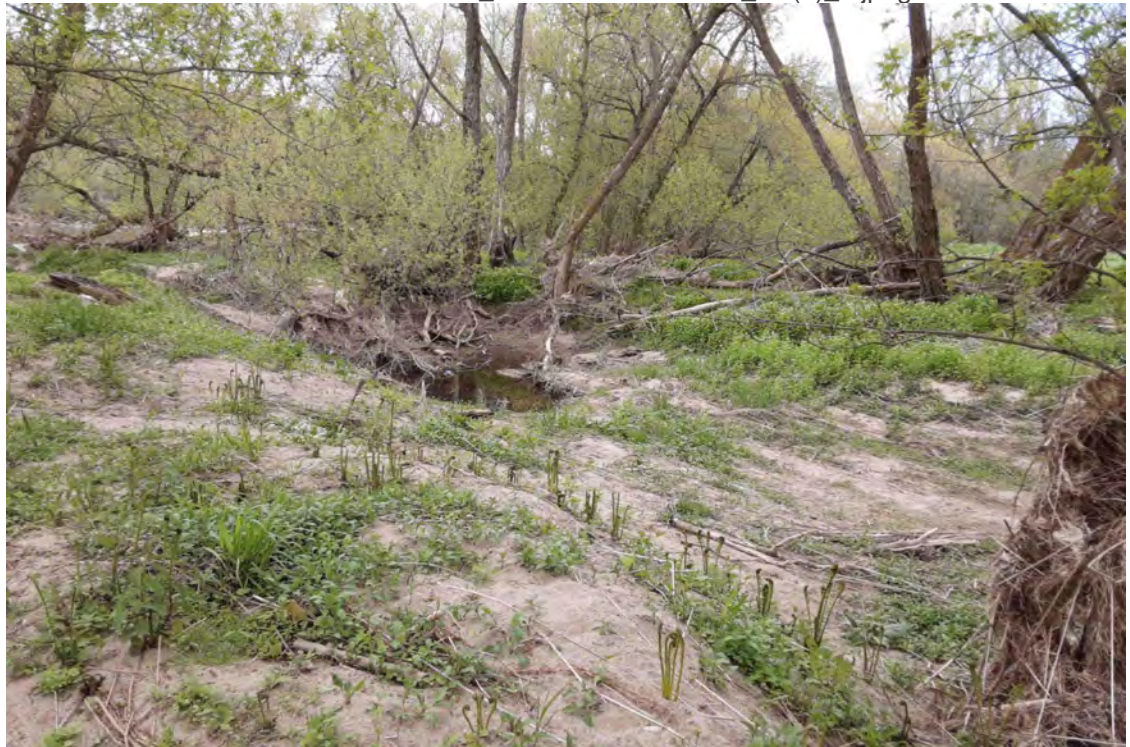
Inland lateral bank erosion and surface scouring -likely seasonal flood plain with ponding. Possible over land flow bypassing main channel during period of flooding / high flow due to meandering river.

EROSION TYPE(S)	SEVERITY	N	E	Z	PTID
Lateral Bank Erosion	2- Moderate	4792791.98	543074.92	281.5	11

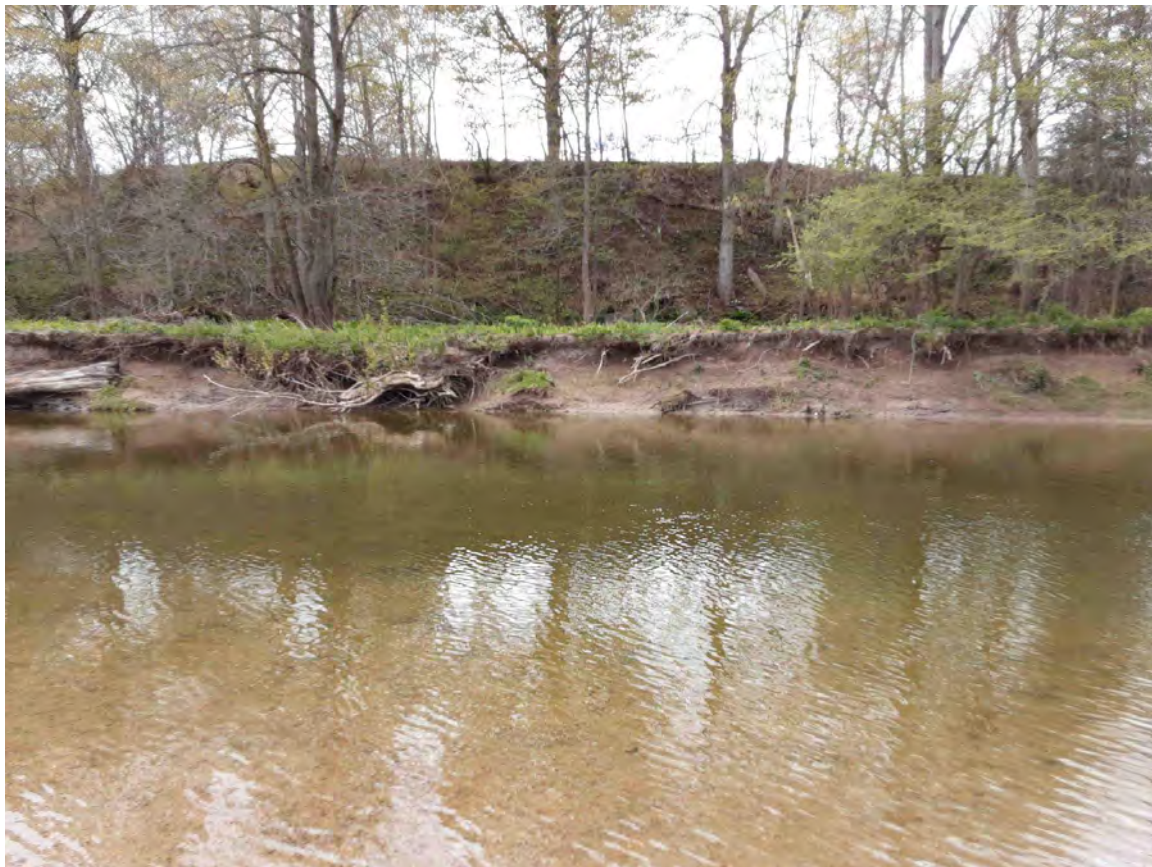
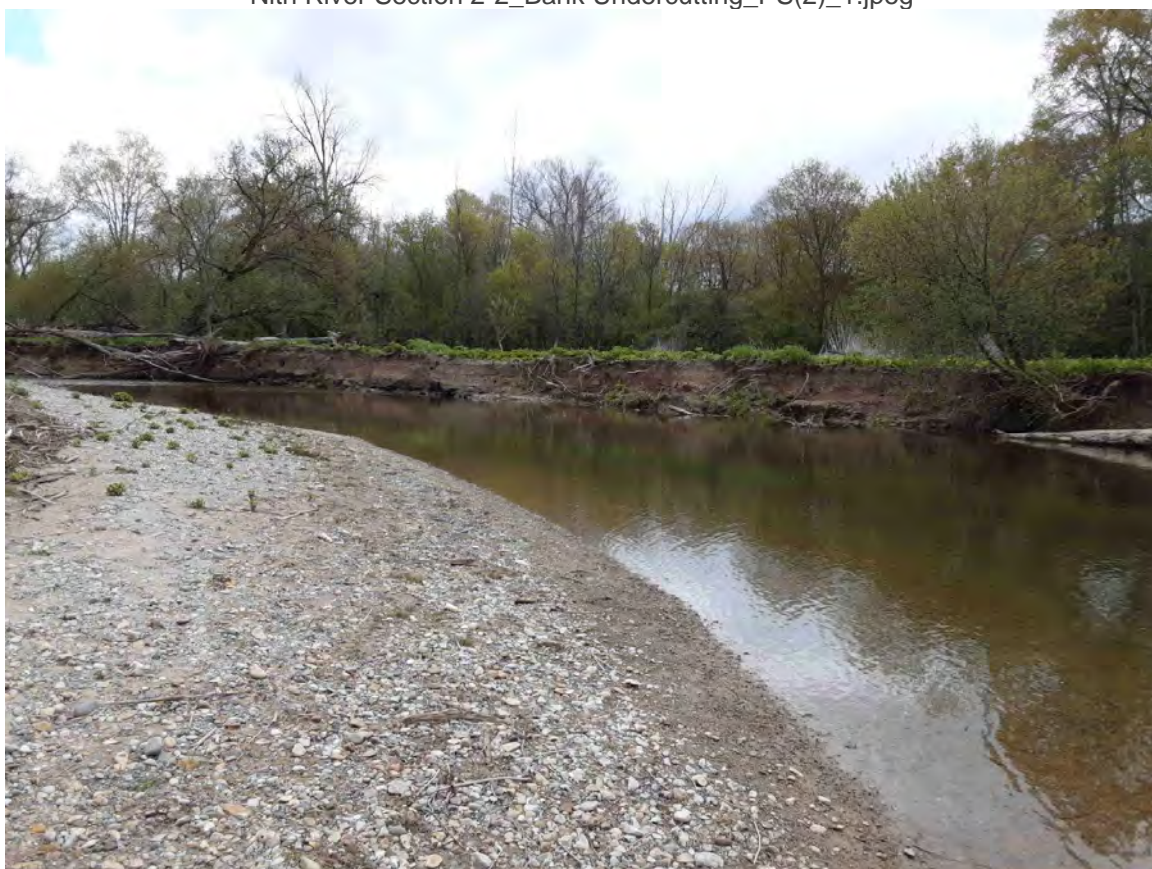
Bank undercutting due to high flow volume and velocity at tight meander. Log debris in main channel.

EROSION TYPE(S)	SEVERITY	N	E	Z	PTID
Bank Undercutting	2- Moderate	4792723.28	543137.04	279.89	12

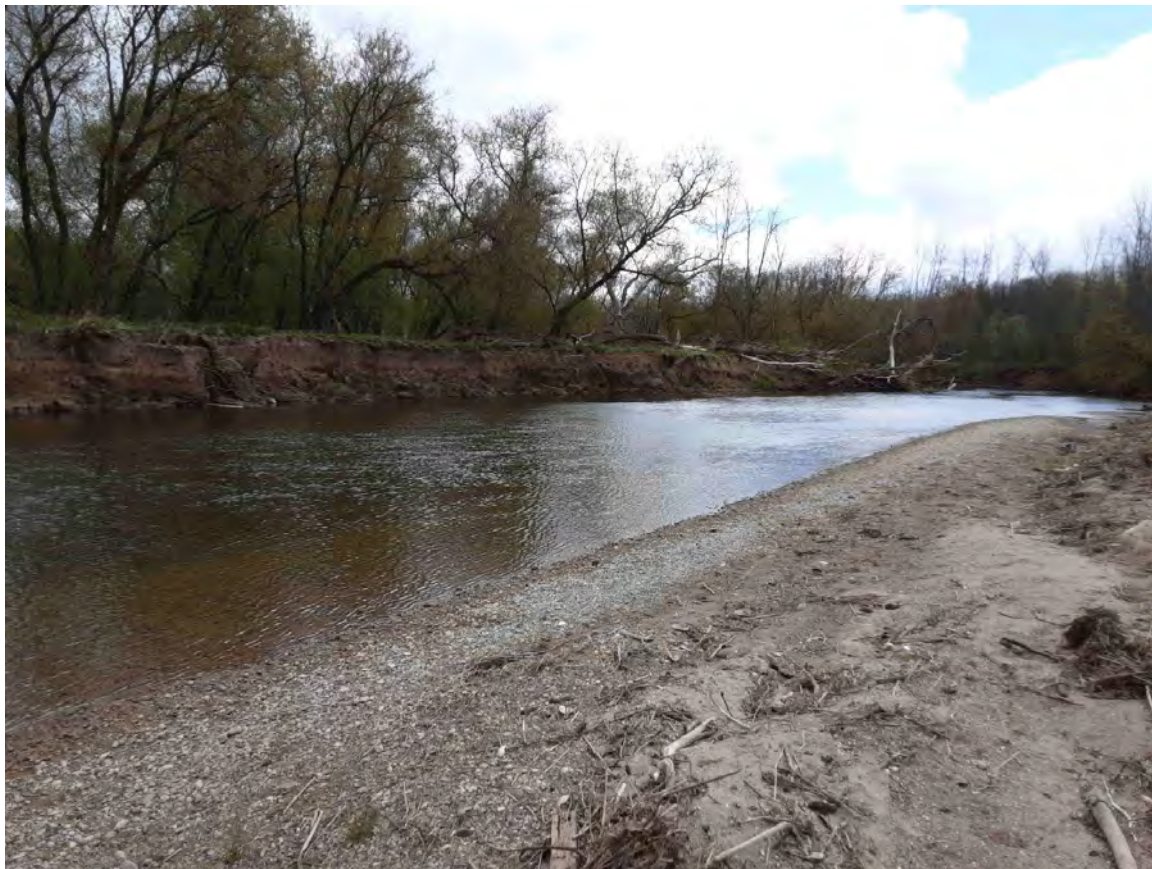
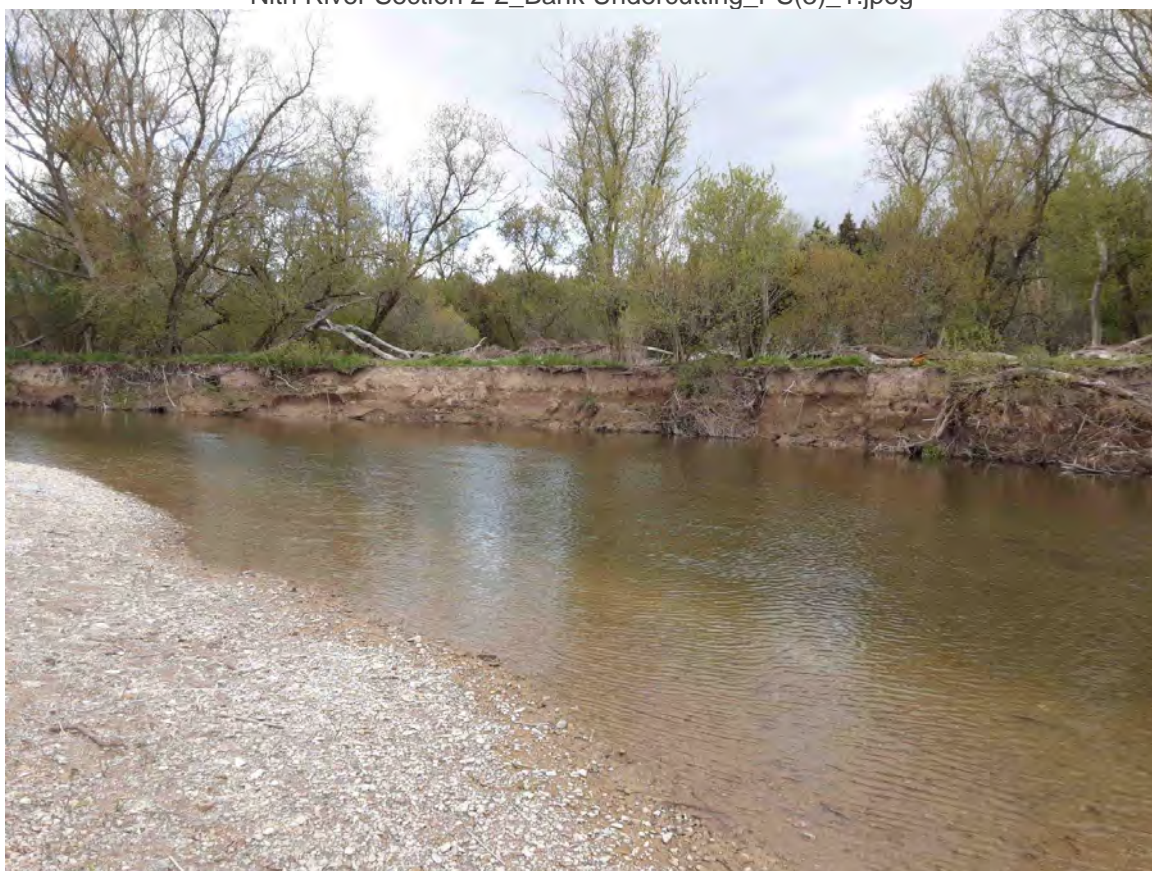
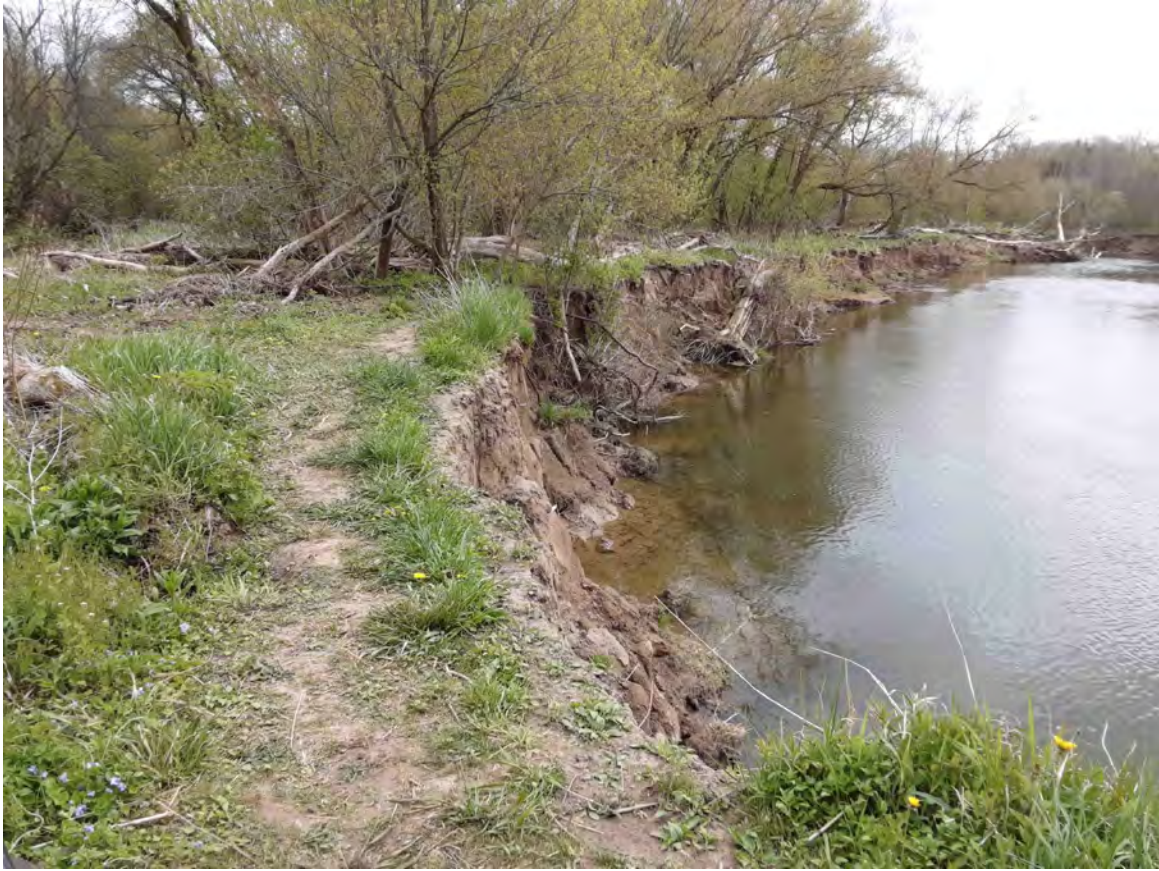
EROSION TYPE(S)	SEVERITY	N	E	Z	PTID
Bank Undercutting	4- Safety Hazard	4792838.43	543322.48	279.79	13

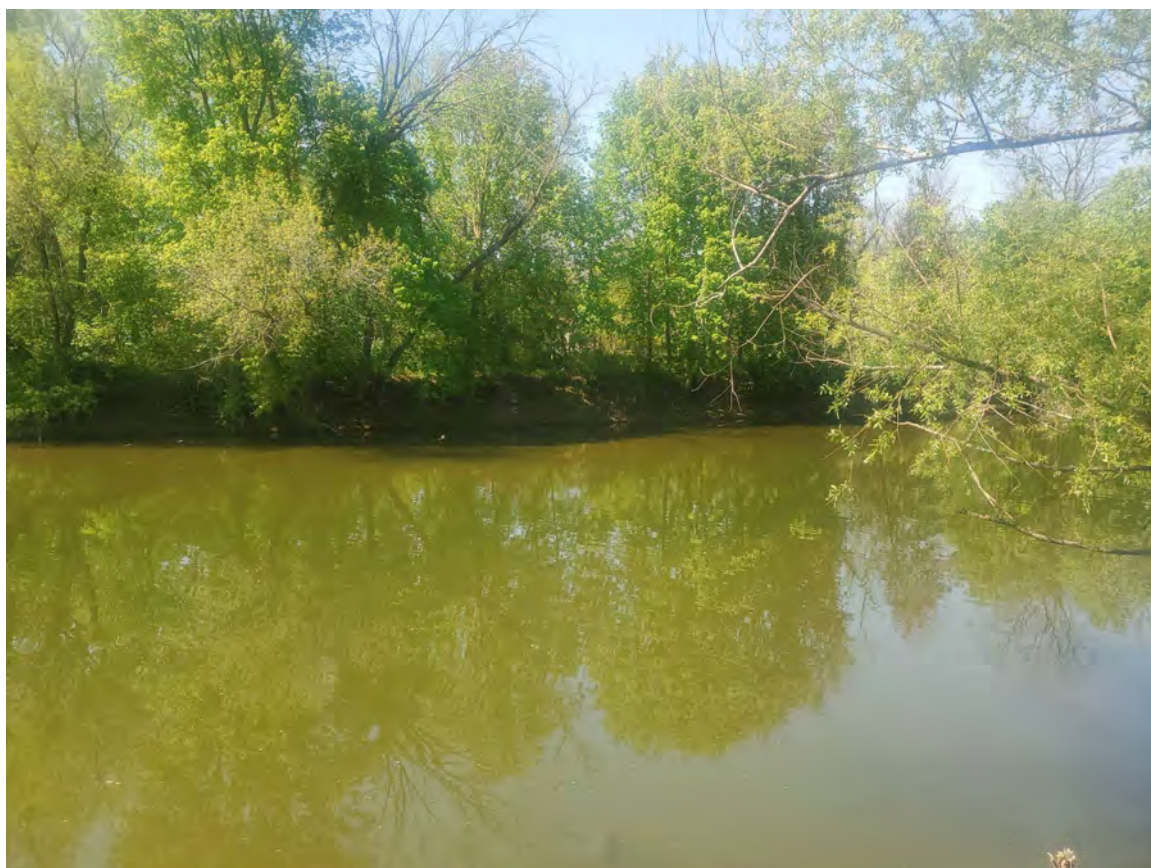
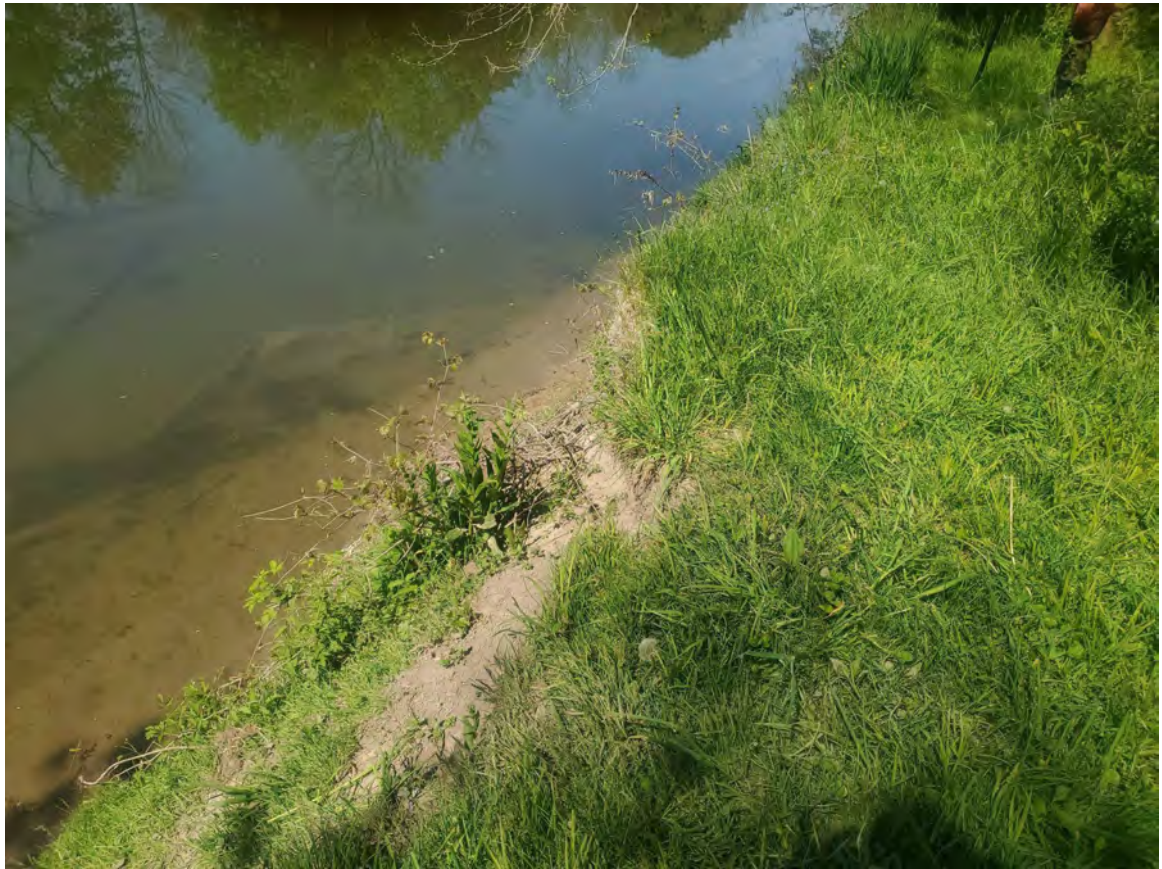
Significant bank undercutting. Loose sediment on banks erode with high flows leaving tree roots exposed. Photos taken of trees on south side of river. Man made path on north side of river is also eroding. Doesn't seem to be a public path but there is evidence of pedestrian traffic.
