APPENDIX H

Erosion Inventory and Assessment Information

Ayr, ON - Watercourse Erosion Inventory and Assessment

Watercourse Erosion Inventory and Assessment
Ayr, ON
County of North Dumfries

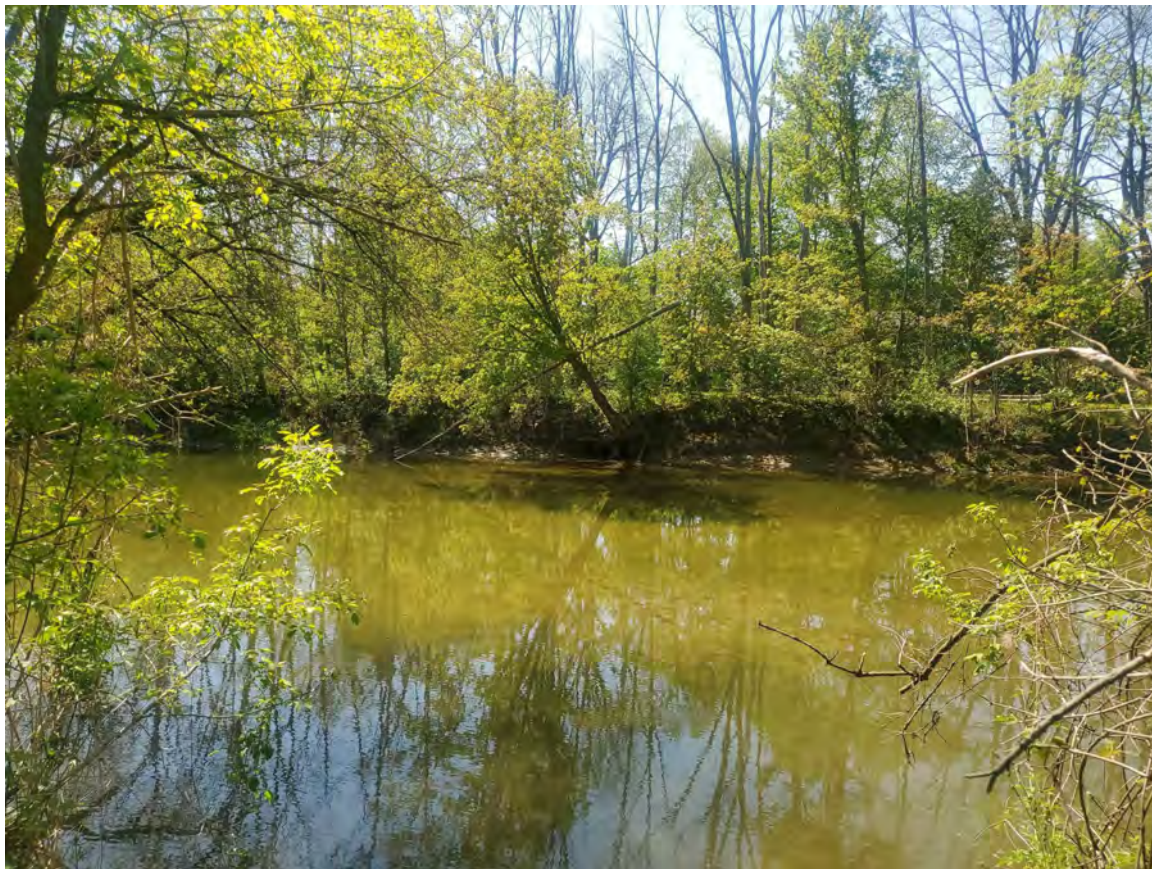
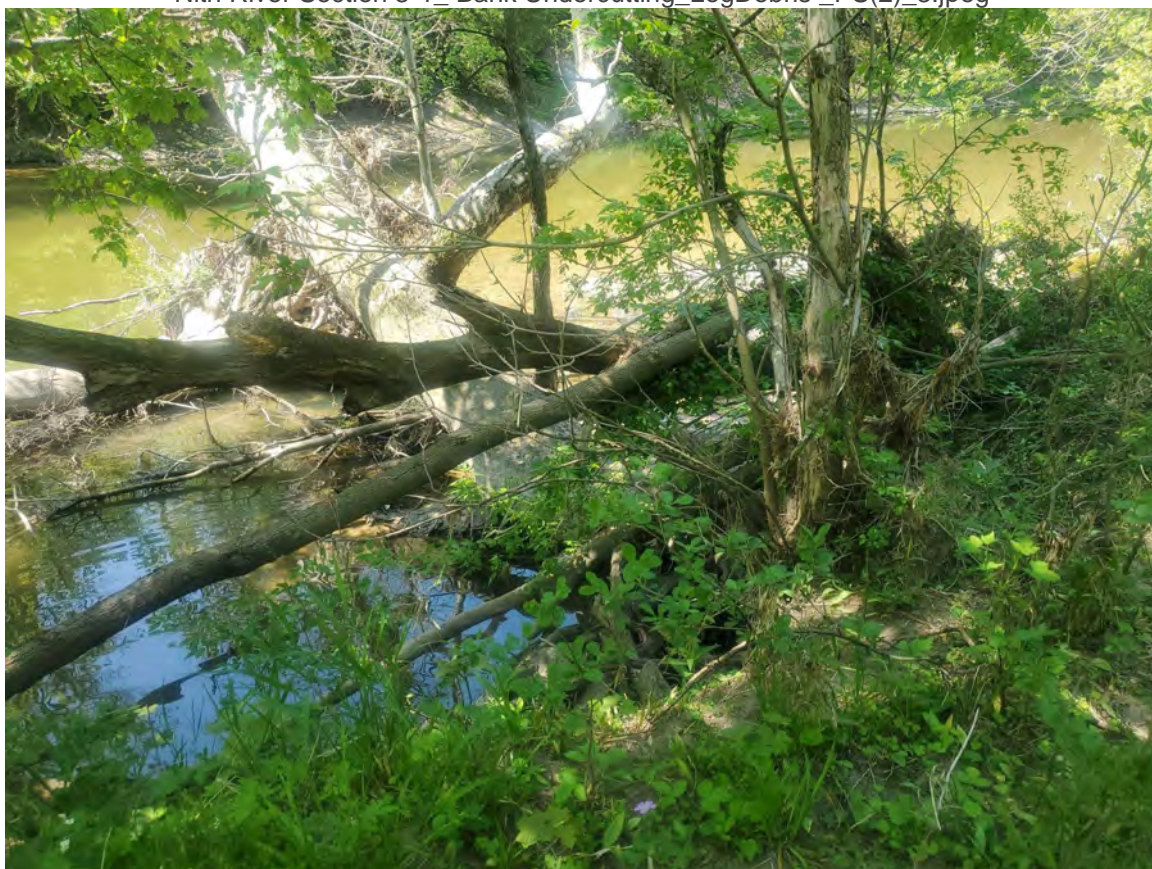
Additional information Significant bank undercutting causing tree roots to be exposed. Banks are

undercut throughout this entire section (see PTID32 to the east). North side has fallen trees that have caused some log/debris in river.

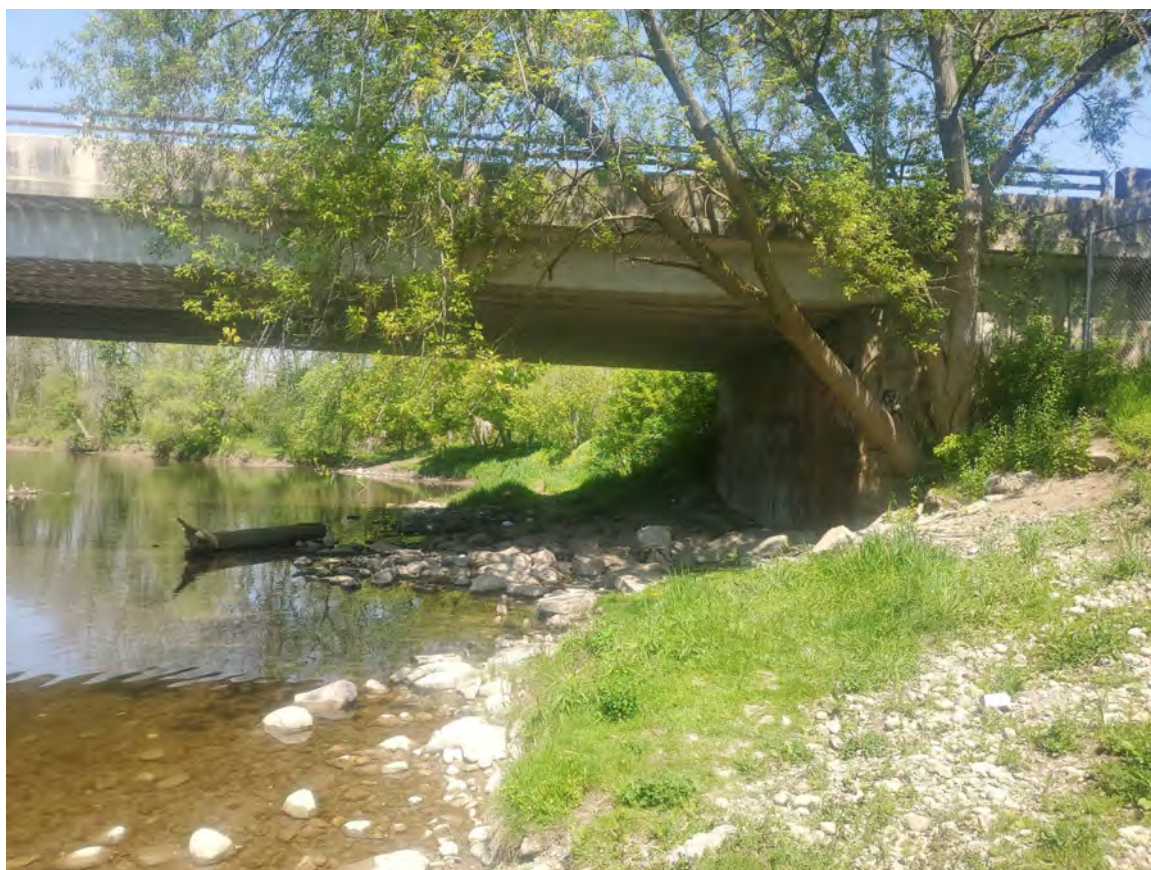
Nith River Section 3-2_Active Erosion_PS(1)_1.jpeg

Stones moved out of place likely due to high flows. Tree trunk debris under bridge. Tree growing out of the side of the bridge is growing close to power lines on bridge.

EROSION TYPE(S)	SEVERITY	N	E	Z	PTID
Active Erosion	1- Minor	4792607.17	544489.25	279.88	34

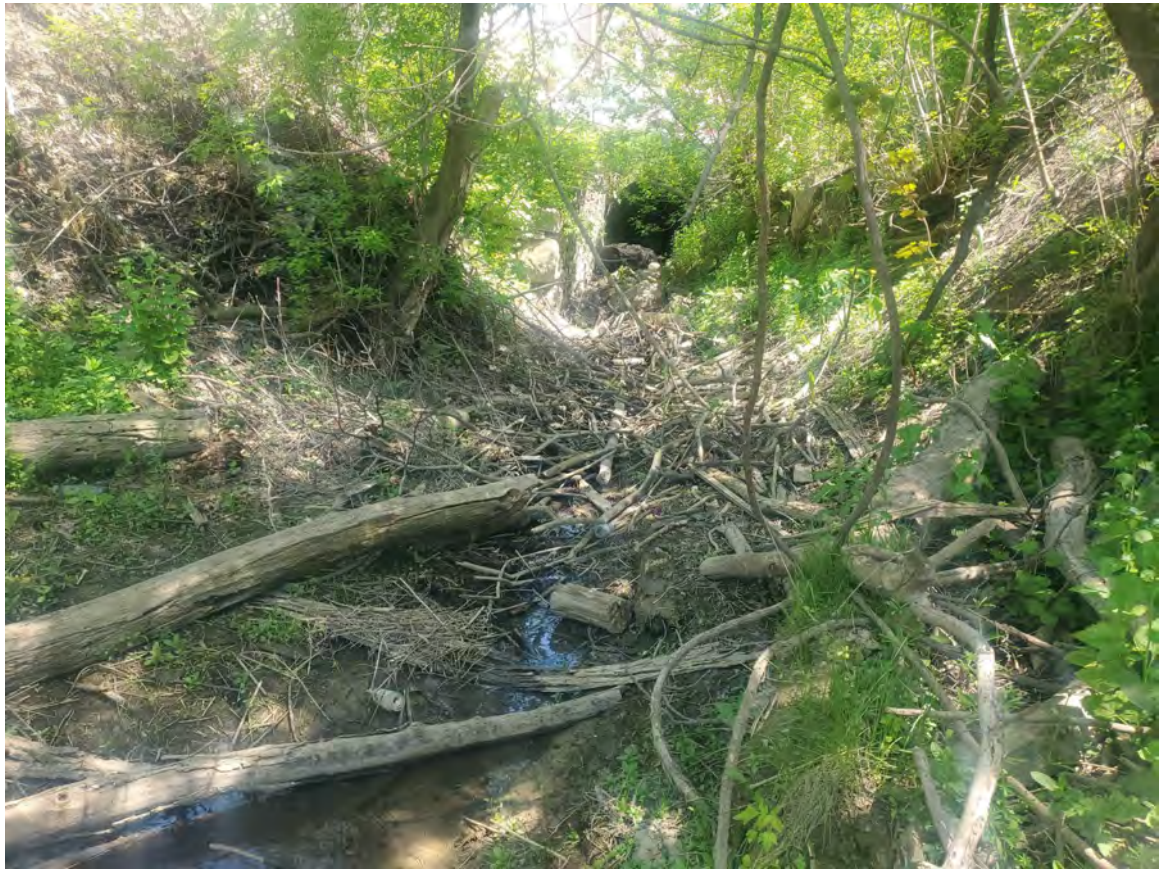
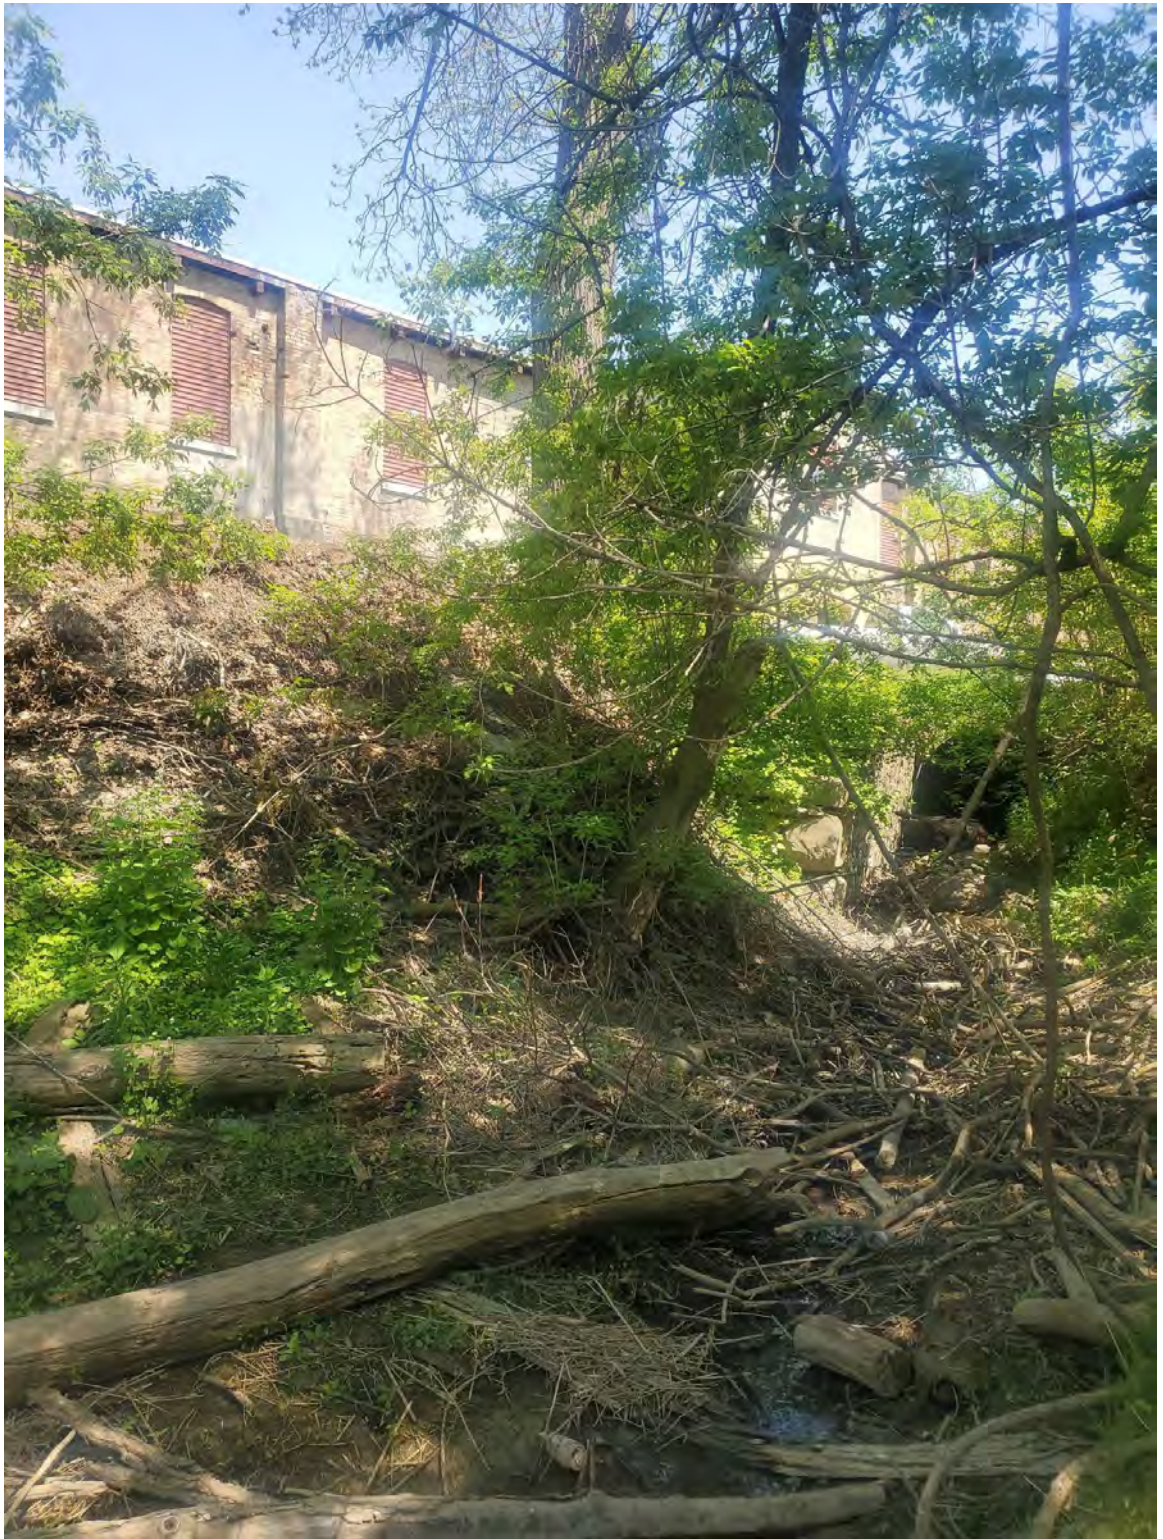
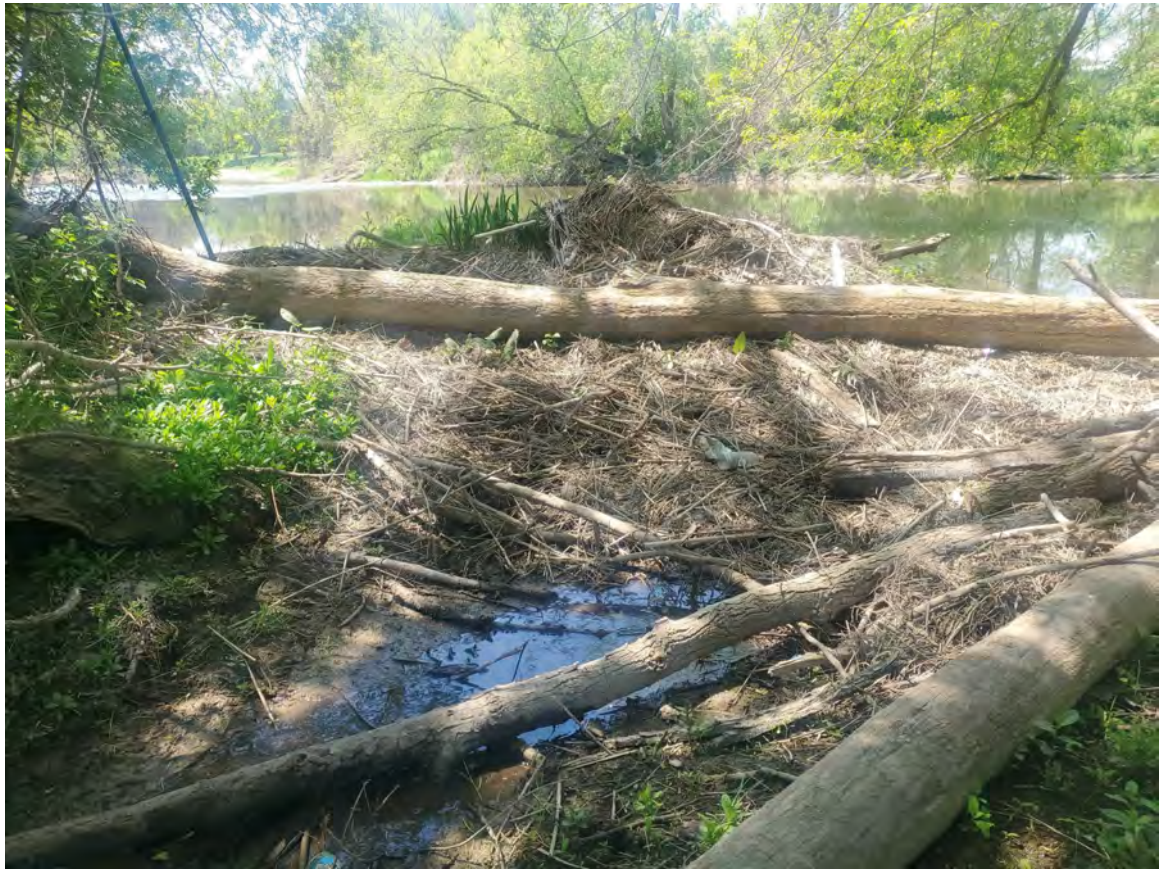
Some debris from banks falling in blocking culvert. Area is adjacent to a parking lot.

EROSION TYPE(S)	SEVERITY	N	E	Z	PTID
Log/Debris Jam	1- Minor	4792582.76	544513.98	279.54	35

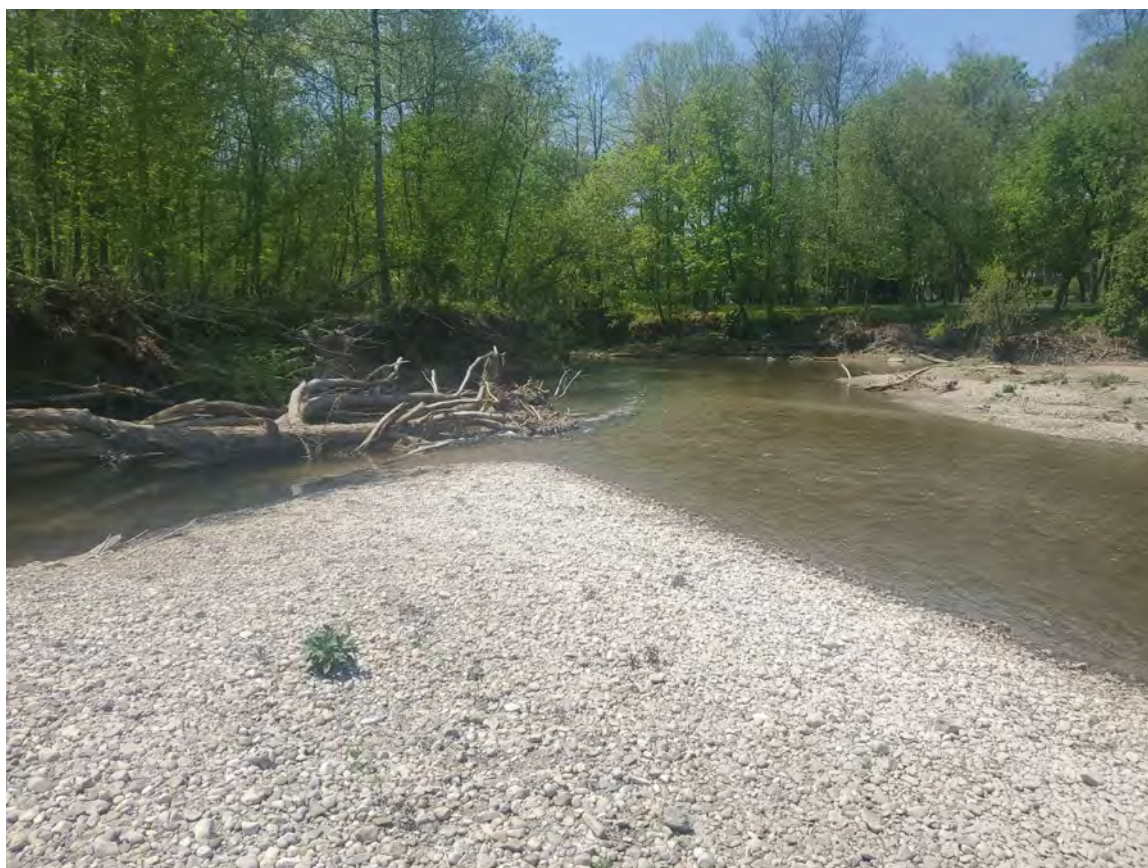
Nith River Section 4-1_Bank Undercutting and Log Jam _PS(1)_1.jpeg

High spring flows cause flooding of backyards at properties on Colonial Dr. High flows cause undercutting of bank and have created additional flow paths at meander. Significant flows caused trees to fall into river. Island (where tree debris found) may contribute to river backup into residential backyards.

EROSION TYPE(S)	SEVERITY	N	E	Z	PTID
Bank Undercutting and Log Jam	4- Safety Hazard	4792178.58	544501.53	278.9	37

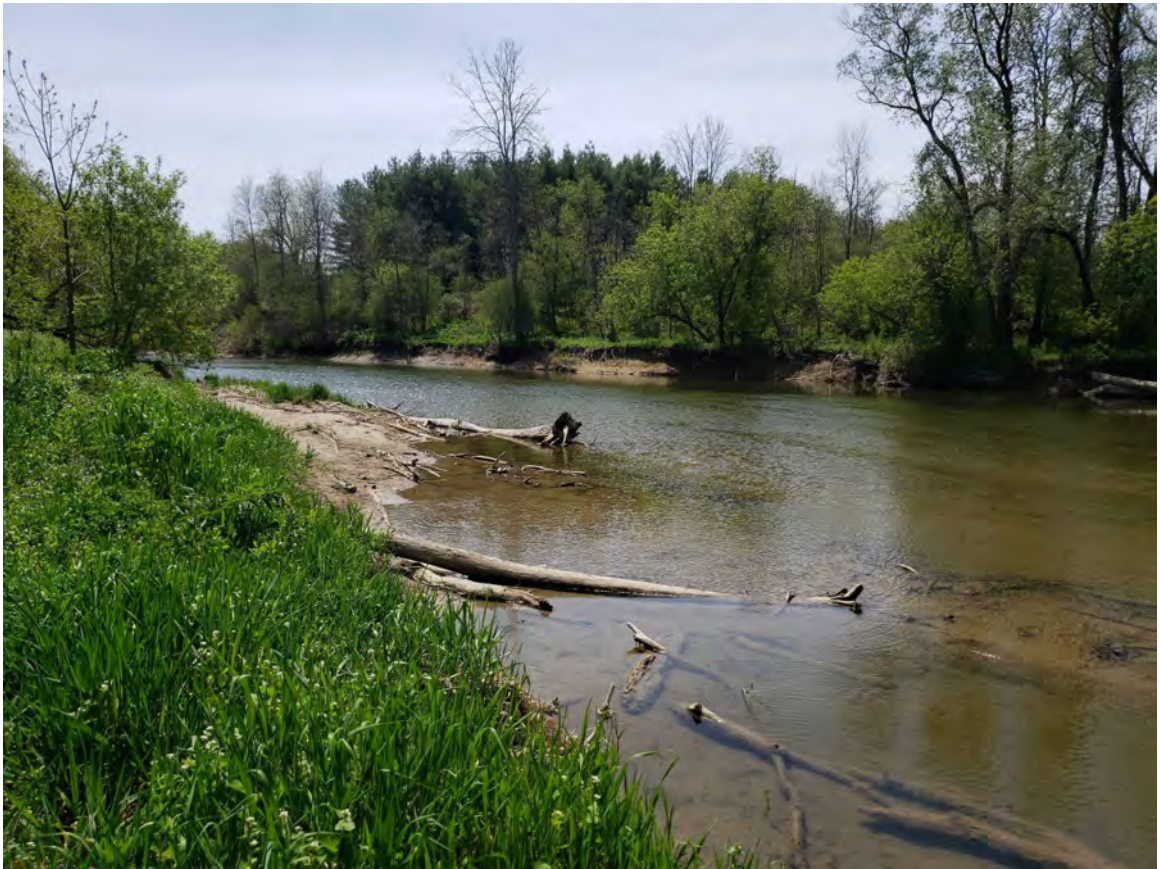
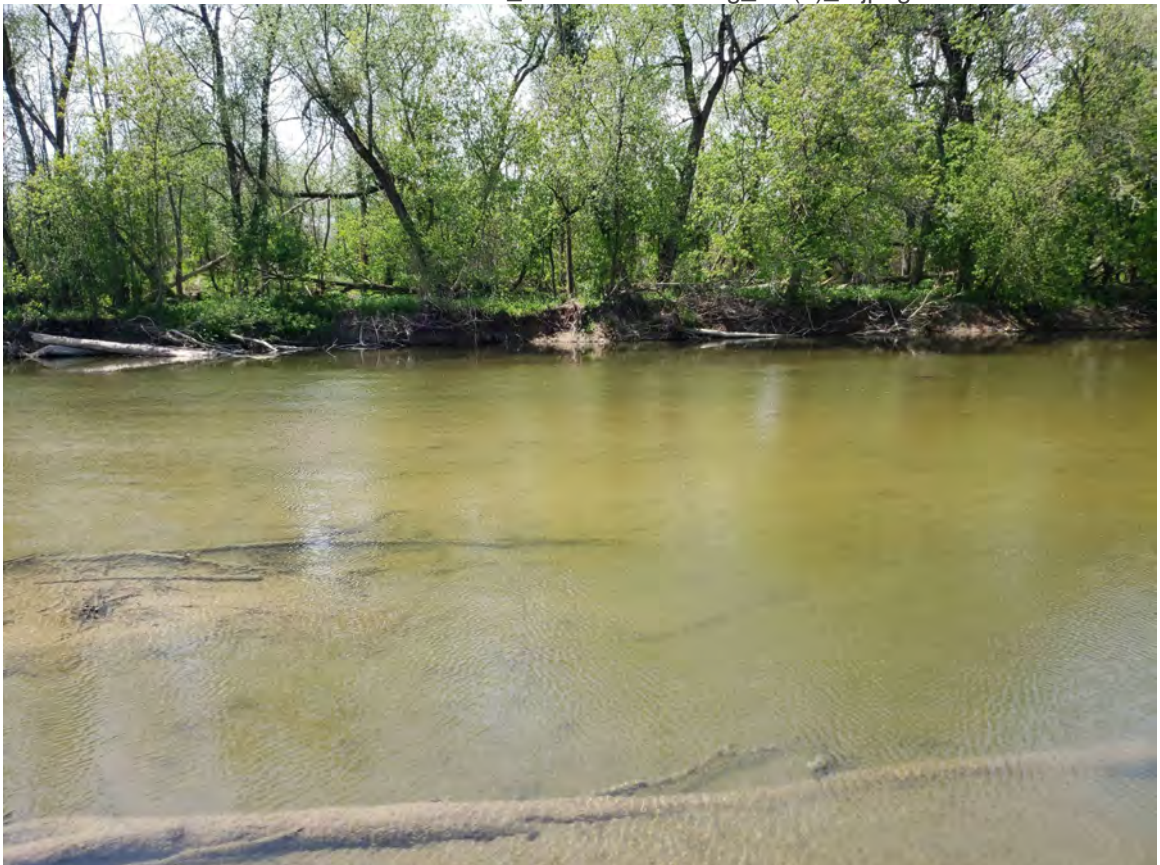
bank undercutting on opposite side of river.

EROSION TYPE(S)	SEVERITY	N	E	Z	PTID
Bank Undercutting	2- Moderate	4792077.75	543984.57	278.794	45

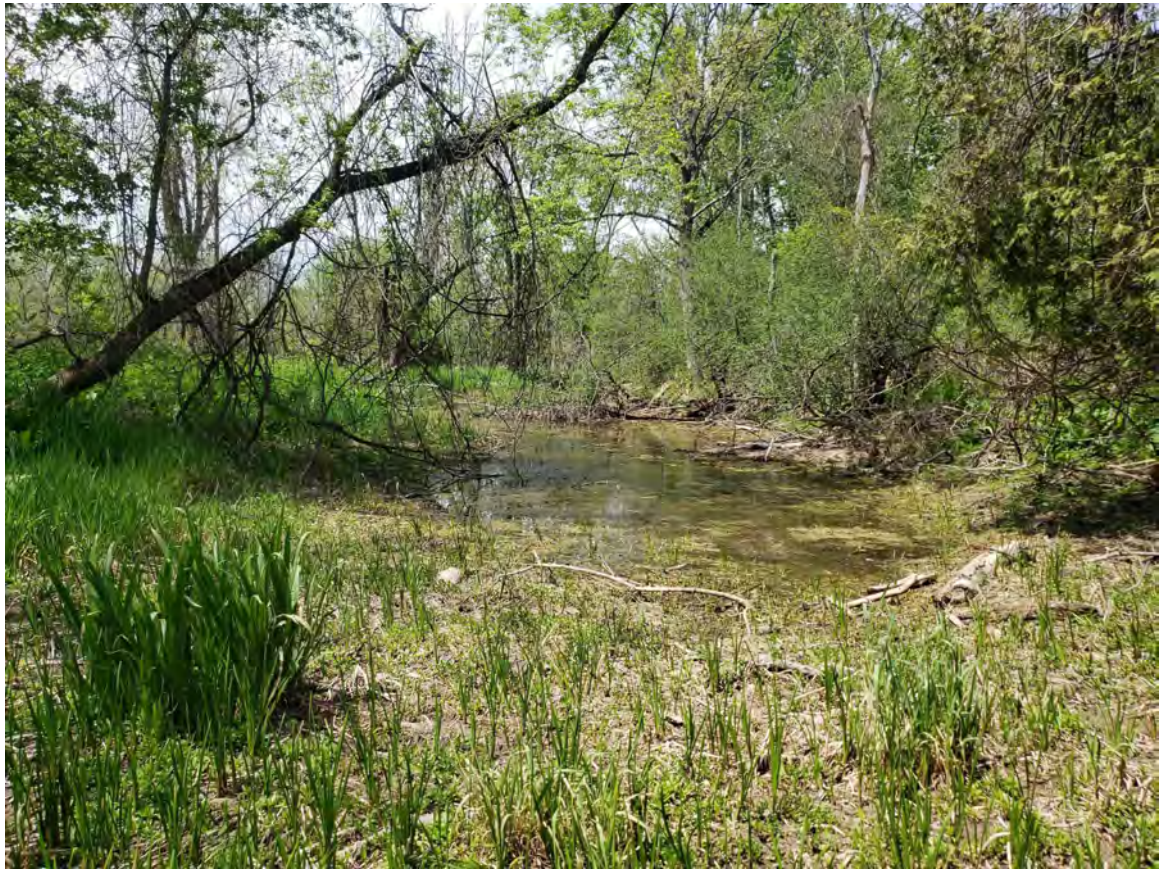
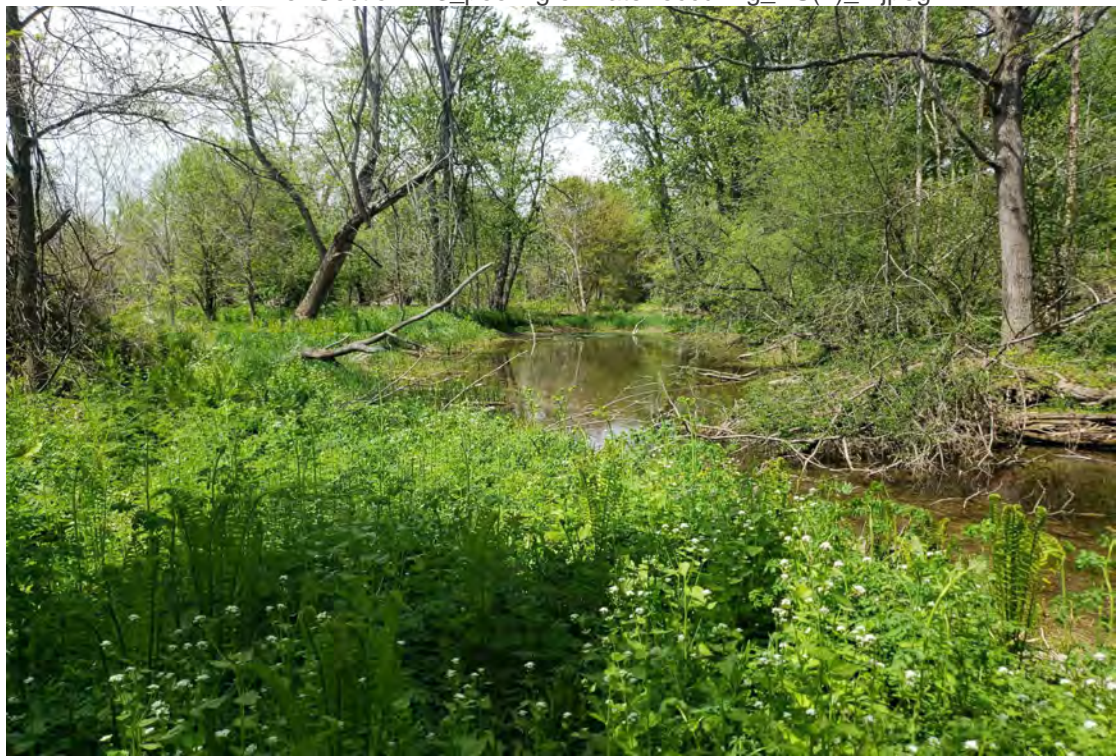
Nith River Section 4-3_pooling of water occuring_PS(4)_1.jpeg

EROSION TYPE(S)	SEVERITY	N	E	Z	PTID
Pooling /Ponding	1- Minor	43.2814471	80.4580911	NA	47

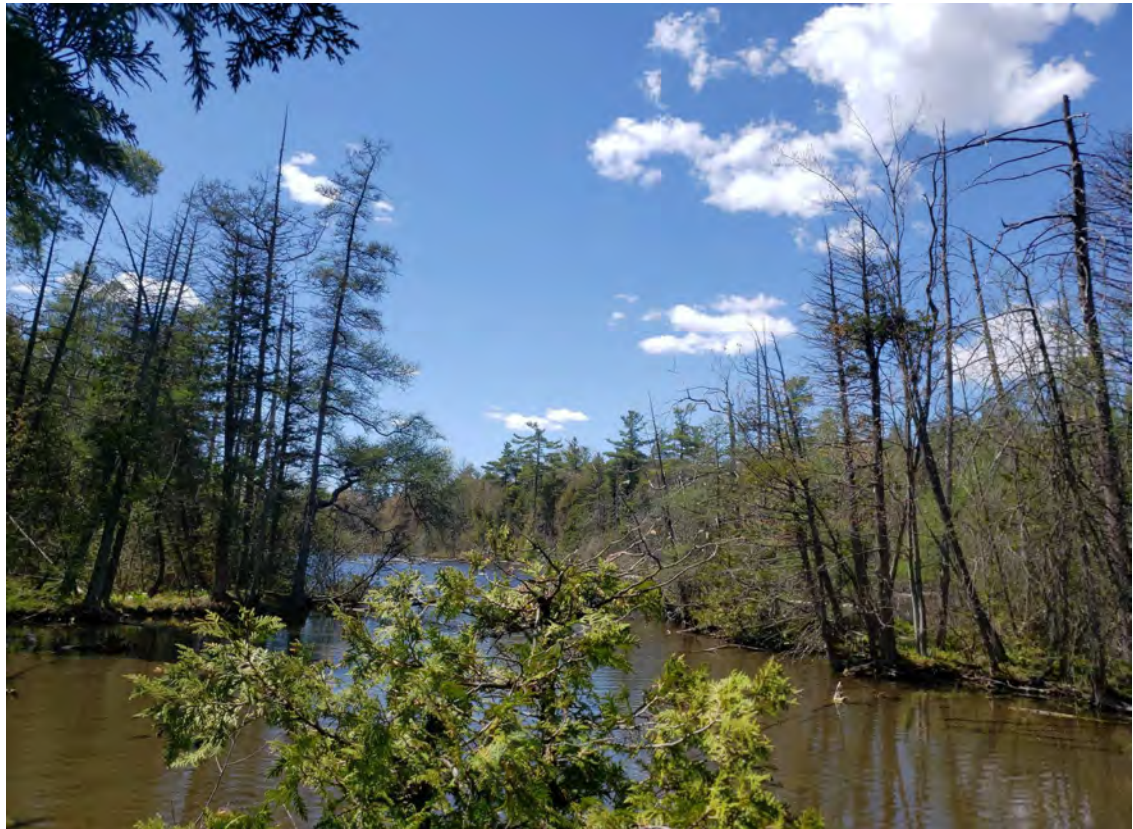
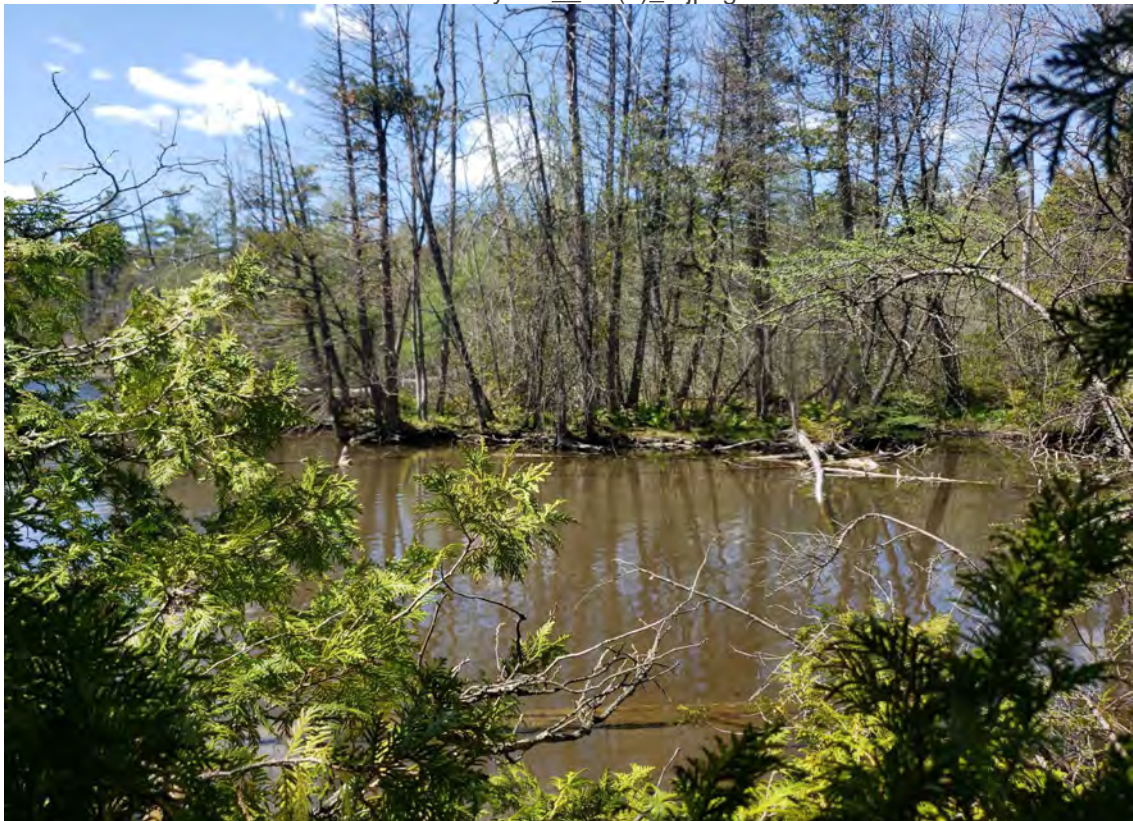
EROSION TYPE(S)	SEVERITY	N	E	Z	PTID
No Erosion – just photo documentation	NA	4793130.77	545123.14	291.866	29

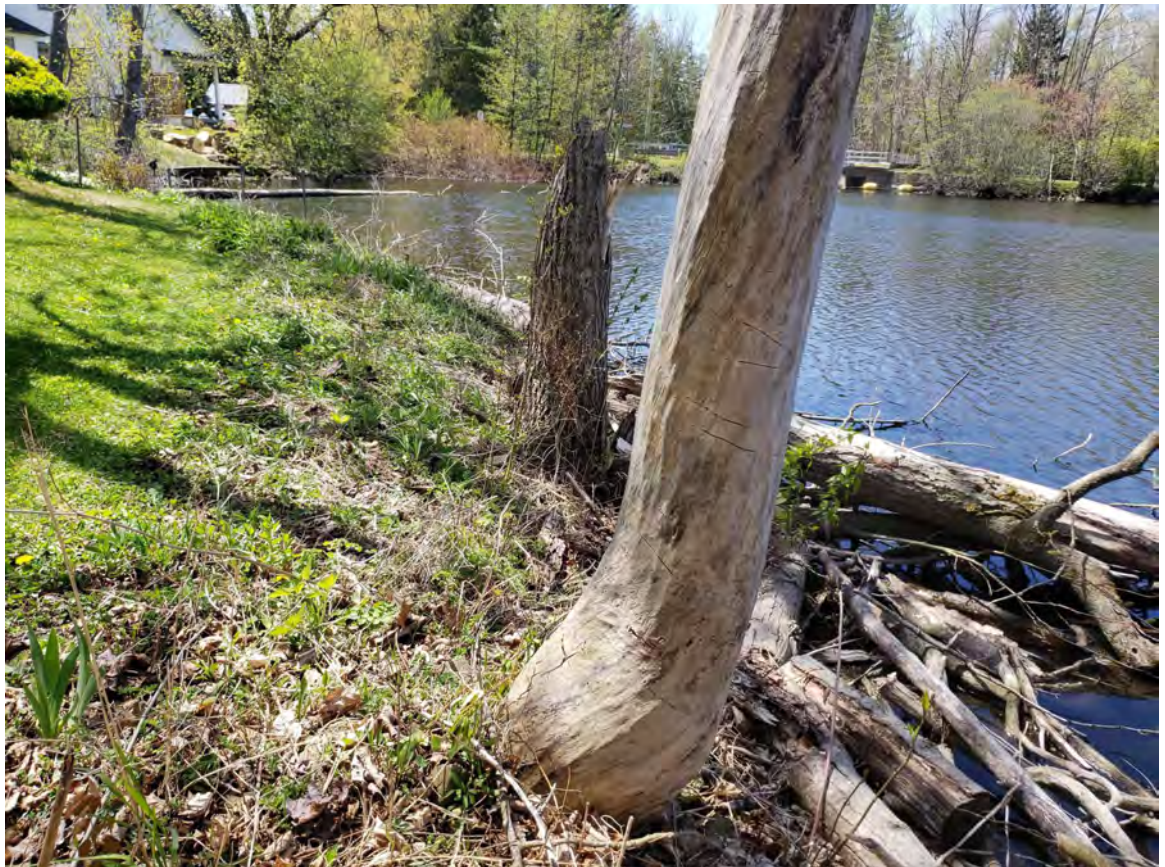
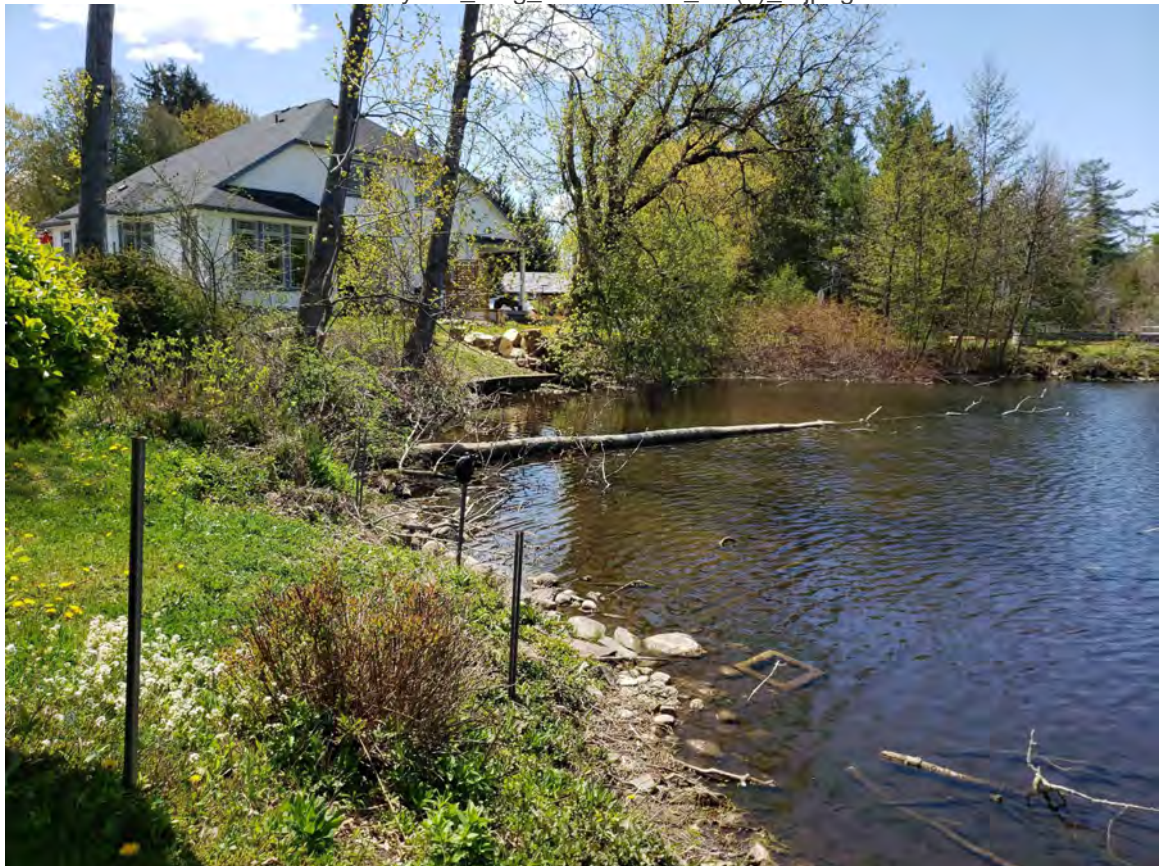
Large tree has fallen in water may be contributing to small localized band erosion.

EROSION TYPE(S)	SEVERITY	N	E	Z	PTID
Log/Debris Jam	1 - Minor	4793033	544912.39	287.661	28

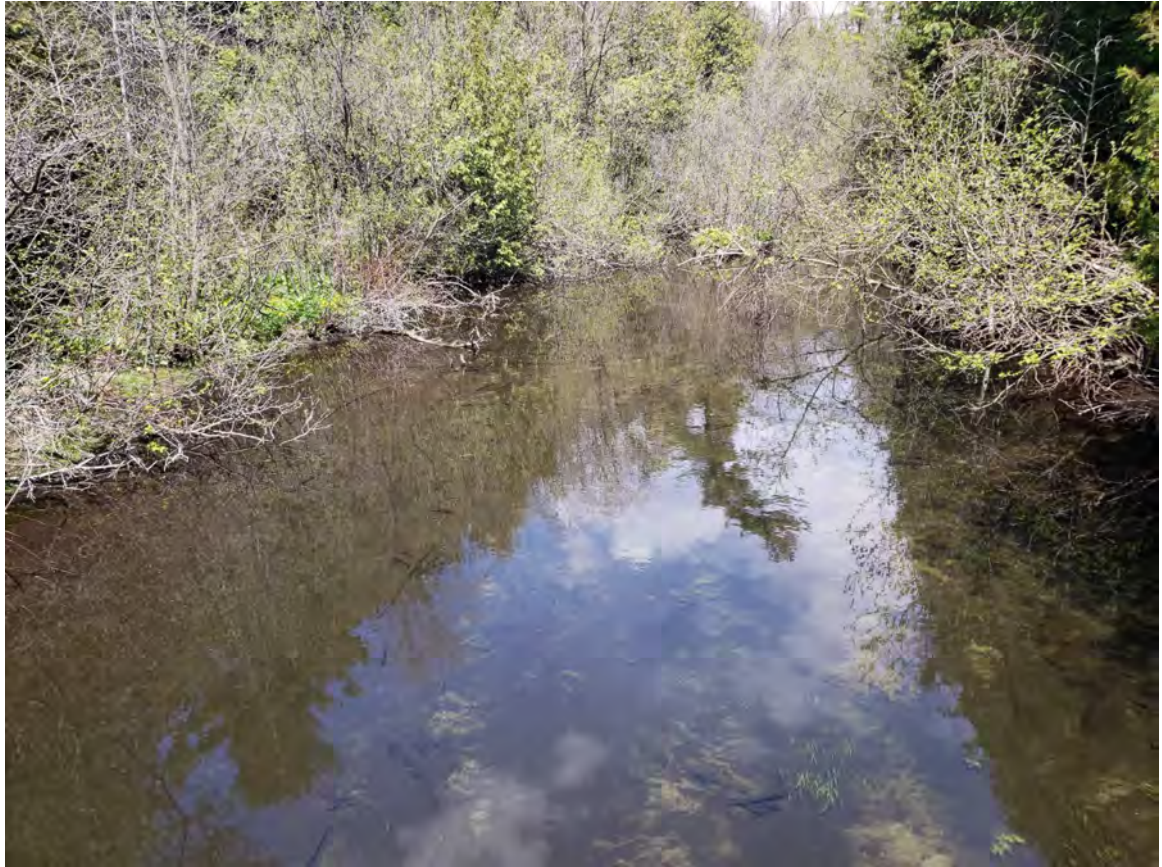
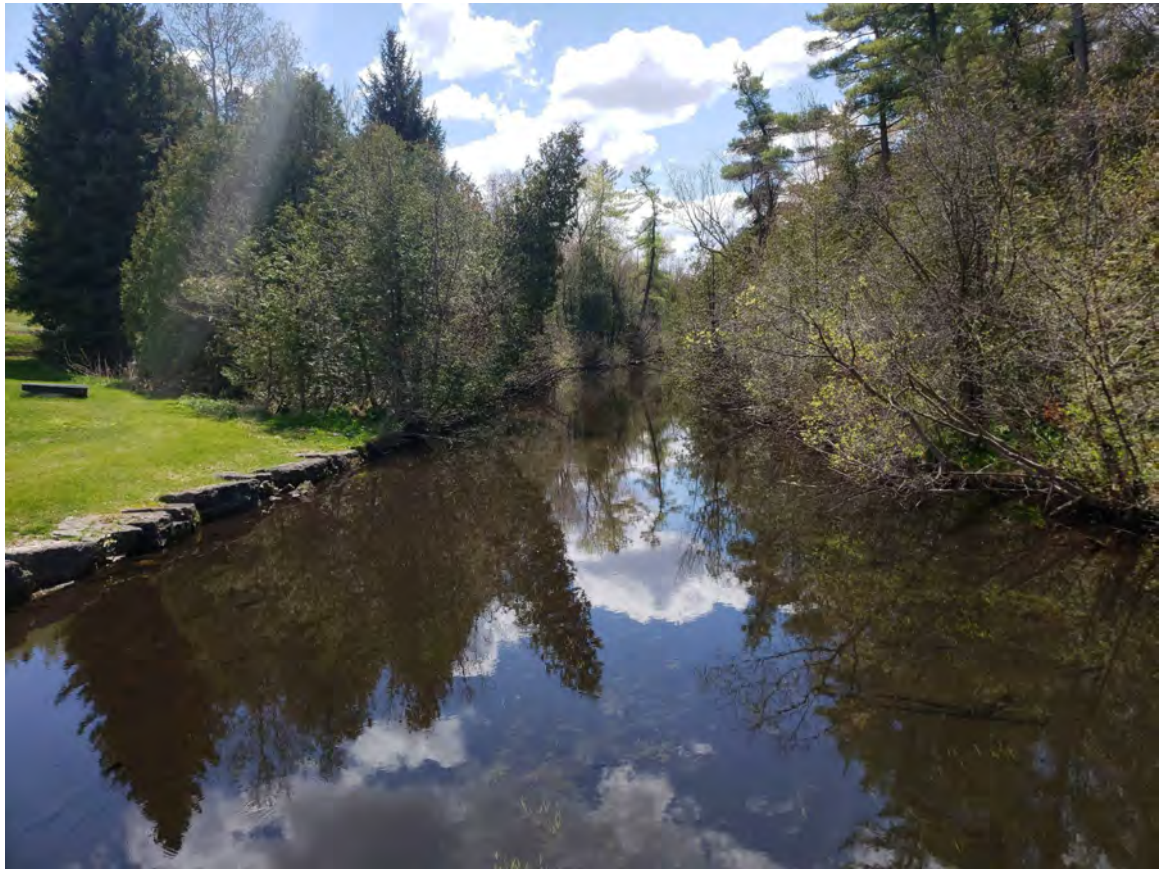
EROSION TYPE(S)	SEVERITY	N	E	Z	PTID
Erosion Control	NA	4793392.11	545224.84	288.133	30

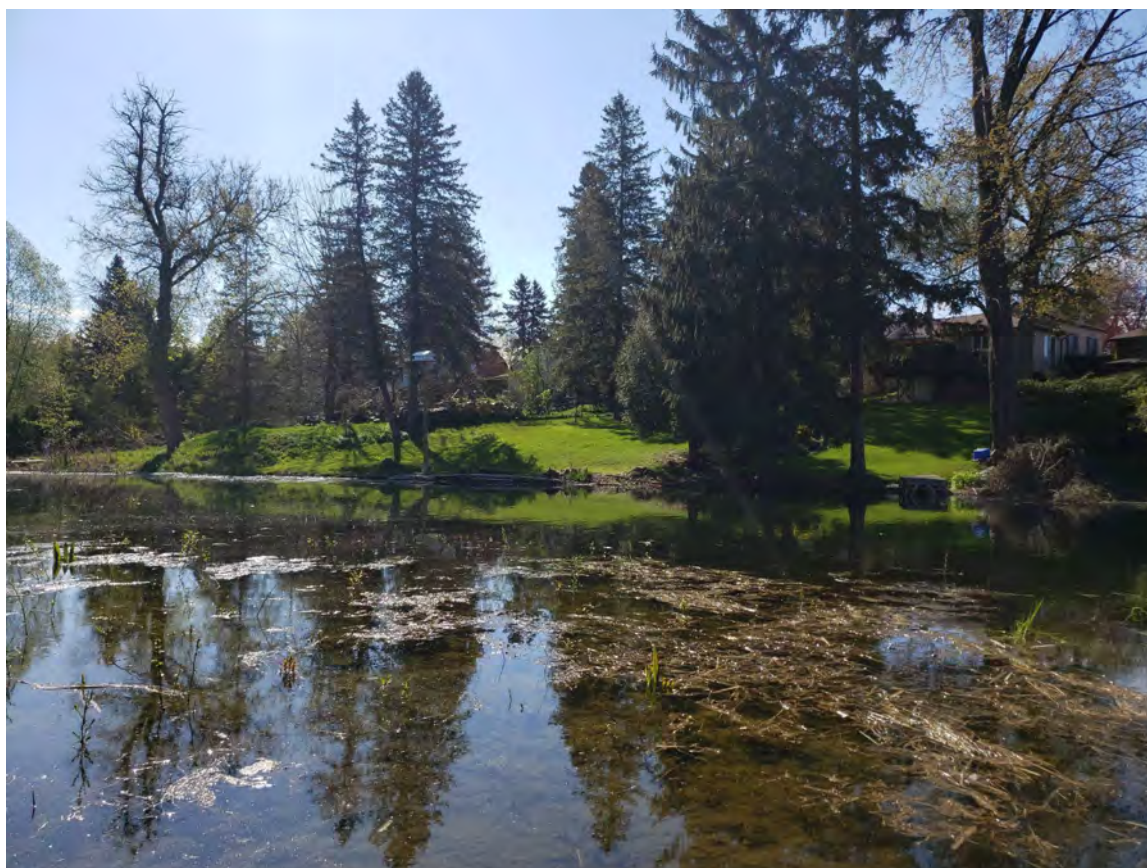
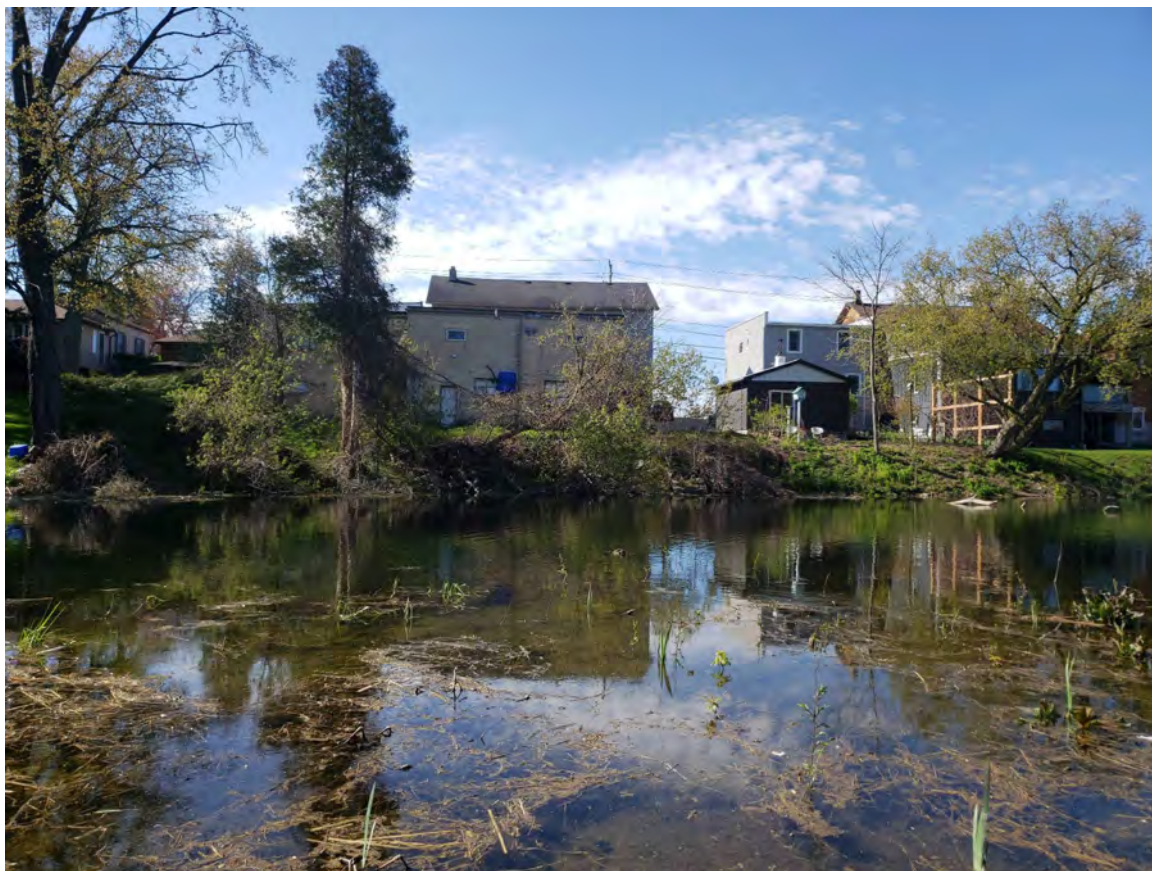
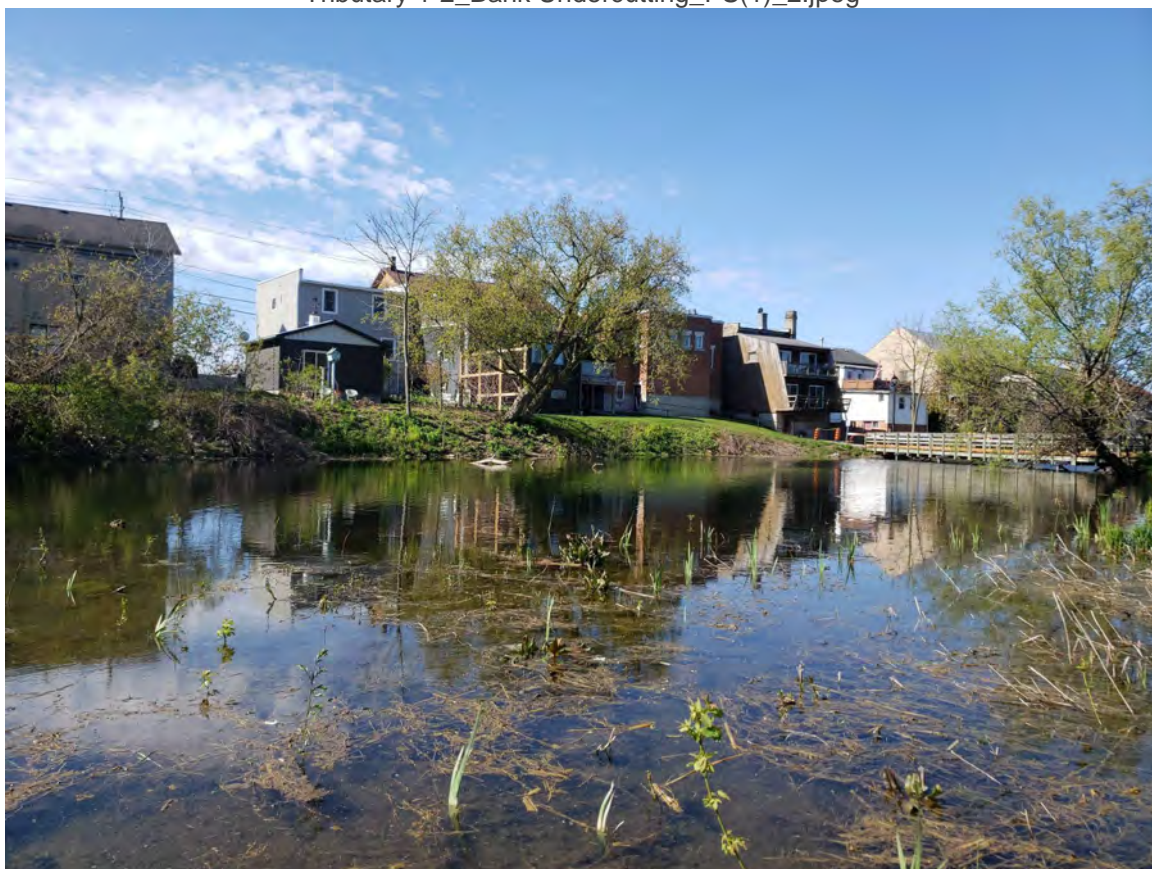
Evidence of active erosion, some bank undercutting beginning to infringe on

back yard of private residences. some trees have fallen over – potential safety hazard

EROSION TYPE(S)	SEVERITY	N	E	Z	PTID
Bank Undercutting	4- Safety Hazard	4792760.94	544672.16	282.356	23

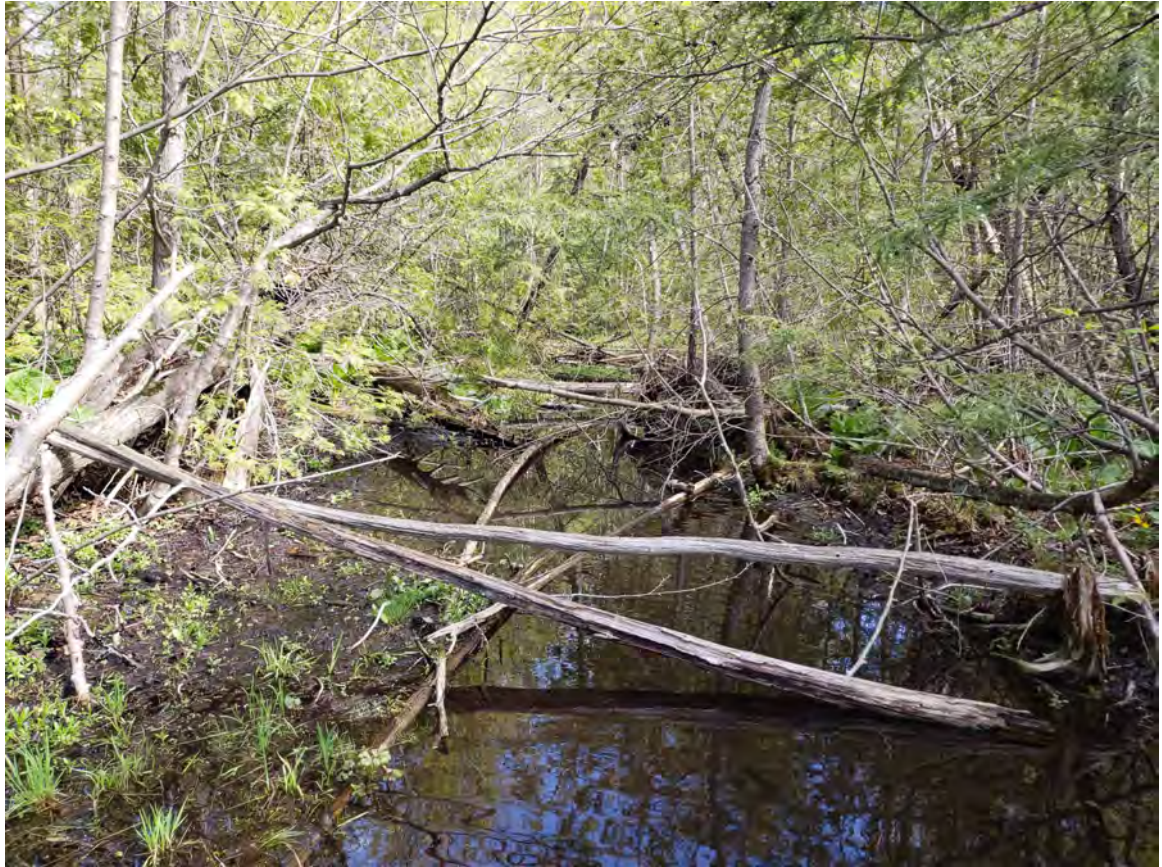
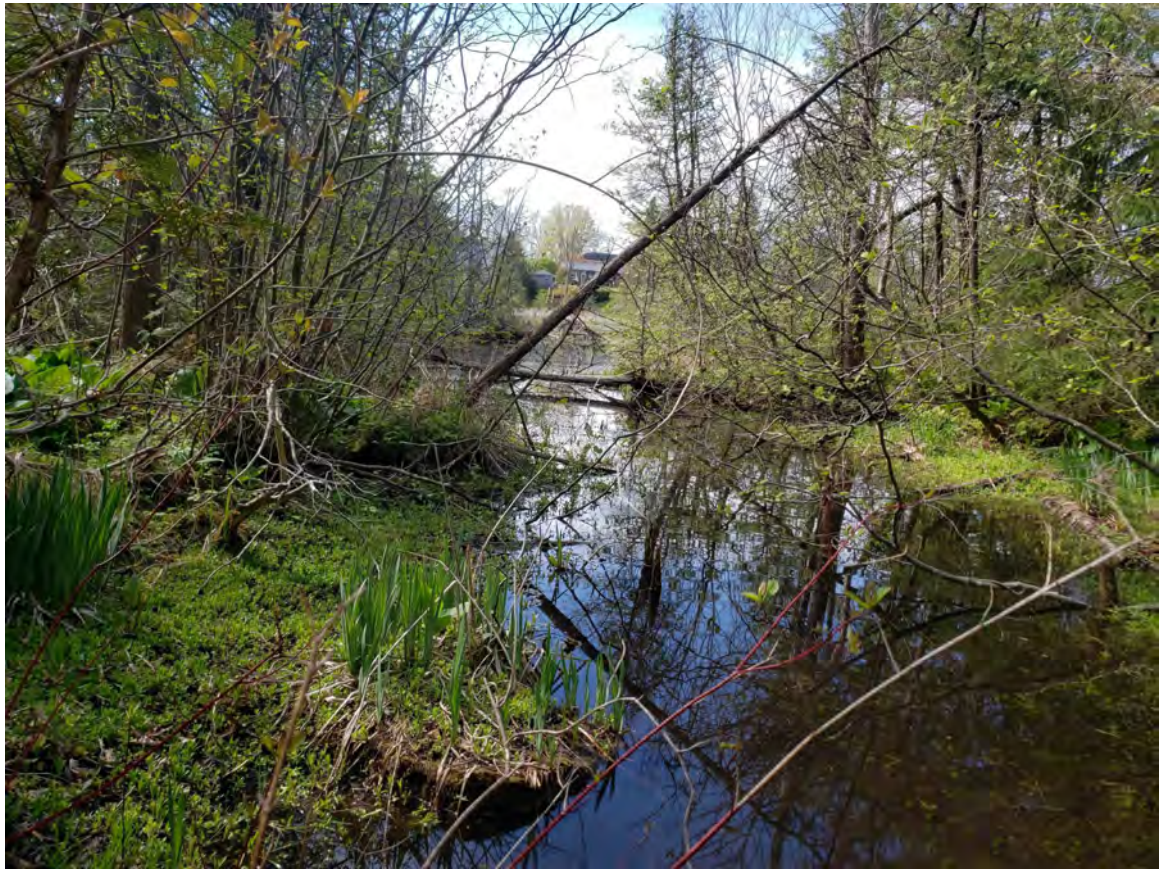
many trees in creek that feeds into Watson pond. Evidence of tree buildup from further upstream.

EROSION TYPE(S)	SEVERITY	N	E	Z	PTID
Log/Debris Jam	2- Moderate	4792900.02	544754.36	282.75	24
