APPENDIX H

Erosion Inventory and Assessment Information

Ayr, ON - Watercourse Erosion Inventory and Assessment

Watercourse Erosion Inventory and Assessment
Ayr, ON
County of North Dumfries

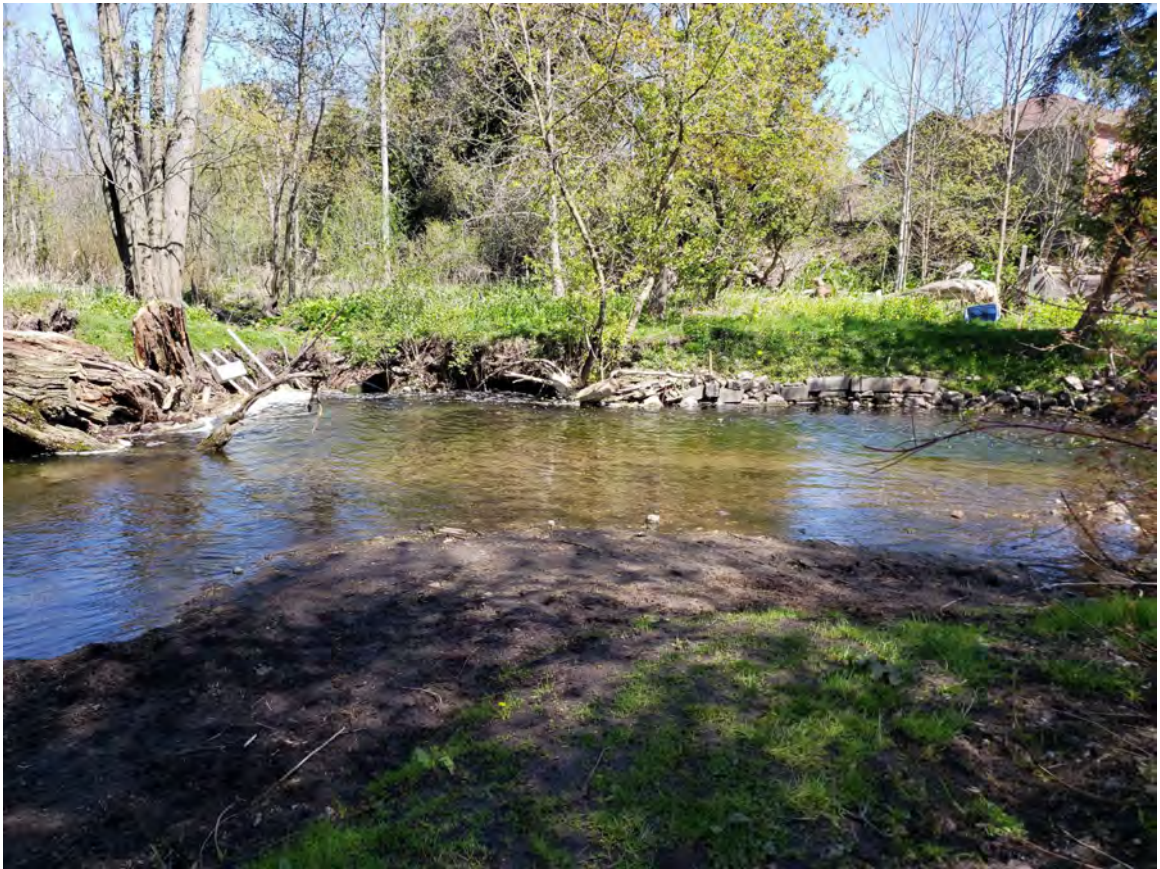
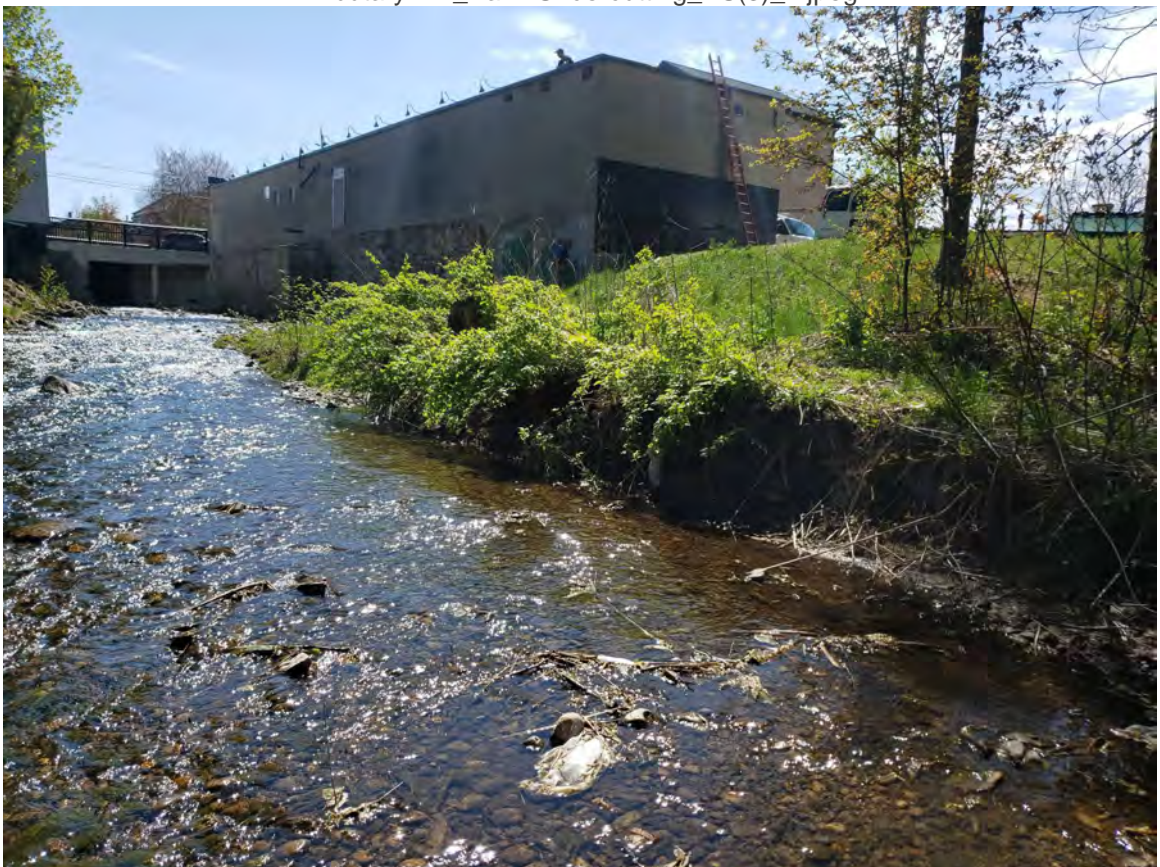
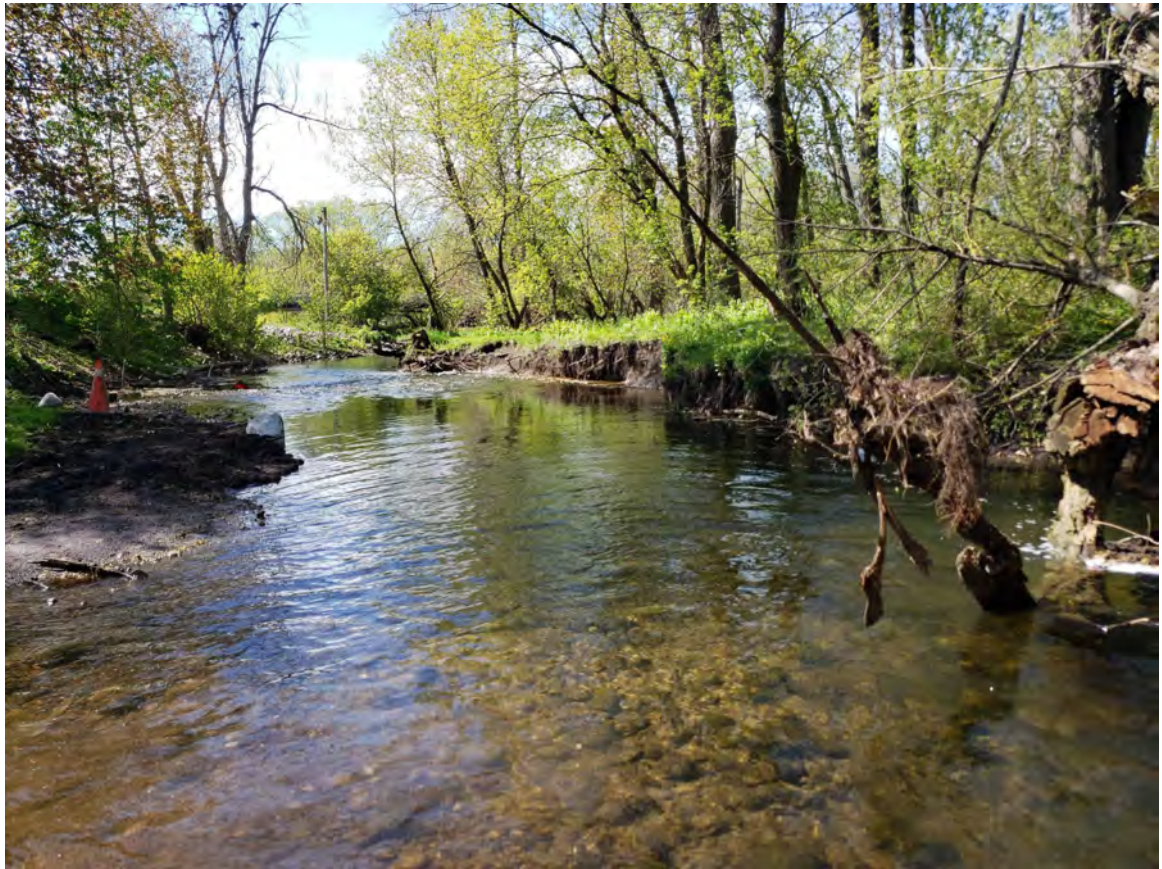
Evidence of active erosion, some bank undercutting beginning to infringe on back yard of private residences. some trees have fallen over – potential safety hazard

EROSION TYPE(S)	SEVERITY	N	E	Z	PTID
Bank Undercutting	4- Safety Hazard	4792718.81	544461.63	279.964	25

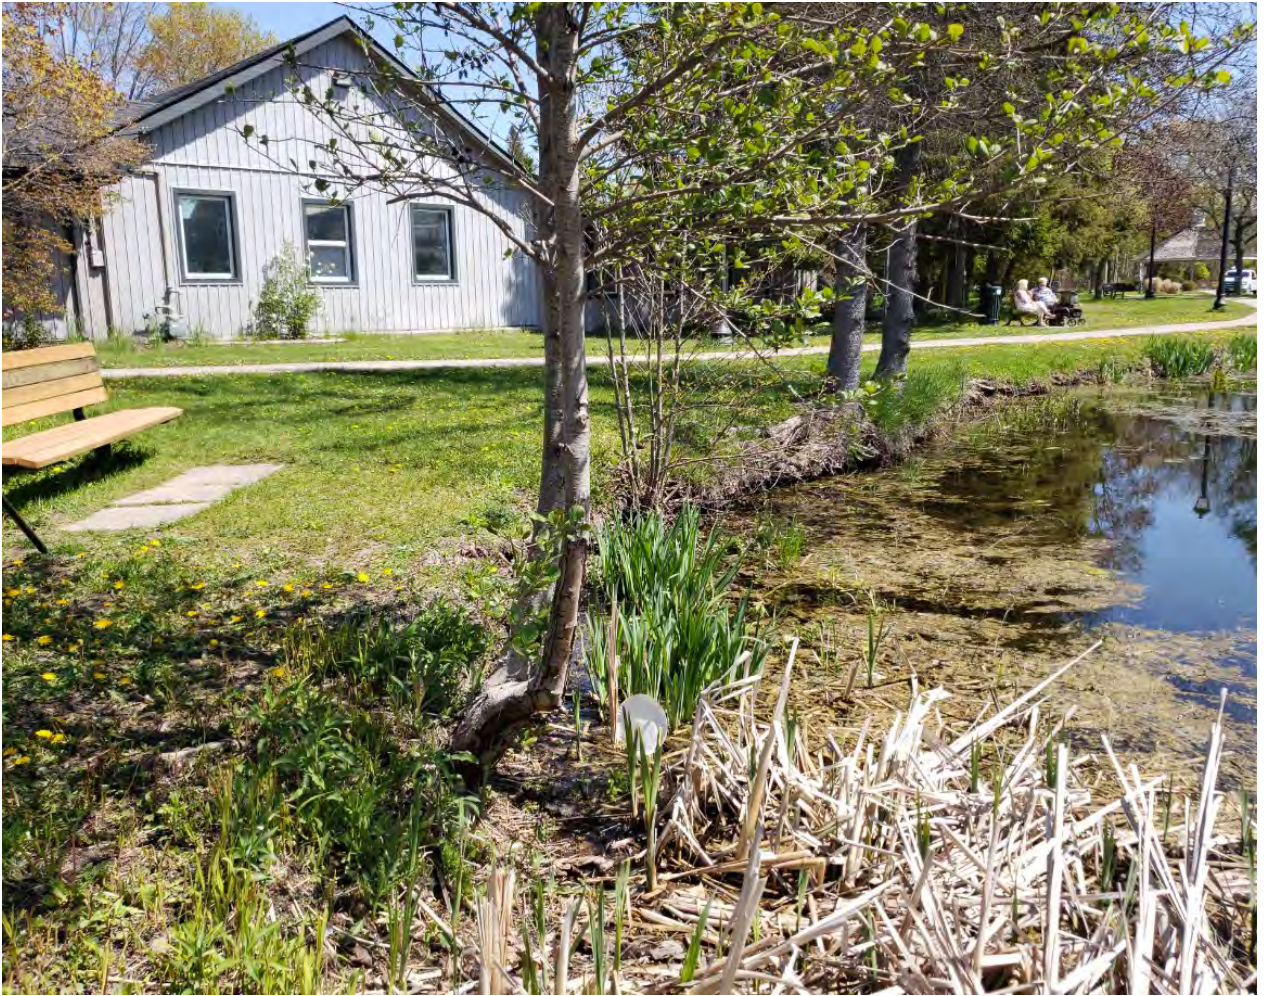
Some bank undercutting beginning north shore, close to private residences/walking path.

EROSION TYPE(S)	SEVERITY	N	E	Z	PTID
Bank Undercutting	1 - Minor	4792753.349	544532.1257	283.1448	27

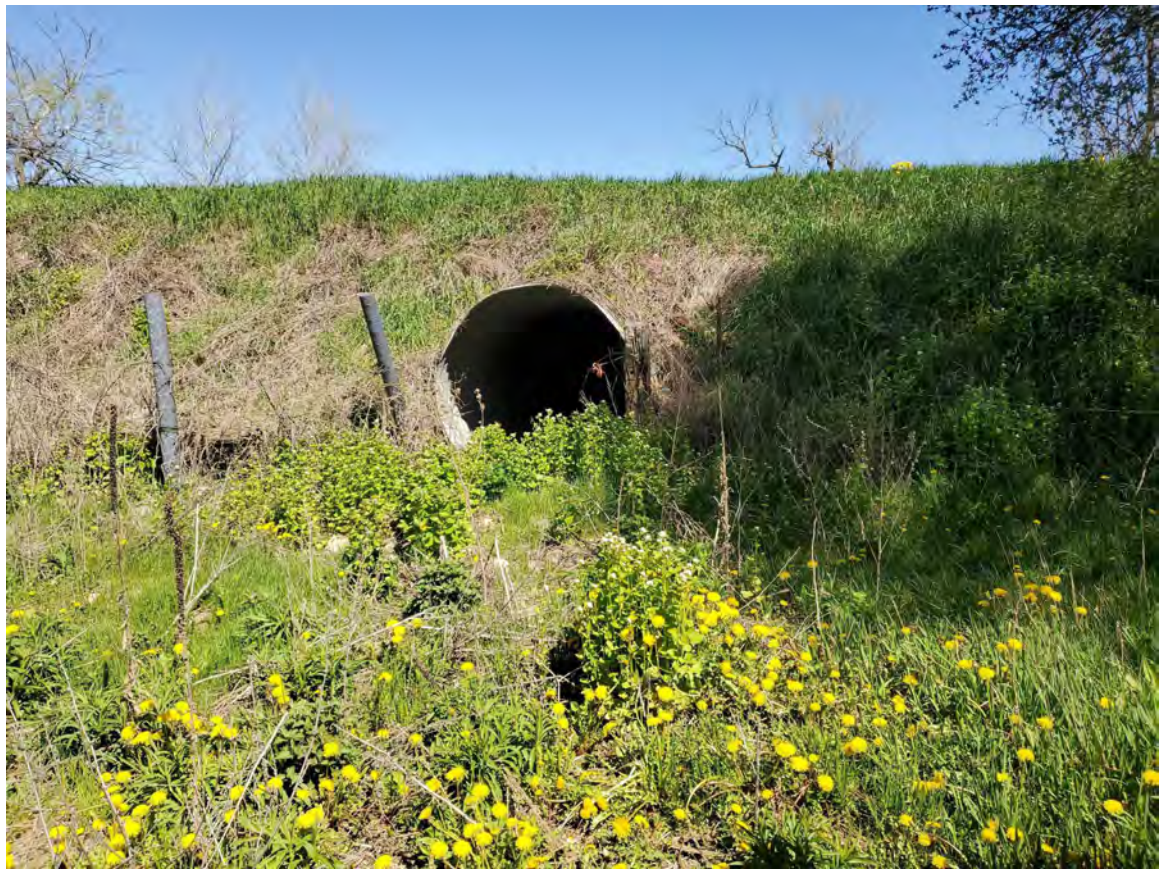
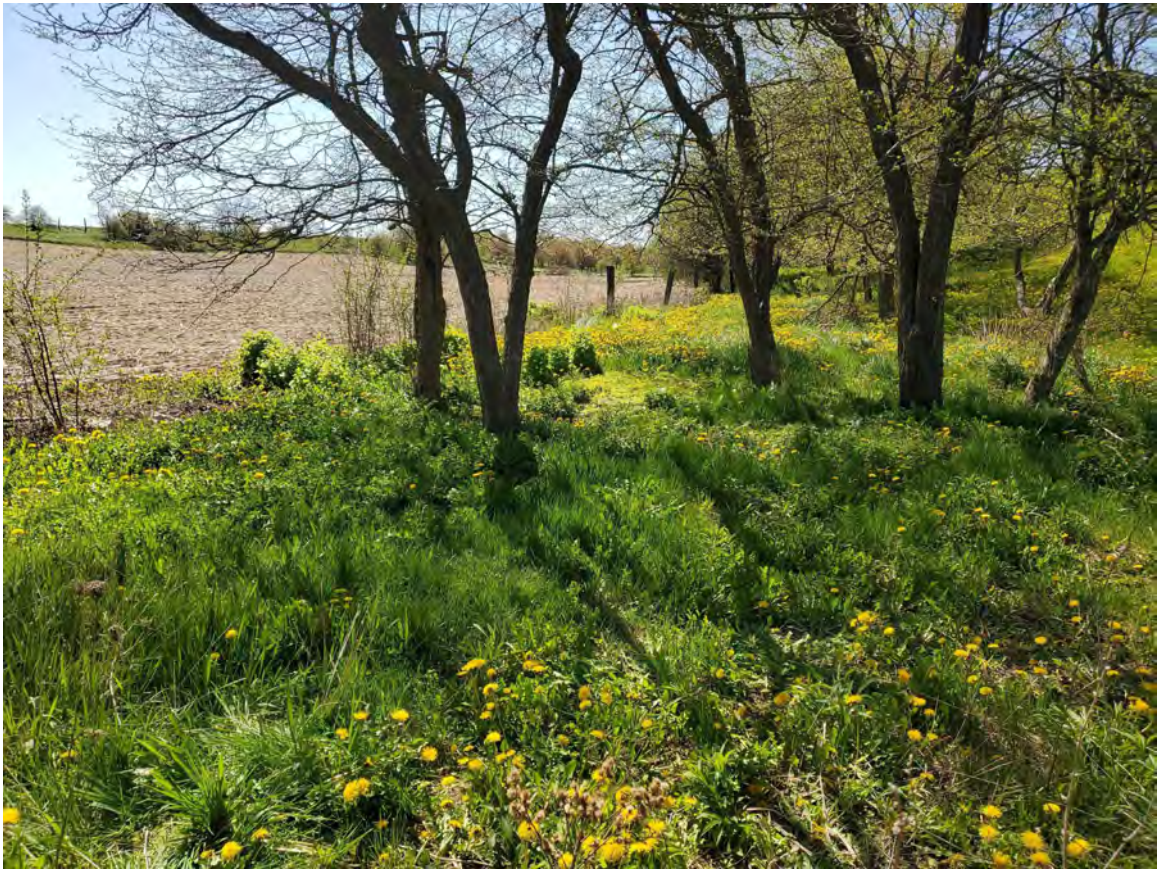
Additional information No erosion found

EROSION TYPE(S)	SEVERITY	N	E	Z	PTID
No Erosion	NA	4794295.25	544422.64	293.15	15

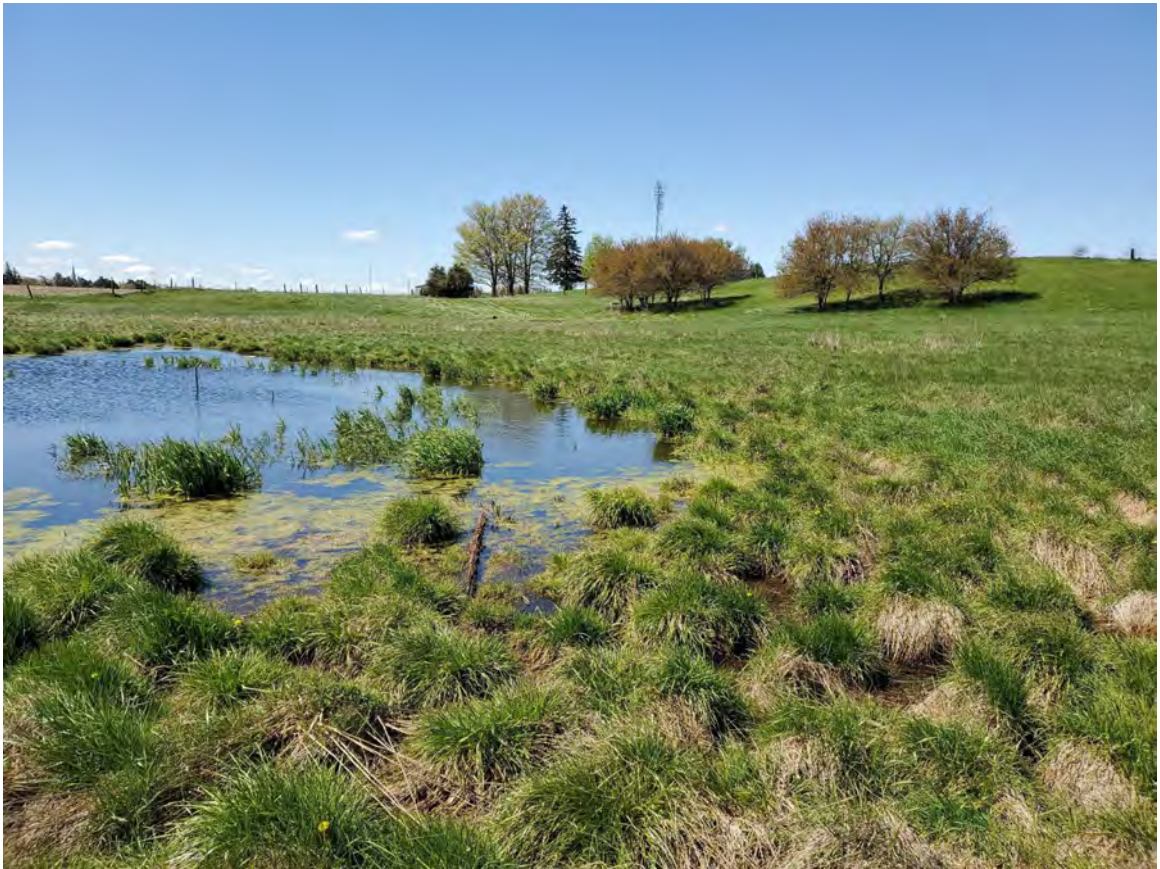
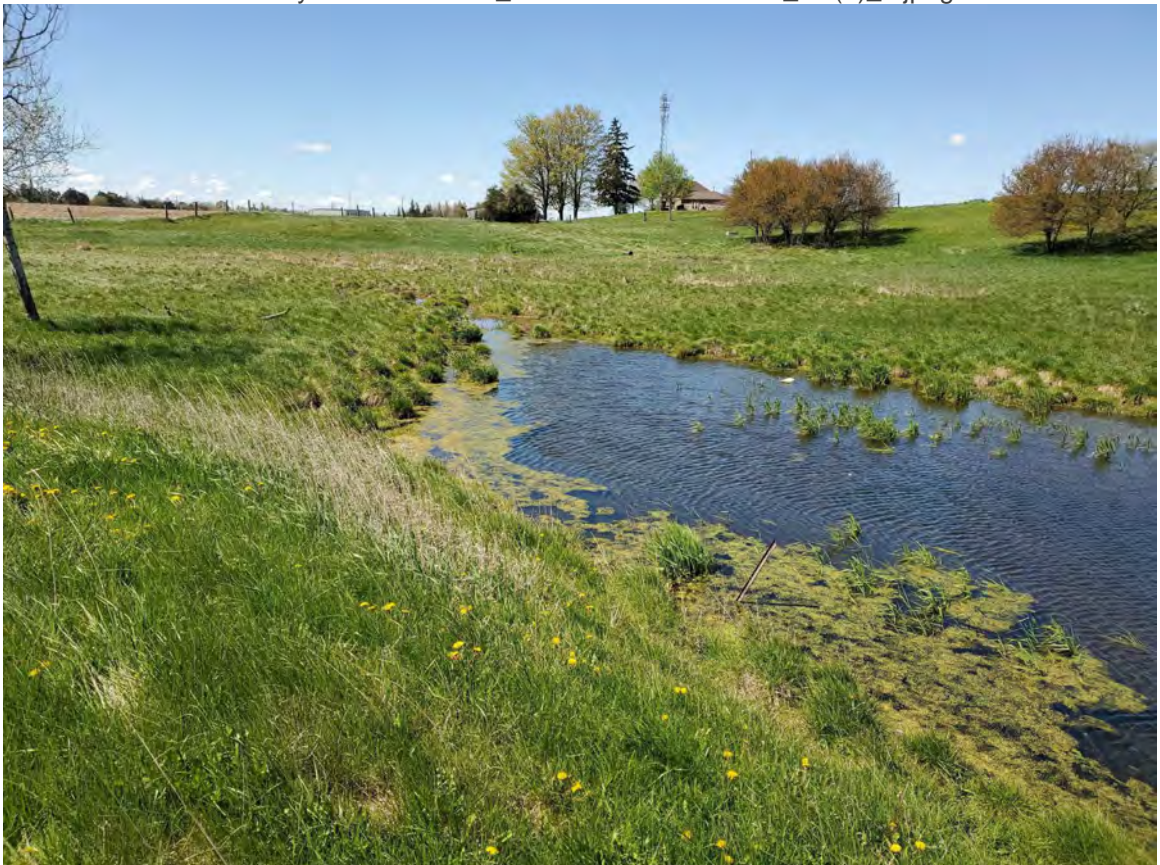
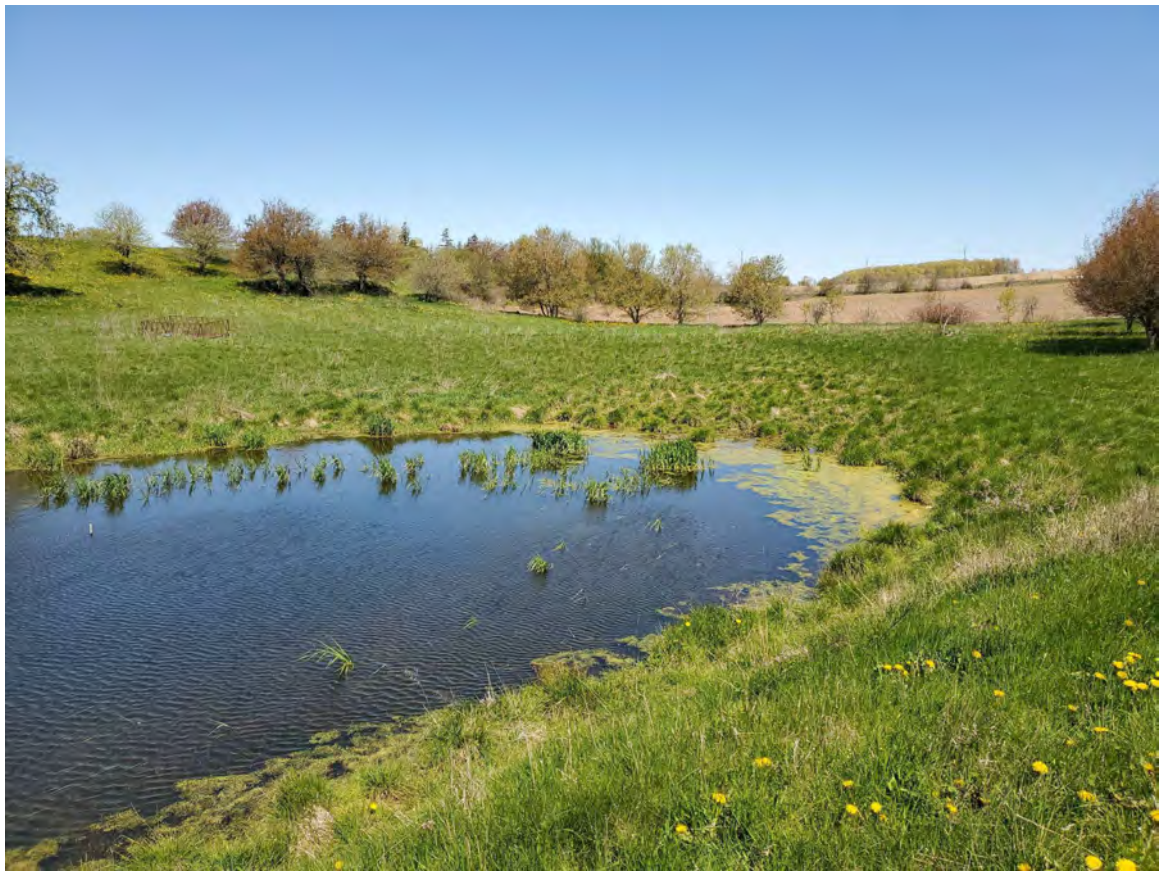
Additional information Some evidence of lateral erosion likely only occurring during wet weather but the erosion -very minor.

EROSION TYPE(S)	SEVERITY	N	E	Z	PTID
No evidence of erosion	NA	4794070.84	544542.48	292.01	16

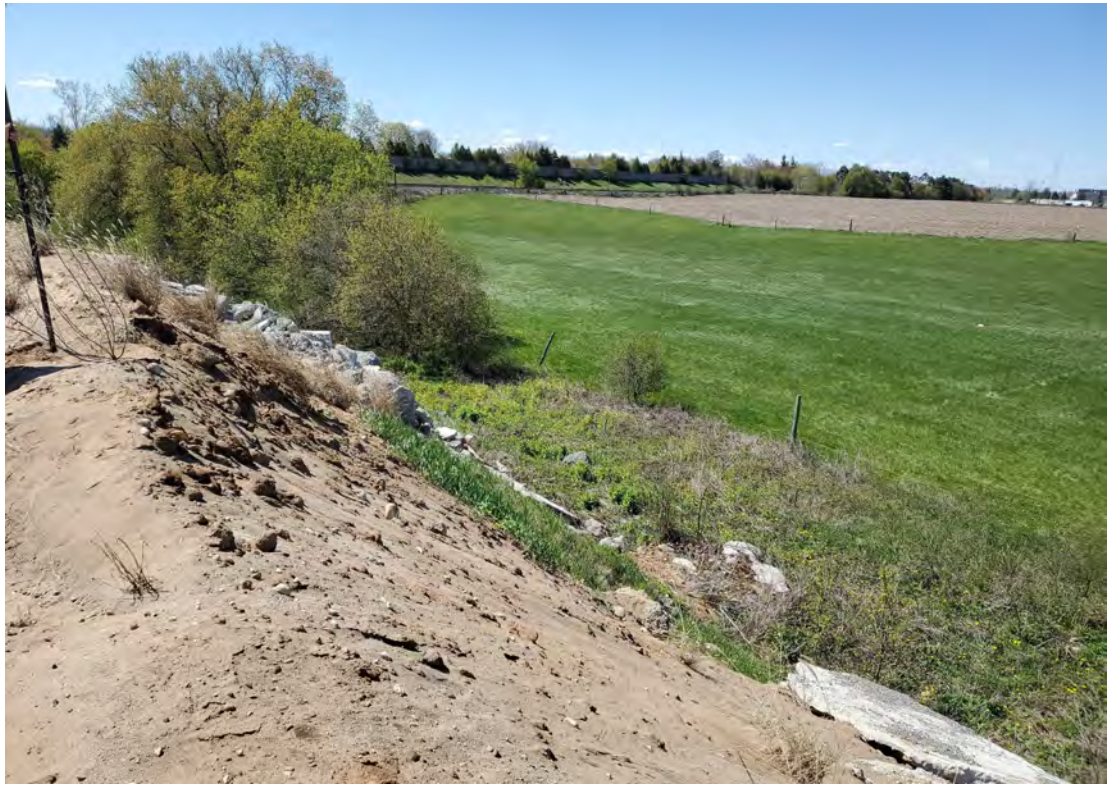
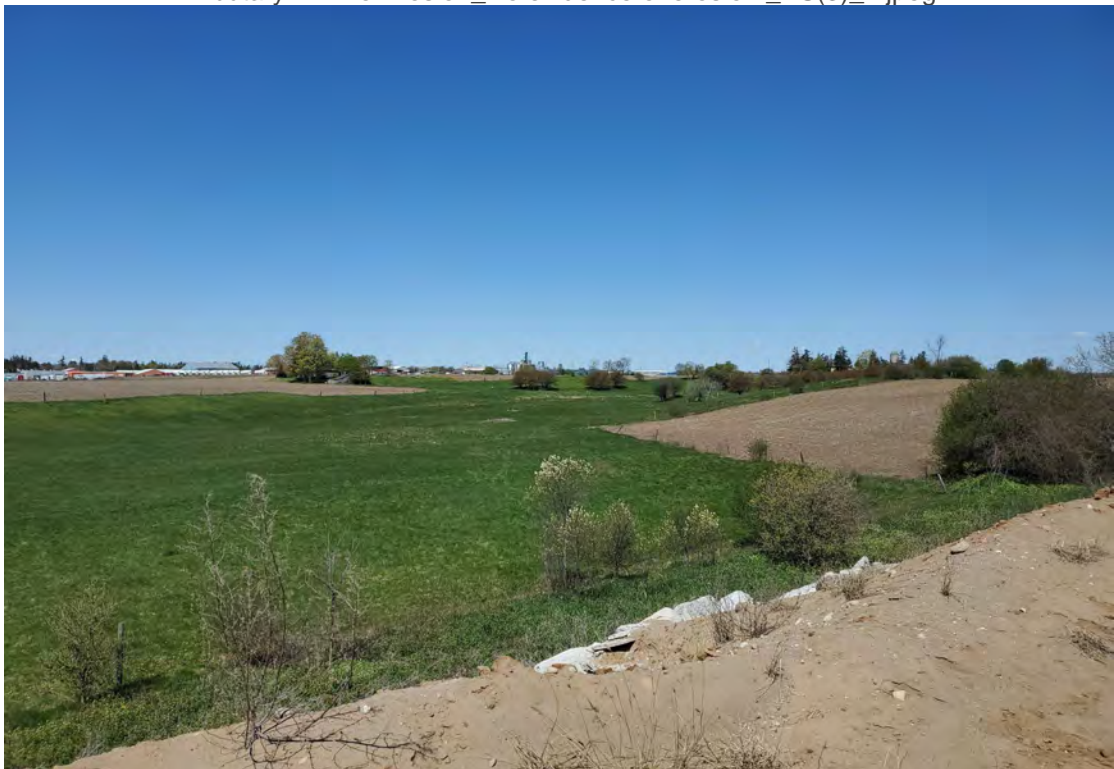
Additional information No erosion found

EROSION TYPE(S)	SEVERITY	N	E	Z	PTID
No evidence of erosion	NA	4793889.92	544773.2	297.78	17

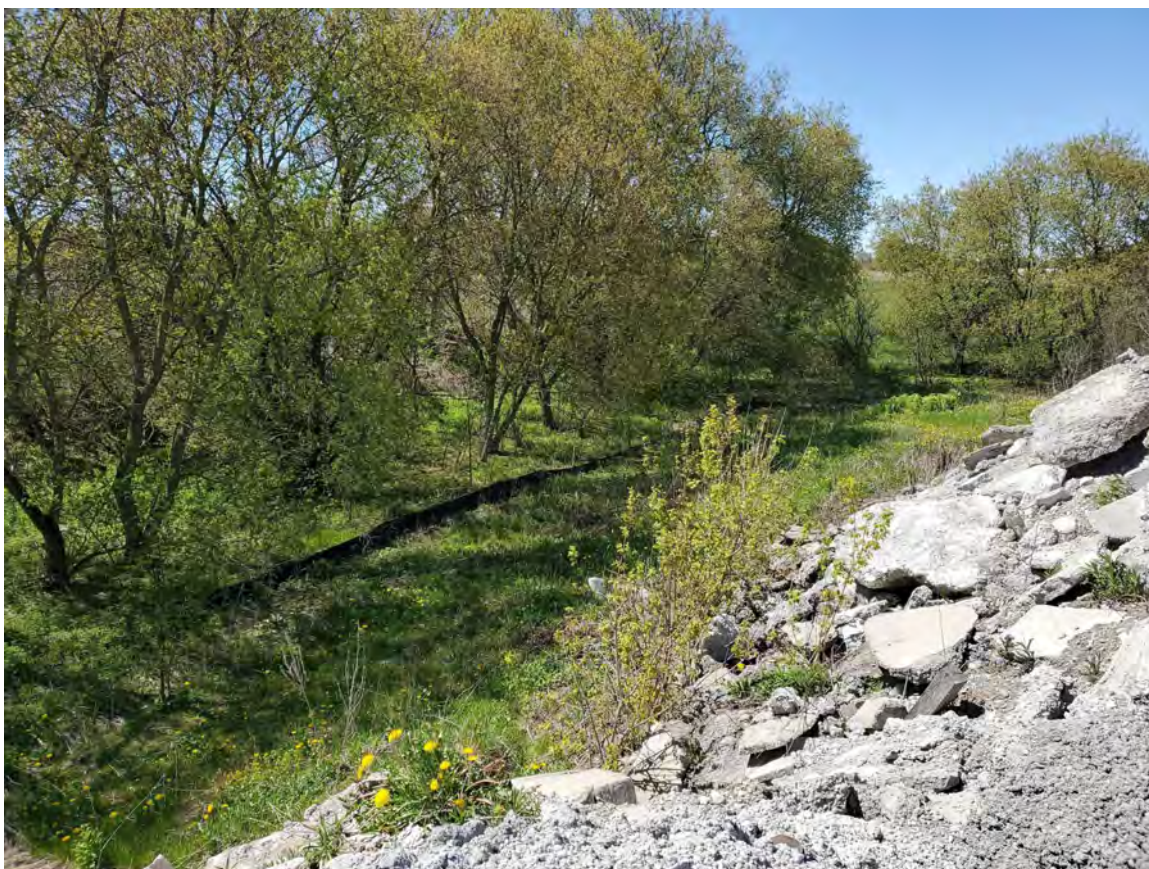
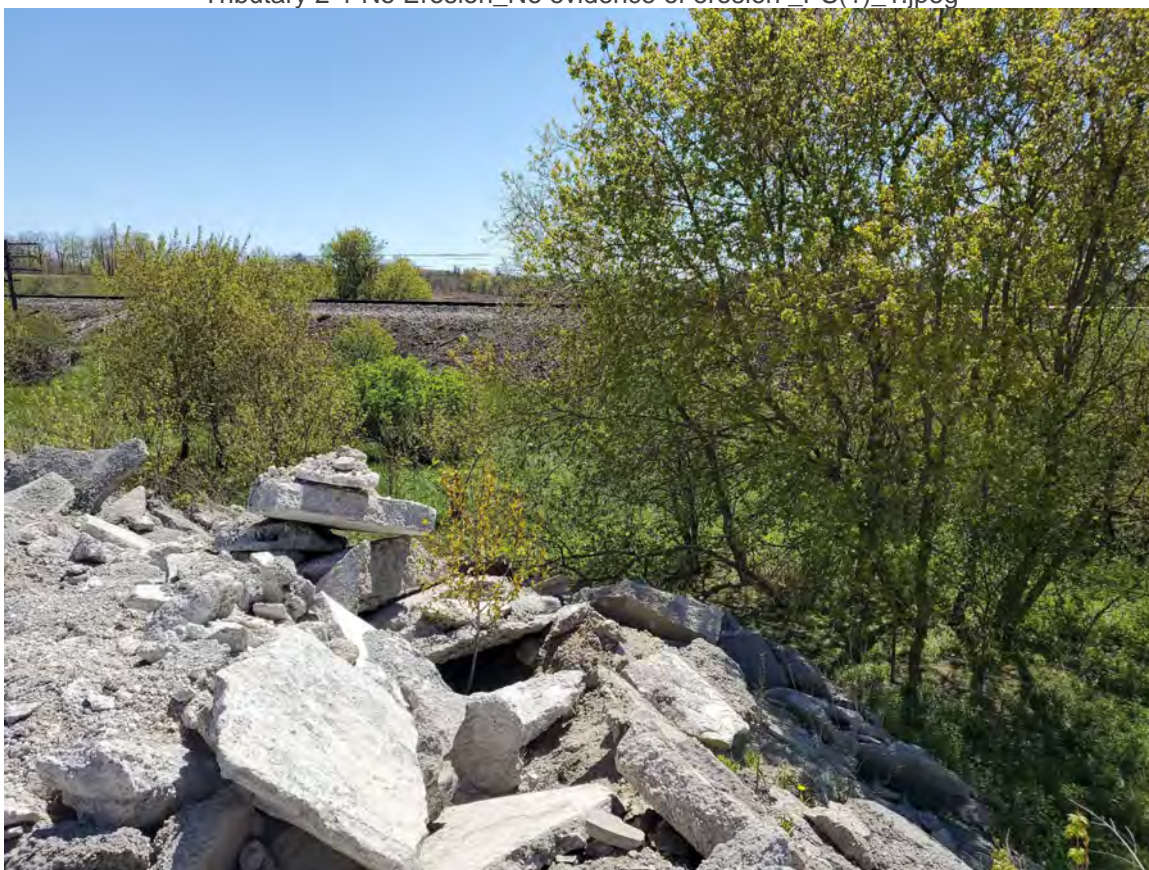
Additional information No erosion found. No evidence of erosion near train tracks.

EROSION TYPE(S)	SEVERITY	N	E	Z	PTID
No evidence of erosion	NA	4793834.87	544824.41	294.5	18

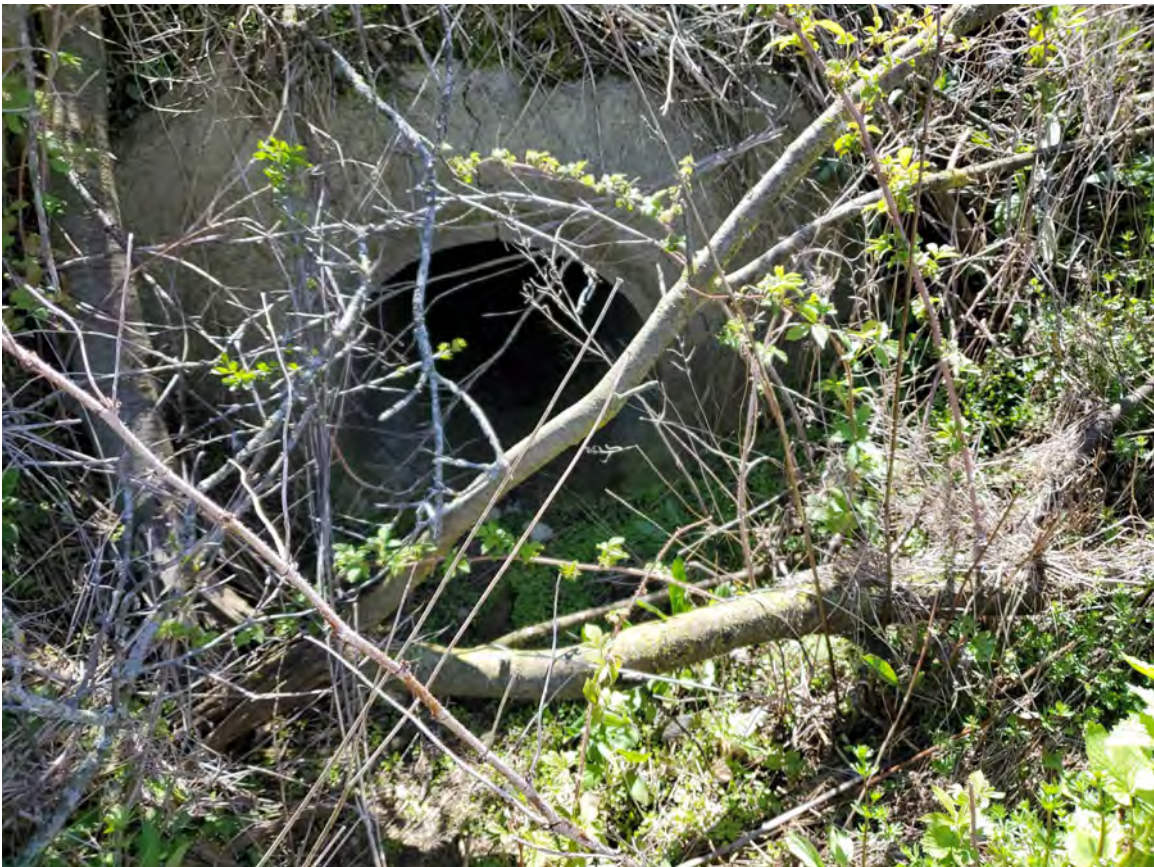
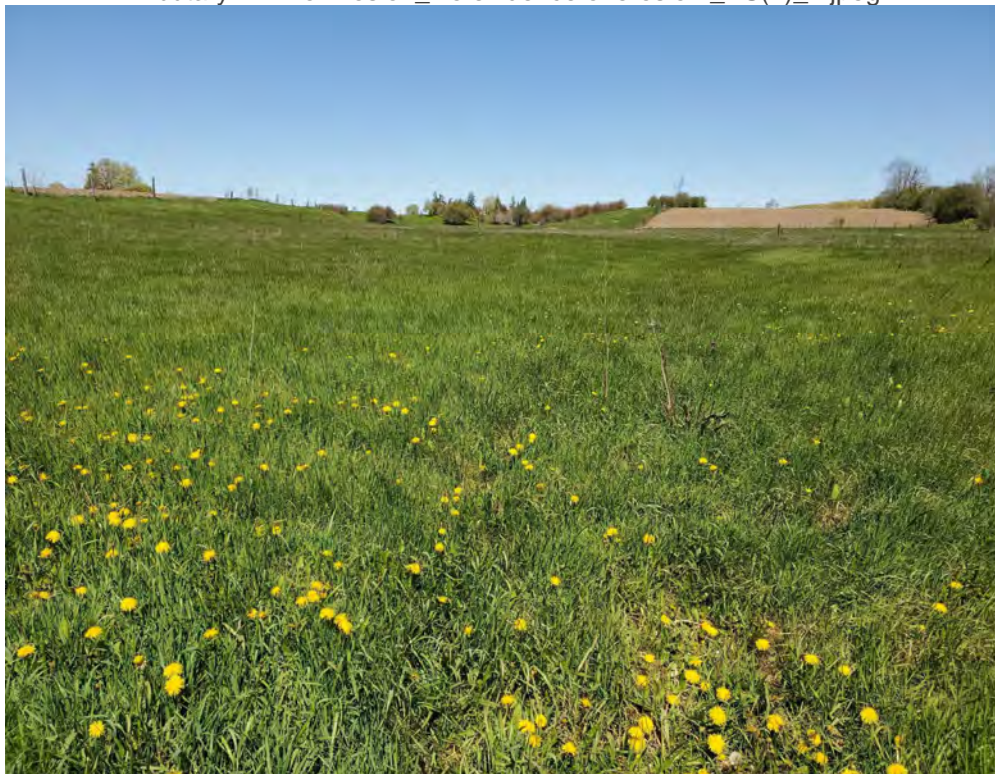
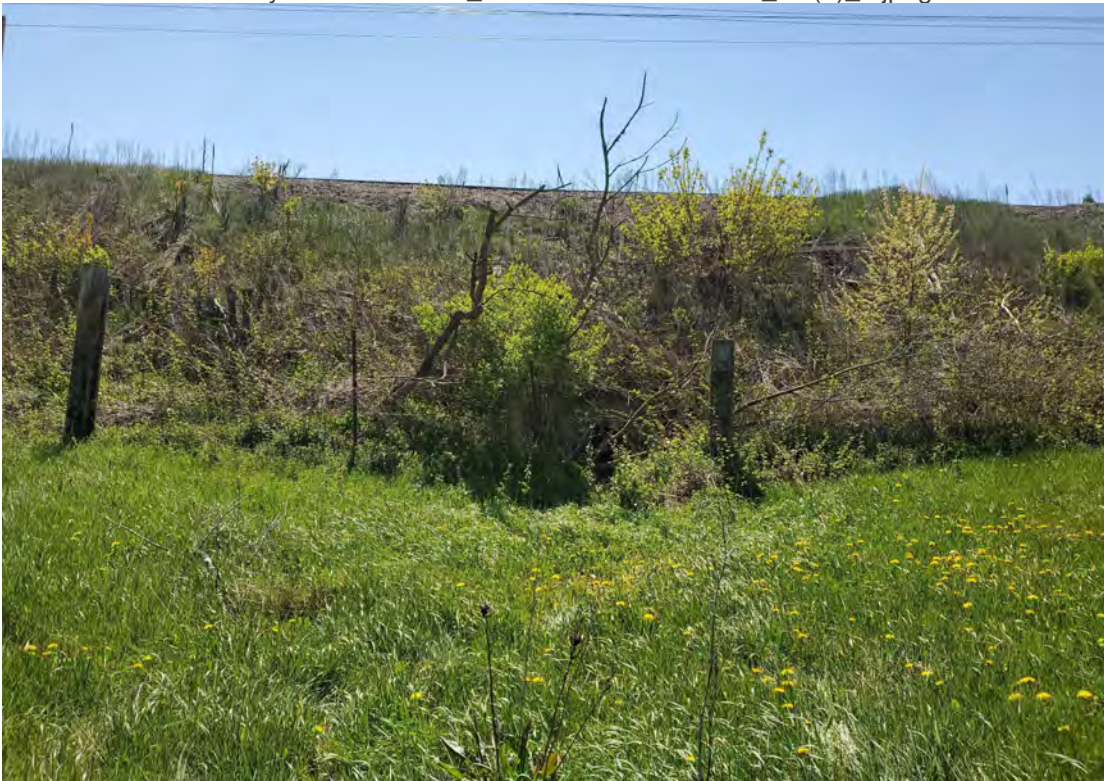
Additional information No erosion found. Some debris/twigs/branches blocking culvert but no significant erosion of field or area around train tracks.

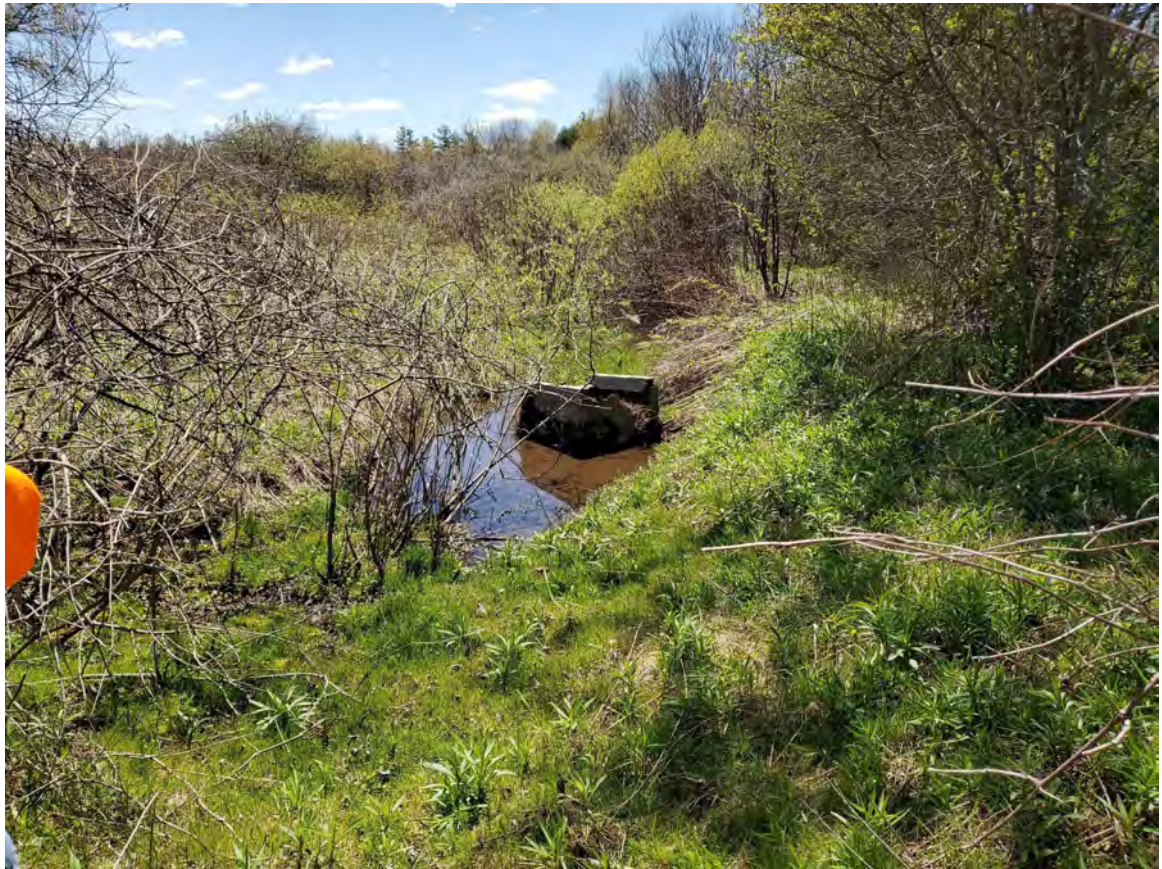
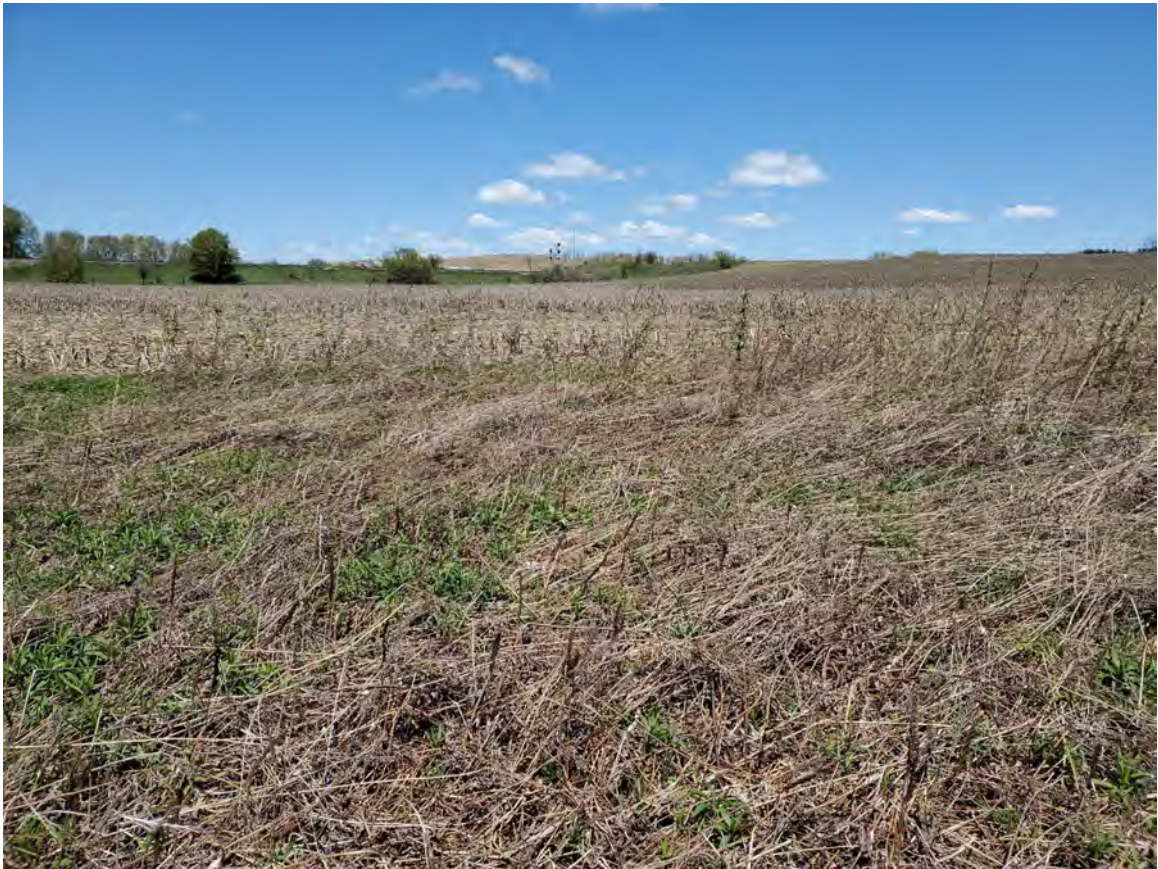
EROSION TYPE(S)	SEVERITY	N	E	Z	PTID
No evidence of erosion	NA	4793617.36	544957.54	288.64	20

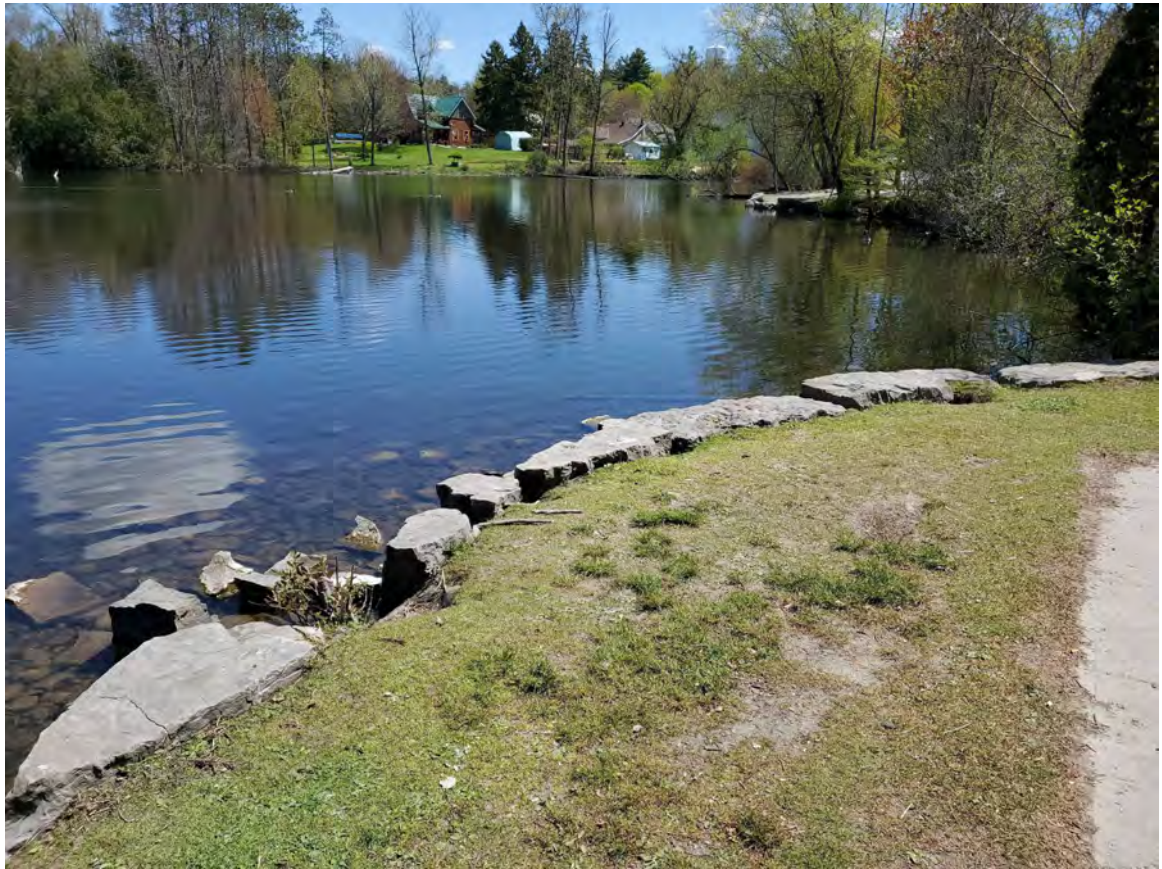
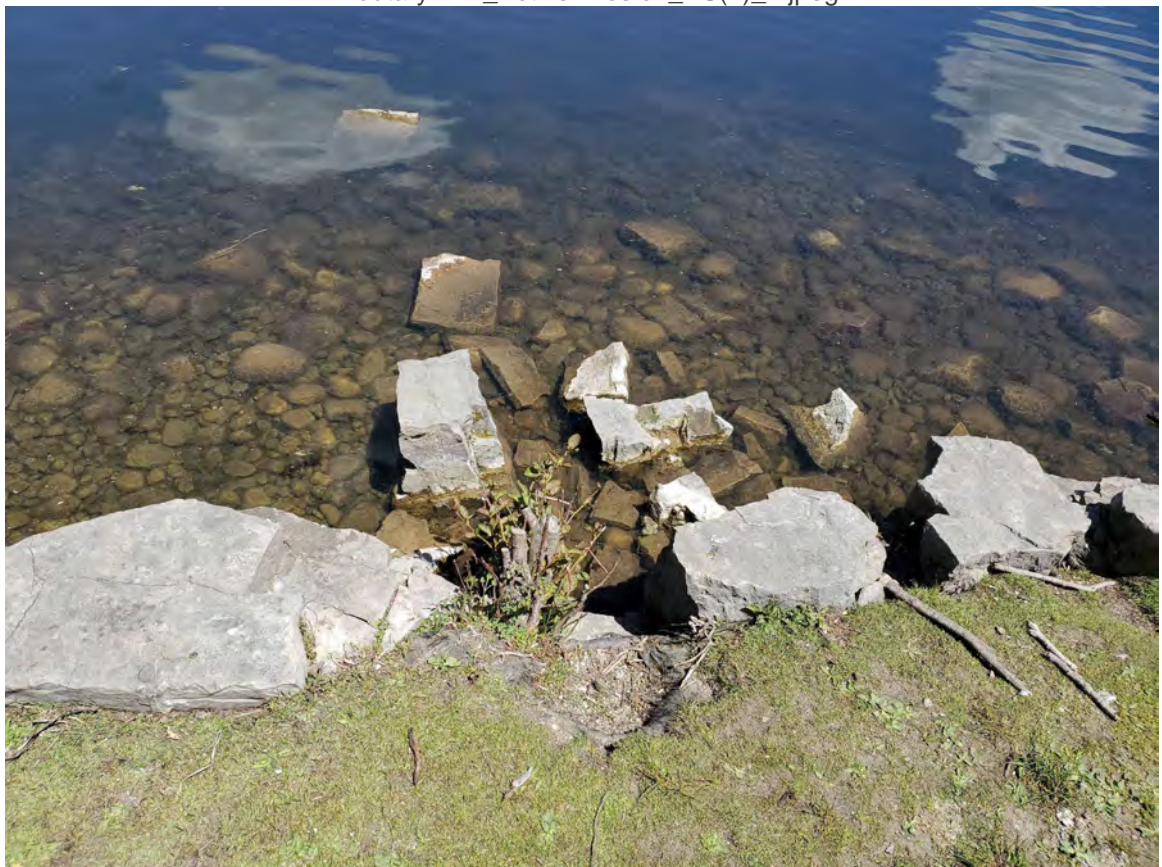
Stones bordering public pond look out are collapsing

EROSION TYPE(S)	SEVERITY	N	E	Z	PTID
Active Erosion	4- Safety Hazard	4793083.08	544818.67	287.17	21
