# 2022 OSIM Inspections for Municipal Bridges and Culverts larger than 3 meters

Township of North Dumfries

**MEDA Engineering and Technical Services**

**31 May 2022**

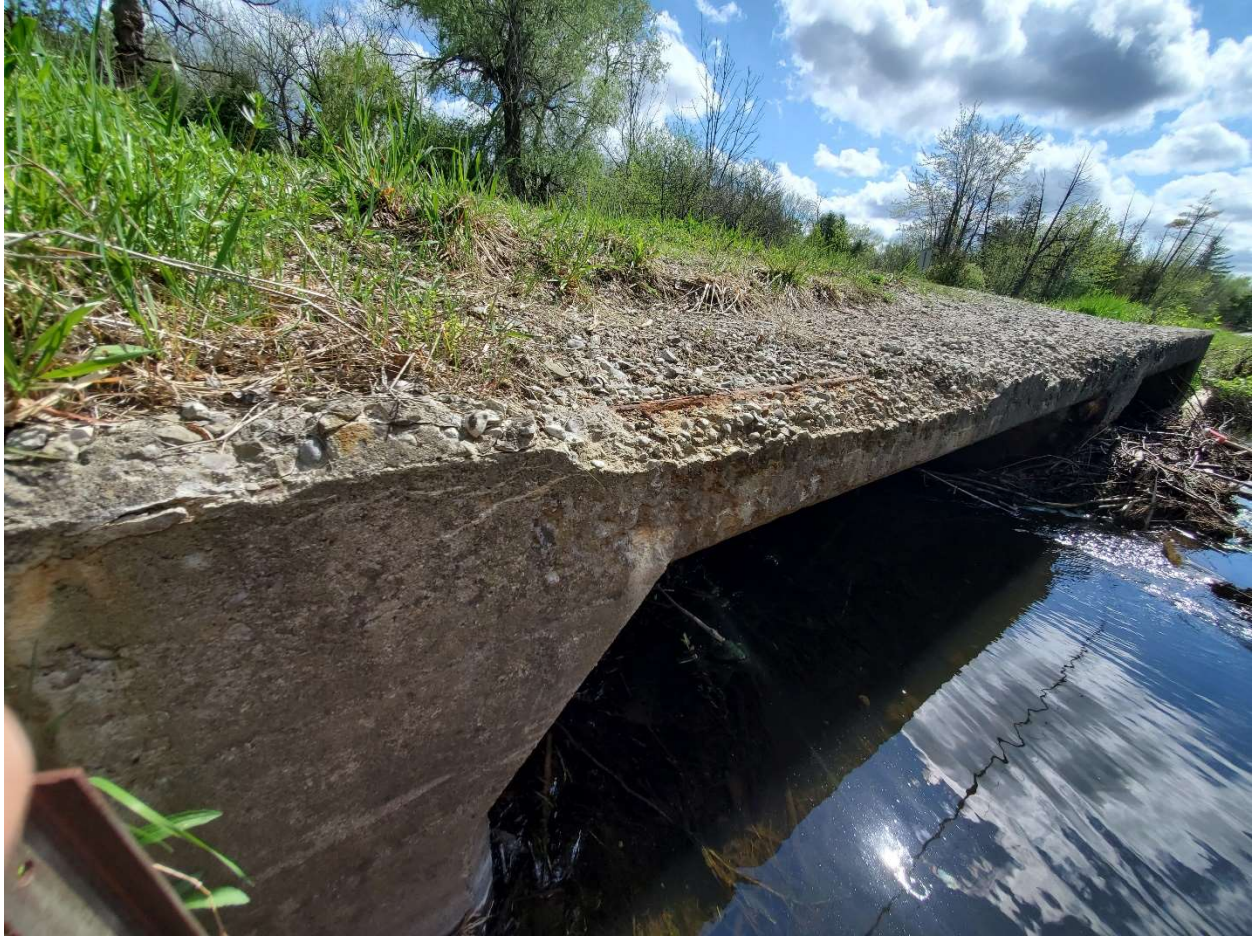
Water obstruction
