BUILDING CONDITION ASSESSMENT FOR

THE TOWNSHIP OF NORTH DUMFRIES

PUBLIC WORKS BUILDINGS

1168 GREENFIELD ROAD

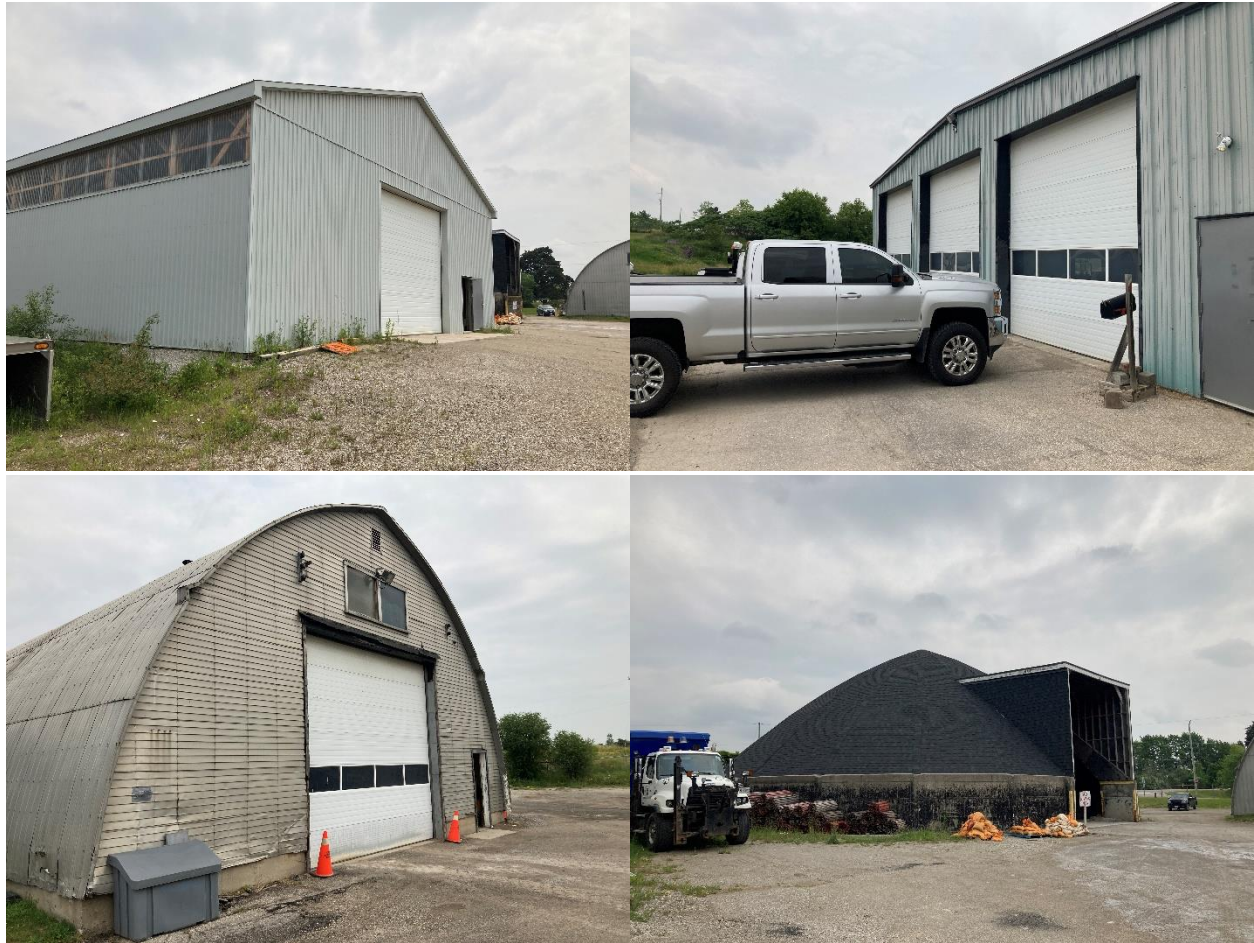
The North Dumfries Public Works Depot is located at 1168 Greenfield Road in Ayr and includes the main service shop, a sand storage dome, a Quonset hut for material and equipment storage, and a storage shed for vehicles. The main service shop is a pre-engineered steel structure with metal wall panels, aluminum windows and metal sectional overhead doors. The Quonset hut is a wood structure with metal siding and a metal sectional overhead door. The storage shed is a wood framed structure with metal siding and a sloped metal roof. The sand dome is a wood structure with asphalt shingles.
