# BUILDING CONDITION ASSESSMENT FOR

THE TOWNSHIP OF NORTH DUMFRIES

### **BRANCHTON PARK**

### 30 MARY ST., BRANCHTON

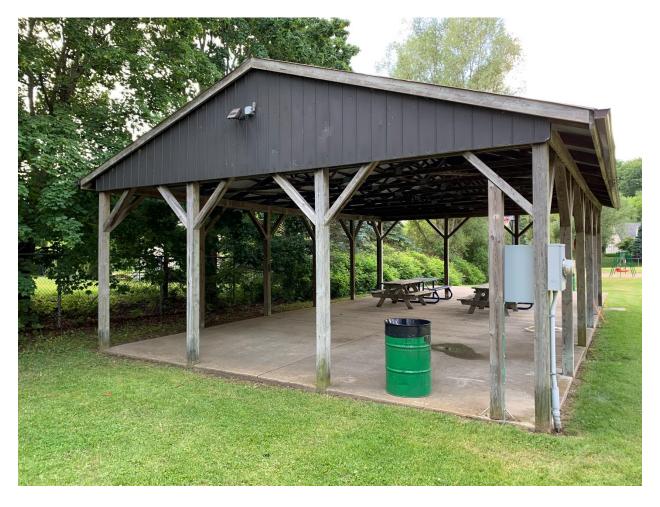
Branchton park is a public park located at the end of Mary Street and Jenkings Court in Branchton. The park features a baseball diamond, playground equipment and a pavilion. The pavilion is a wood structure with a concrete floor slab and a sloped metal roof. The park includes a section of roadway at the end of Mary Street that enters into the park.

The pavilion is unserviced except for LED lighting on the gables and soffit.

Branchton park is a public park located at the end of Mary Street and Jenkings Court in Branchton. The park features a baseball diamond, playground equipment and a pavilion. The pavilion is a wood structure with a concrete floor slab and a sloped metal roof. The park includes a section of roadway at the end of Mary Street that enters into the park.
