BUILDING CONDITION ASSESSMENT  
FOR

THE TOWNSHIP OF NORTH DUMFRIES

**COWAN PARK**

**2958 GREENFIELD ROAD**

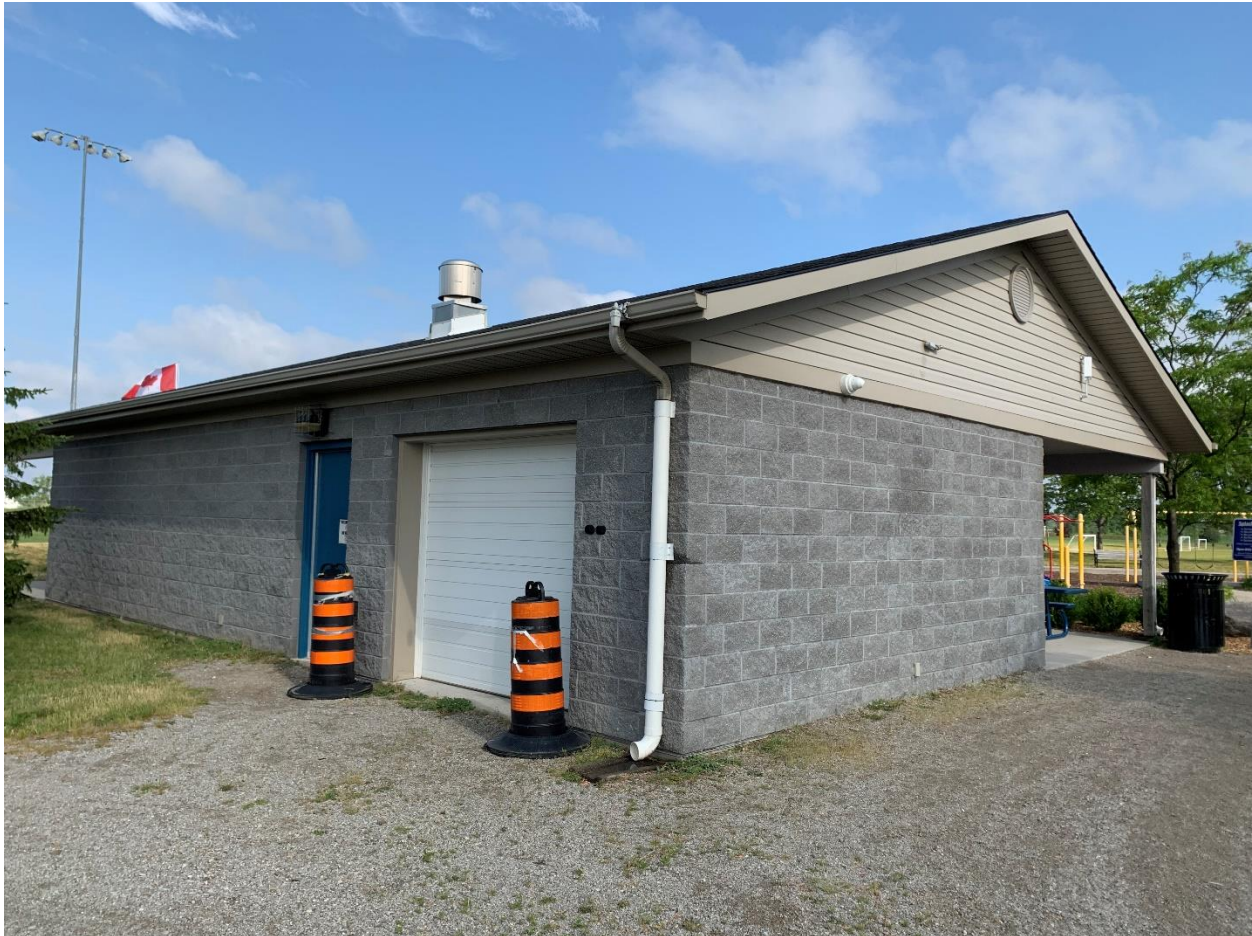
Cowan Park is located on Sangers Lane adjacent the North Dumfries Community Complex. The park includes soccer fields, a splash pad, a washroom building, skate park, exercise equipment and a walking path. The washroom building is a concrete block masonry structure with a concrete slab-on-grade. The roof is sloped with an asphalt shingle finish. The washroom doors are hollow metal with button activated openers.
