BUILDING CONDITION ASSESSMENT FOR

AYR FIRE STATION

501 SCOTT STREET

PROJECT NO:	GDR223-0353-00
SITE VISIT DATE:	June 15, 2023
REPORT DATE:	October 11, 2023

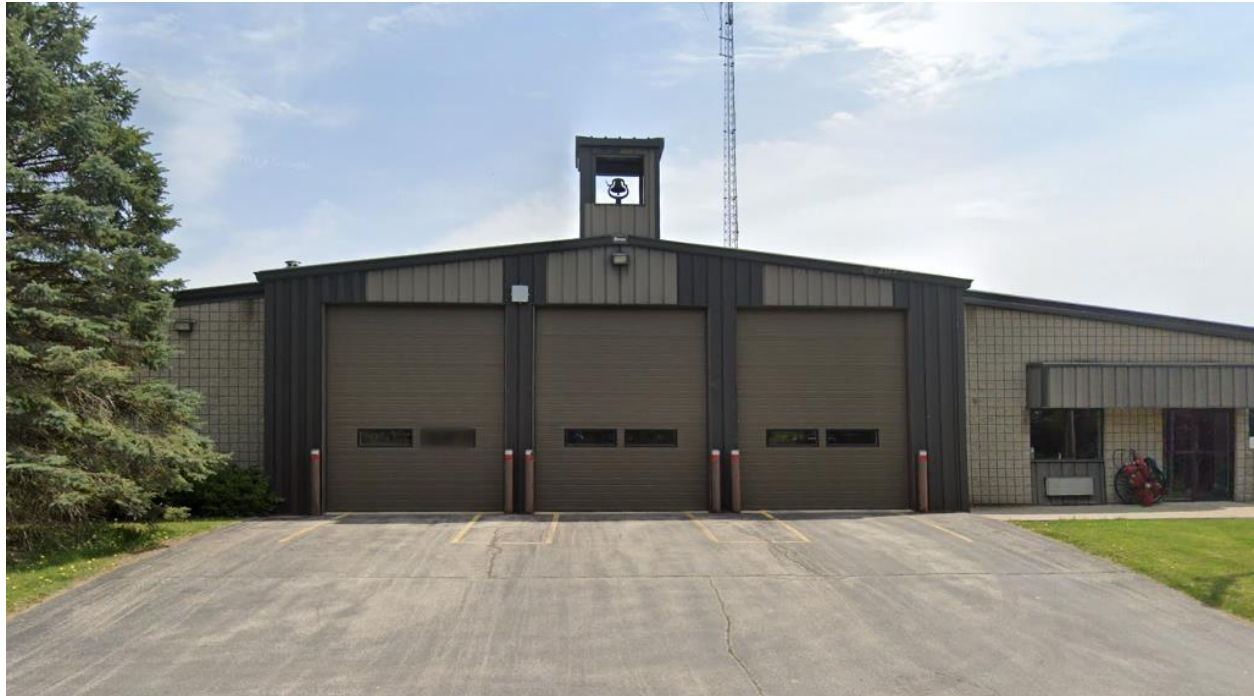
The Ayr Fire Station is a pre-engineered steel and concrete block masonry structure built circa. 1990. The exterior walls of the facility consist of split faced architectural concrete block masonry and prefinished metal siding. The roofing system is a sloped standing seam metal roof assembly. The garage side of the building has three vehicle bays including one drive-through bay with overhead doors on each end. The administrative side includes meeting rooms, offices, kitchen, washrooms, storage space and utility rooms.
