ASHRAE LEVEL II ENERGY AUDIT

VICTORIA PARK STORAGE BUILDING 75 Rose Street, Ayr, Ontario

Project No.: 2018-0527-11

May 8, 2019

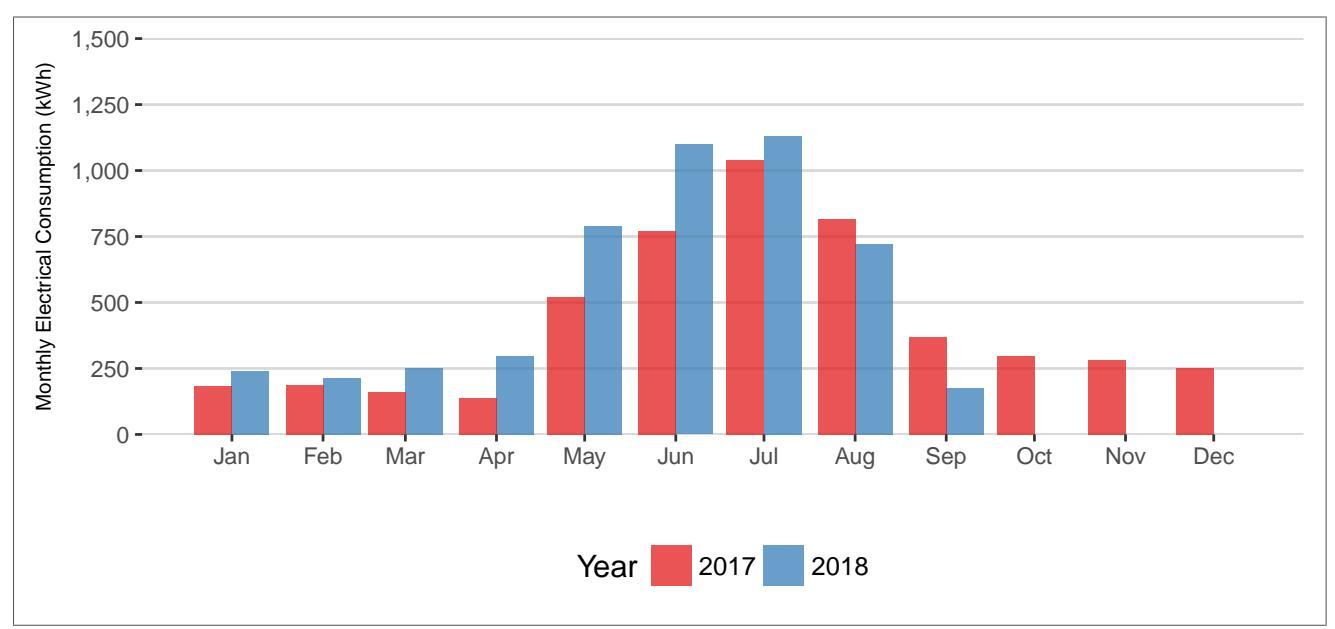
Figure 1: Monthly electricity consumption for the baseline period

Electricity is used for lighting and ventilation. As seen in Figure 1, monthly electricity consumption is typically higher in summer months.

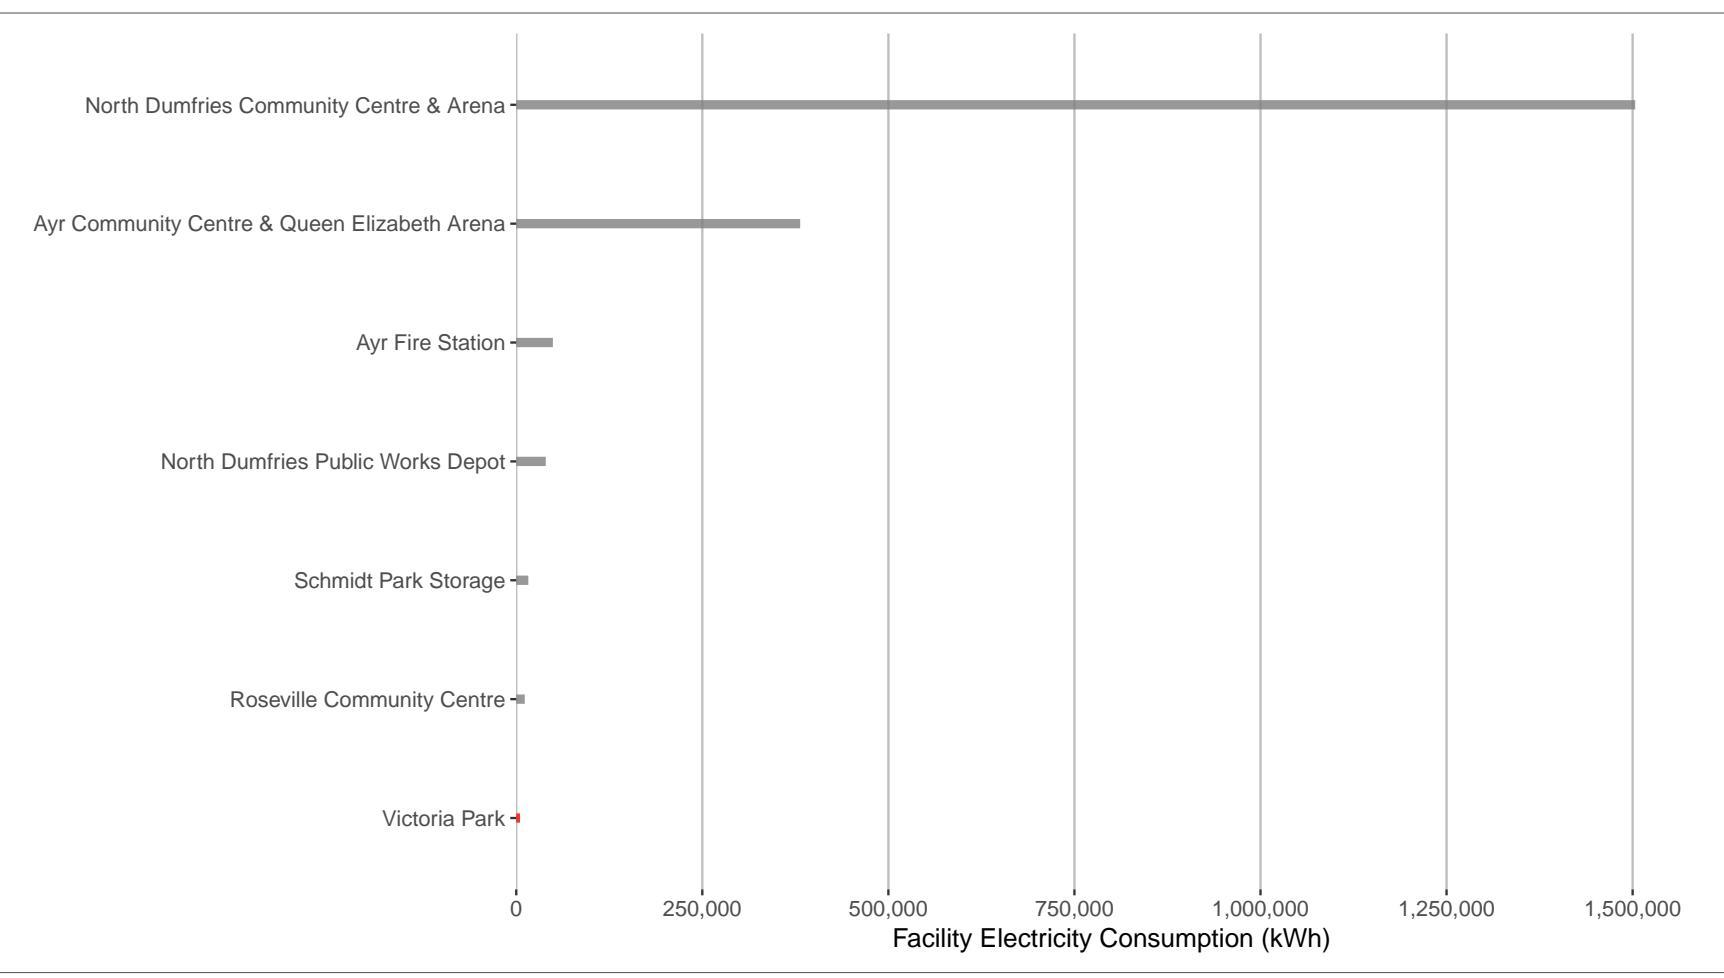
Figure 2: Annual electricity energy use by building

Figure 2 compares the total annual electricity of all North Dumfries facilities.

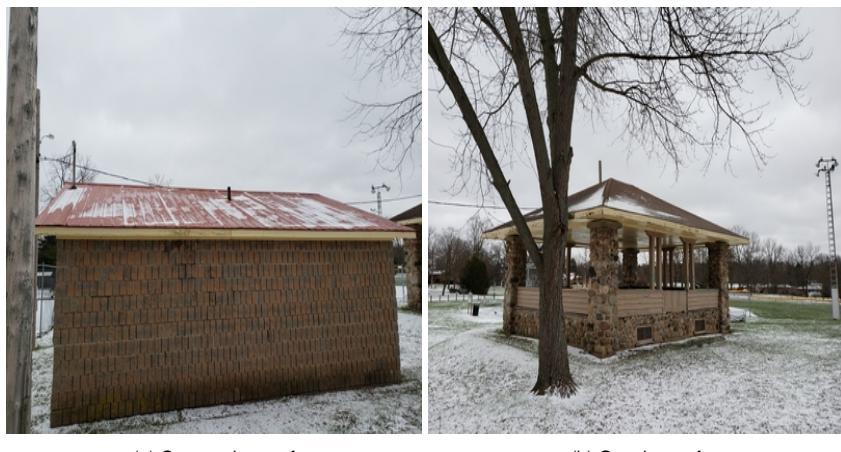
(a) Concession roof (b) Gazebo roof Figure 3: Building exterior walls

The gabled roof of the concession building is topped with a standing seam metal roofing assembly and painted wood fascia. The hipped roof of the gazebo is topped with ashpalt shingles and painted wood fascia.

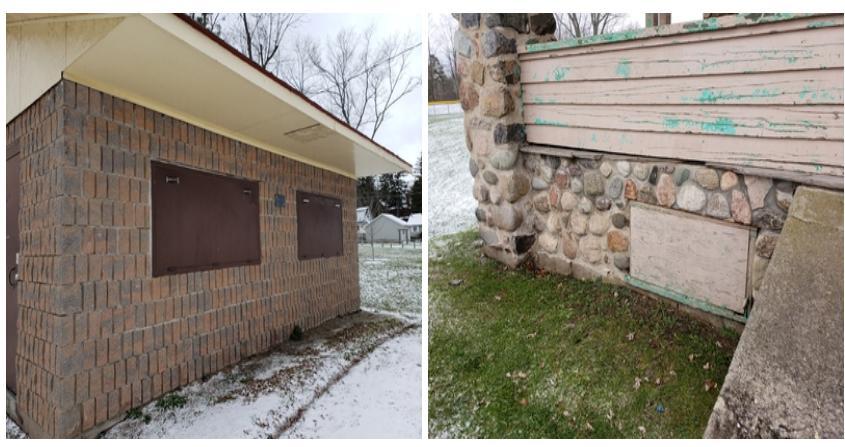
(a) Concession exterior wall (b) Gazebo exterior wall Figure 4: Building exterior walls

The exterior walls of the concession building are comprised of concrete block masonry. The exterior walls of the gazebo are comprised of natural stone masonry.

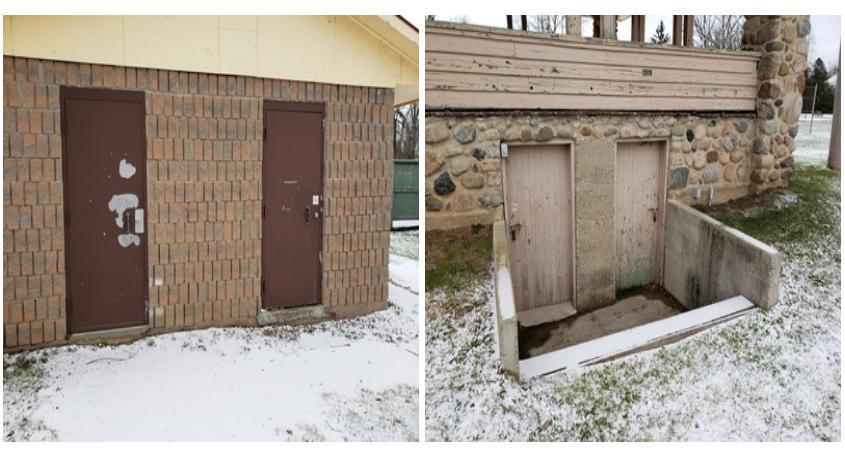
(a) Concession exterior doors (b) Gazebo exterior doors Figure 5: Building exterior doors

There are two concession stand windows situated along the east elevation of the concession building. There are two hollow metal doors which are situated along the south elevation of the concession building.

There are four openings in the exterior walls of the gazebo which were windows for the changerooms below. These openings are now blocked off.

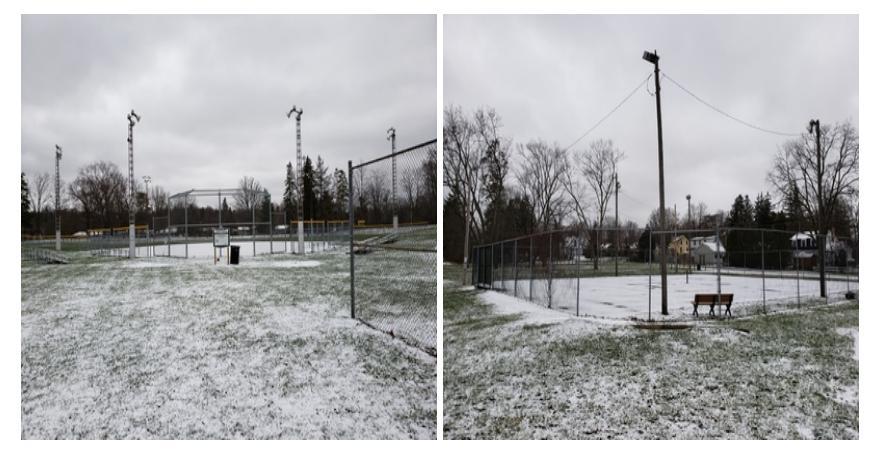
(a) Baseball diamond exterior lighting (b) Baseball diamond exterior lighting Figure 6: Exterior lighting

Table 12: Existing lighting fixtures					
Location	Fixture Type	Wattage	Quantity	Installed	
Baseball Diamond 1 Baseball Diamond 2	Spotlight Spotlight	1,000 400	6 6	N/A 1960

The exterior lighting consists of spotlights in the baseball diamonds.

This report analyzes an exterior LED fixture replacement with no fixture reduction.

Ta	able 14: Exte	erior LED lig	hting retrol	it	
ECM	Electricity Savings [kWh]	Nat. Gas Savings [m³]	Cost Savings [\$]	Capital Cost [\$]	Utility Incentive [\$]	Simple Payback [years]
Exterior LED lighting retrofit	2,213.6	0	330	18,000	2,100	48.2
