December 2, 2016

Reference No. 11116995

Re: 2016 OSIM Inspections for Municipal Bridges and Culverts Larger Than 3 Metres

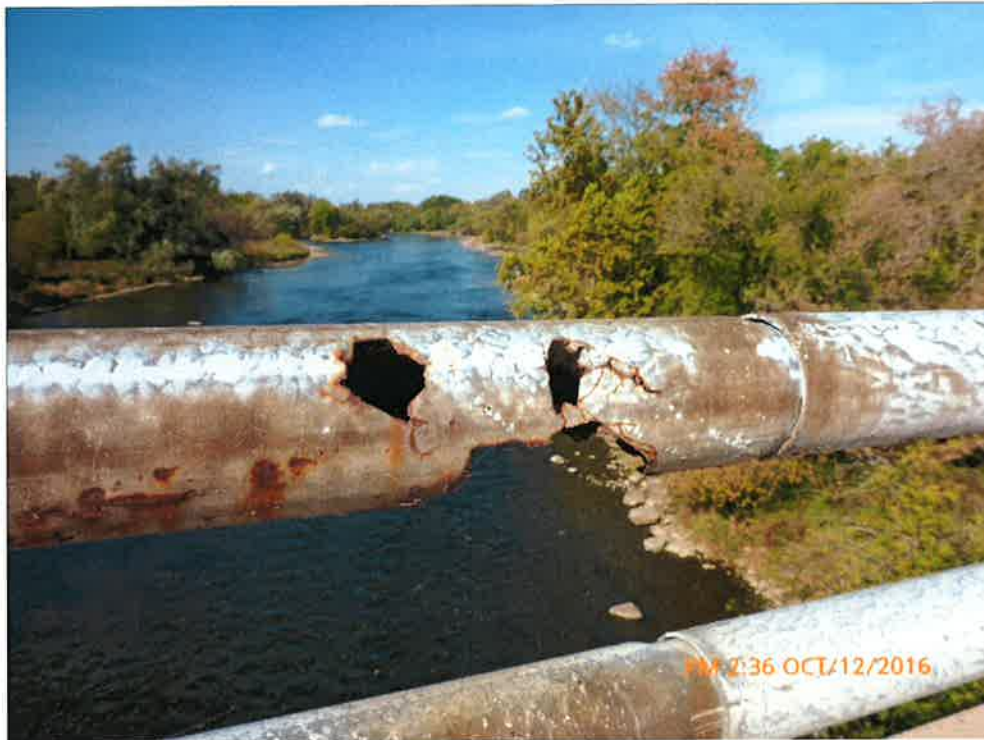
Severe Corrosion and Perforations on Handrail

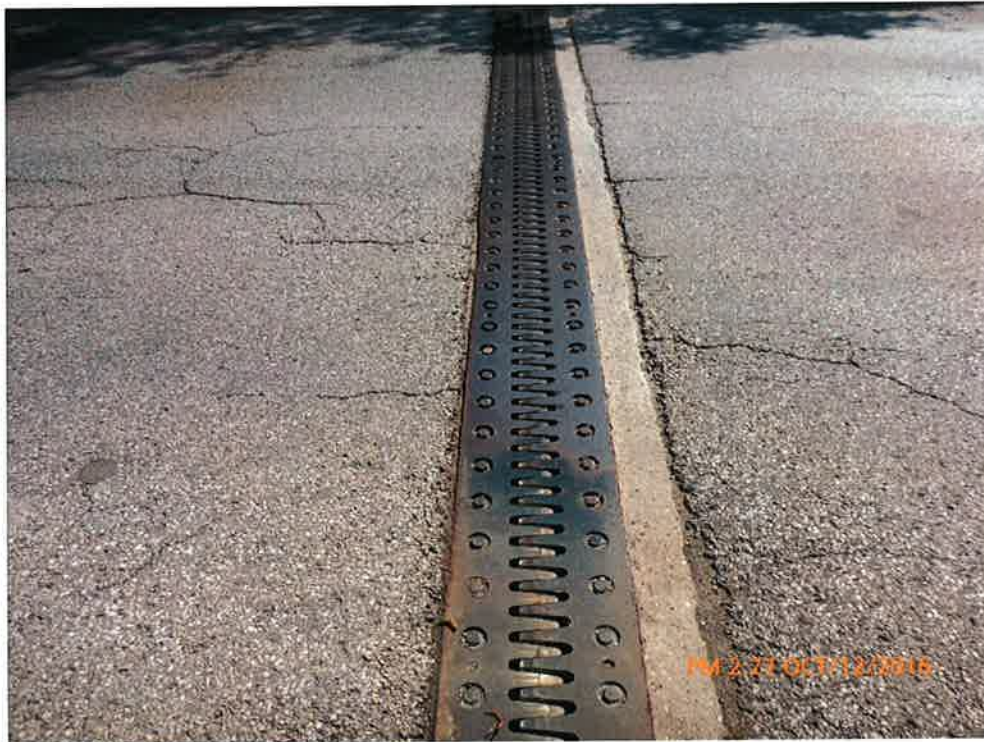
West Expansion Joint

Joints	Armouring/Retaining Devices		Replace Costed under seals	1-5 yrs	\$0
Joints	Seals/Sealants		Replace Replace expansion joints	1-5 yrs	\$70,000
Sidewalks/curbs	Curbs		Replace Replace with sidewalk on one side	1-5 yrs	\$250,000
Total Repair/Rehabilitation Cost					\$1,593,000

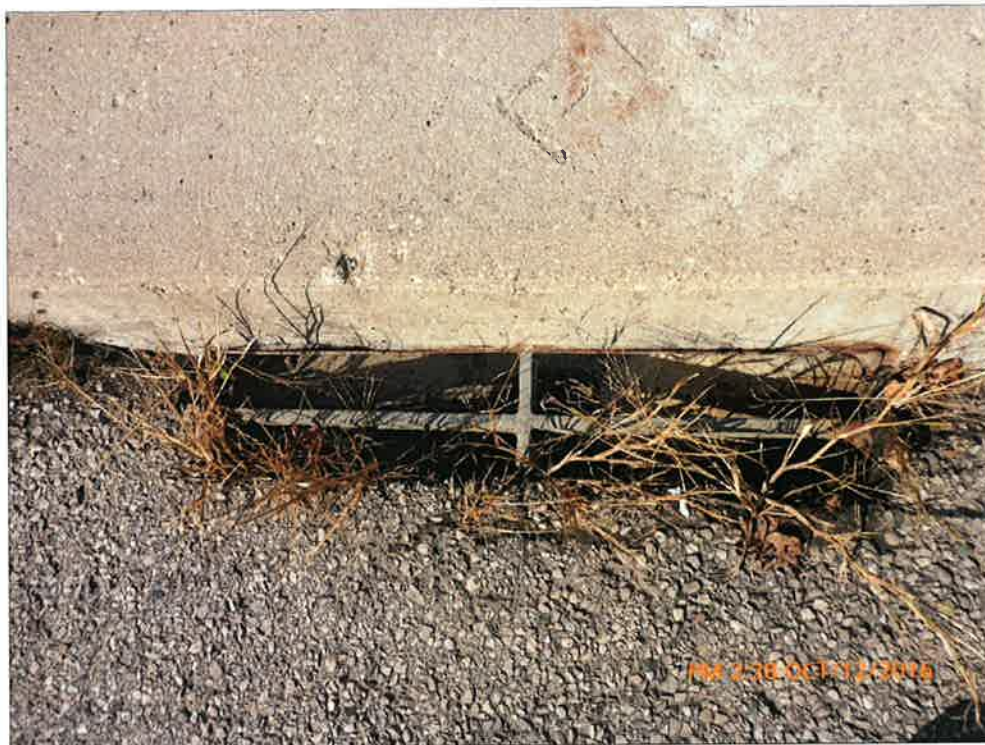
Broken Deck Drain

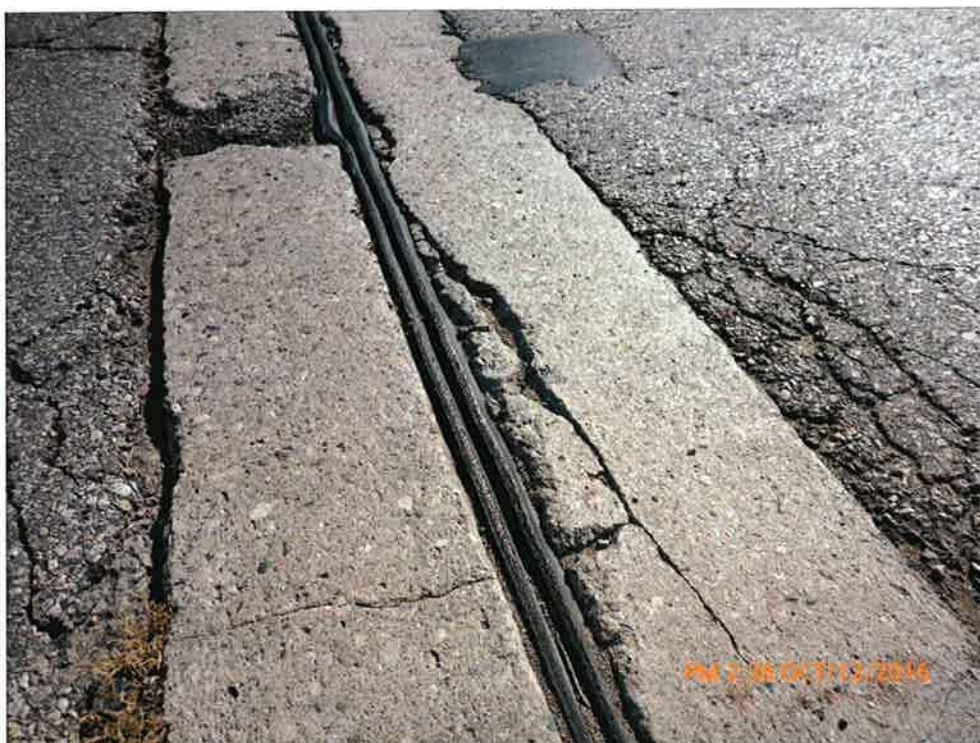
Delamination on Concrete End Dams

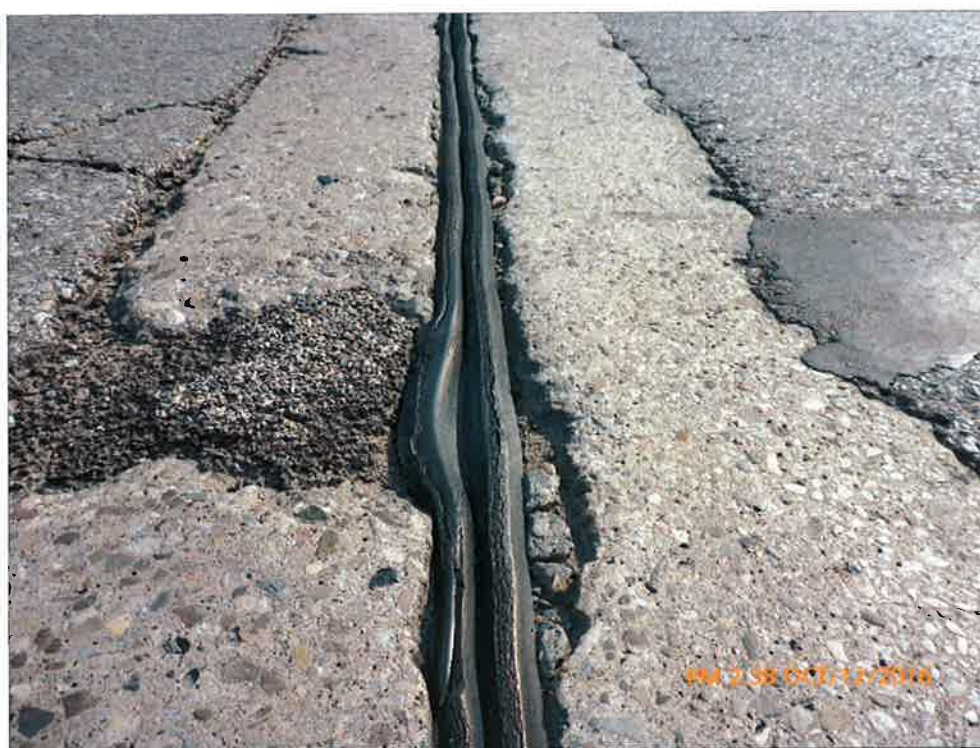
Displaced Seal

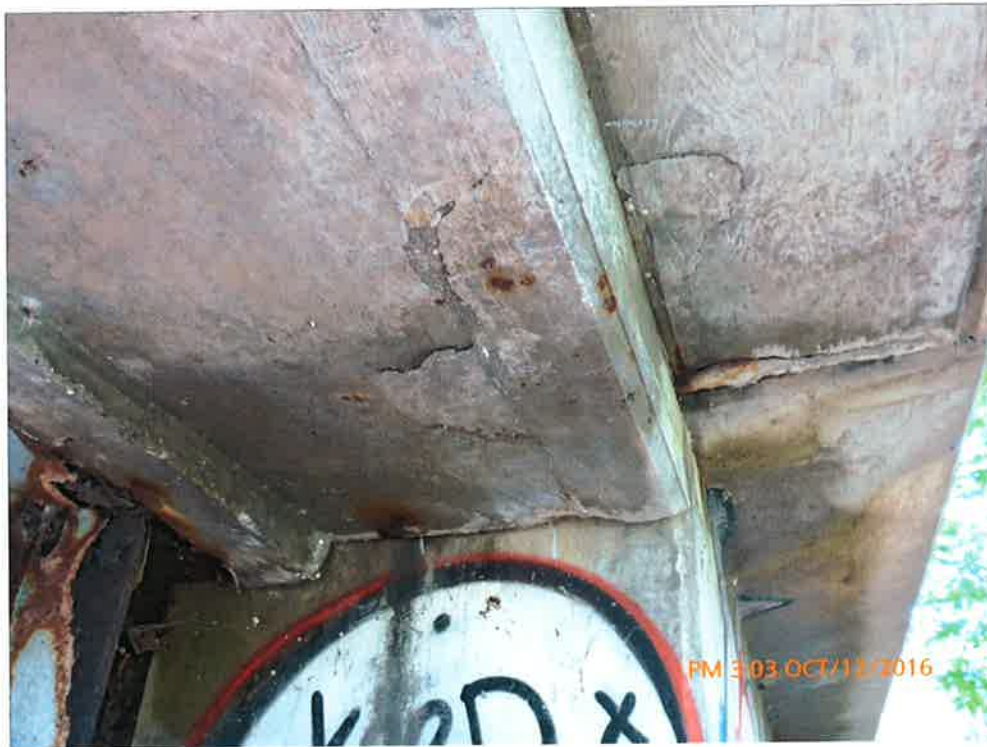
Delamination on End Soffit

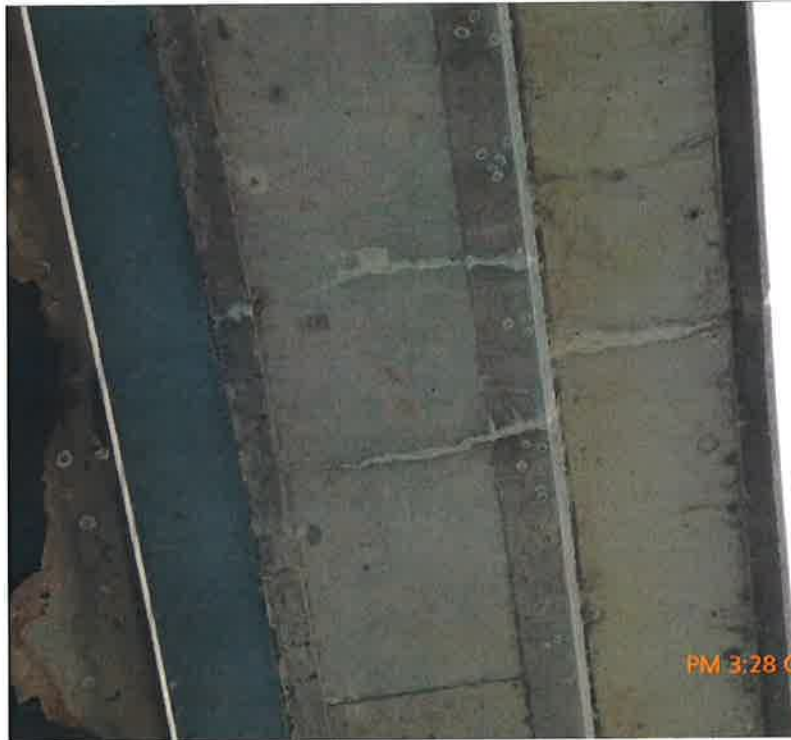
Narrow Stained Cracks on Exterior Soffit

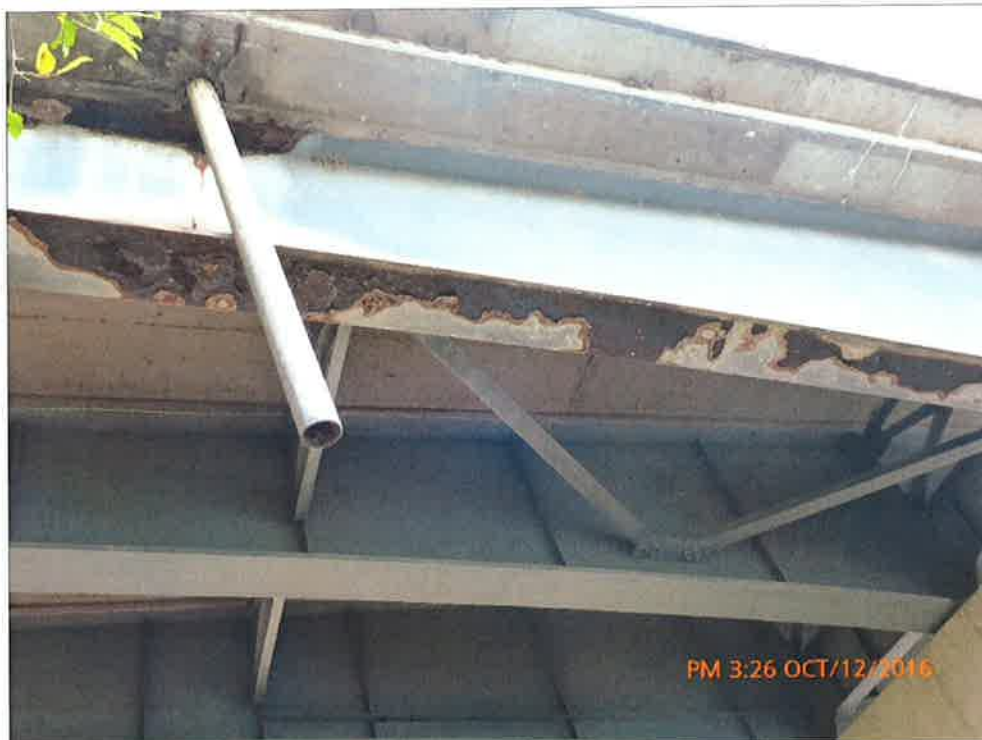
Breakdown of Protective Coating

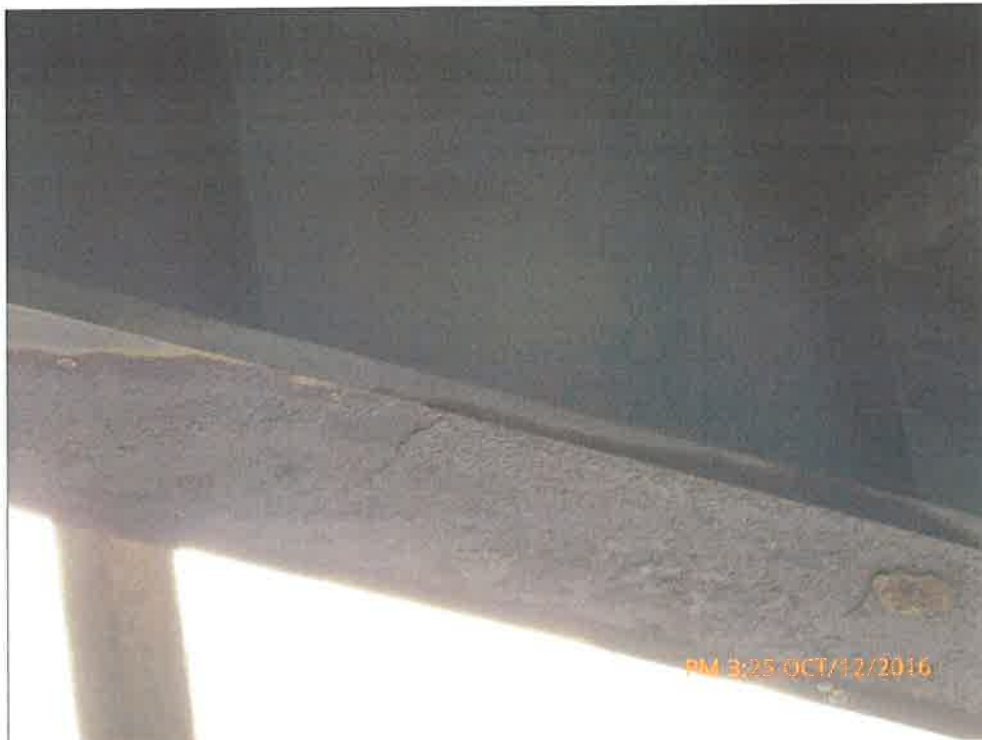
Localized Medium Corrosion on Girder Middle

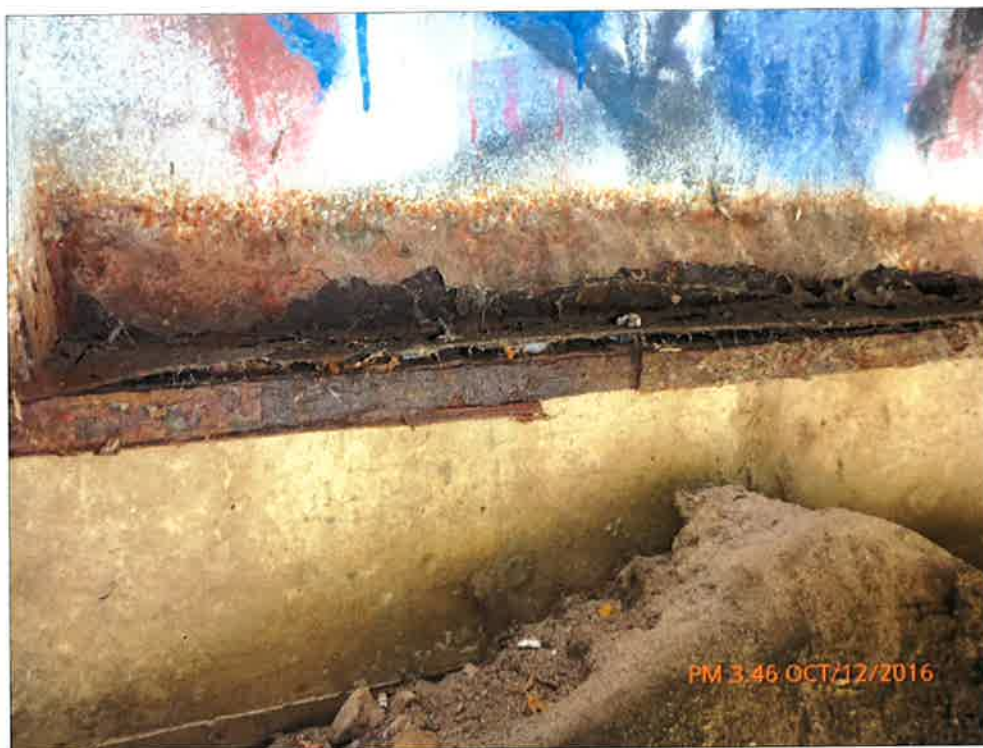
Medium Corrosion on End Diaphragm

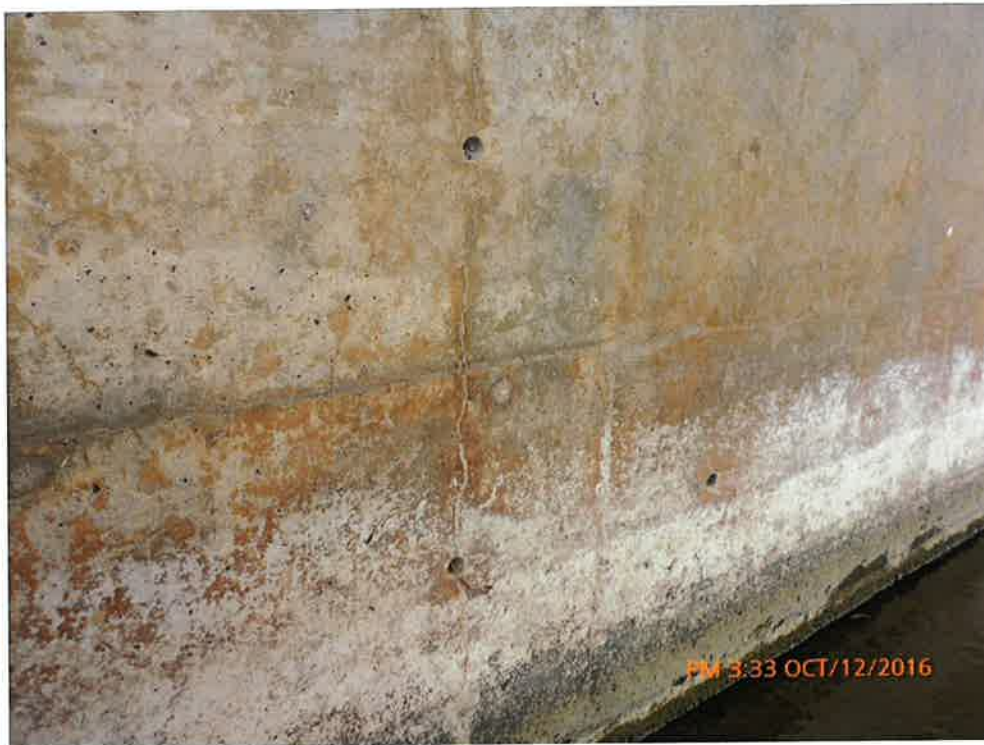
Narrow Stained Crack on Pier

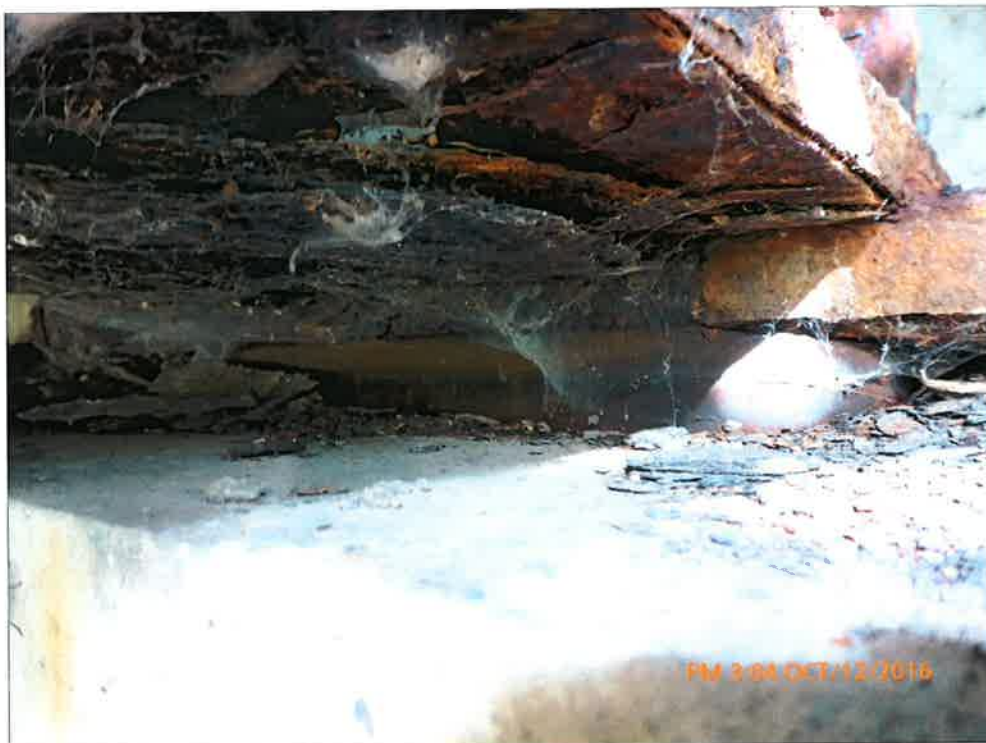
Severe Squashing of East Abutment Bearing

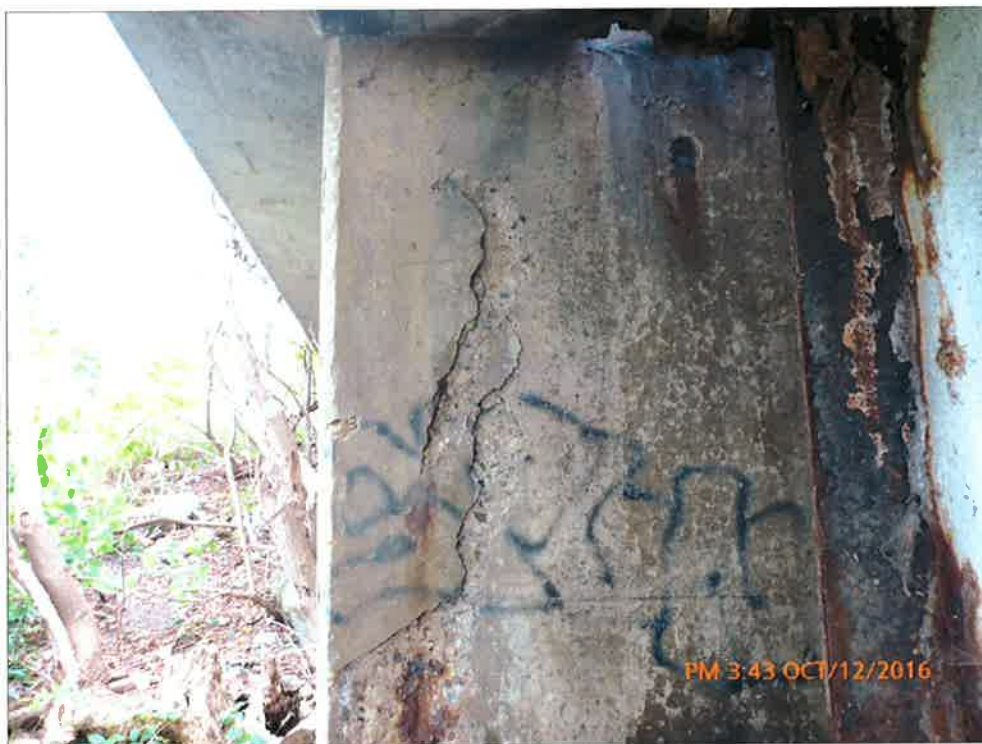
Delamination on Ballast Wall

Element Group	Element		Repair/Rehabilitation	Priority	Cost
Abutments	Abutment Walls		Rehab Patch repair	1-5 yrs	\$10,000
Abutments	Ballast Walls		Rehab Replace with semi-integral joints (costed under Joints)	1-5 yrs	\$0
Approaches	Approach Guiderail	Terminal	Replace Costed under Approach Guide Rail		\$0
Abutments	Wingwalls		Rehab Patch repairs	1-5 yrs	\$3,000
Approaches	Approach Guiderail		Replace Replace Guide Rail	1-5 yrs	\$110,000
Barriers	Barrier/Parapet Walls	Interior	Replace Replace Parapet Walls & Railing	1-5 yrs	\$420,000
Barriers	Hand Railings		Replace Costed under Barriers Interior	1-5 yrs	\$0
Barriers	Barrier/Parapet Walls	Exterior	Replace Costed under Barriers Interior	1-5 yrs	\$0
Decks	Drainage		Rehab Replace two drains near east pier. Repair leaking drain at northwest.	1-5 yrs	\$5,000
Decks	Deck Top		Rehab Costed under Deck Wearing Surface	1-5 yrs	\$0
Decks	Wearing Surface		Rehab Overlay, Waterproof & Pave	1-5 yrs	\$725,000

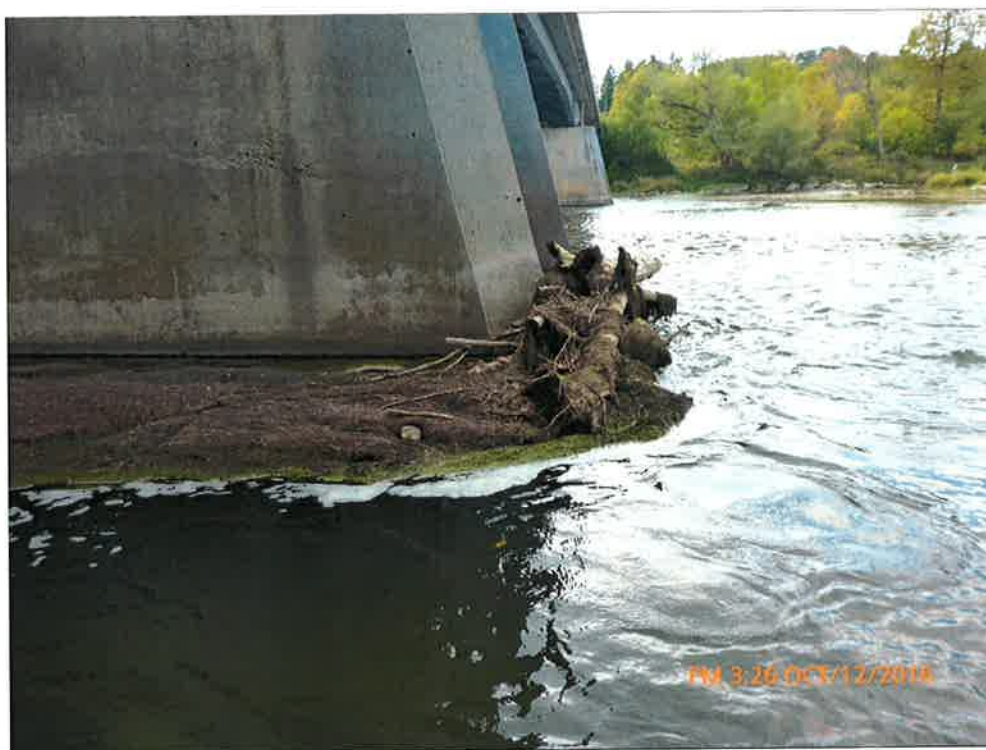
Minor Build-up of Debris in Watercourse

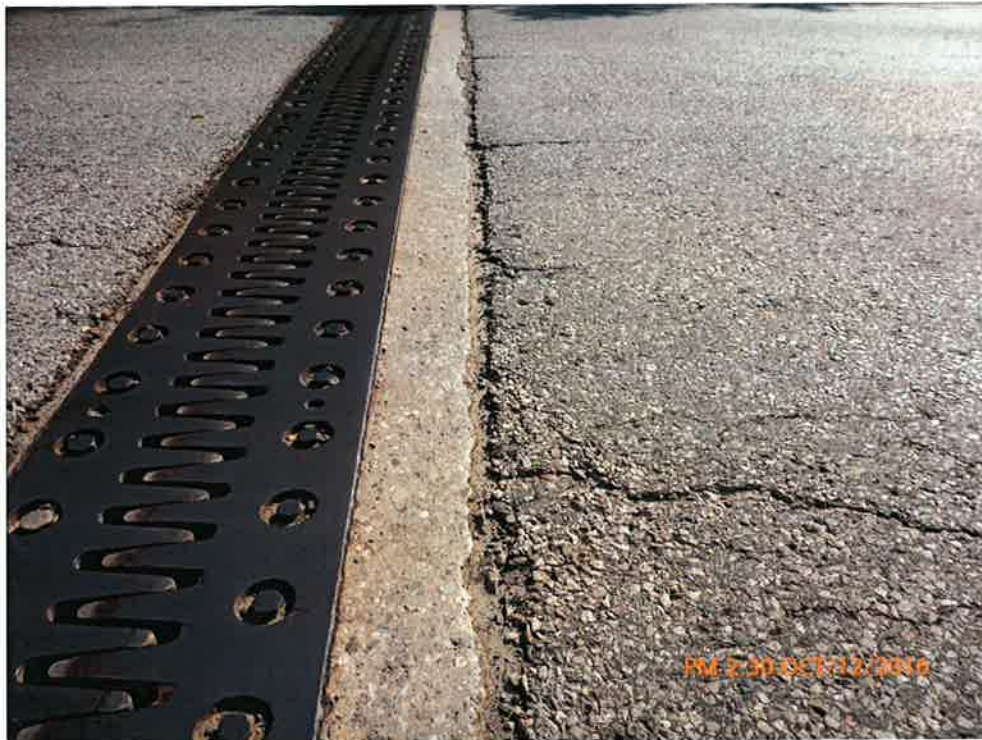
Gap Between End Dam and Approach Wearing Surface

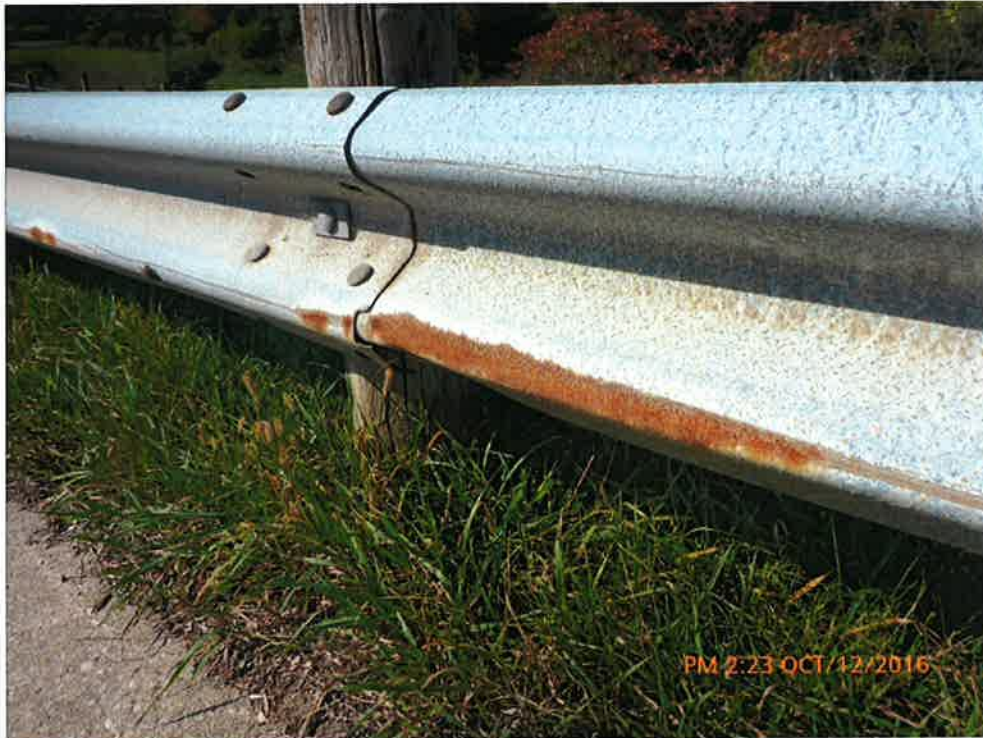
Minor Breakdown of Protective Coating

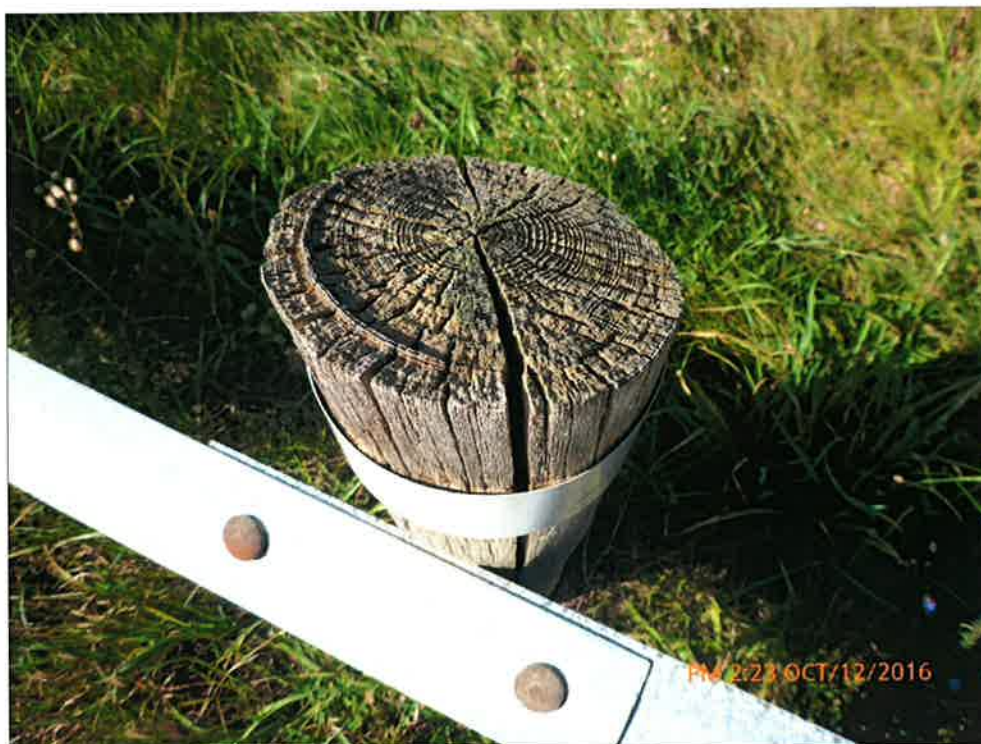
Light Split in Approach Guiderail Post

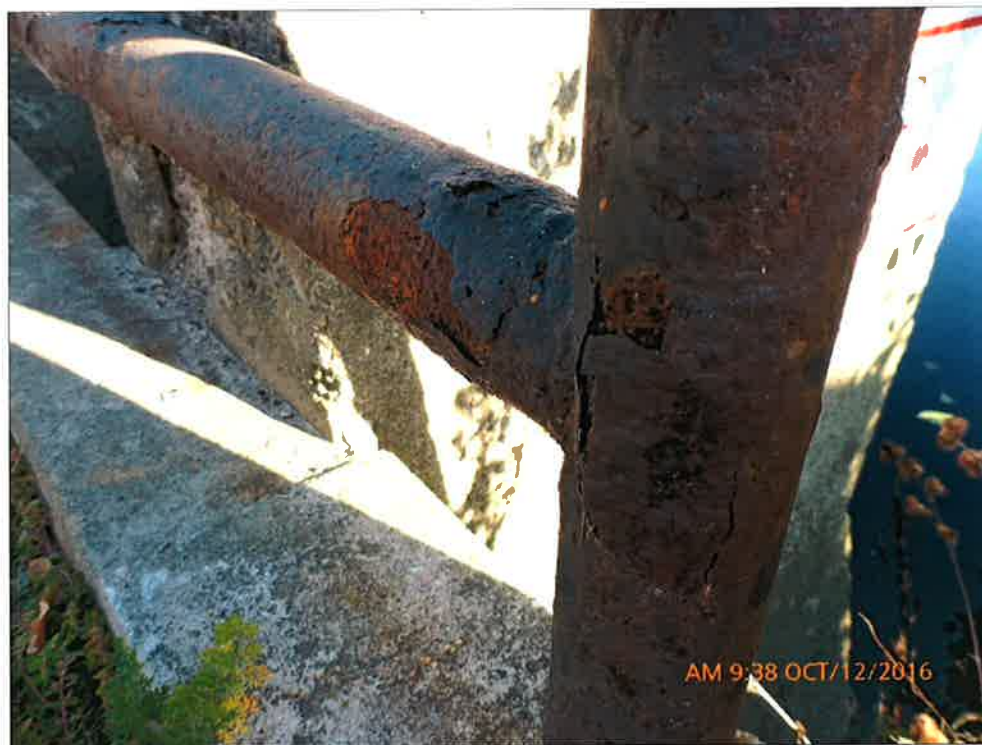
Flaking of Protective Coating on Handrail

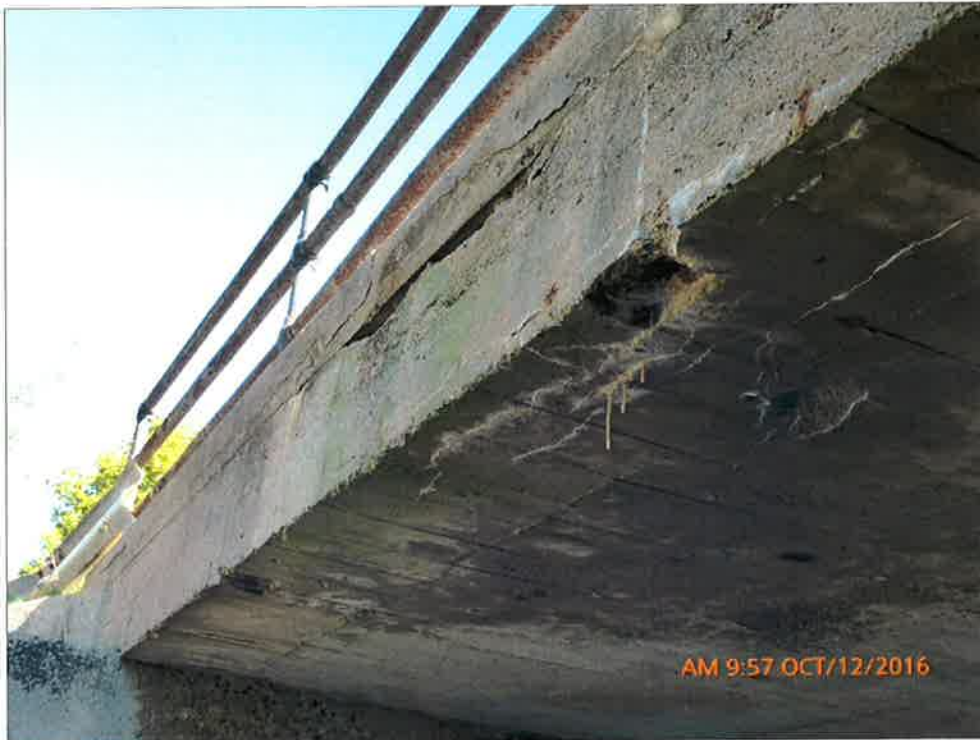
Light Spall on Exterior Soffit

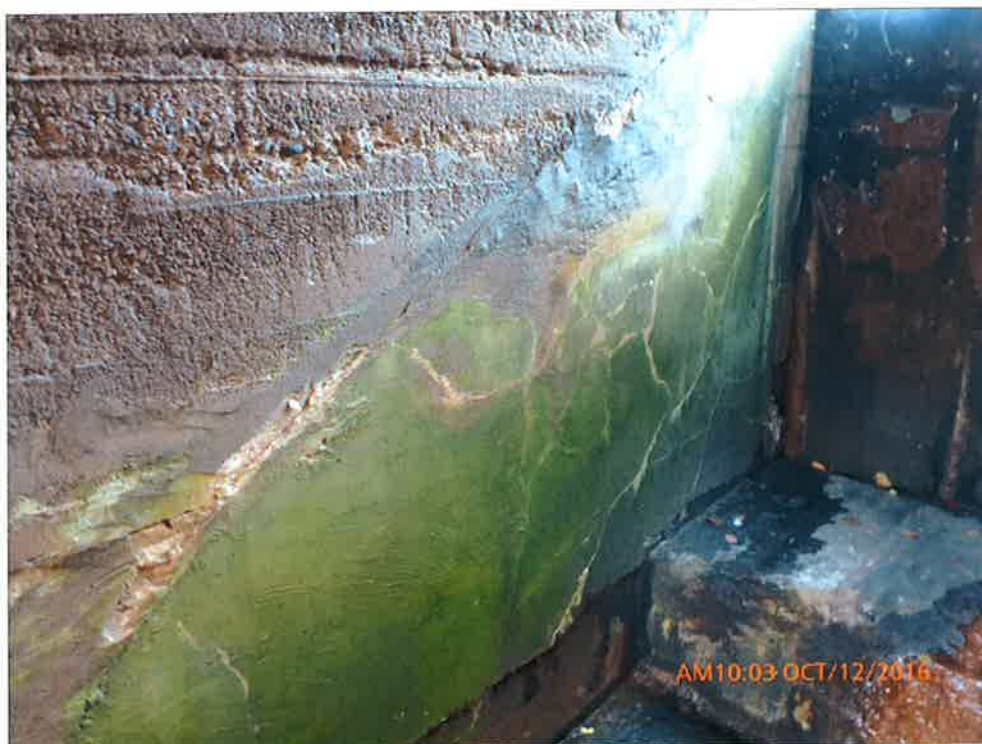
Severe Delamination on Pier

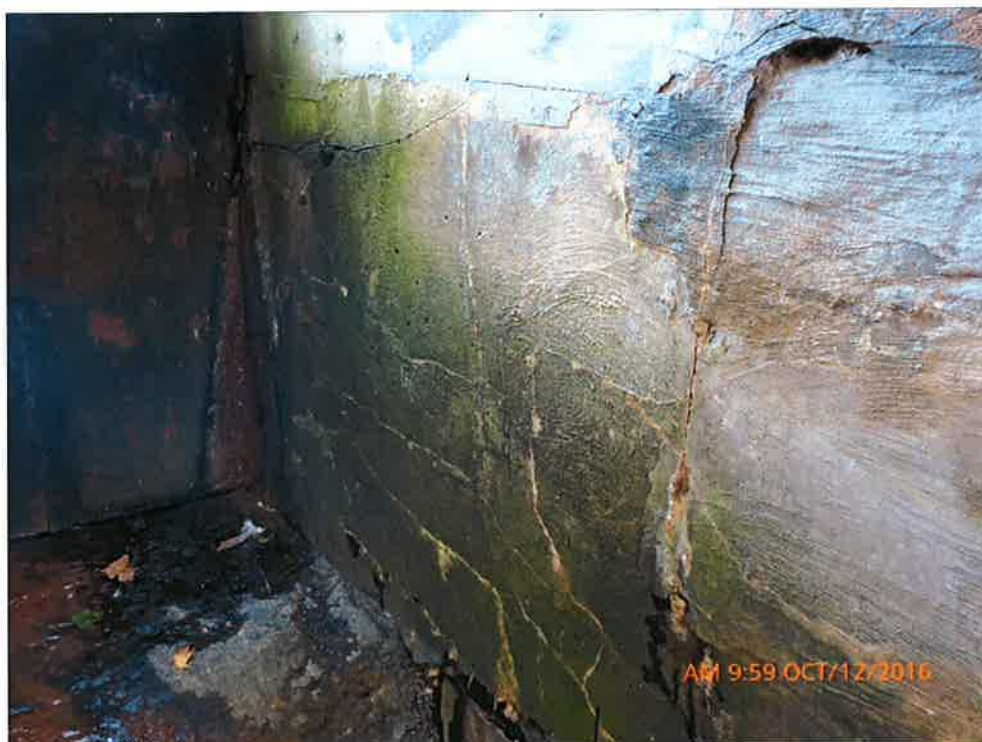
Severe Delamination on Abutment

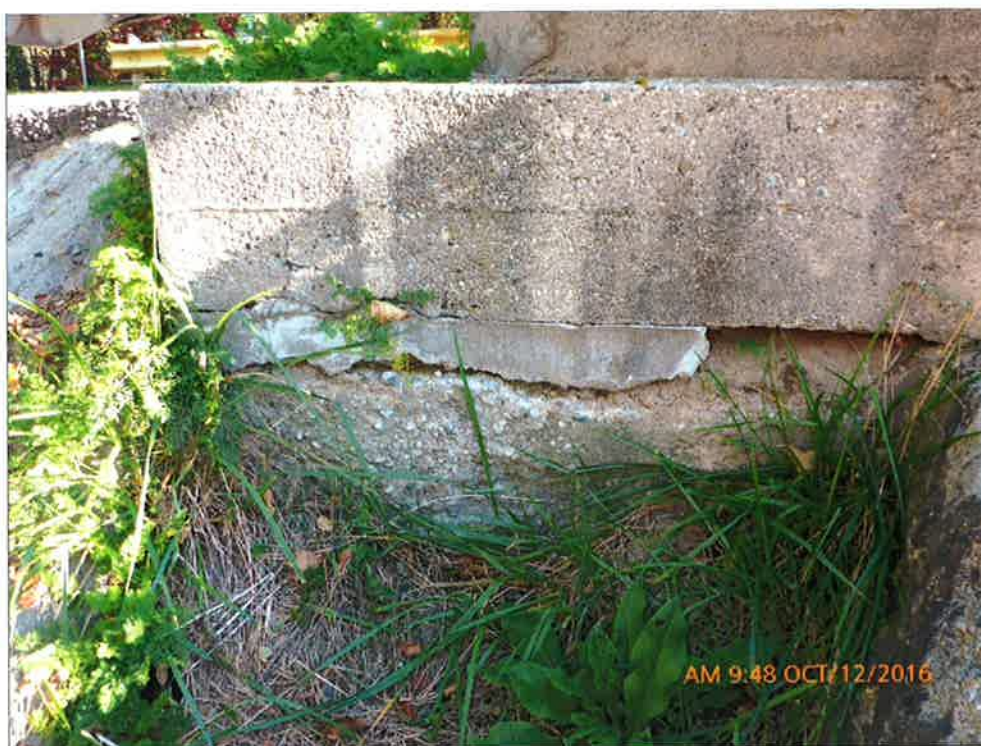
Debonded Concrete Patch on Wingwall

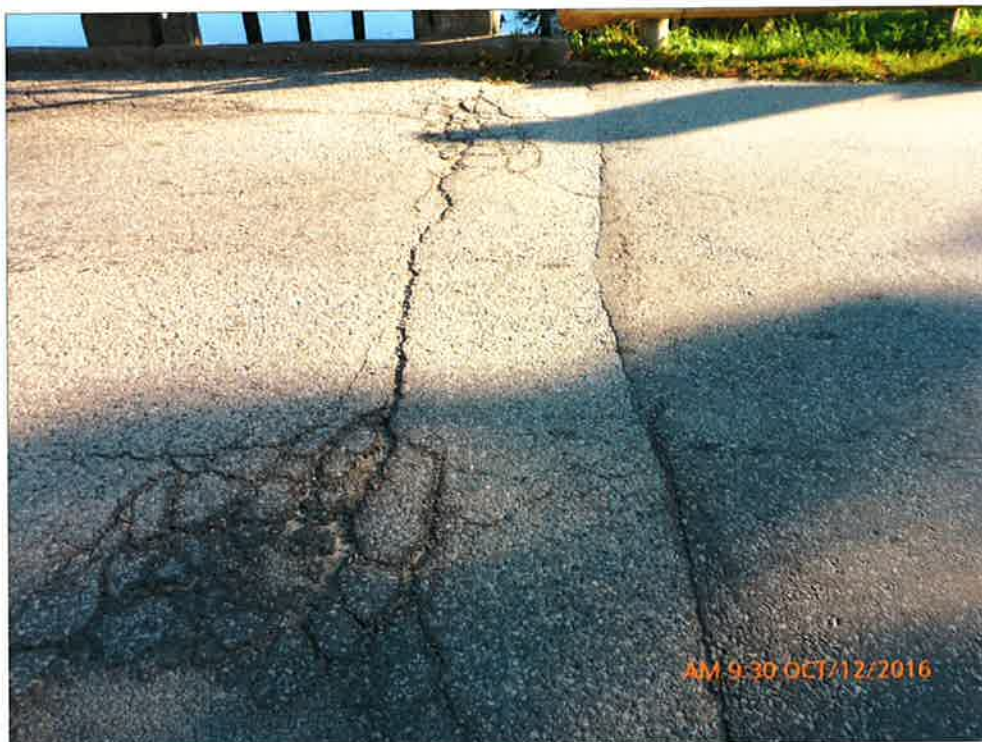
Wide Crack in Approach Wearing Surface

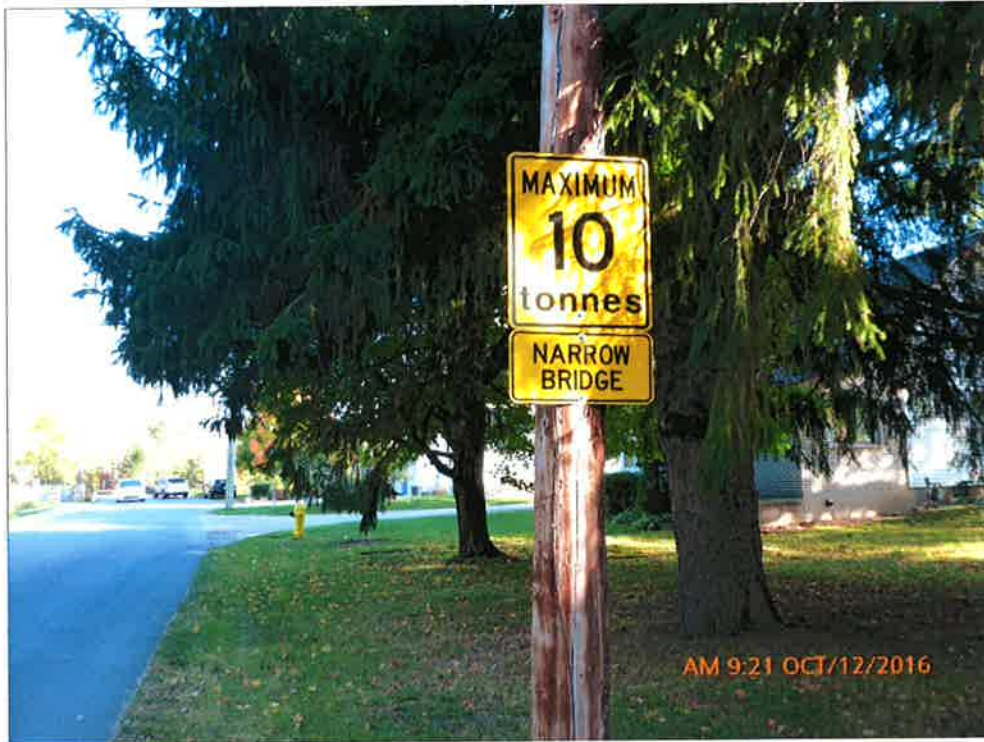
Typical Load Posting Sign on Approach

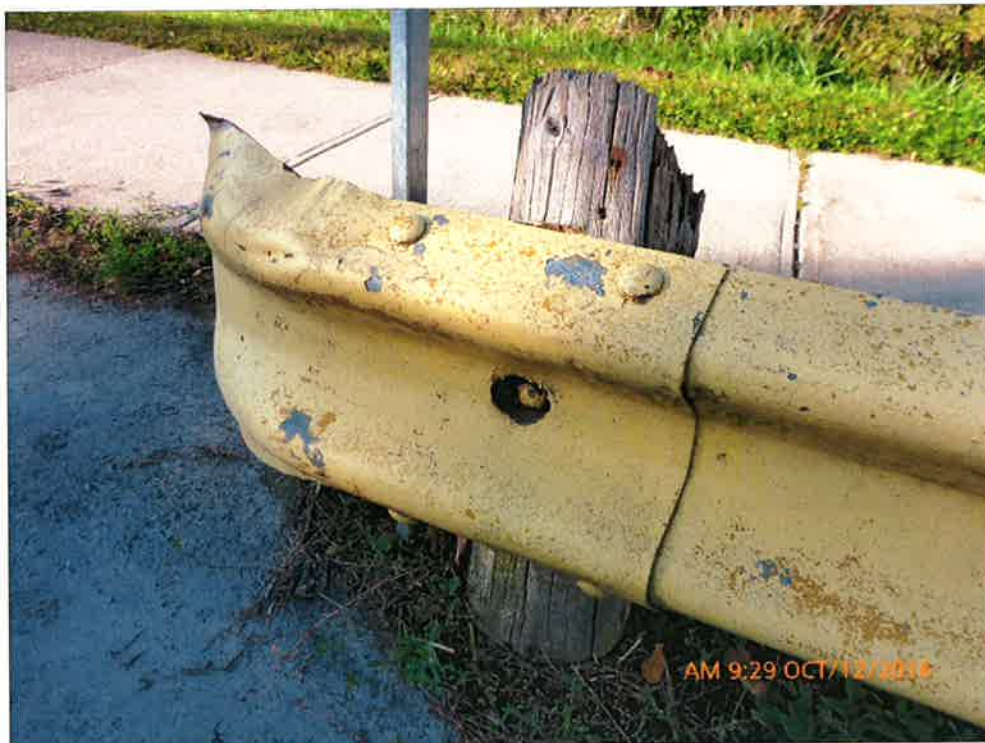
Guiderail Not Attached to Post

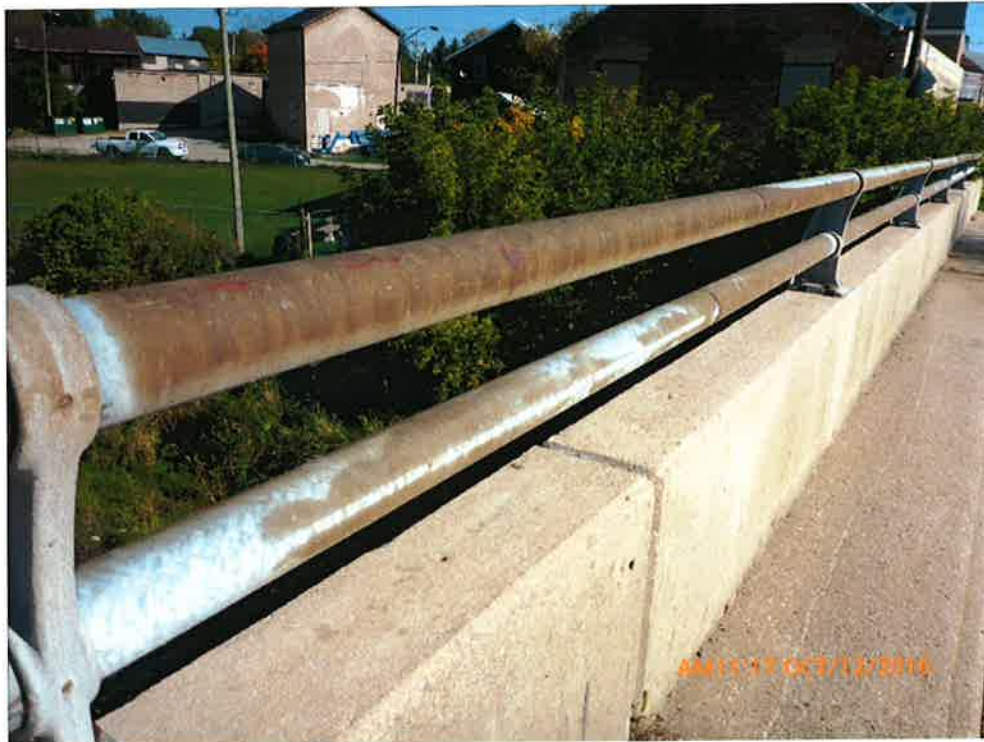
Breakdown of Protective Coating

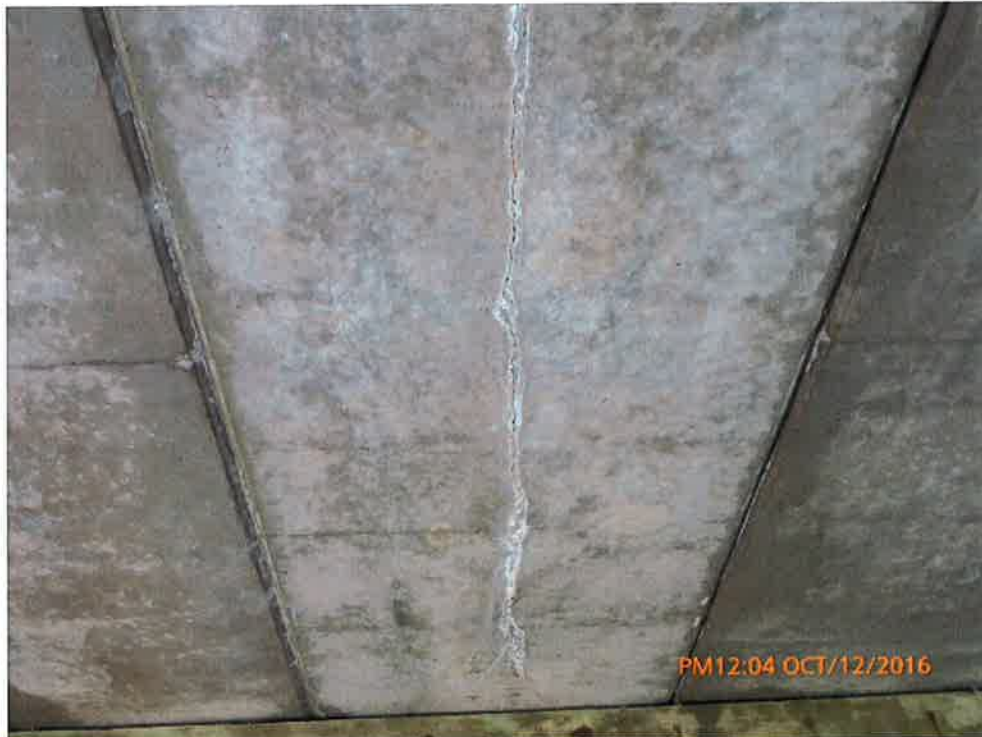
Wide Longitudinal Crack in Box Beam at End

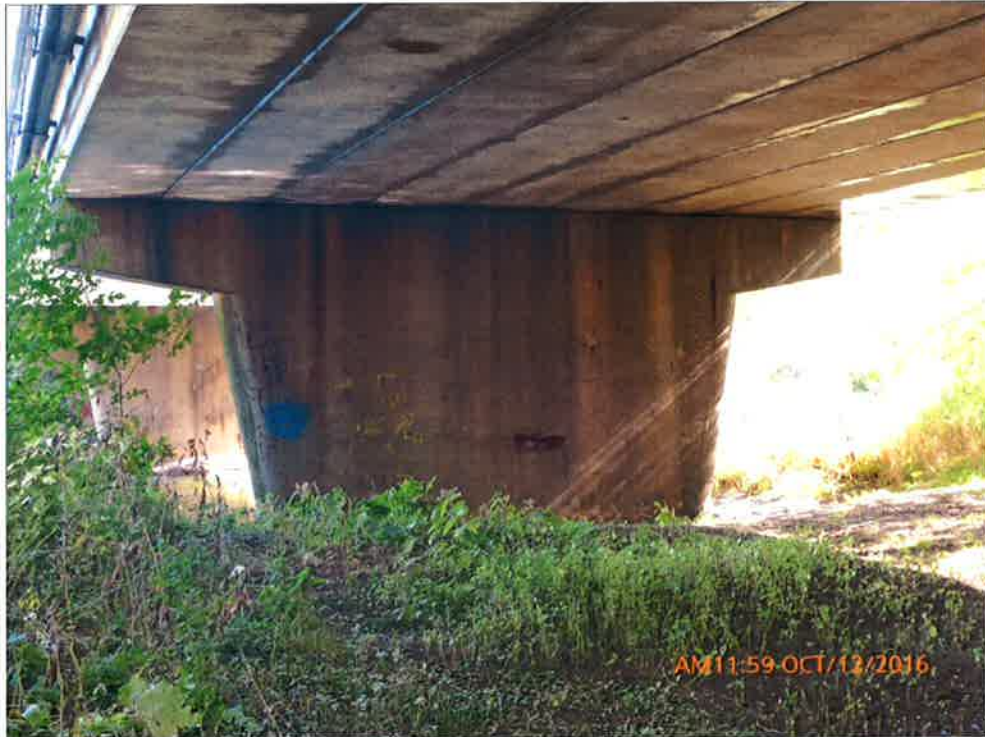
Typical Pier

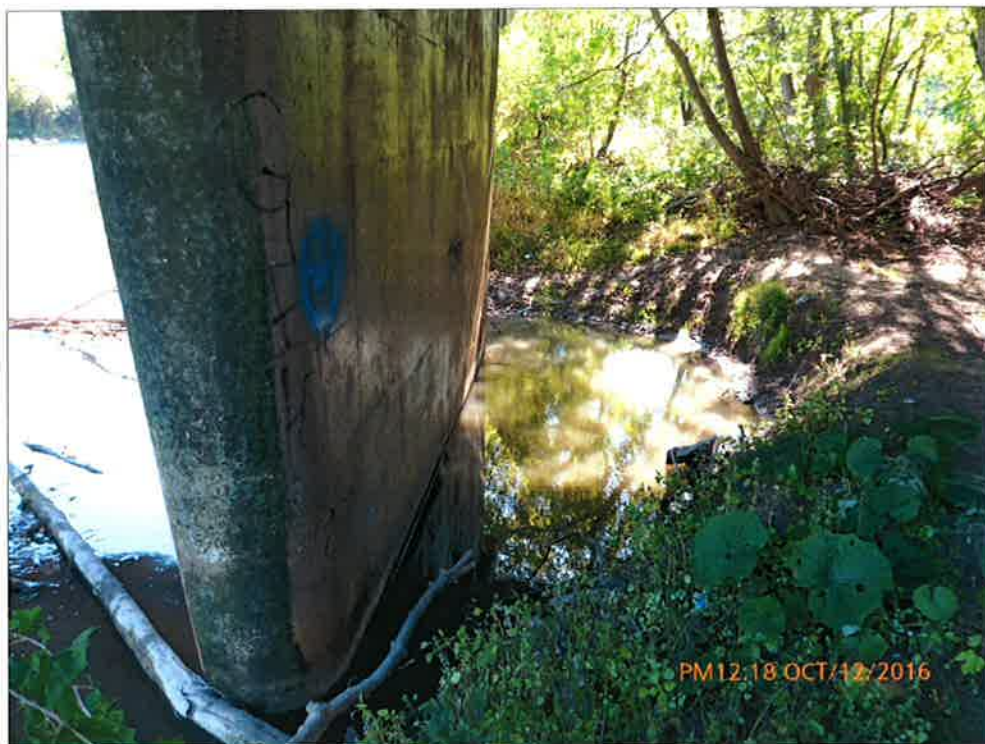
Minor Erosion Around West Pier

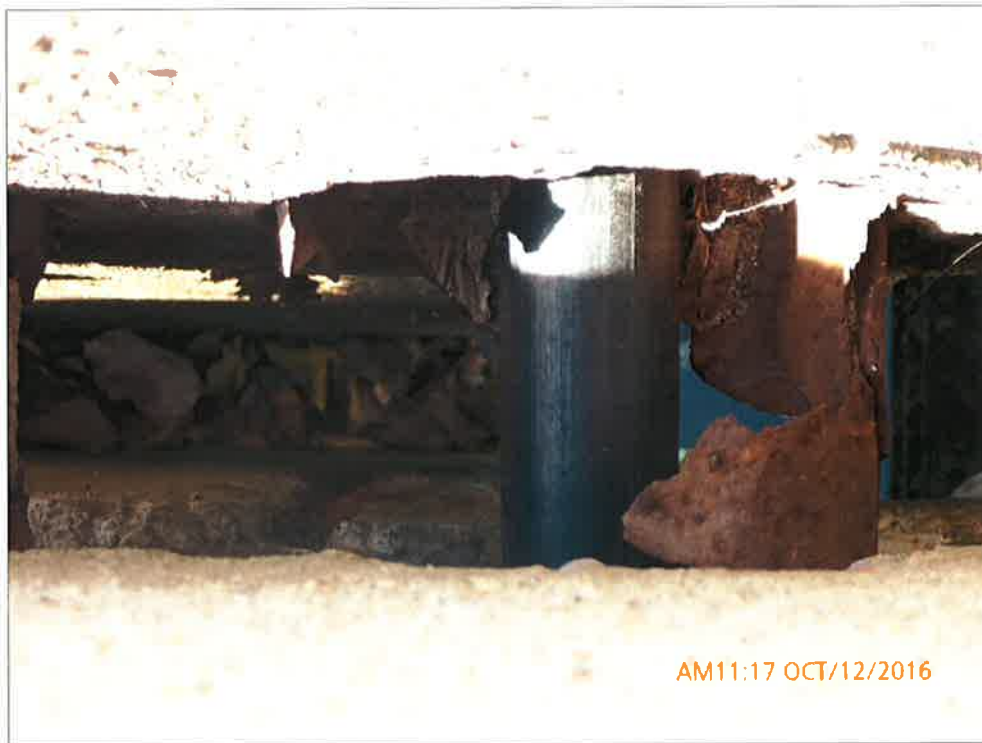
Severely Corroded Utility at Joint

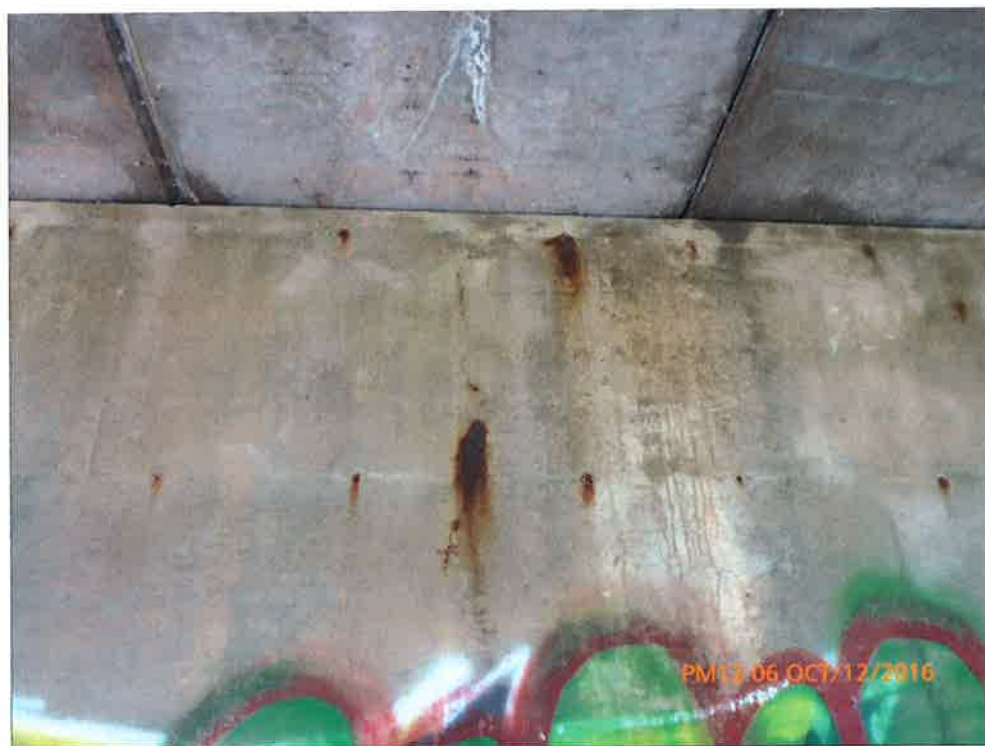
Rust Stains on Abutment Wall
