December 2, 2016

Reference No. 11116995

Re: 2016 OSIM Inspections for Municipal Bridges and Culverts Larger Than 3 Metres

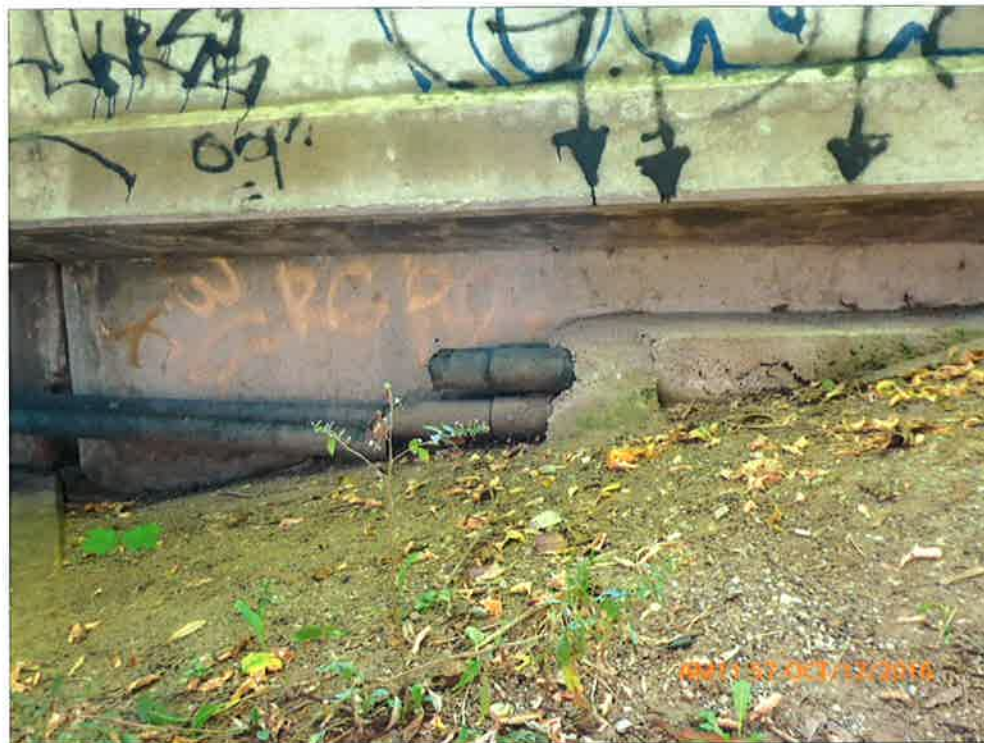
Typical Wingwall

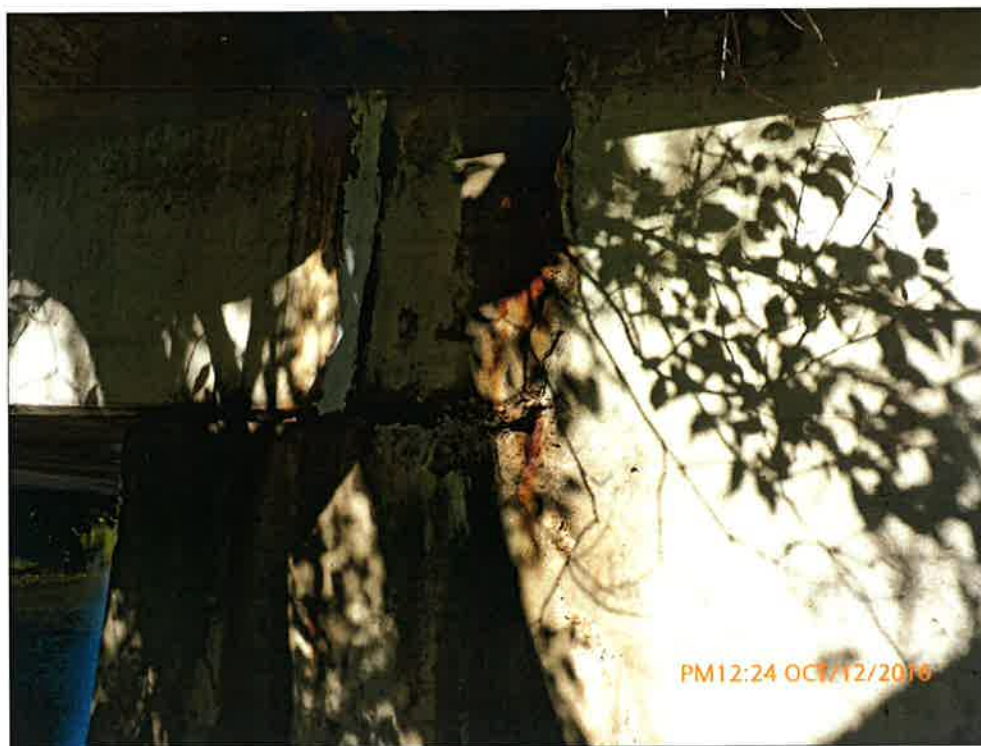
Narrow Stained Crack on Southeast Wingwall

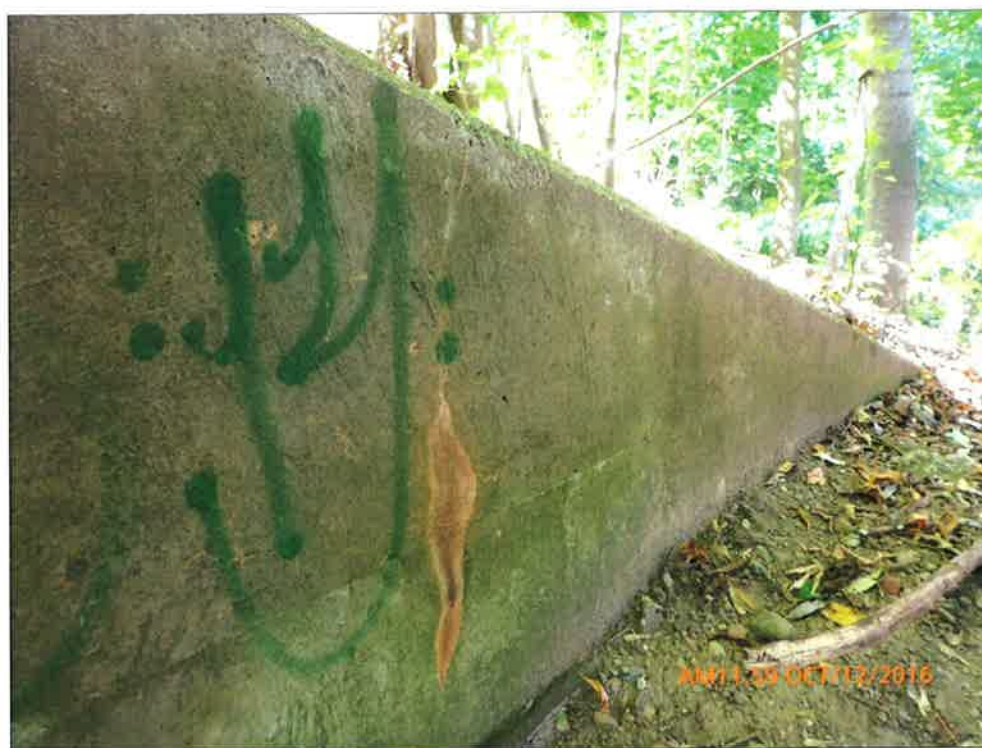
Narrow Stained Crack on Retaining Wall

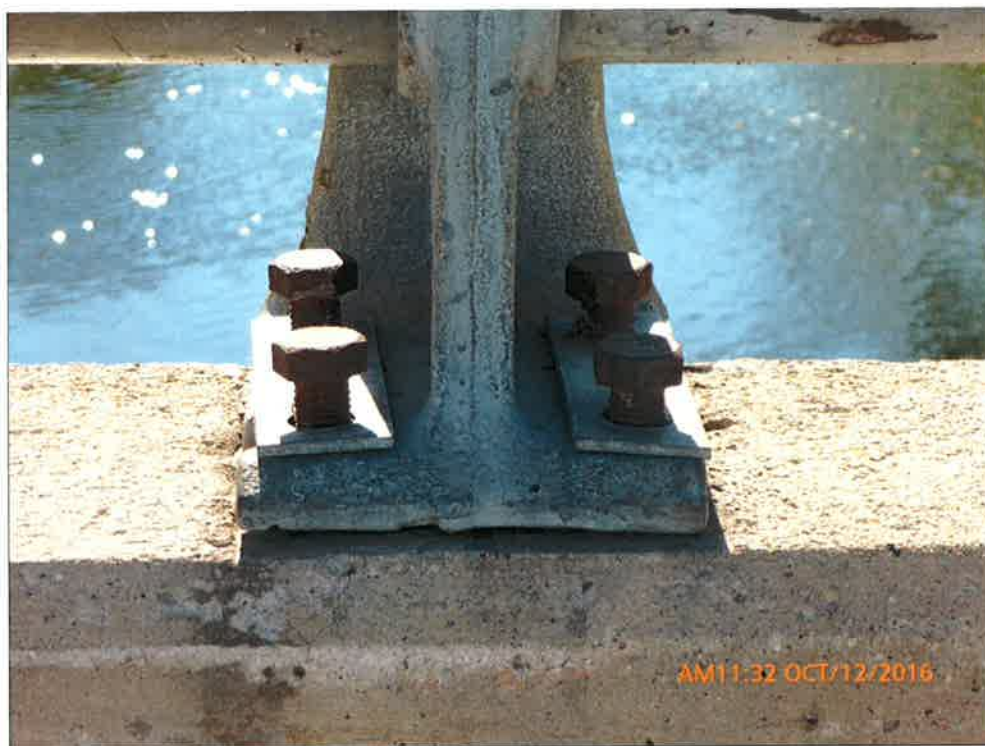
Loose Anchor Bolts on Handrail Post

Element Group	Element	Maintenance Required	Priority	Comment
Accessories	Utilities	Other	1 yr	Replace junction box cover plates
Barriers	Hand Railings	Bridge Handrail Maintenance	1 yr	Reposition/secure handrail
Barriers	Railing Systems	Bridge Handrail Maintenance	1 yr	Replace deteriorated panels

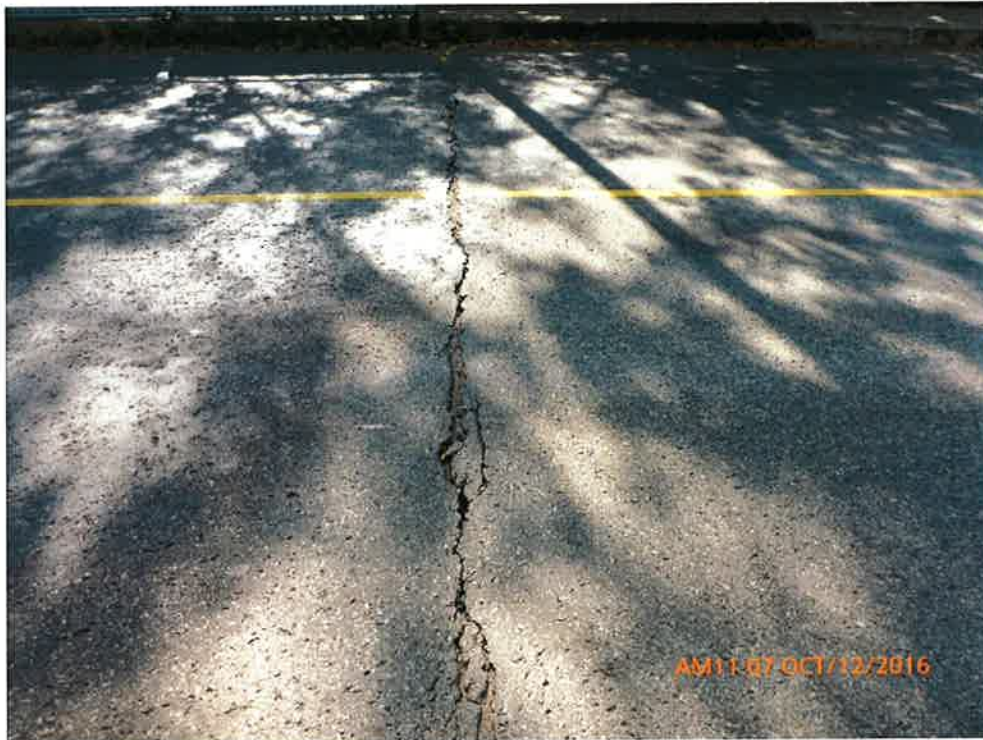
Wide Crack at End of Deck on Approach

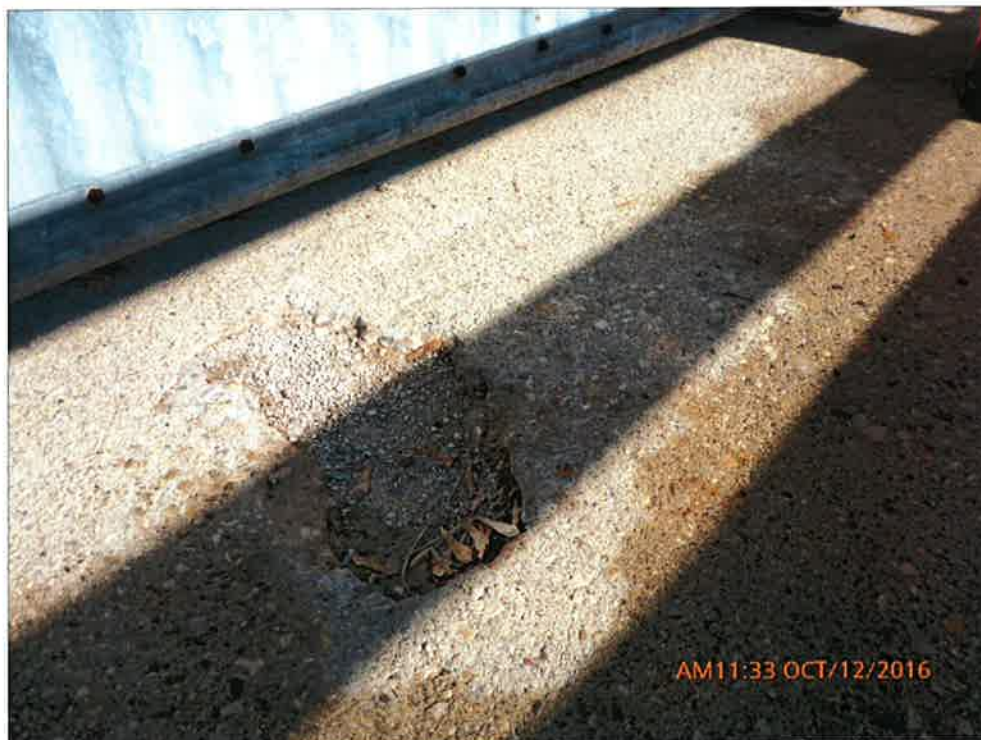
Severe Delamination on Sidewalk

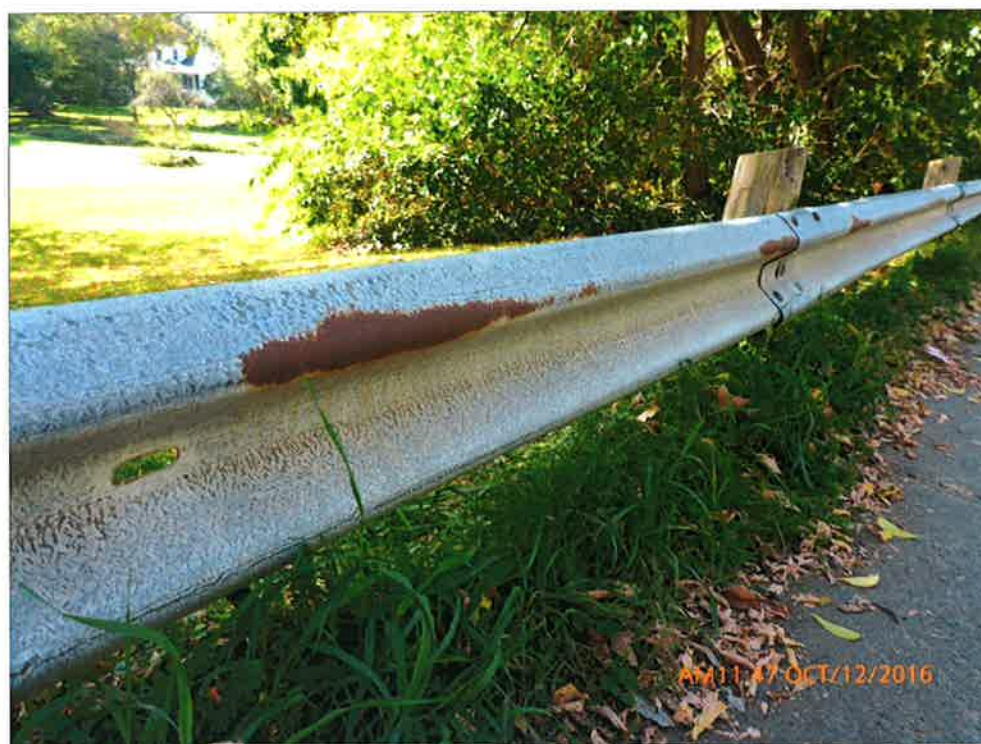
Localized Breakdown of Protective Coating on Approach Guiderail

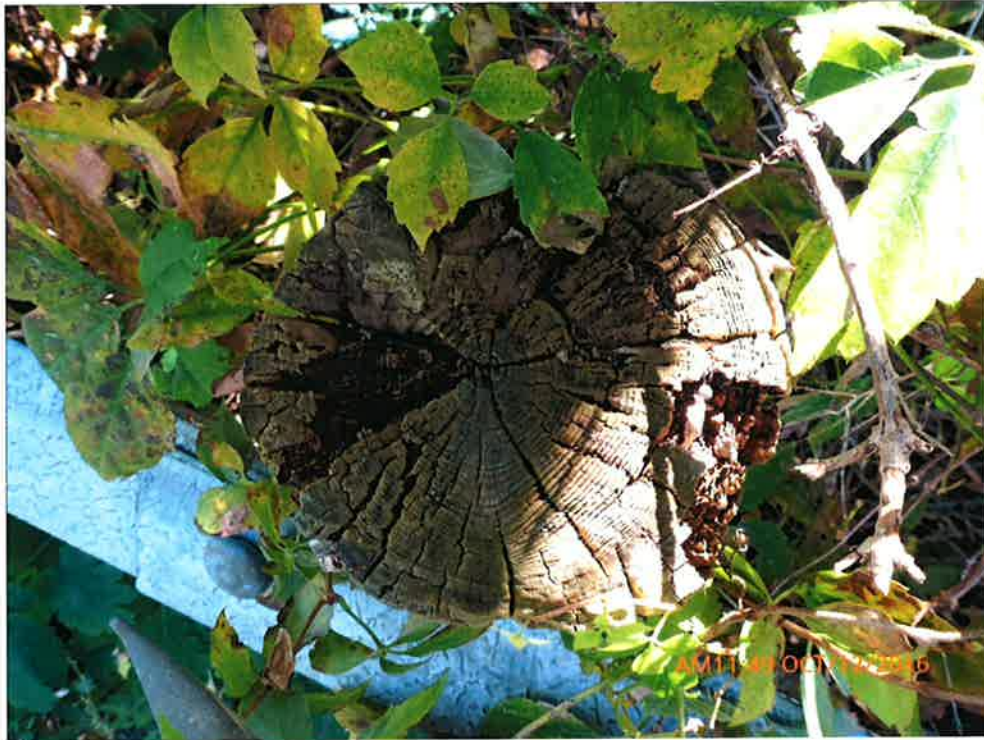
Moderate Weathering of Guiderail Post

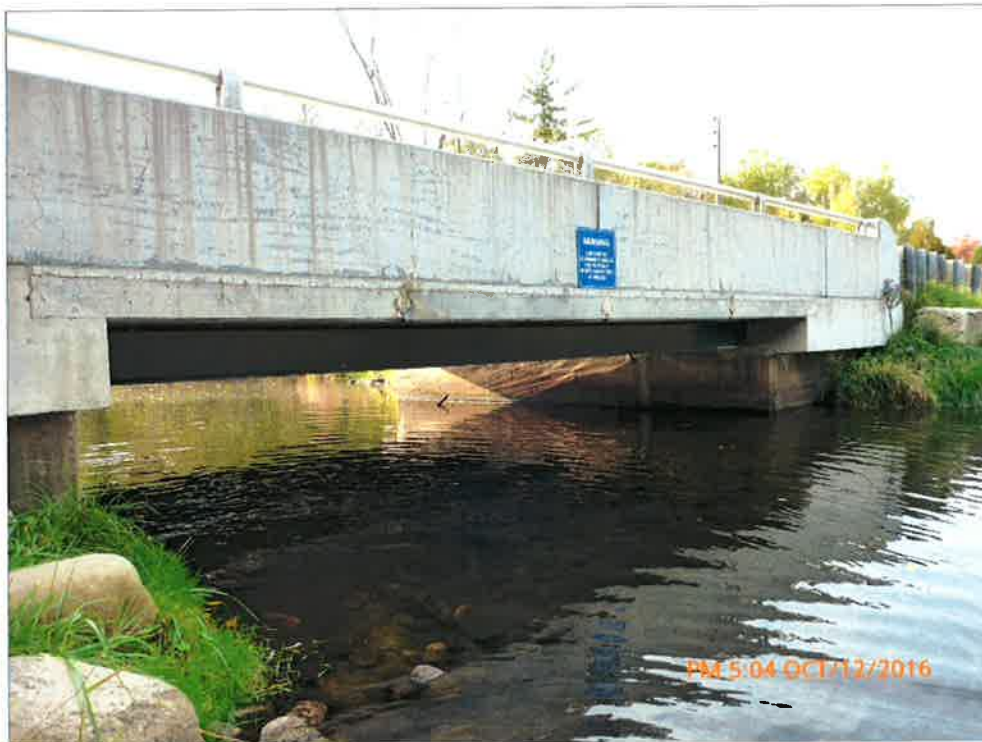
East Elevation

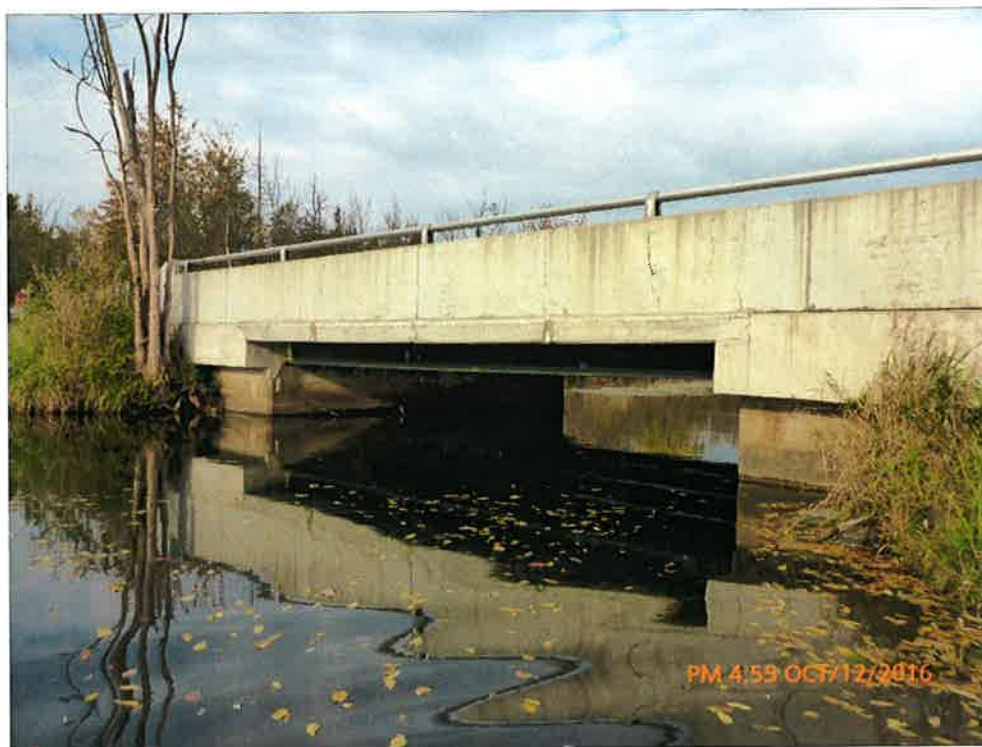
West Elevation

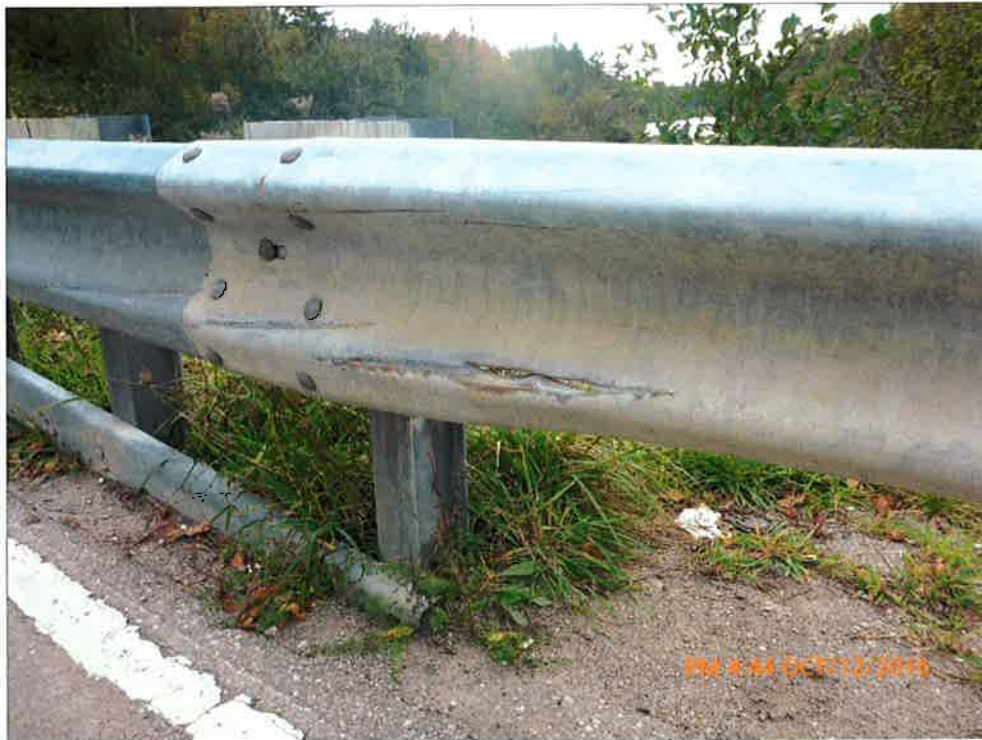
Severe collision damage in Southwest quadrant.

Severe Collision Damage to Guiderail

Replace damaged section of flex beam

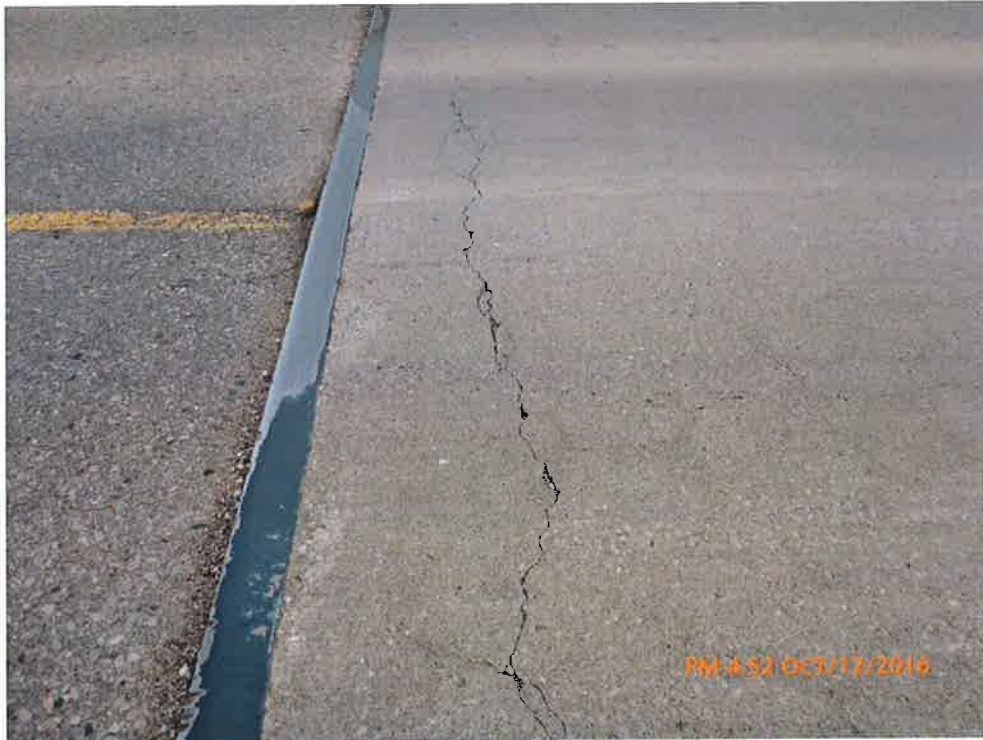
Wide Crack on Exposed Concrete Deck

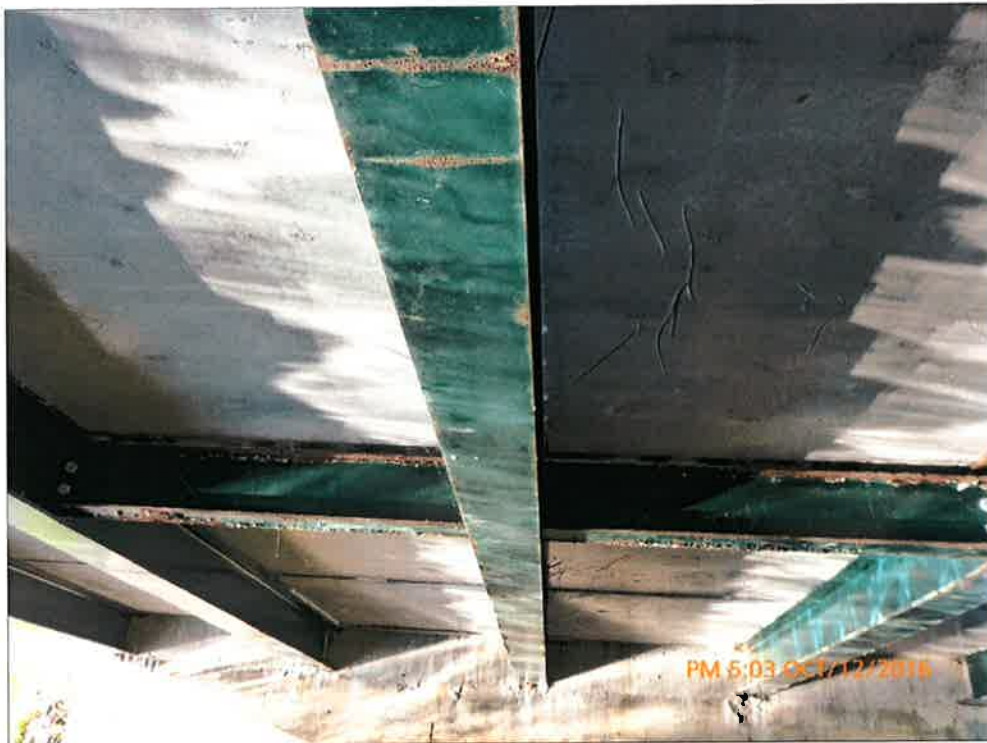
Typical Soffit

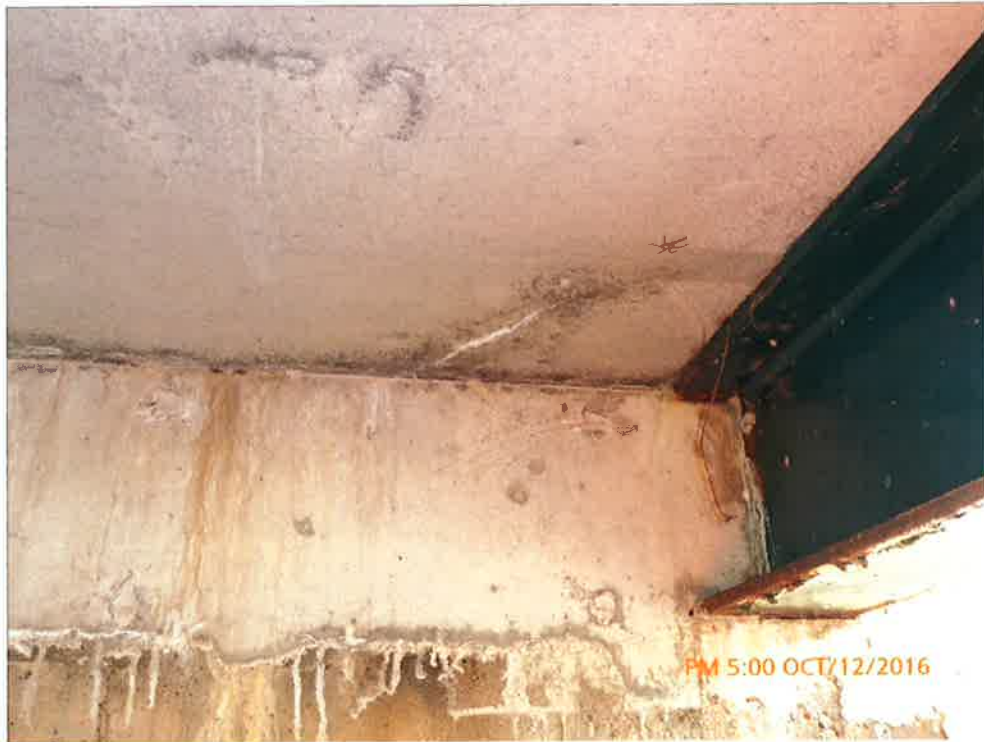
Narrow Stained Crack on Interior Soffit

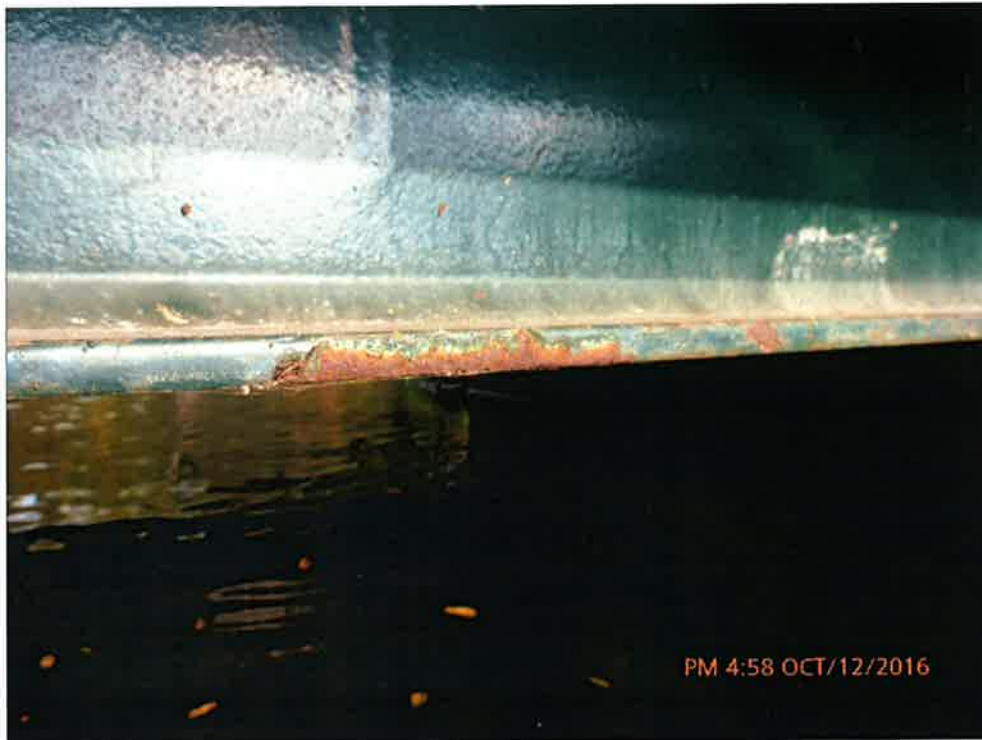
Light Corrosion on Girder

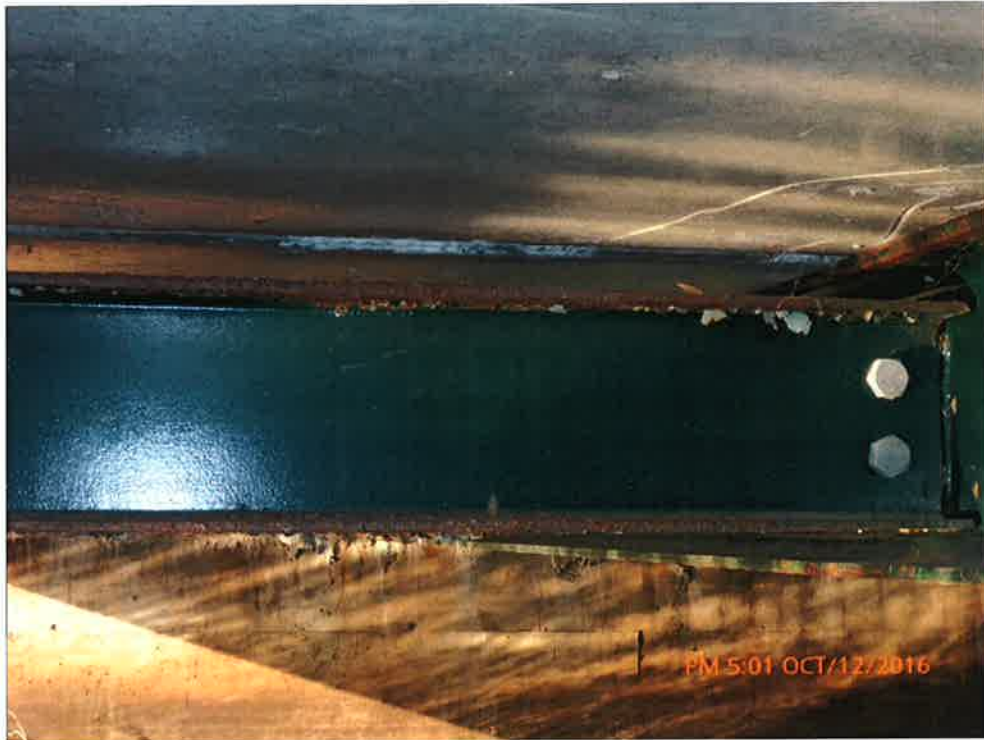
Light Corrosion on Diaphragm

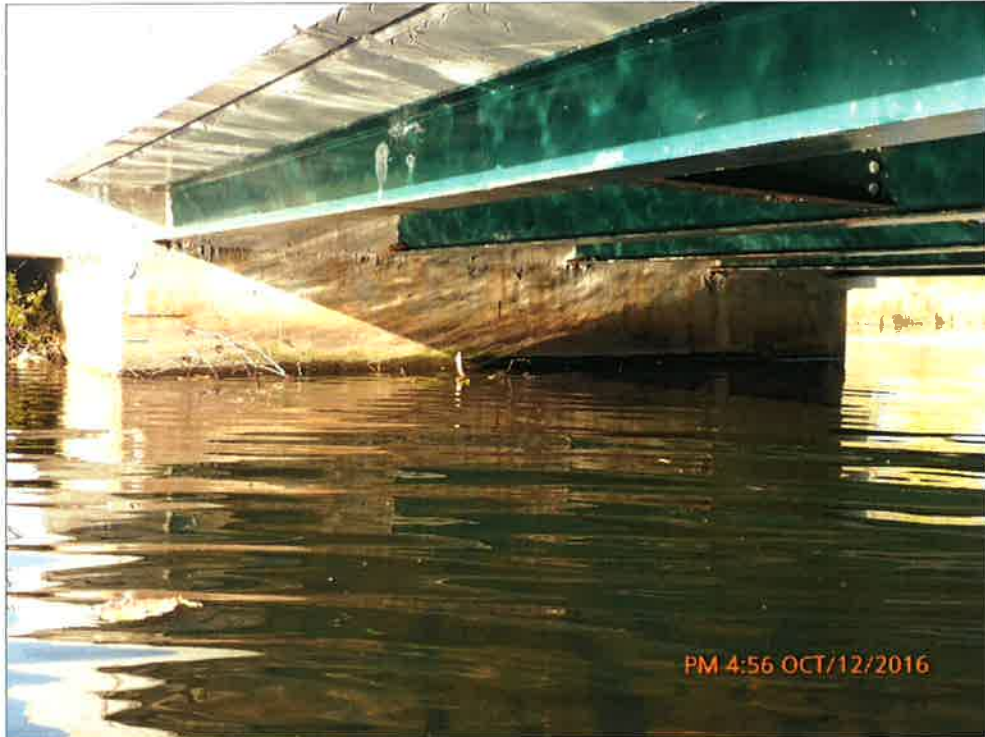
North Abutment

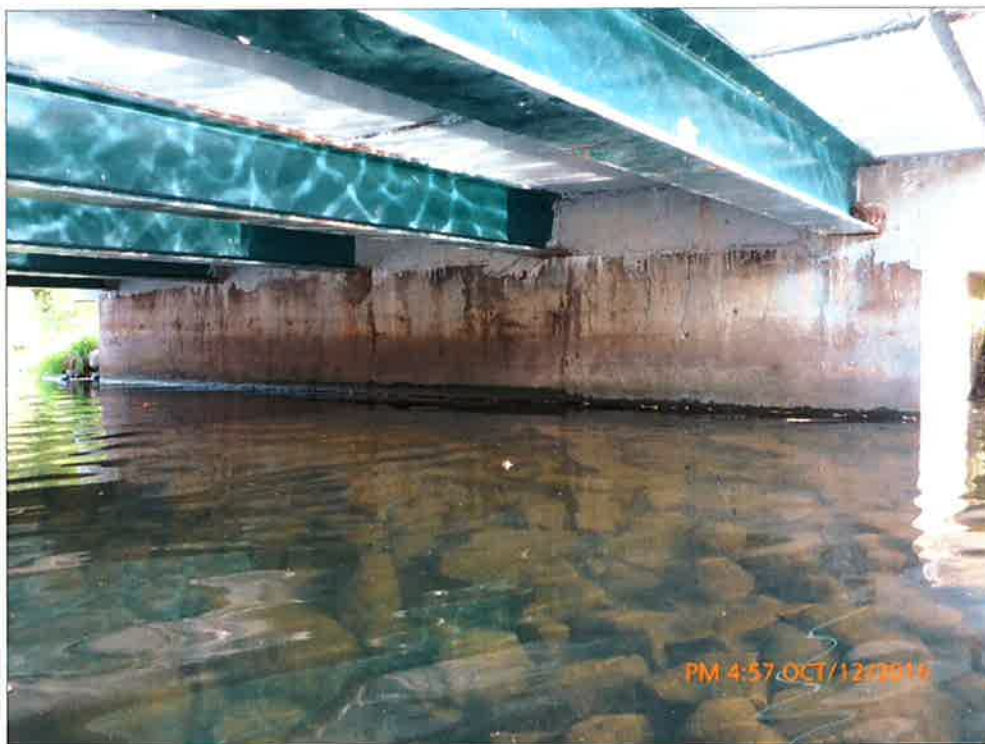
South Abutment

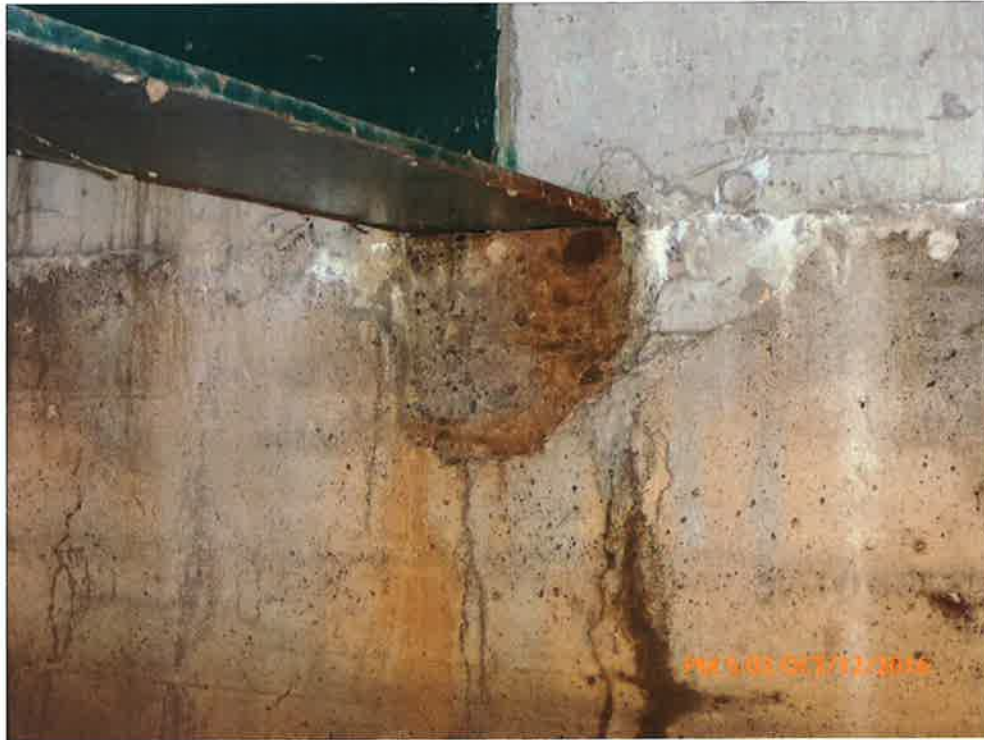
Light Spall on Abutment Below Girders

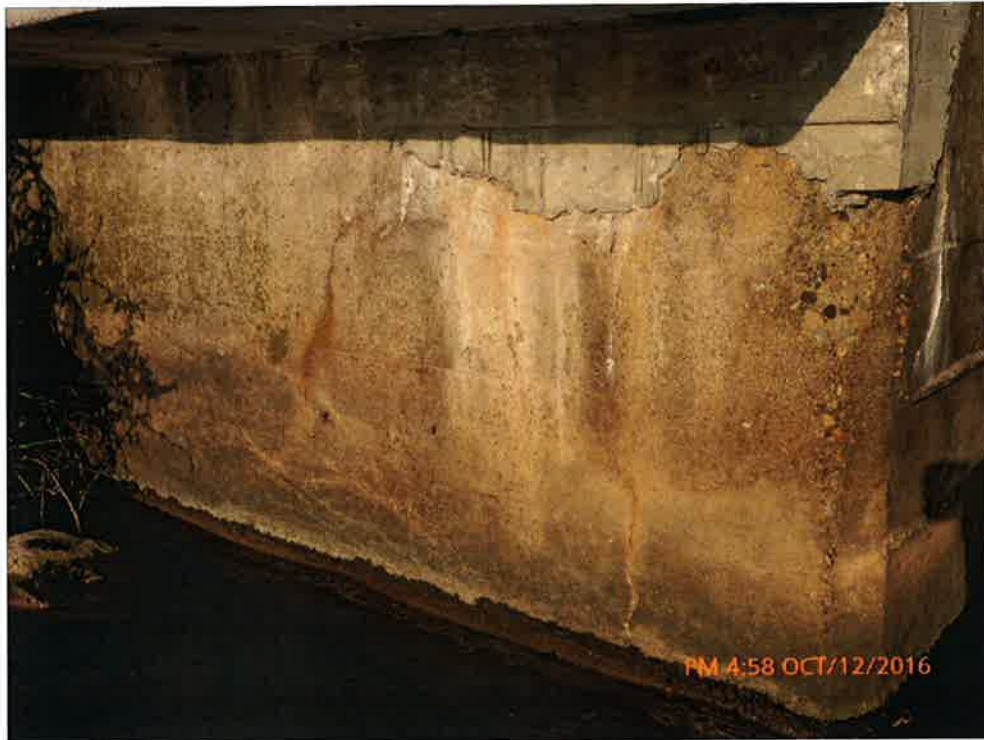
Narrow Stained Crack on Wingwall

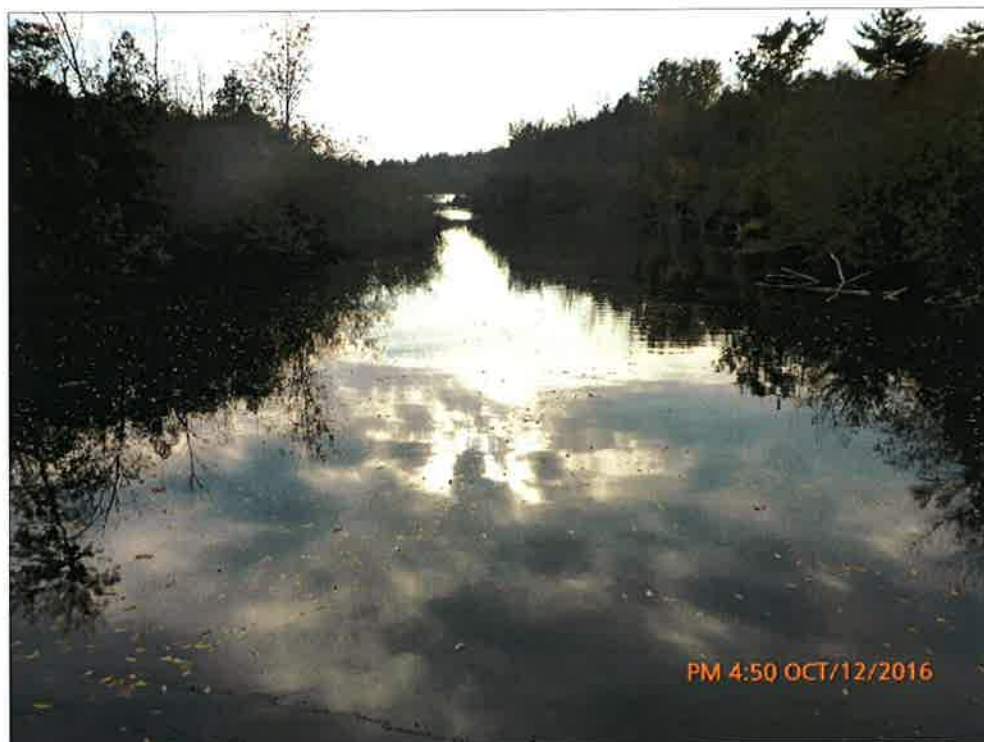
Looking West Downstream

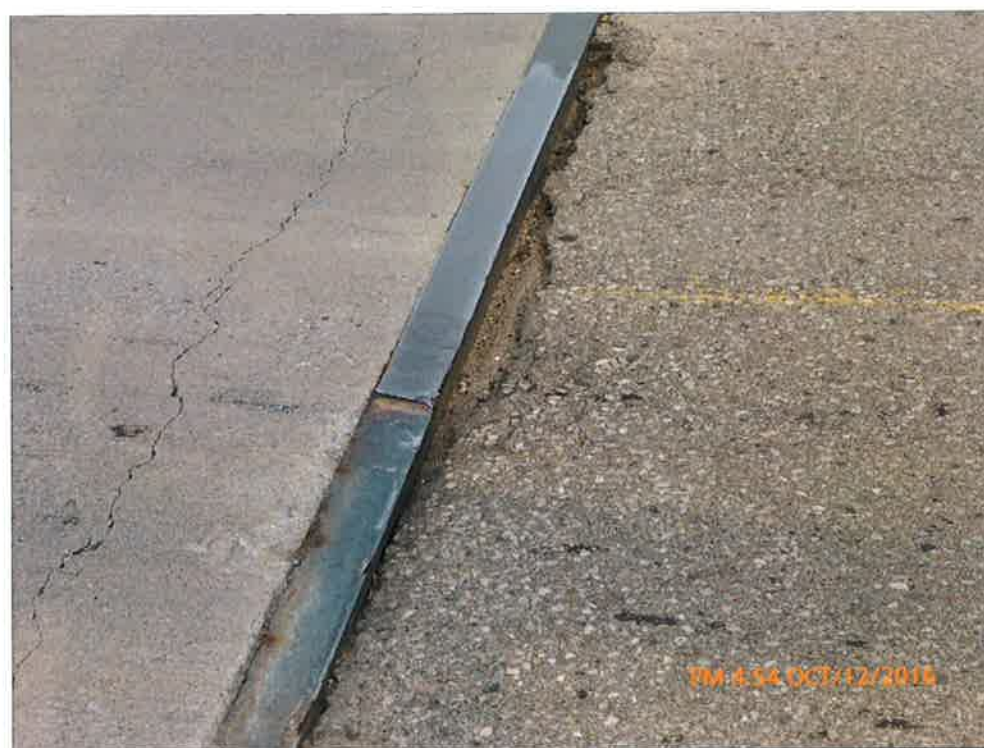
New approach asphalt wearing surface in 2009. Approach asphalt has settled at both ends of bridge, minor potholes, narrow cracks, settlement adjacent to armouring angles.

Pothole on Approach Wearing Surface

Performance Deficiencies	Maintenance Needs	Priority	Comments
Rough riding surface	Bridge Surface Repair	1 yr	Patch potholes/pad approaches
Rehab/Repair Recommendations	Priority	Cost	Comments

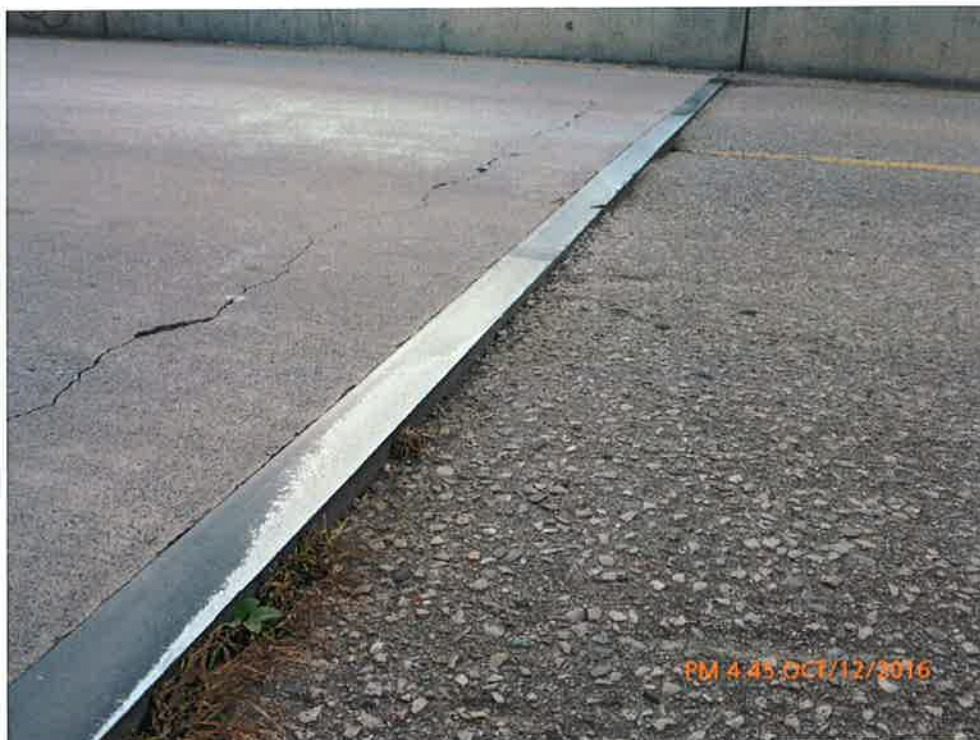
Settlement on Approach
