# 2022 OSIM Inspections for Municipal Bridges and Culverts larger than 3 meters

Township of North Dumfries

**MEDA Engineering and Technical Services**

**31 May 2022**

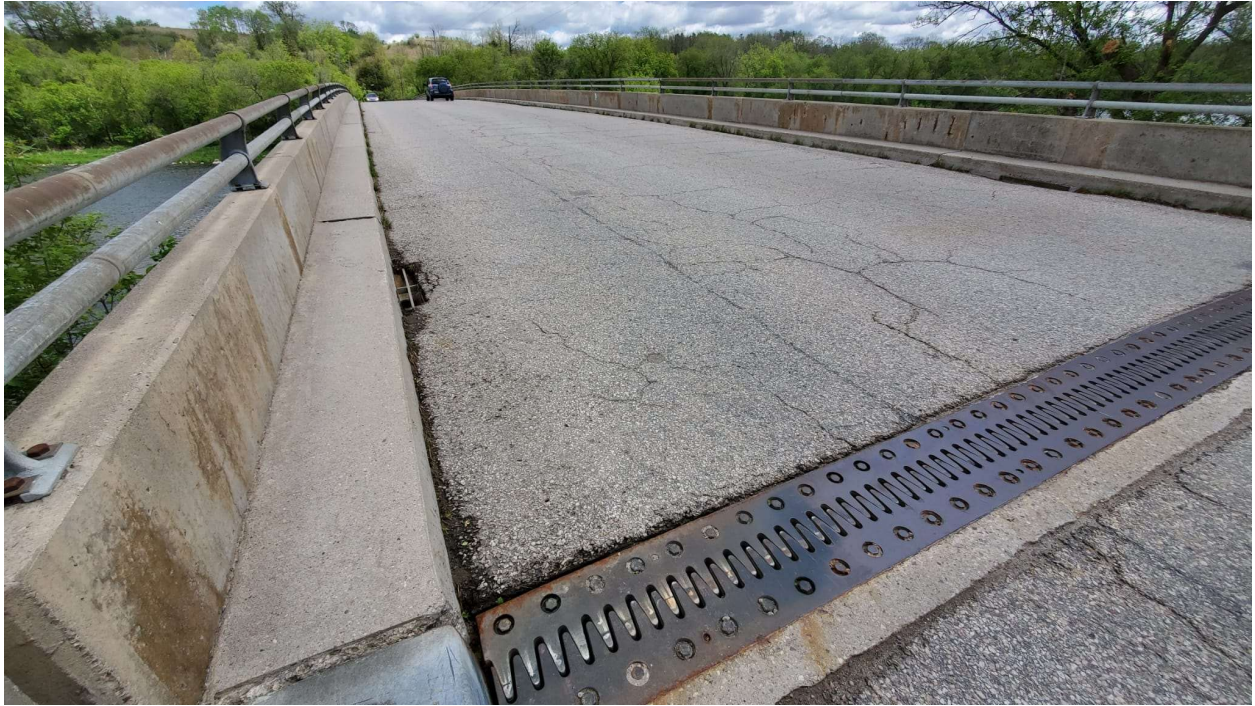
Expansion joints at the West Approach

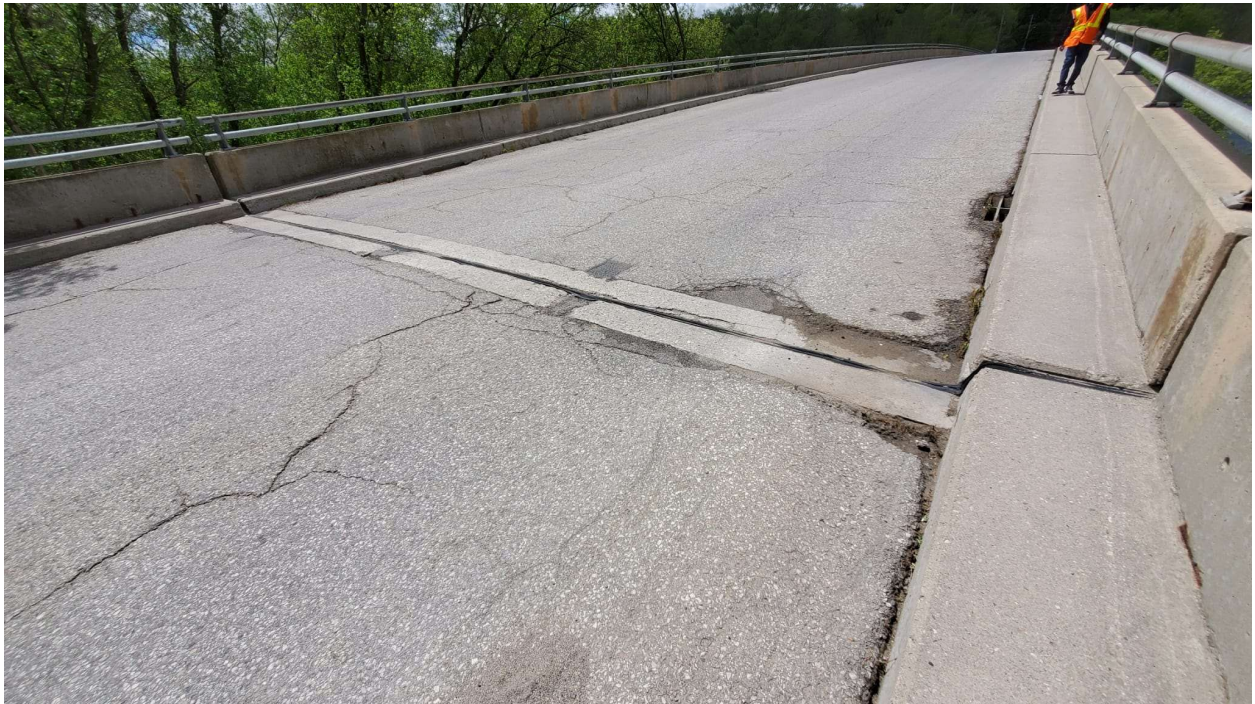
Expansion joints at the East Approach

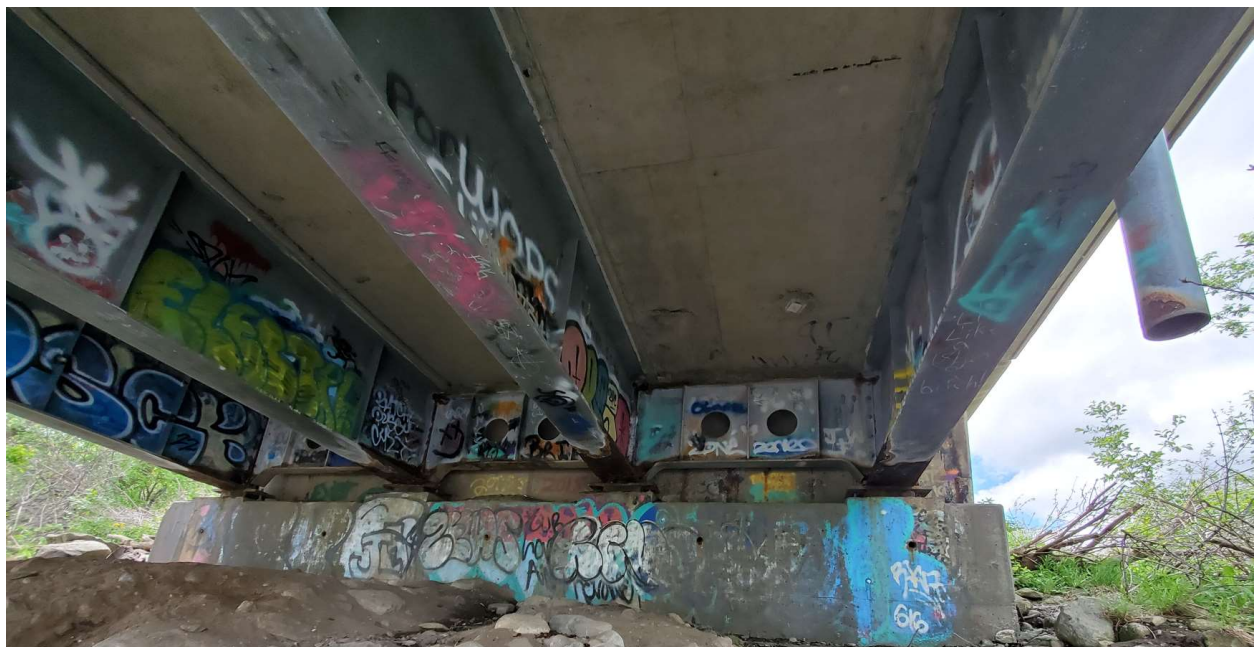
Underside of East Abutment

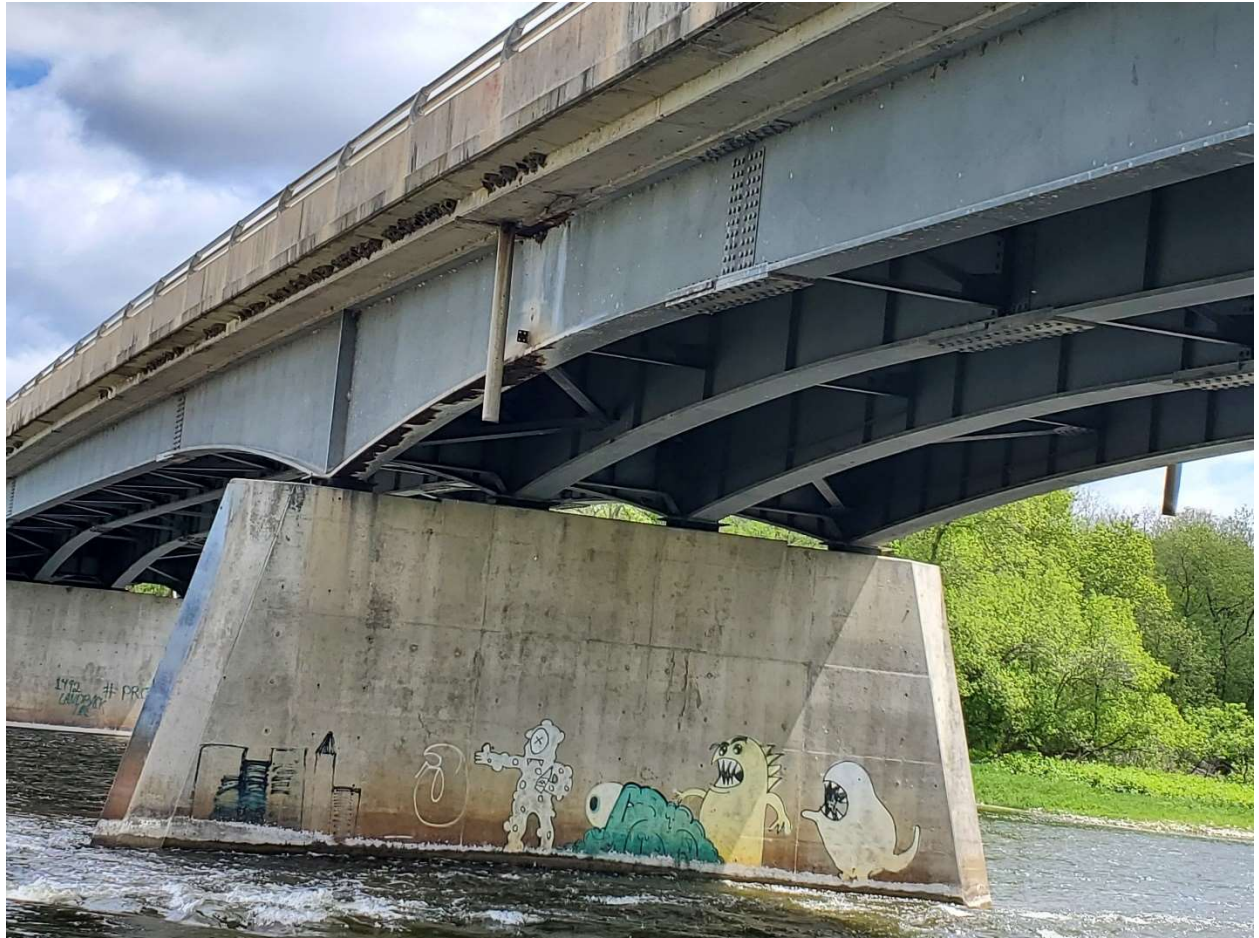
Pier East Side

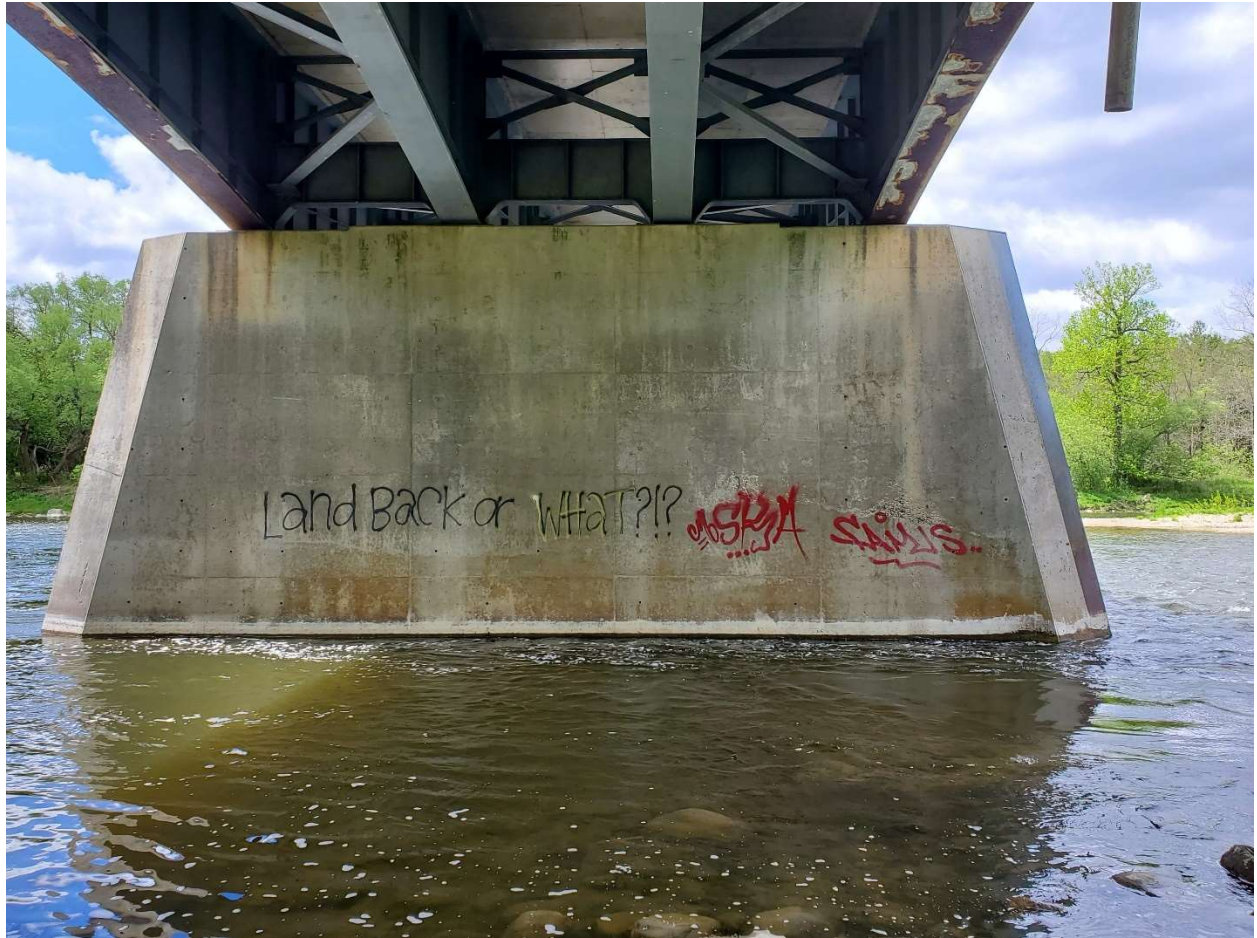
Pier West Side

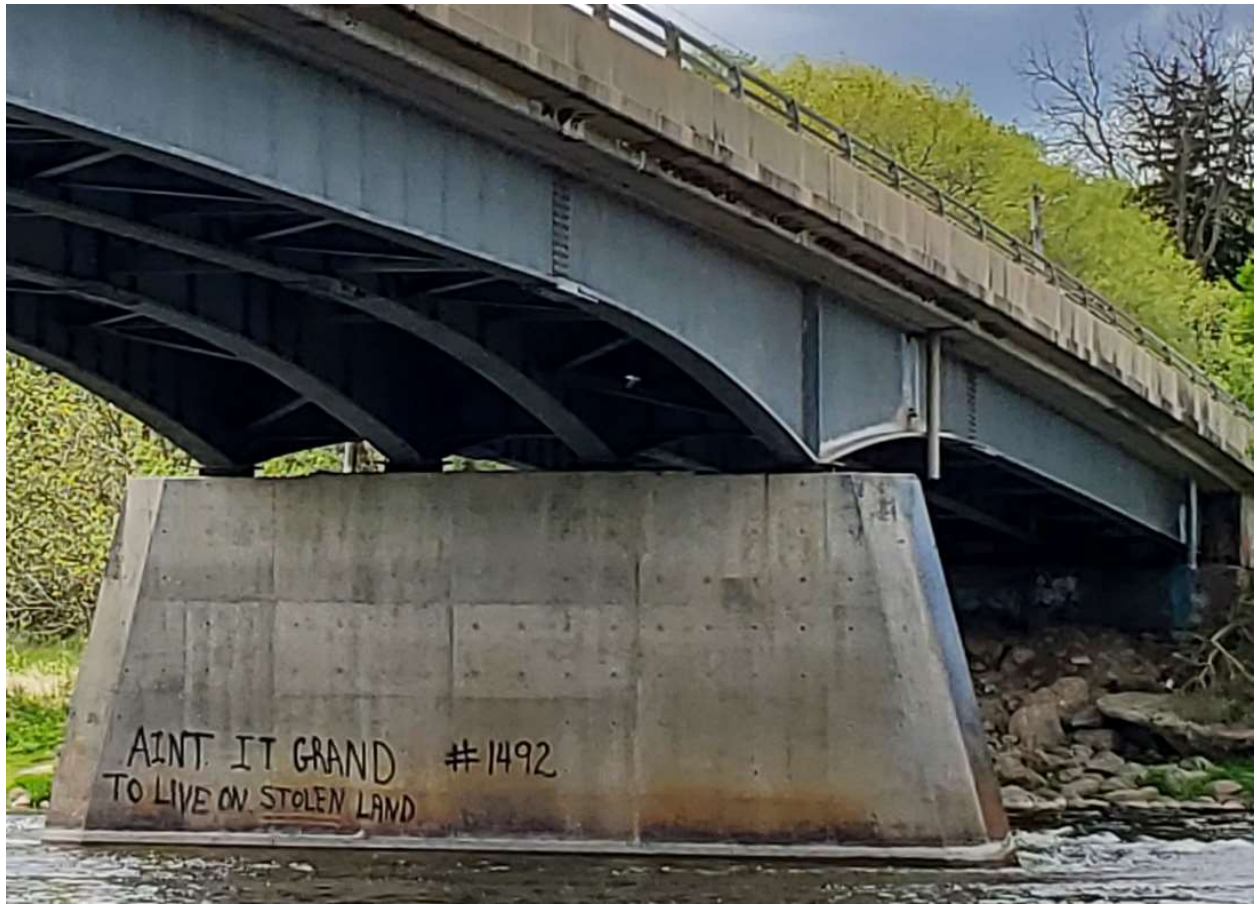
Pier 2 East side

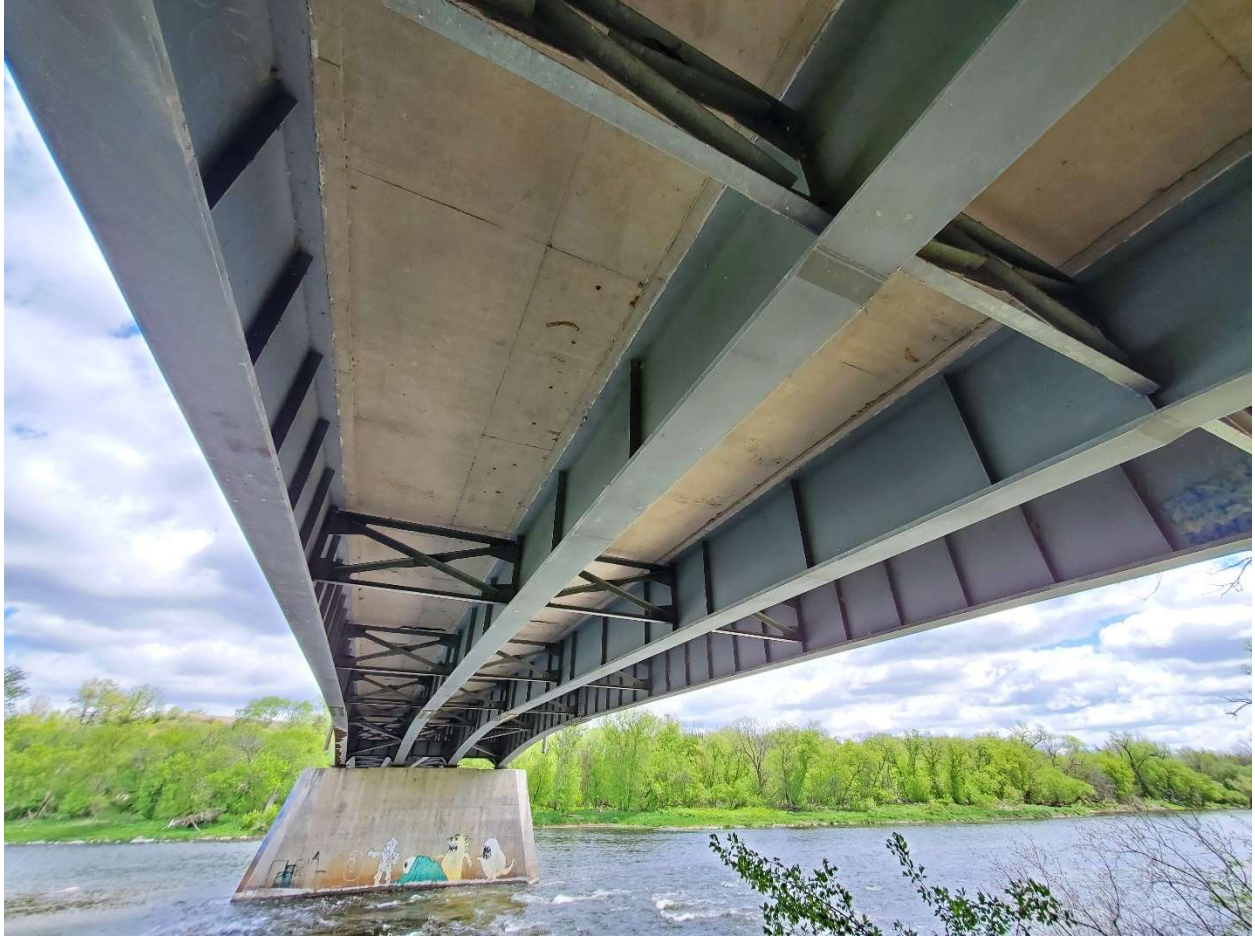
Soffit of the bridge deck

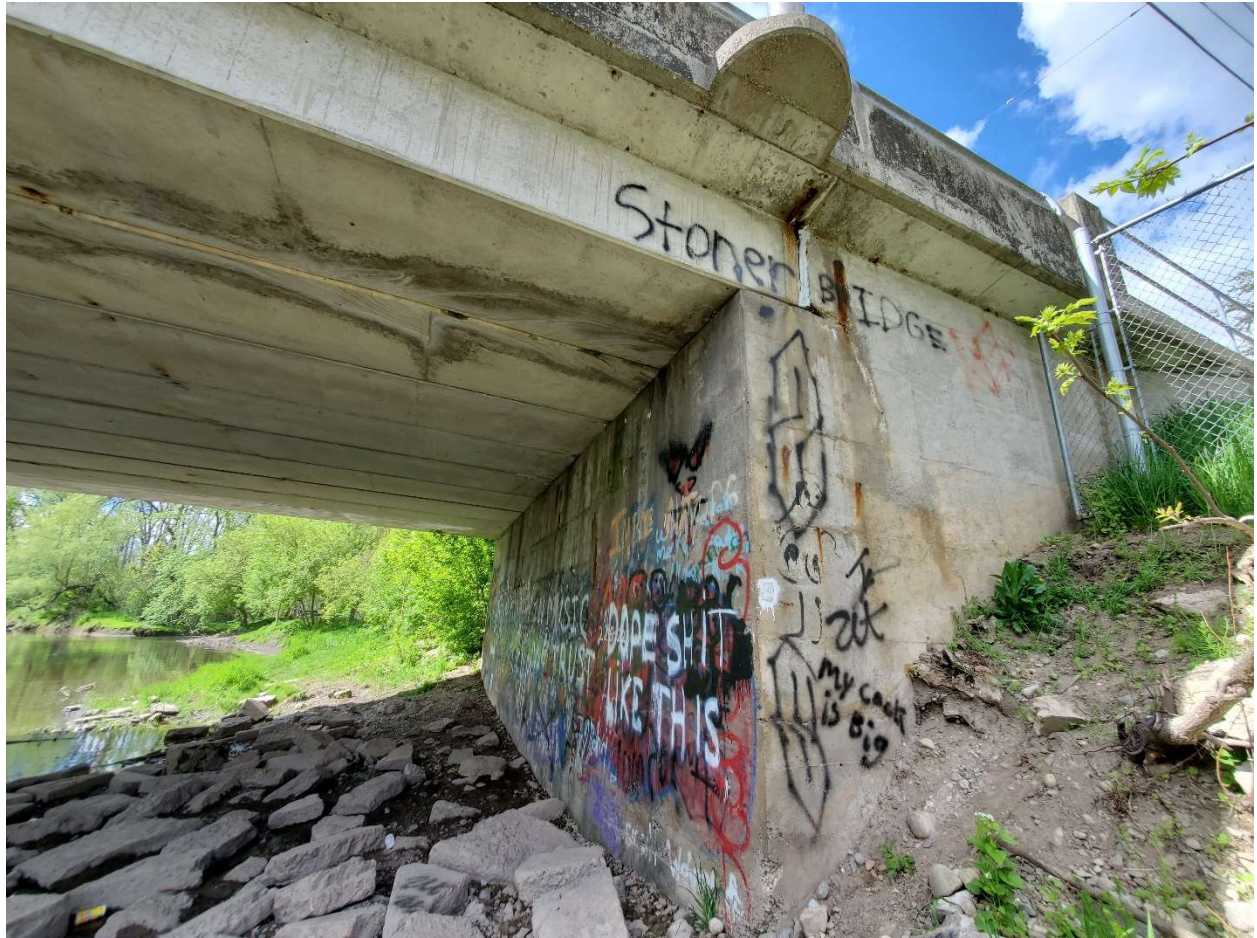
Bridge Underside East Abutment

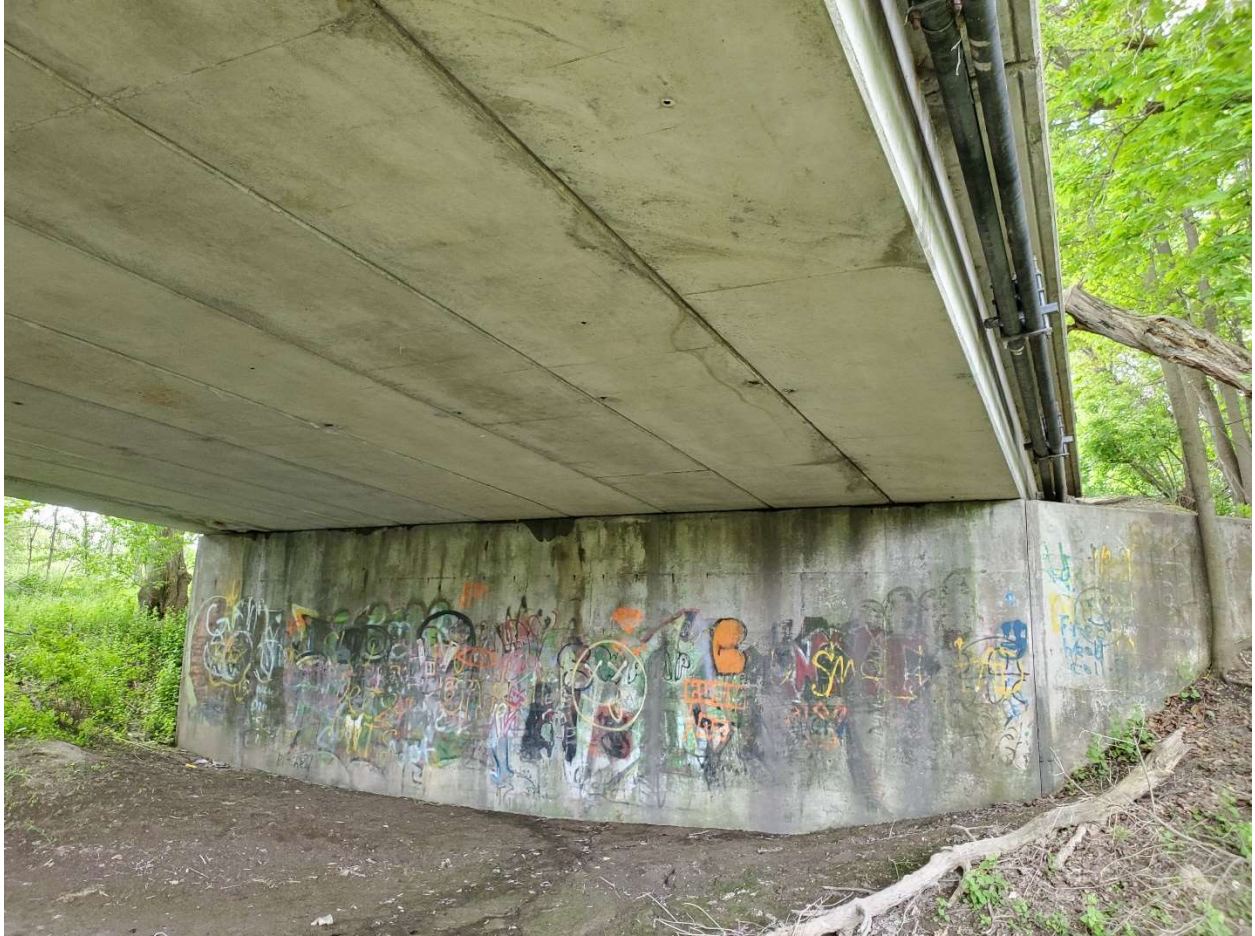
Bridge Underside West Abutment

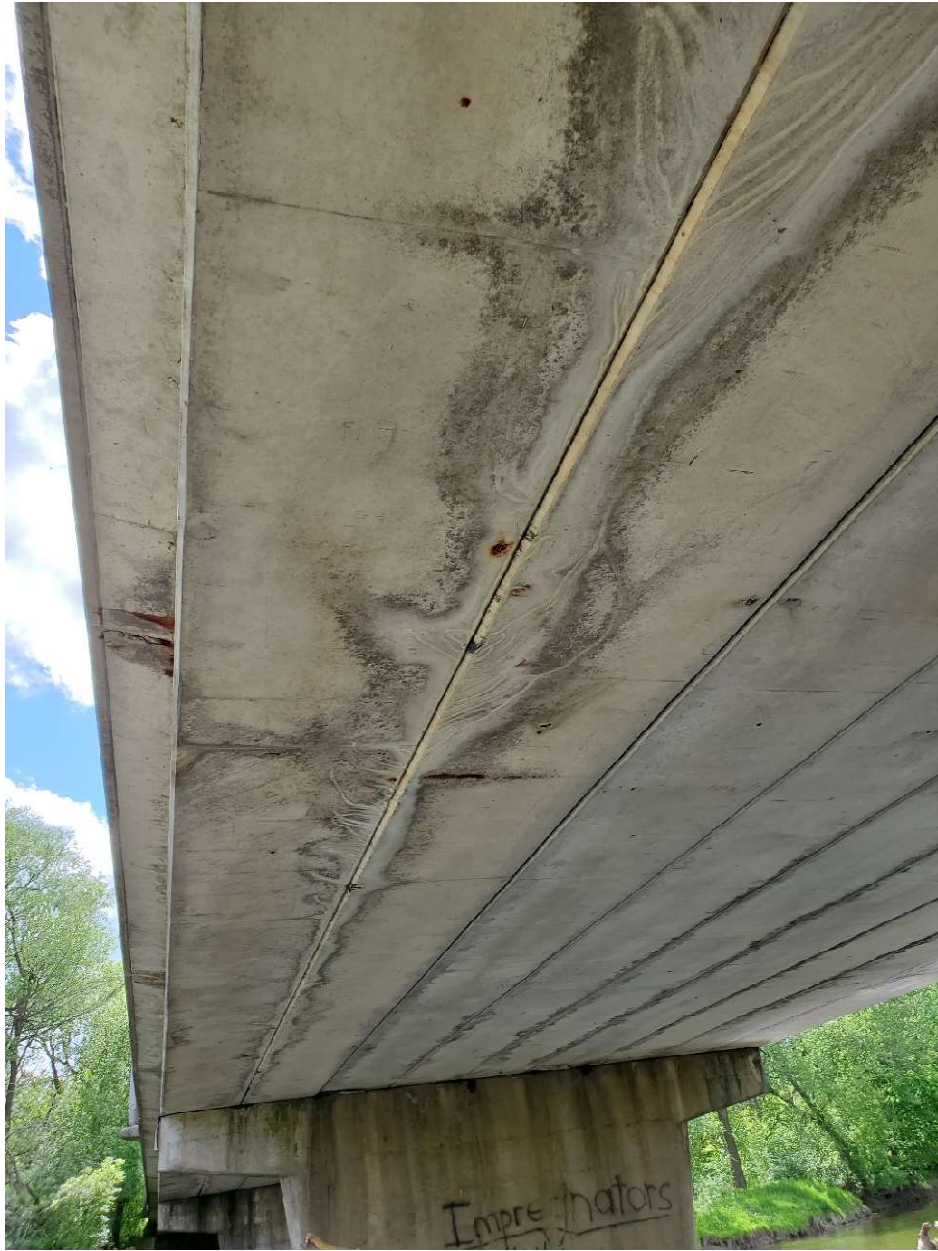
Soffit view

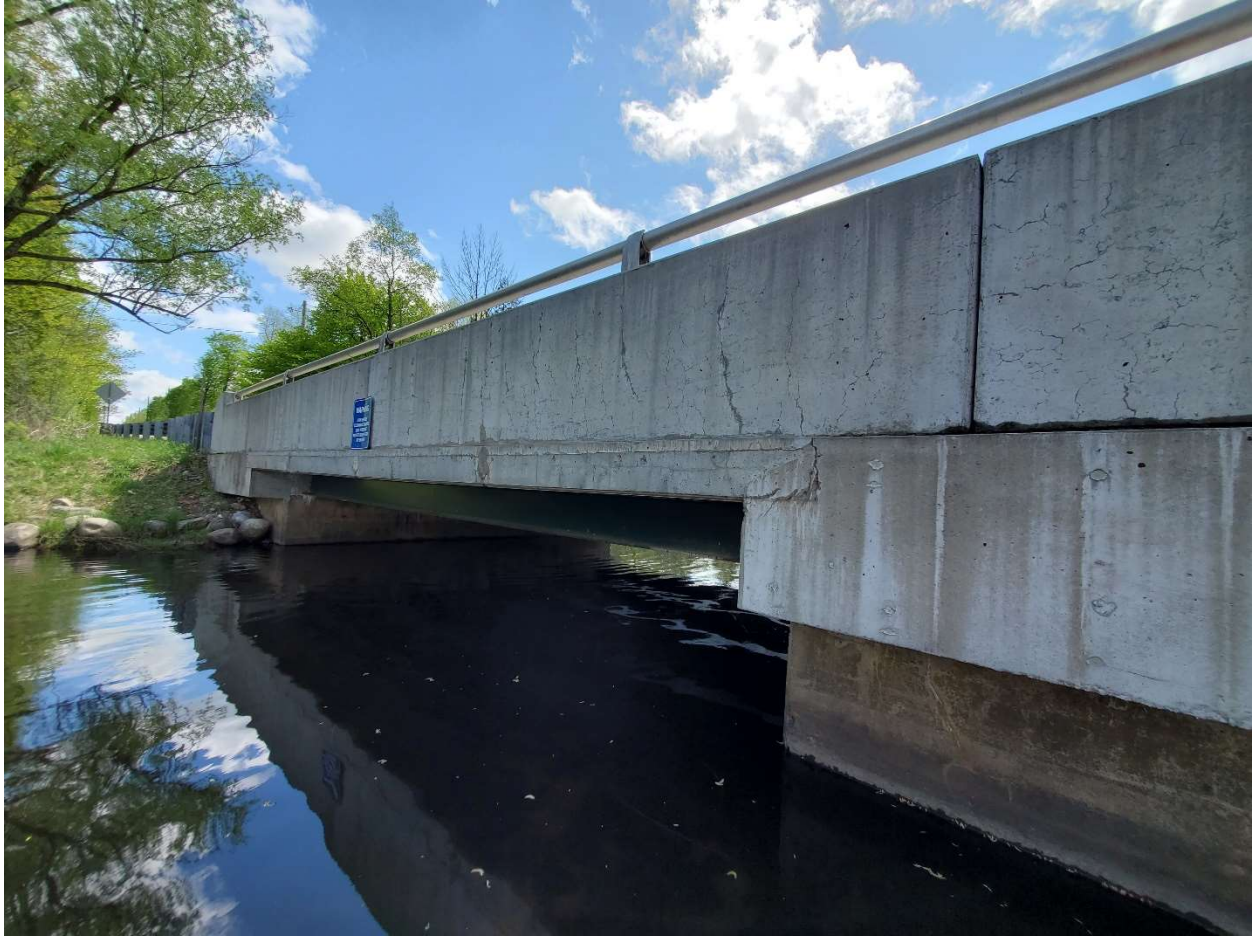
Bridge underside North Embankment

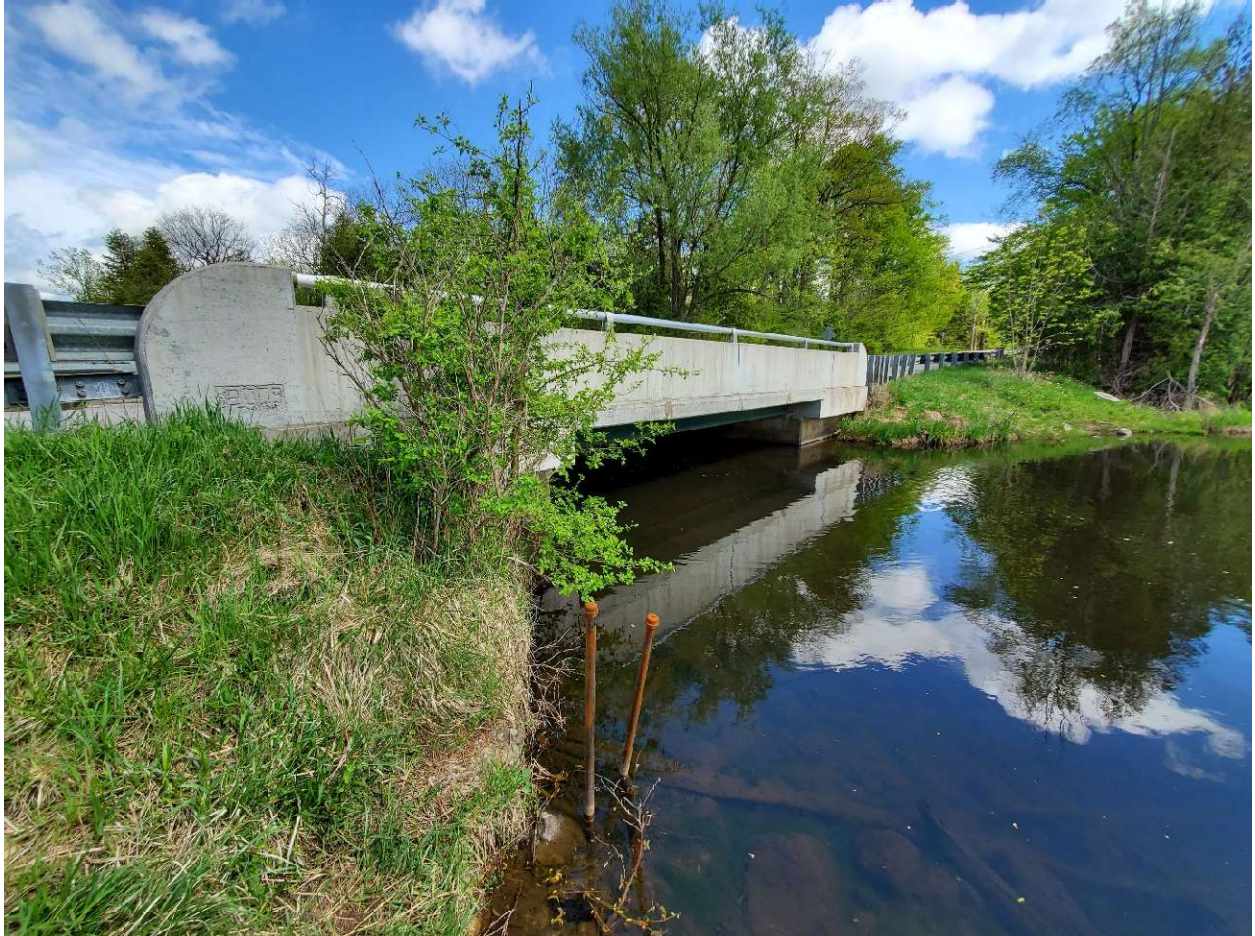
Bridge underside North Embankment

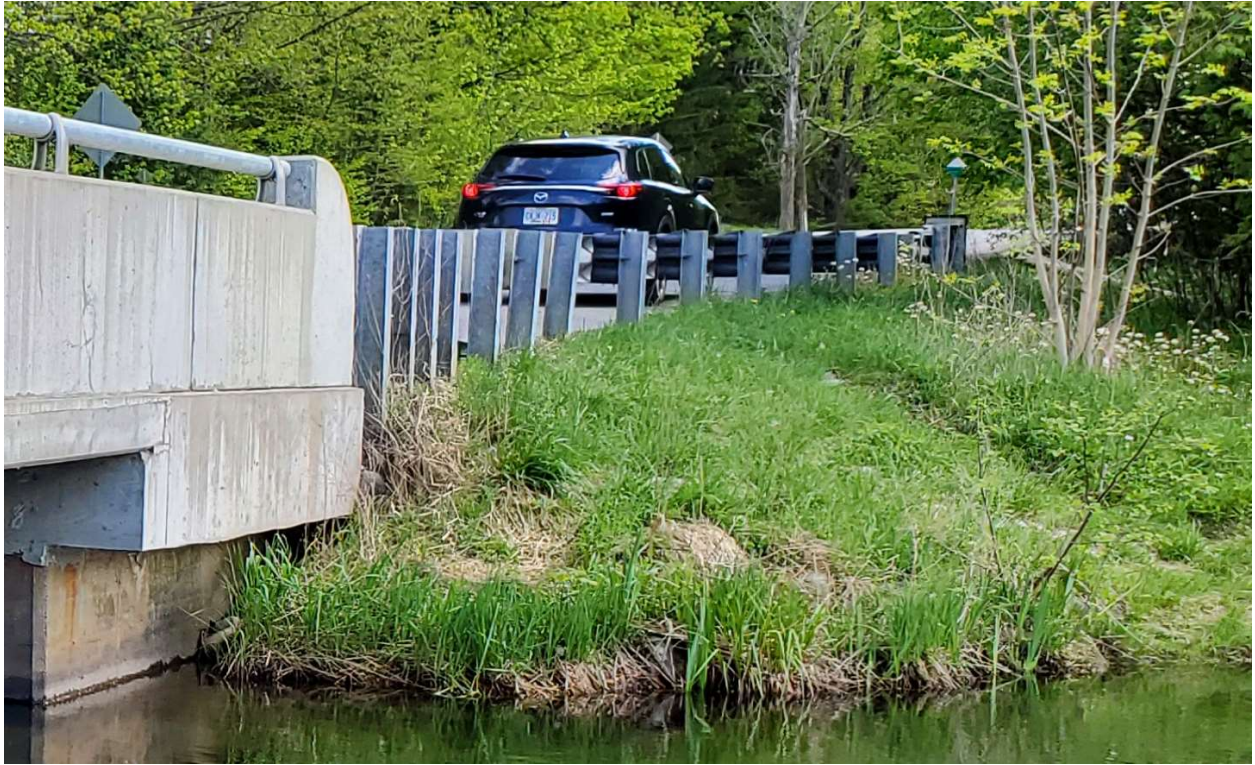
Southwest Embankment

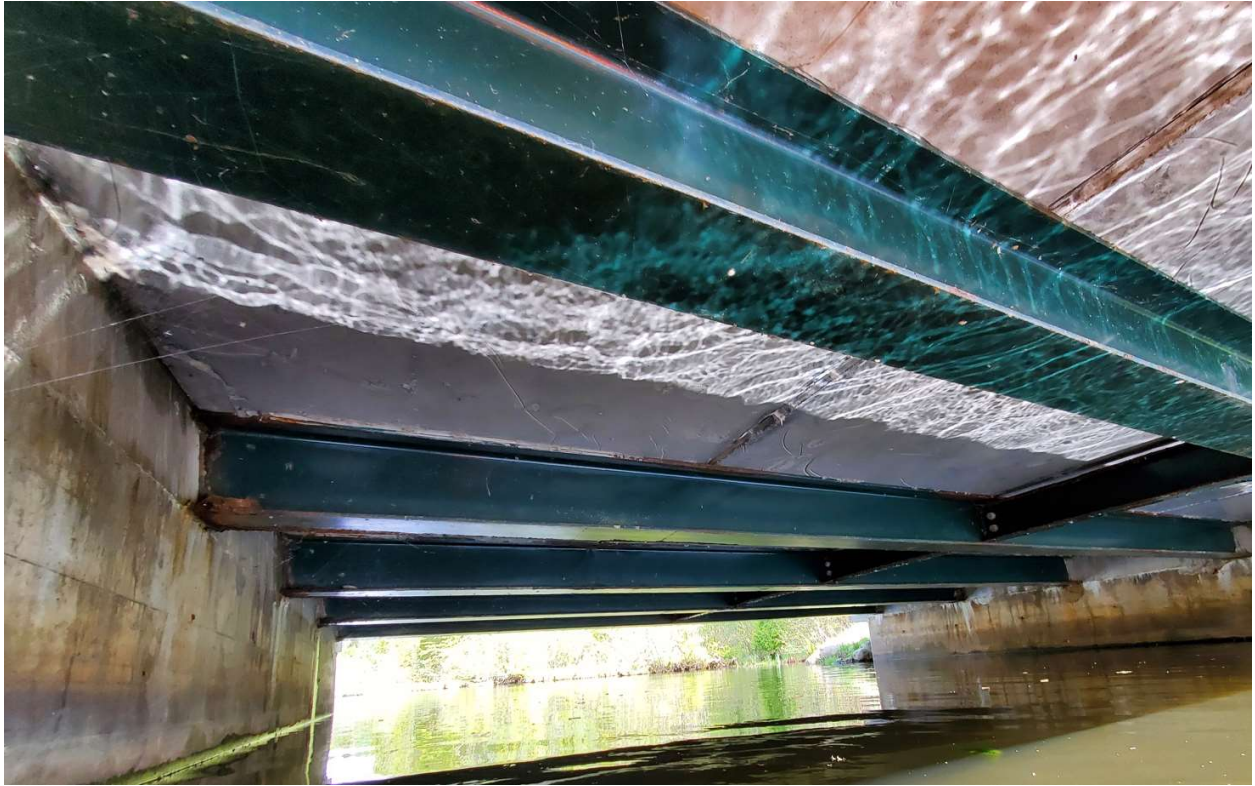
Steel girders underneath the bridge

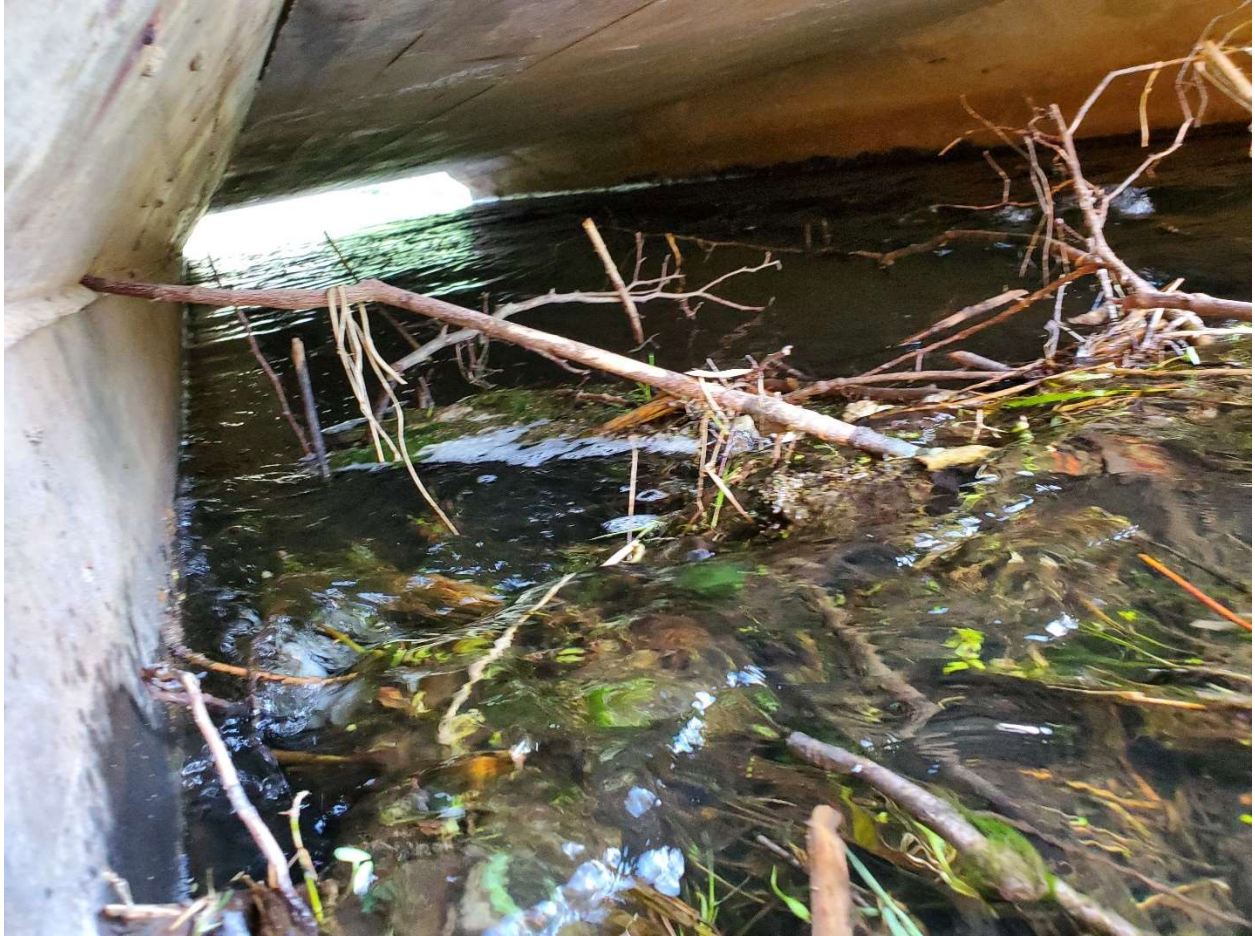
Water obstruction

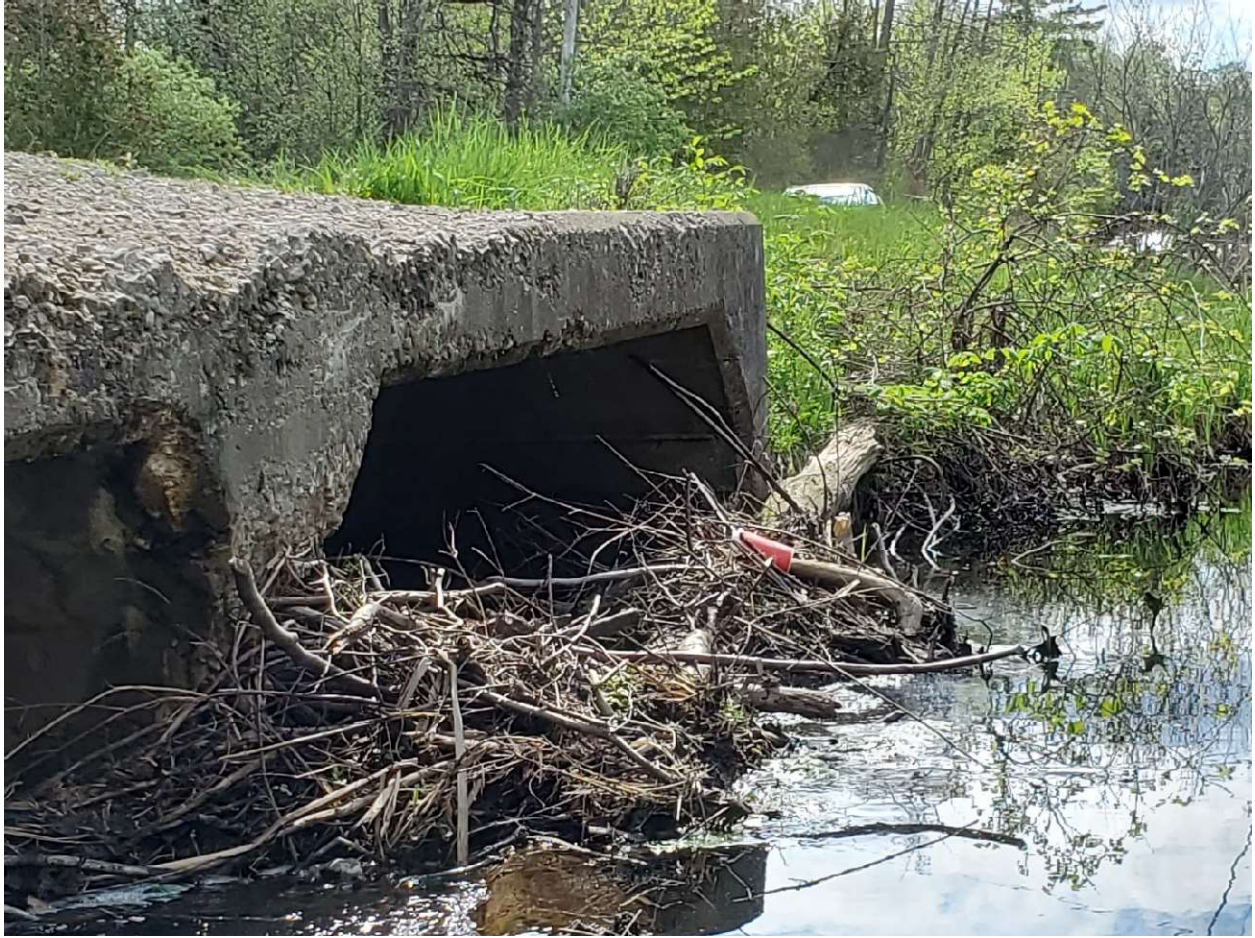
Exposed rebar on the top of the box culvert

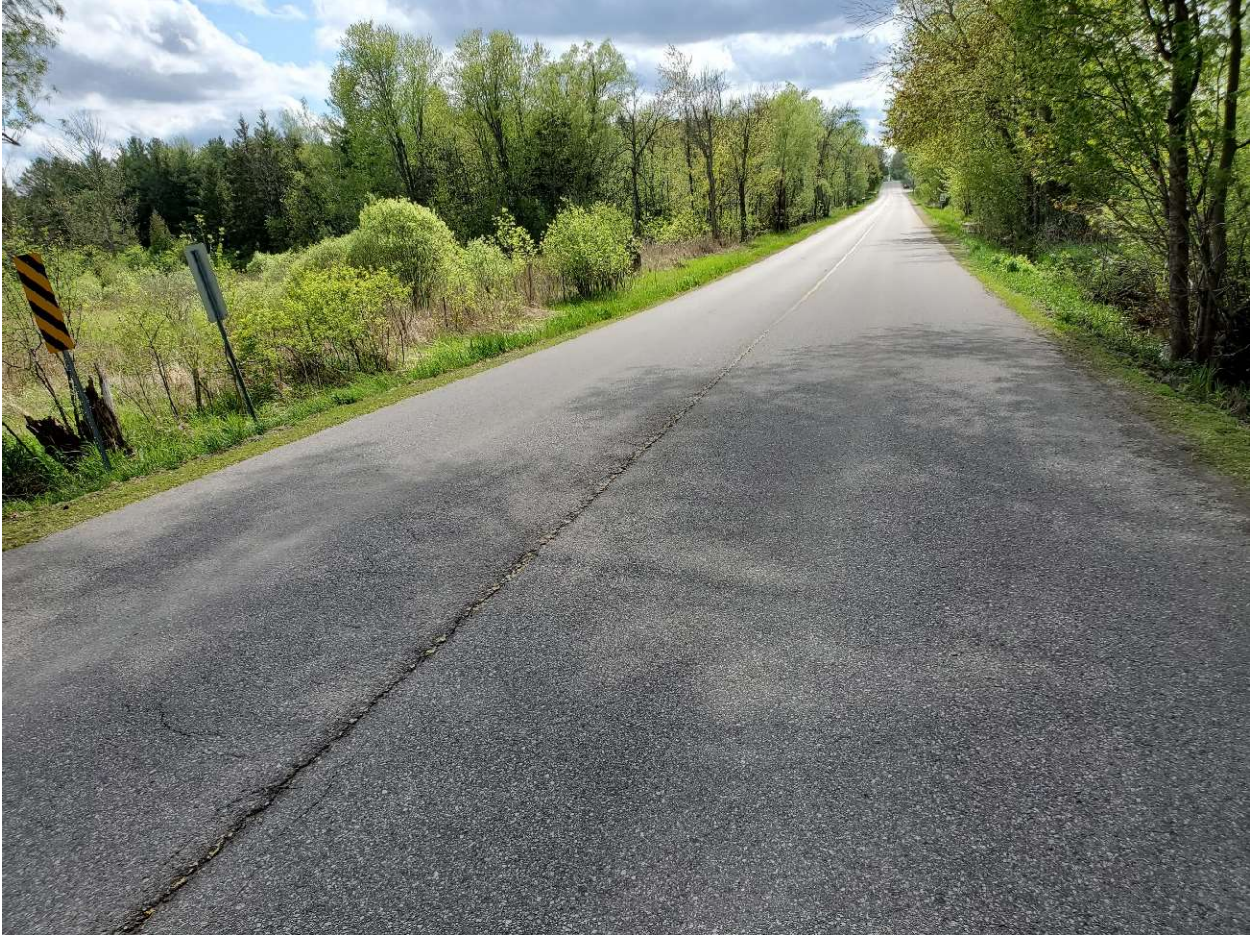
Approach from East

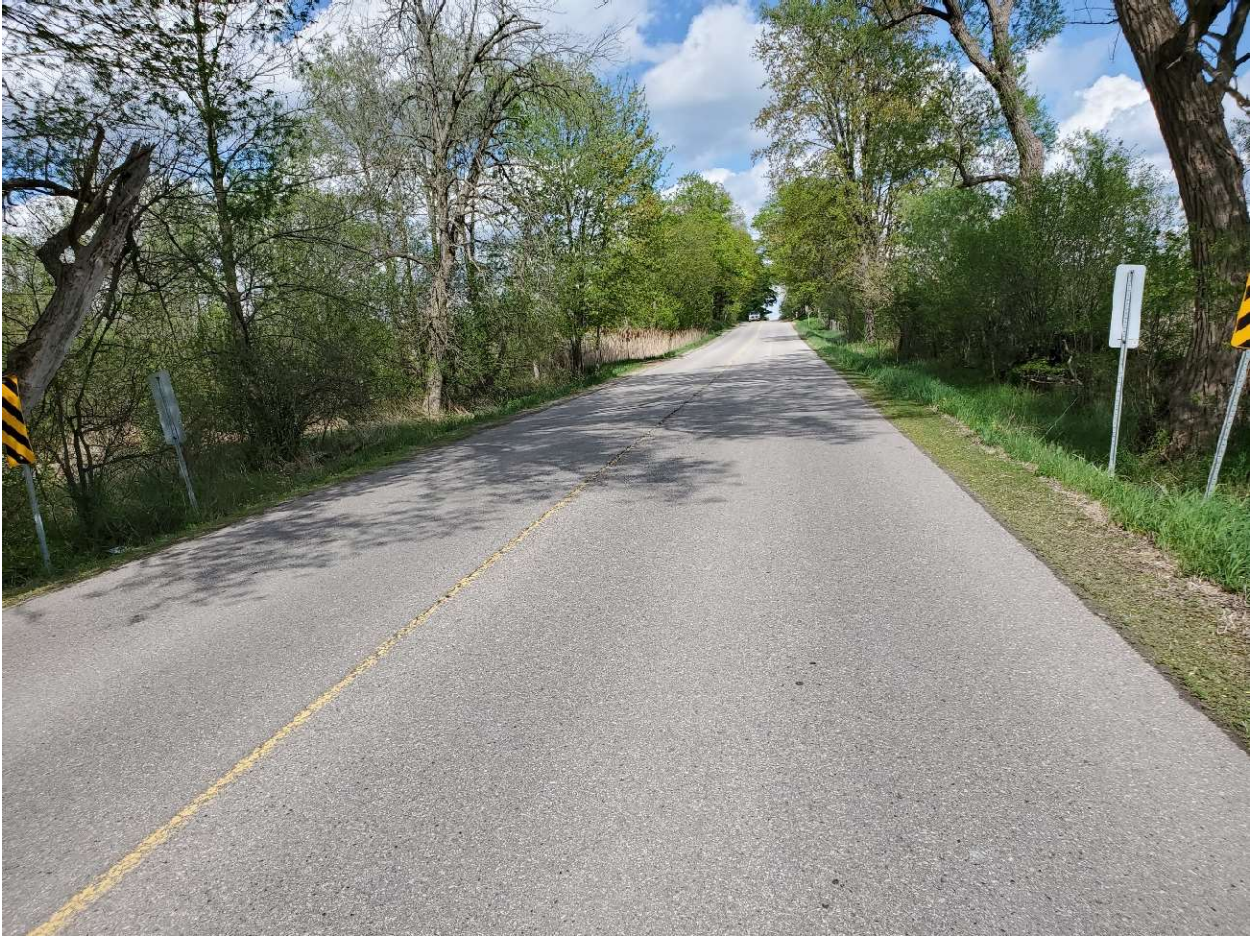
Approach from West

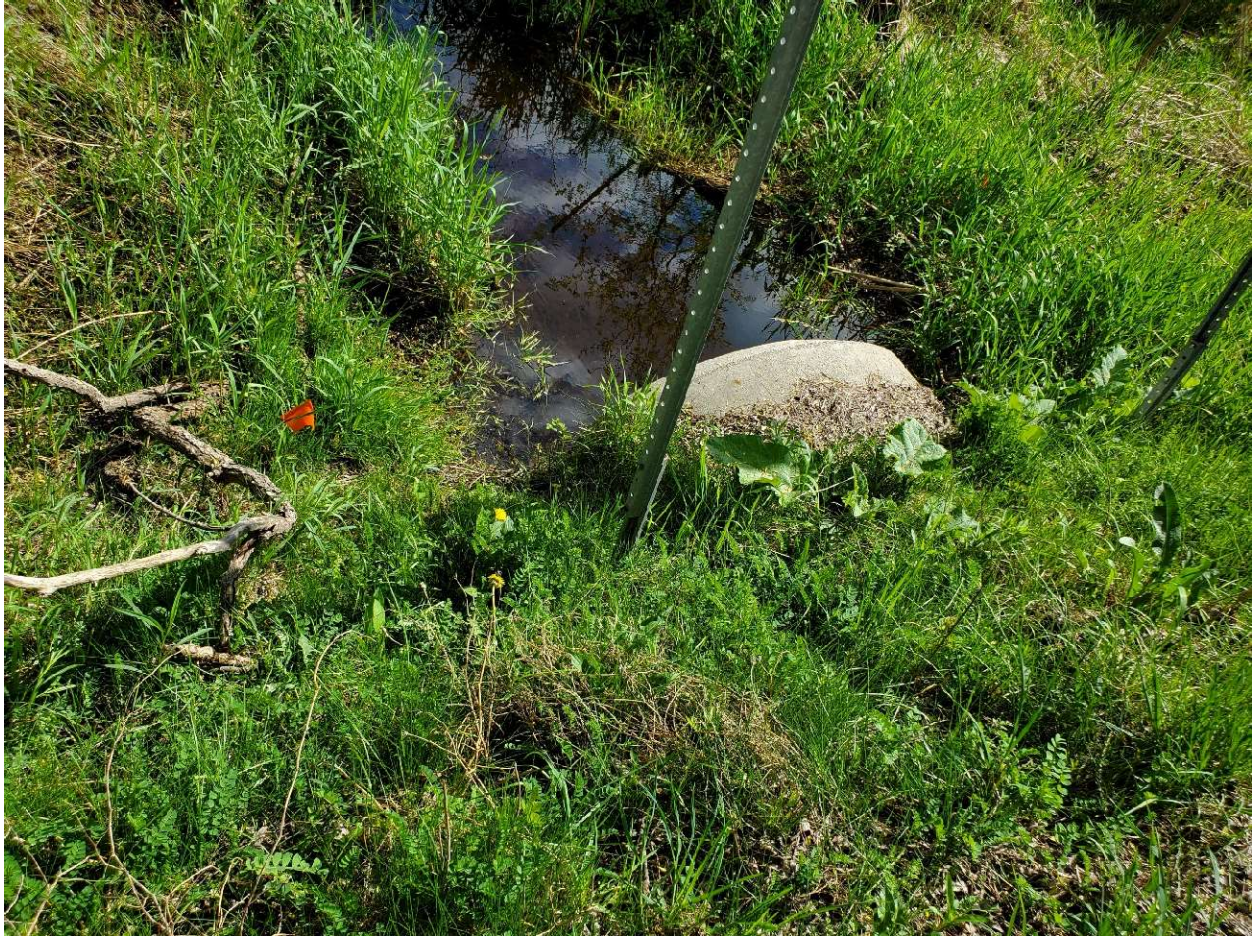
Upstream view

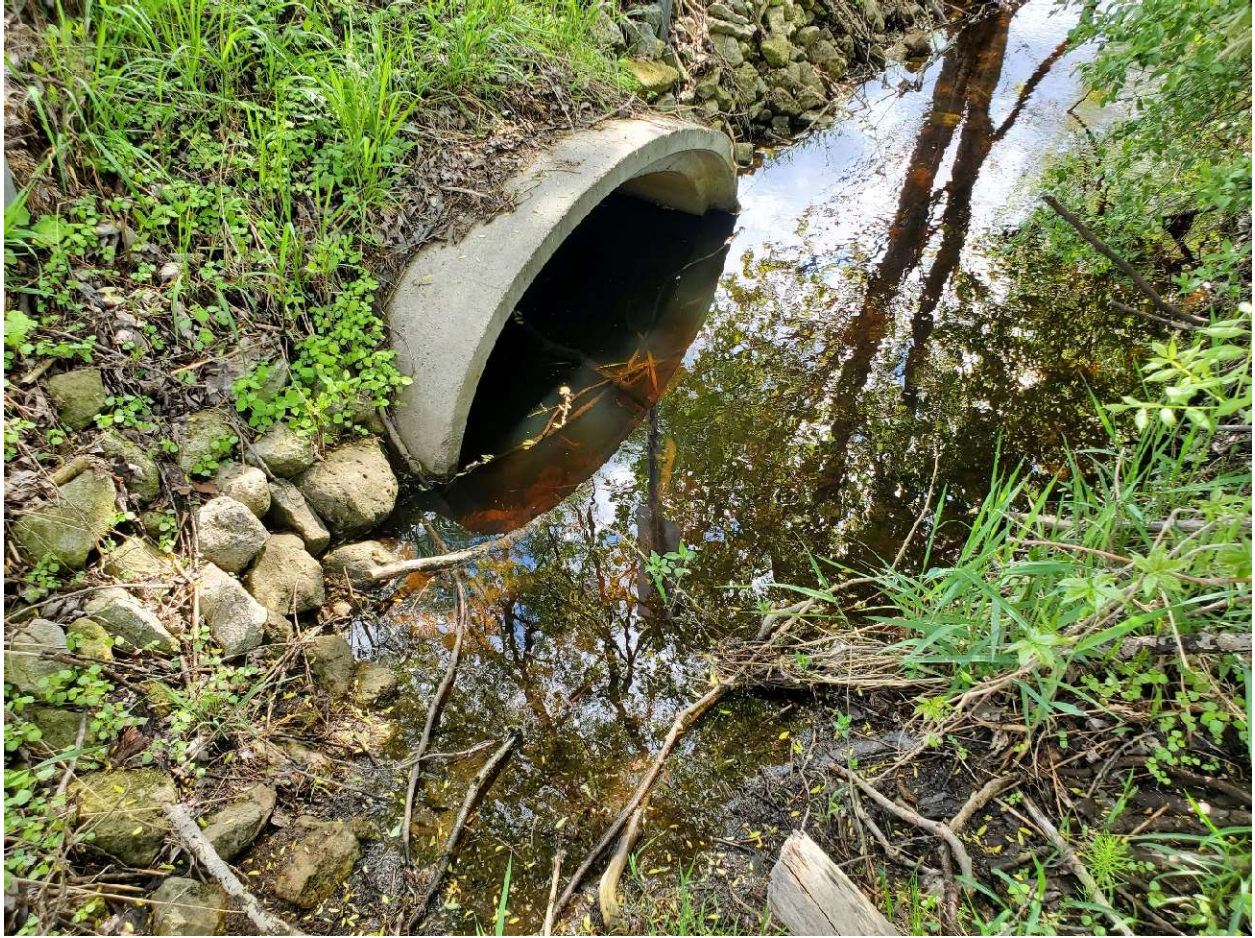
Downstream view
